Lochrin Basin, Edinburgh: Archaeological Excavation Data Structure Report

AOC Project 22769
22nd May 2015

Lochrin Basin, Edinburgh: Archaeological Excavation

Data Structure Report

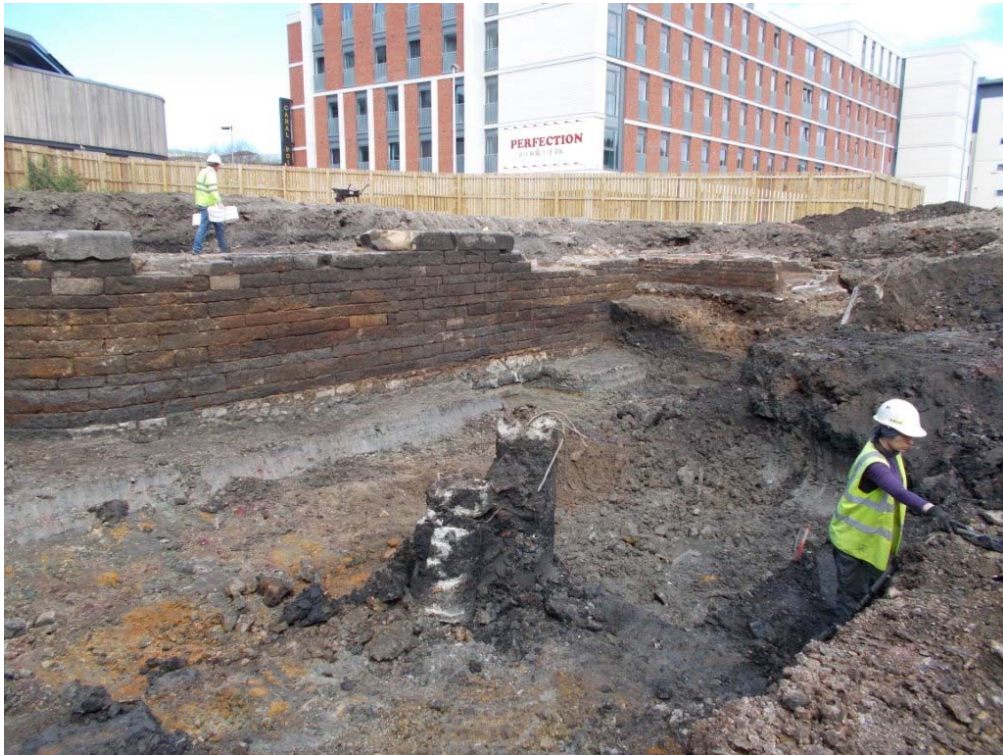
Plate 1 - Concrete piles within basin fill

- 4.2 Within Areas A and E, the remains of large concrete piles for the garage construction were revealed that truncated the basin deposits. Furthermore, several drainage and other service pipes had also impacted upon the original basin deposits, removing the basin silt completely in parts of Area C, D & E (Plate 1). Finally, two walls [002] and [035] with concrete foundations, and a clay lined structure [025] (Plate 2) were recorded within the basin or truncating the basin wall (Figure 10). These all related to the modern disturbance of the site after the basin had been backfilled. The remainder of the report will detail the findings related to the basin and the 18th century engine house.

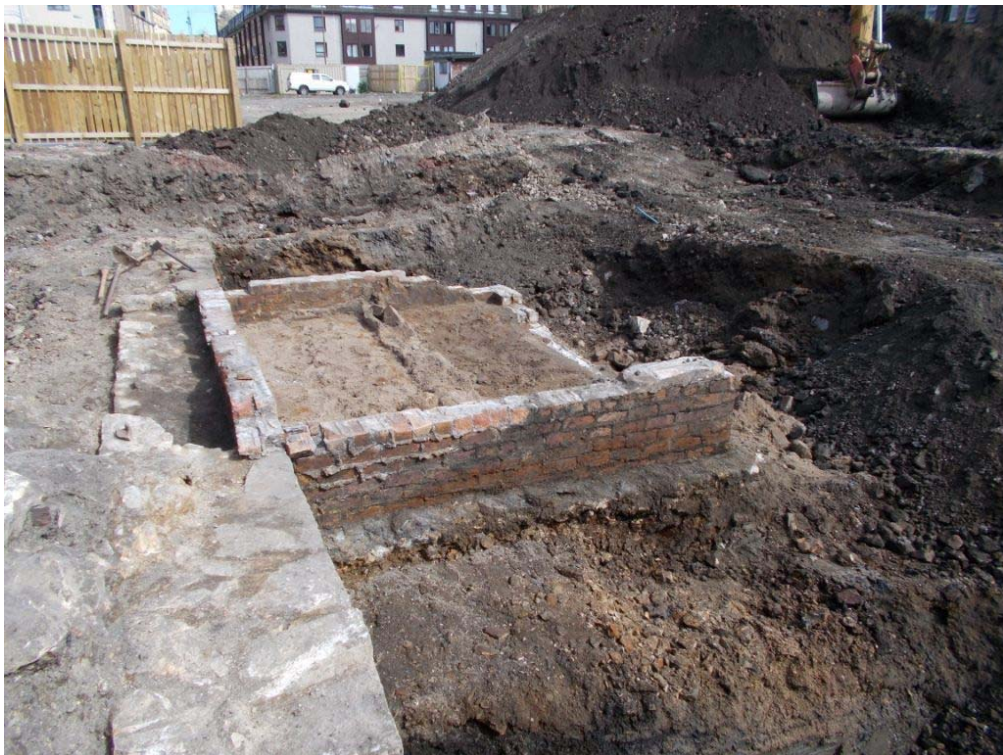
Plate 2 - Modern structure [025]

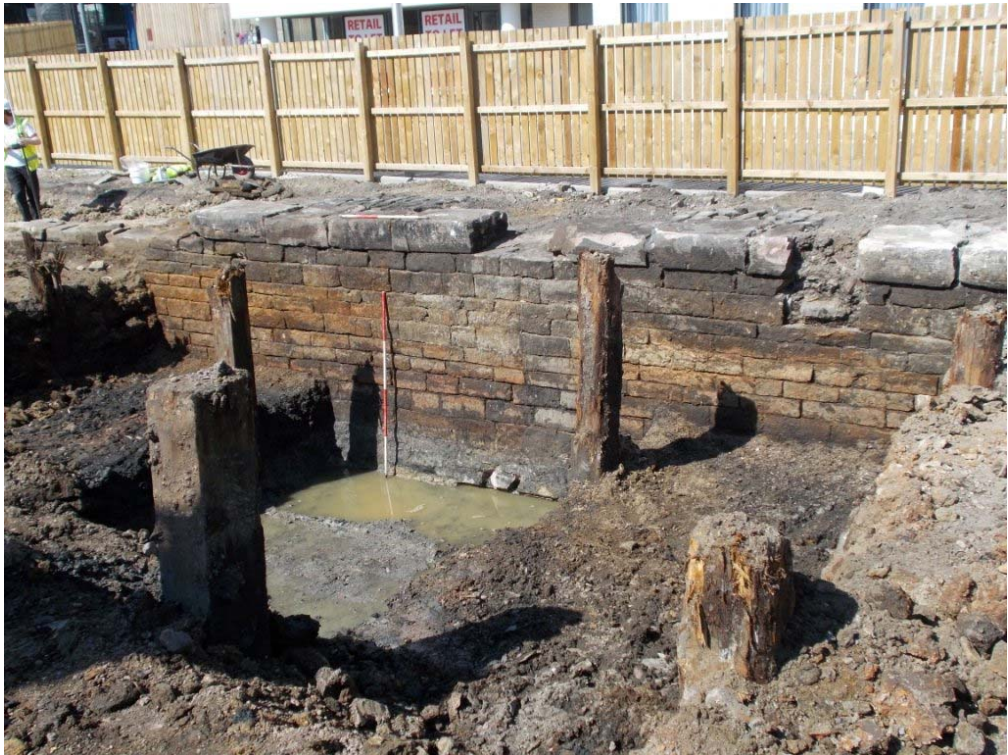
Plate 3 - Wall [003] in Area B

- 4.3 *Lochrin Basin*
- 4.3.1 The partially truncated basin wall [003] was revealed to the N edge of the site boundary (Areas A & B) and was aligned E to W, before curving to the NW where it would have connected to the Union Canal. Over 45 m of the wall was revealed, measuring 0.85 m wide and, where it survived to its full height, 2.6 m high (Plates 3 & 4). Where it survived to its full height, the S face of the wall consisted of 13 courses of dressed sandstone blocks overlying three courses of undressed sandstone, all capped with very large, rounded sandstone coping stones (73.521 m OD) measuring 1.12 m by 0.82 m by 0.26 m. The N face of the wall was only revealed in plan and consisted of medium and large, undressed sandstone with an abundance of sand and lime mortar.

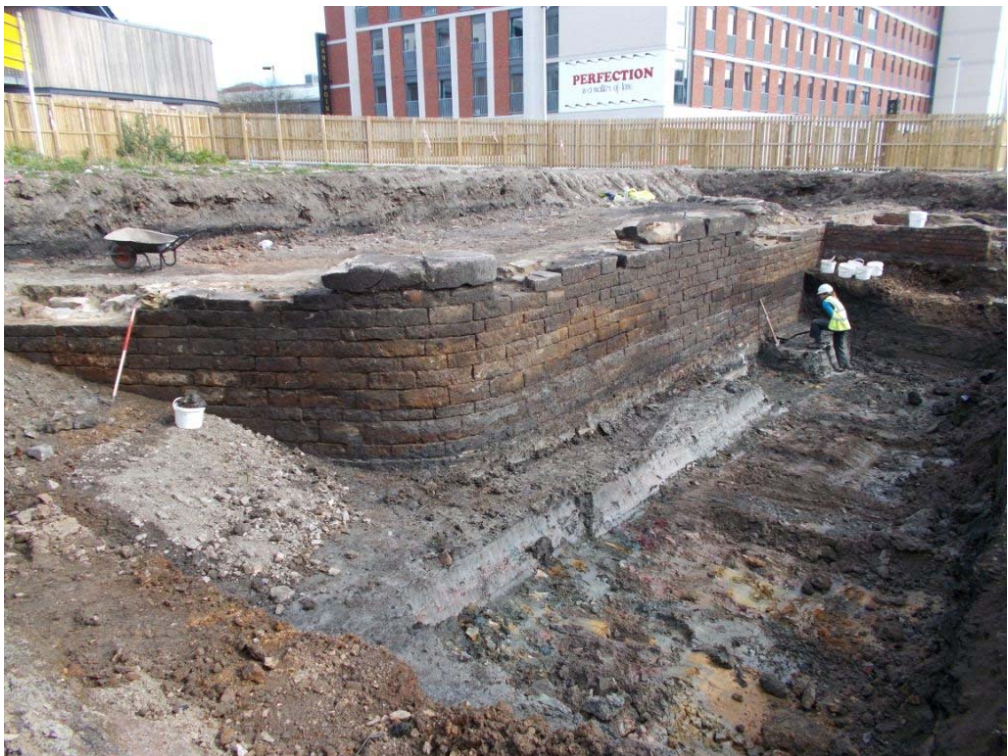
Plate 4 - Wall [003] in Area A

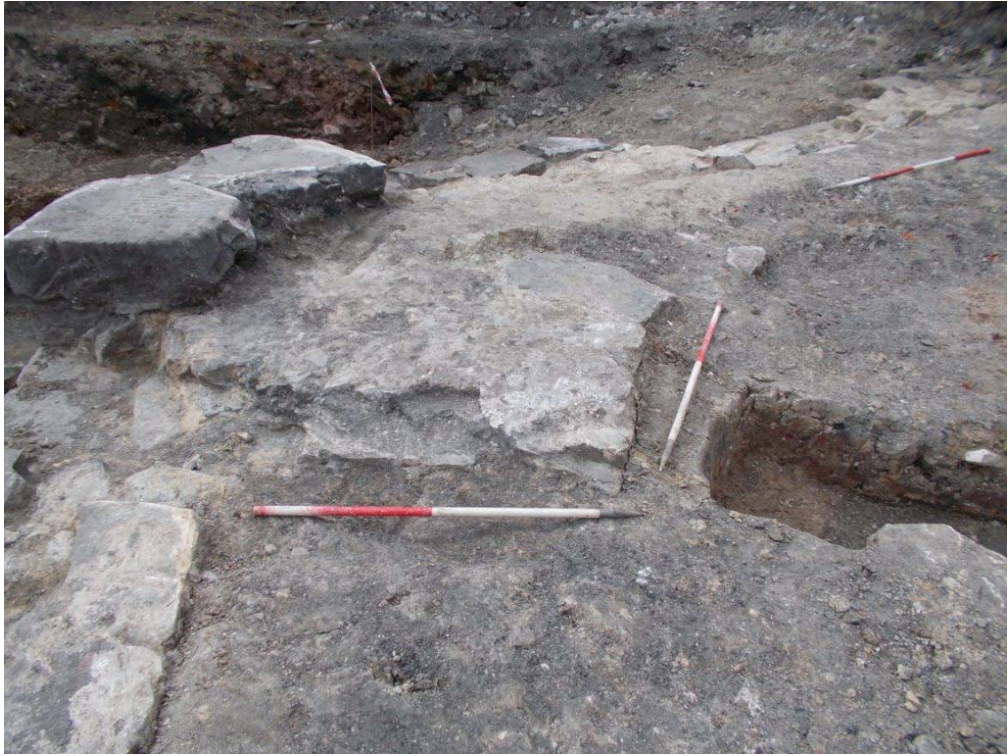
Plate 5 - Buttress [005] at bend in wall [003]

- 4.3.2 Where the wall curved to the NW a possible buttress [005] was noted, abutting the NE face and covered by the clay lining deposit [004] (Plate 5). This clay was present along the entire N edge of the wall and measured 1.3 m wide. The other main deposit of the basin was the clay floor [023], a pale grey clay with an abundance of small stone inclusions (Plate 6). This clay would have been the primary deposit within the basins construction cut, and formed the watertight lining of the basin.

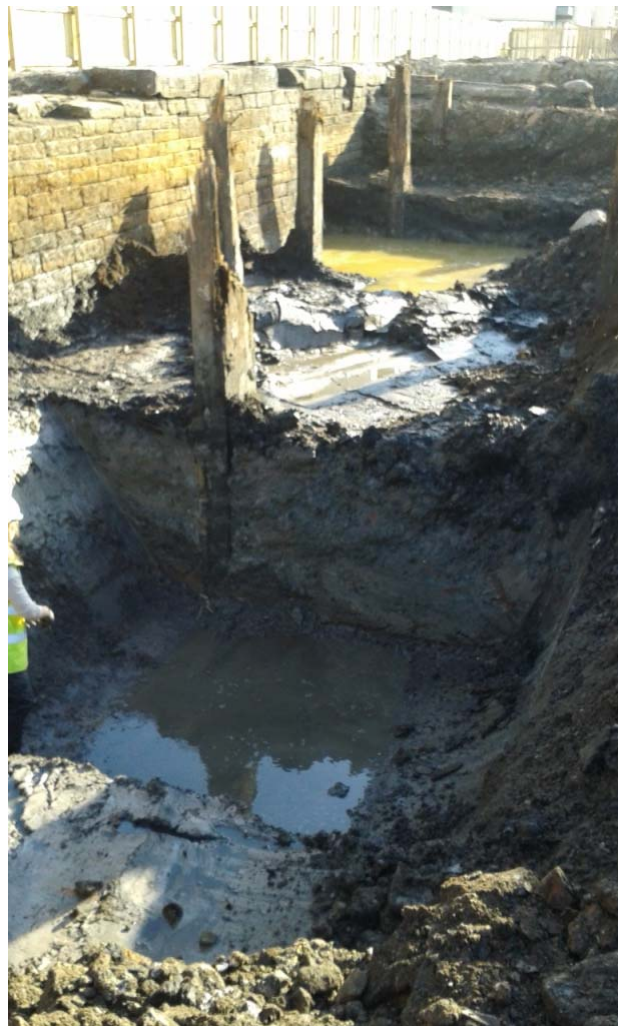
Plate 6 - Basin clay [023] in Area B

- 4.3.3 In the top 0.1 m of this deposit, where the water within the basin had gleyed the deposit, some ceramic fragments and a bucket handle were found. The clay was typically 0.45 m thick, overlying the natural geology [024], and was revealed to be up to 1 m thick in parts of Area B and 0.8 m in Area E. From the levels taken throughout the excavations, the clay deposit indicates that the basin was slightly concave in shape and also sloped from W to E (Figure 11).

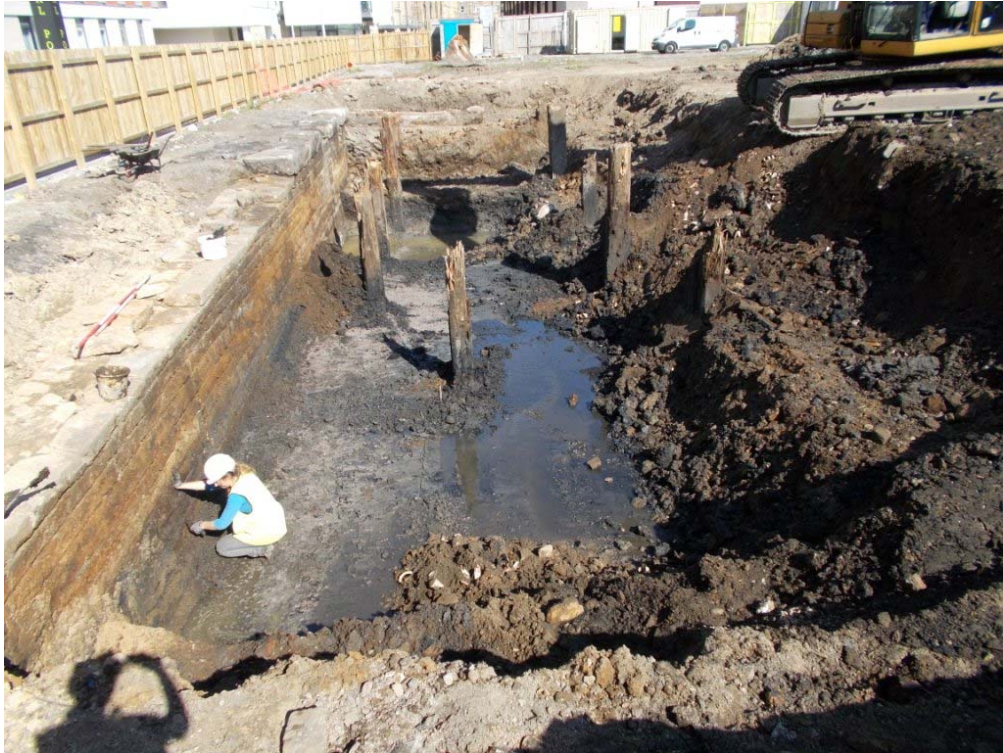
Plate 7 - Timber structure [038]

- 4.3.4 The final structural element to the basin was the timber structure [038] revealed in Areas B, C & D, to the E edge of the excavation area. It consisted of 24 square, timber posts that were driven into the clay [023] (Plate 7). The posts mainly formed a series of six rows and three columns, with further posts to the S (Figure 10). Most of the posts had the top 0.5 to 1 m truncated by modern developments, but the few that had survived to the height of wall [003] indicated they were over 3 m long (Plate 8).

- 5.2 As for the timber structure [038], it is suggested that this was created in order to allow several barges to be loaded and unloaded at the E end of the basin at any one time. Traditionally barges are moored parallel to the canal or quay walls, but by creating a series of bays it would have been possible to moor the barges alongside floating pontoons or each other allowing several barges to be loaded and off loaded at one time by the crane depicted in the 1838 plan of the distillery, or by moving items from one barge to the next until they reached the quayside. The width of the bays measured between 2.35 m and 3.8 m E-W, and 3.4 m to 3.6 m N-S, providing space for five or six barges or narrow boats that were typically 2.1 m in width.

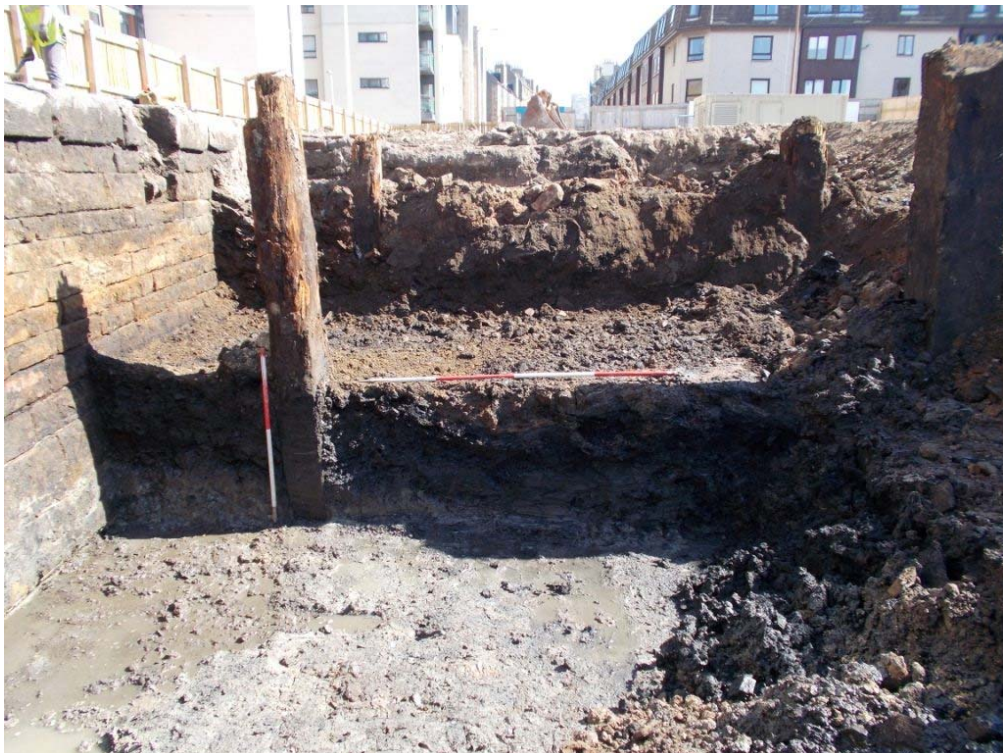
Plate 8 - W-facing section through Area B with full height post

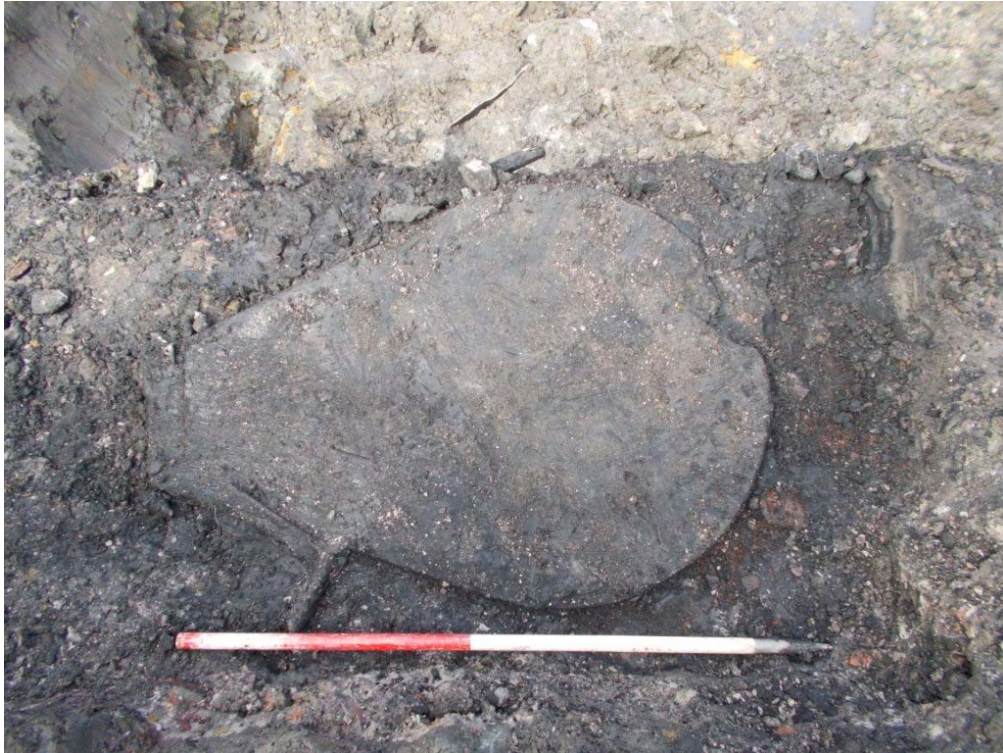
Plate 9 - Industrial bellows (SF 22) in-situ

- 4.3.5 Throughout the basin, the excavations revealed a thick black silty clay deposit [022] that overlay the clay floor [023]. It contained numerous artefacts including: leather shoes; ceramic bowls, plates, bottles, jars and tea pots; glass fragments; metal objects such as a large iron file, a bucket, and several shovel heads; and fragments of timber along with timber planks and one half of a large industrial bellows (Plate 9). This deposit was 0.55 m in depth towards the N edge of the basin although became much shallower towards the S edge of the site, where it was only 0.1 m in depth. As previously mentioned, the service trenches of the modern garage had also truncated this deposit in places.

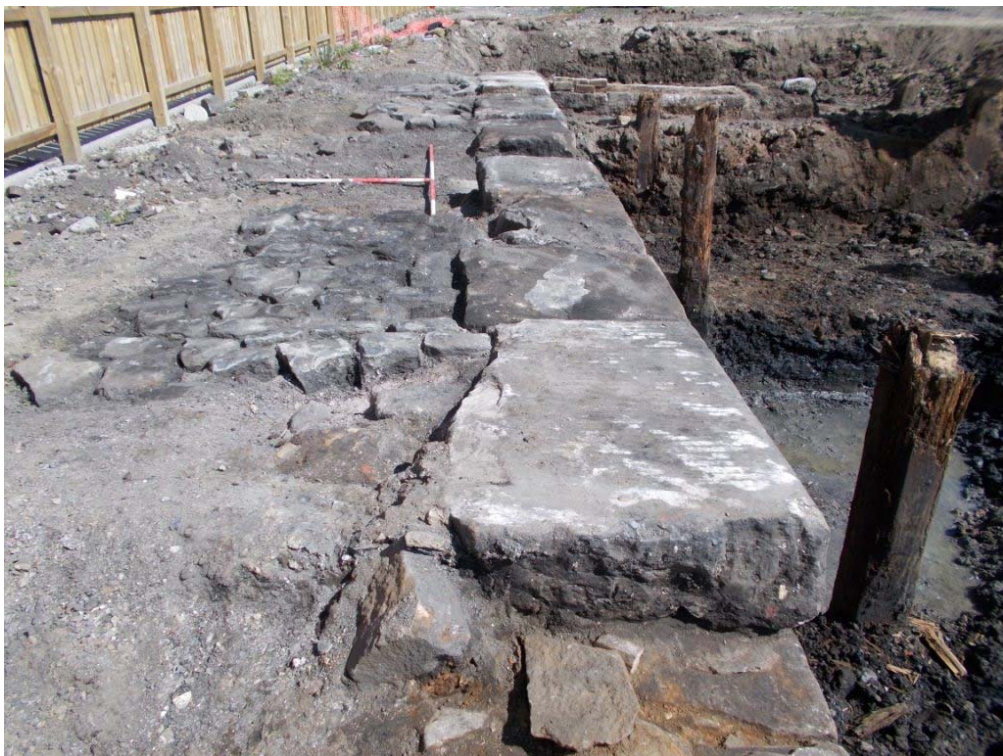
Plate 10 - Cobbles [036] to N of wall [003] in Area B

- 4.3.7 Just outside the N edge of the basin and contemporary with its use were several areas of cobbled surface and flagstones that are the last surviving remains of the quayside. Cobbles [036] consisted of regular, angular setts abutting the basin wall in Area B (Plate 10) next to where timber structure [038] was revealed. However, a mixture of cobbles [007], flagstones [006] and [009], and a concreted surface [008] in Area A (Plate 11) indicates that the quayside may not have been completely uniform with some areas being used for different purposes. The cobbles sat on an ashy bedding layer [016], which in turn overlay a made ground [017] that was present on site prior to construction of the basin. A possible drainage cut [029], with clay lining [030] was present in Area A to the immediate N of the clay lining [004] that would have been underneath the surfaces [006] – [009] (Plate 12).

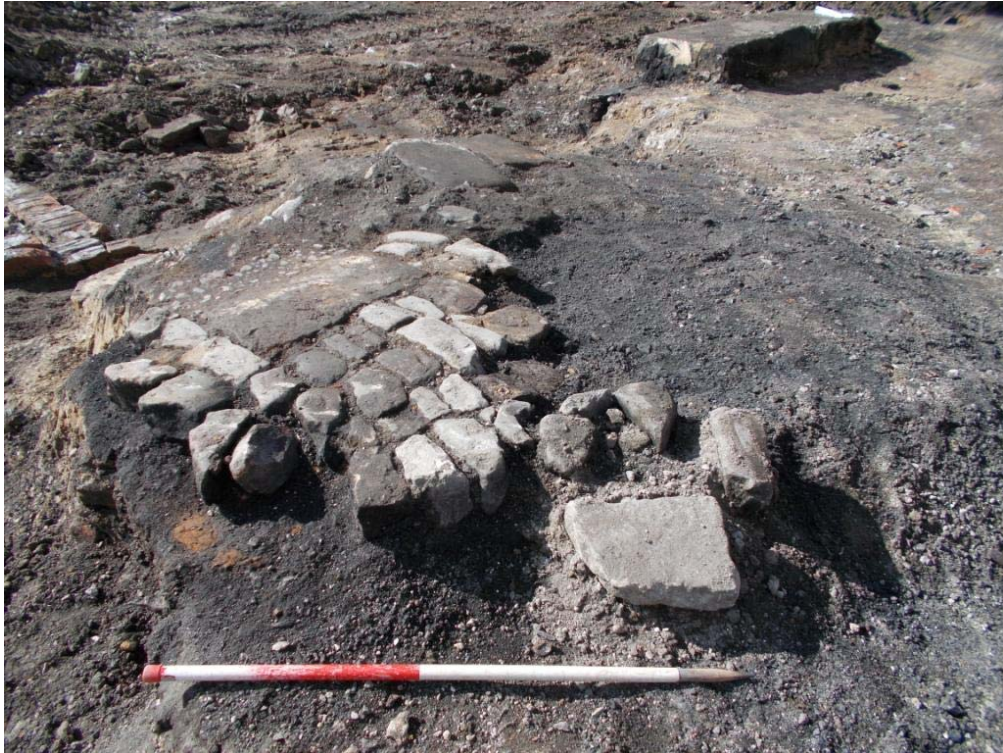
Plate 11 - Surfaces [006] to [009]

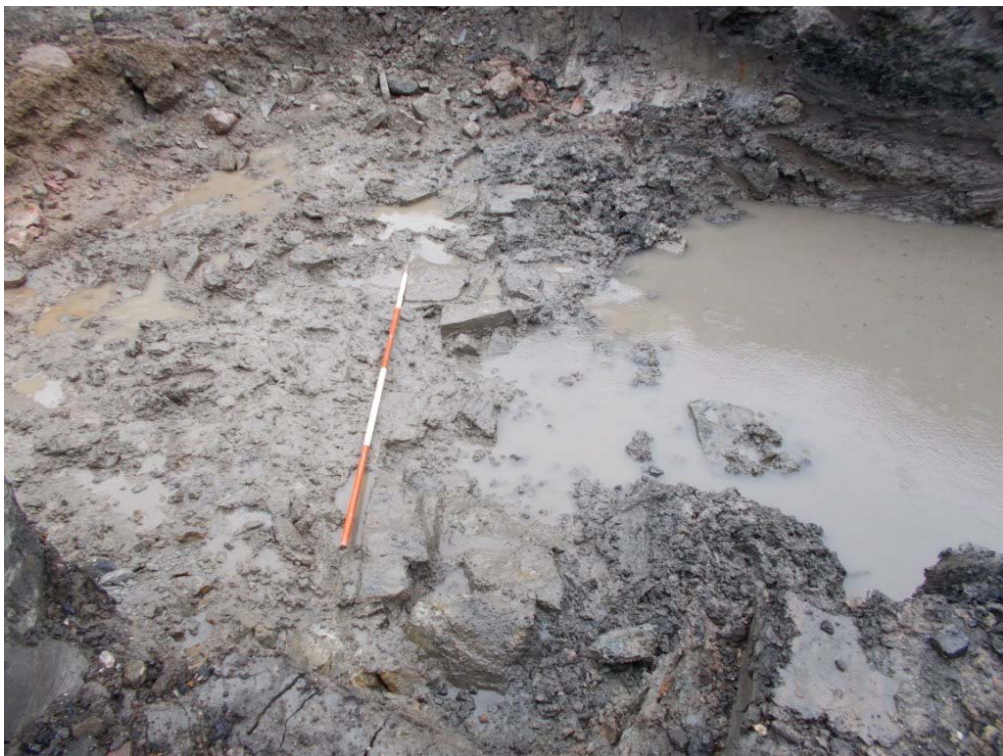
Plate 12 - Distillery pond wall [047]

- 4.4 *Distillery pond*
- 4.4.1 A sandstone wall [047], 5.79 m in length was revealed beneath the clay floor of Lochrin Basin [023], approximately 5 m S of basin wall [003] (Figure 10). The wall was aligned ENE-WSW and only survived to one course in height and had been removed by the basin construction as it sloped W to E. It was set within construction cut [046] and, as with wall [003], had a clay lining [048] on its external face. The wall was 0.6 m in width and the clay was approximately 1 m in width. No evidence of the wall survived further E, with the most eastern 2 m of the wall only visible as a robber trench.

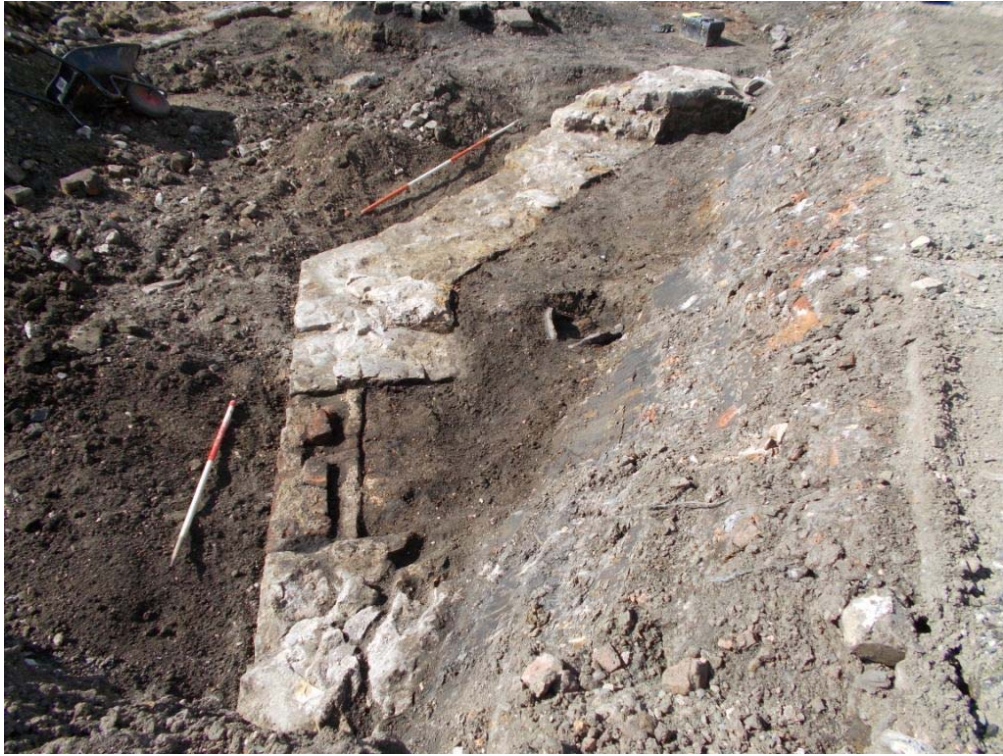
Plate 13 – General view of Engine house [010]

- 4.5 *18th Century Engine House*
- 4.5.1 At the NE edge of Area A was the remains of the Engine House [010], which extended further N out with the excavation area (Figures 10 & 12). This structure consisted of angled walls [012] and [014] to the W and E respectively of a blocked entrance [013] (Plate 13). The

walls were of sandstone construction measuring 0.9 m thick and surviving to a height of 2.1 m, all of which survives below the level of the basin and cobbled surfaces. The structure appears to be octagonal in plan (as suggested by the historical mapping) and is approximately 6 m in diameter. The brick wall within the entrance to the building indicates it had been blocked up prior to the made ground [017] being deposited.

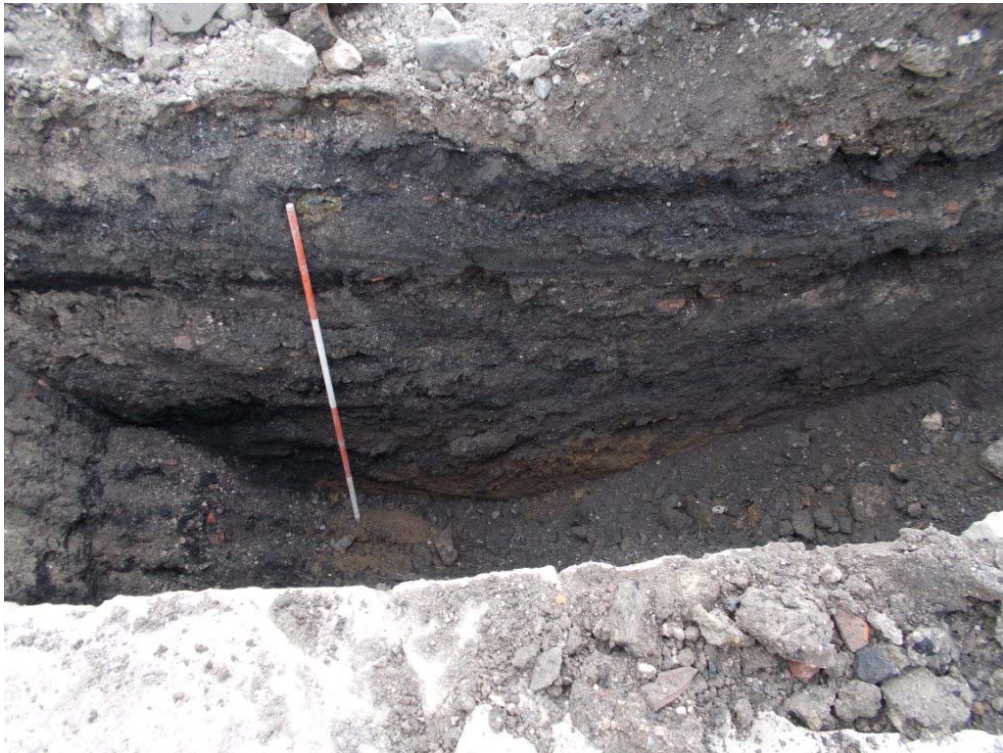
Plate 14 - View of excavations showing made ground [017] depth

- 4.5.2 Excavation of the deposits within the structure indicate that a rudimentary floor level [019], consisting of a compact, dark grey and black stony silty clay, may have been partly floored by timber [018]. This possible floor deposit had been partly truncated by a modern pipe [011] sitting on a slate base [040], relating to the use of the site as a garage. Within the other deposits contained by the structure, some Scottish Post-medieval Reduced Ware (SPMRW) was found. Under the floor surface several thin deposits [049], [043] and [050] overlay the main fill of the structure [044] (same as [039]) (Figure 13).
- 4.5.3 Excavations of the interior had to stop at 1.5 m due to health and safety concerns. However, excavations by machine to the immediate S of wall [012] revealed that the made ground [017] was 2 m deep and that the engine house walls survived to 2.1 m high (Plate 14).

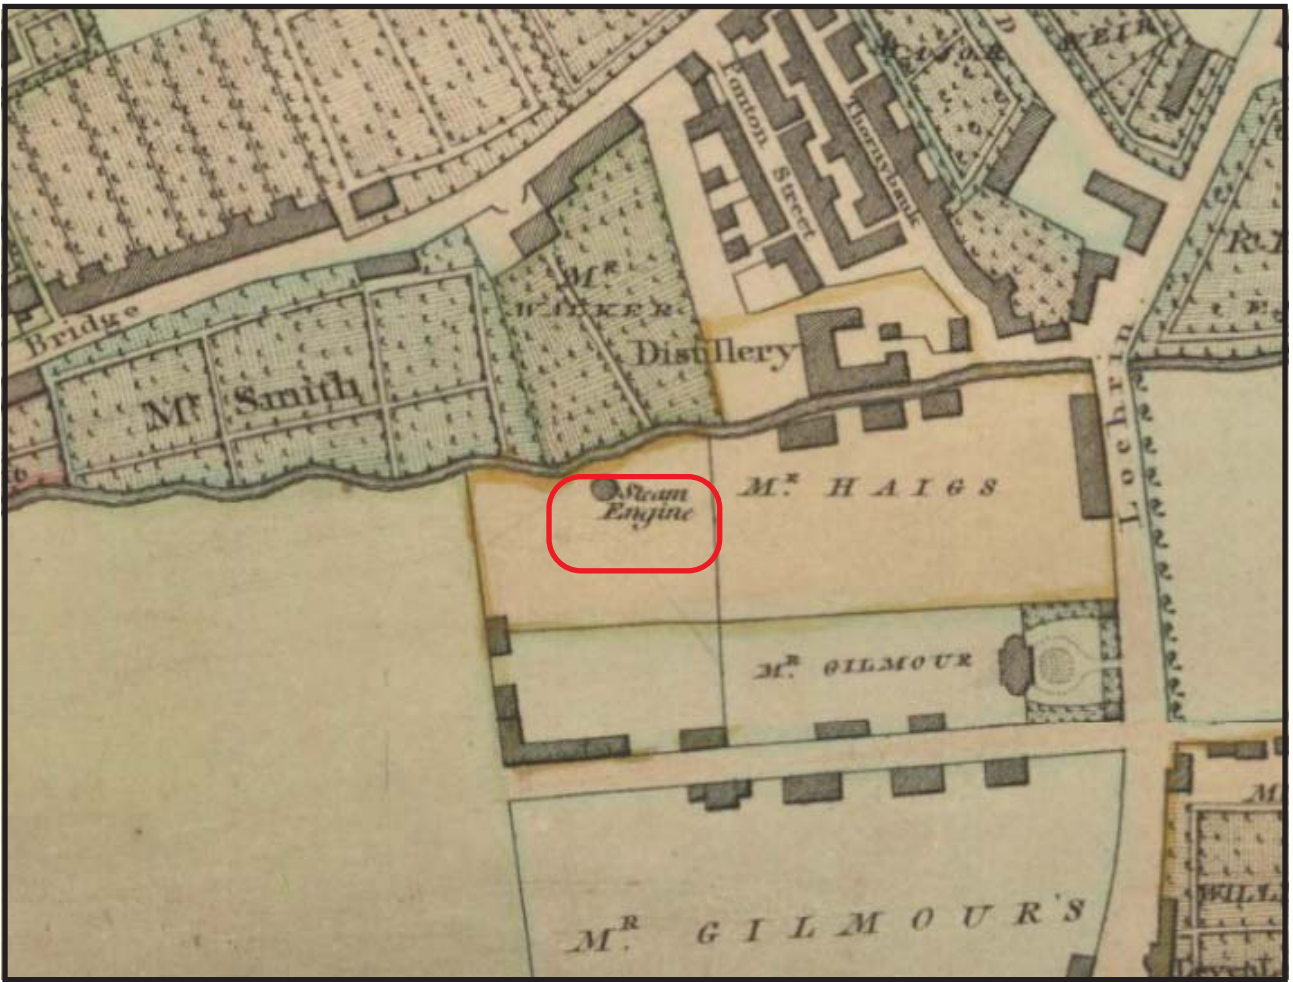
Figure 2 - Extract from Ainslie's Old and New Town of Edinburgh 1804

- 1.3.4 Gray's Brewery was purchased by Haig's Whisky Distillery in 1798 and renamed the Lochrin Distillery. Although short lived, the distillery prospered to become the largest distillery in Scotland. Both the development area and the distillery are first recorded in detail on Ainslie's map of 1804 (Figure 2), which shows distillery buildings immediately northeast of the proposed development, lining both banks of the Dalry Burn. The development area is depicted mainly as open ground, although a round structure marked 'steam engine' is shown

2009). Extending beyond the southern edge of the current development area, the excavation revealed 19th century structural features. The earliest surviving feature recorded was the remains of a wall, which appears to represent the original property boundary wall dividing the land owned by Mr. Haig, the notable distiller, to the north and Mr. Gilmour's to the south, as depicted on Ainslie's map of 1804. This later became the distillery's southern boundary bordering the rope works (see Figure 2). The subsequent excavations revealed 42 m of the southern wall of Lochrin Basin.

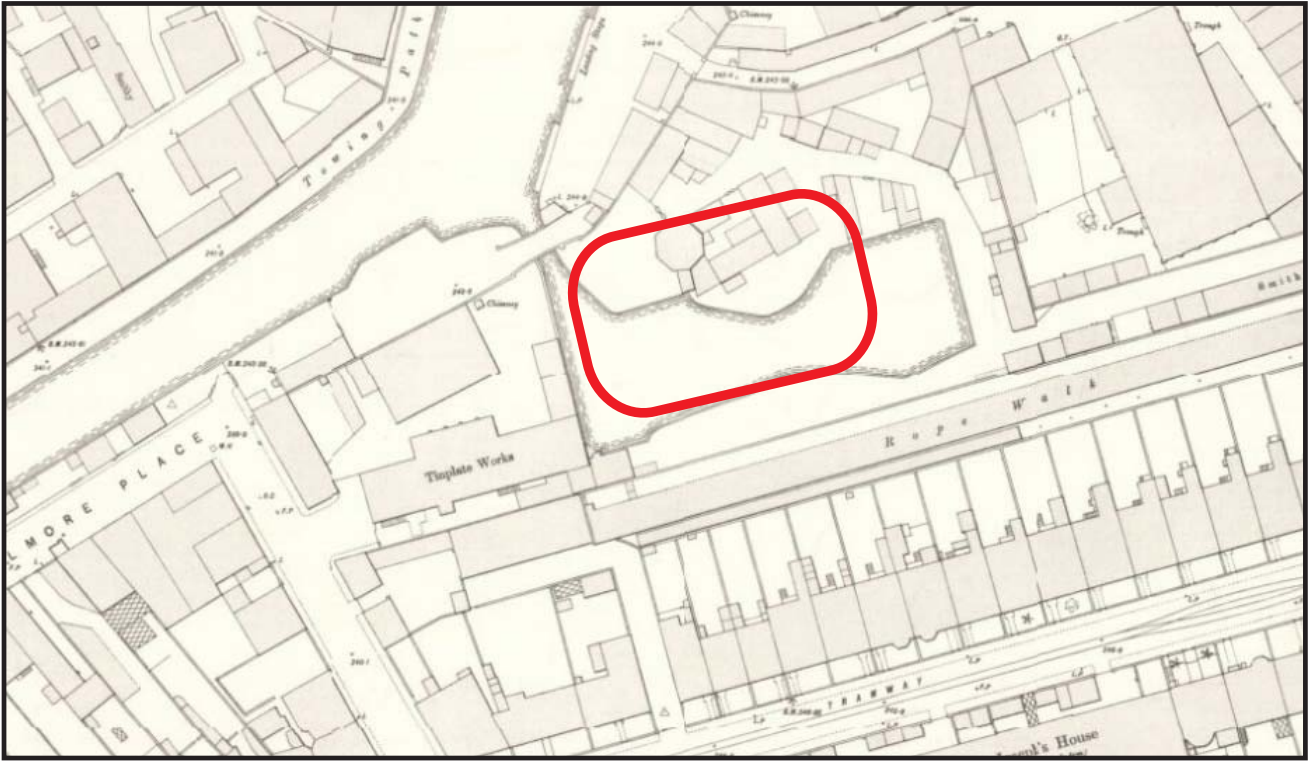
Figure 8 - Extract from Ordnance Survey 1895

- 1.3.10 Ordnance Survey mapping indicates that the infilling of the Lochrin Basin commenced some time after 1877 and had been completed by 1908. The 1895 Survey (Figure 8) shows the

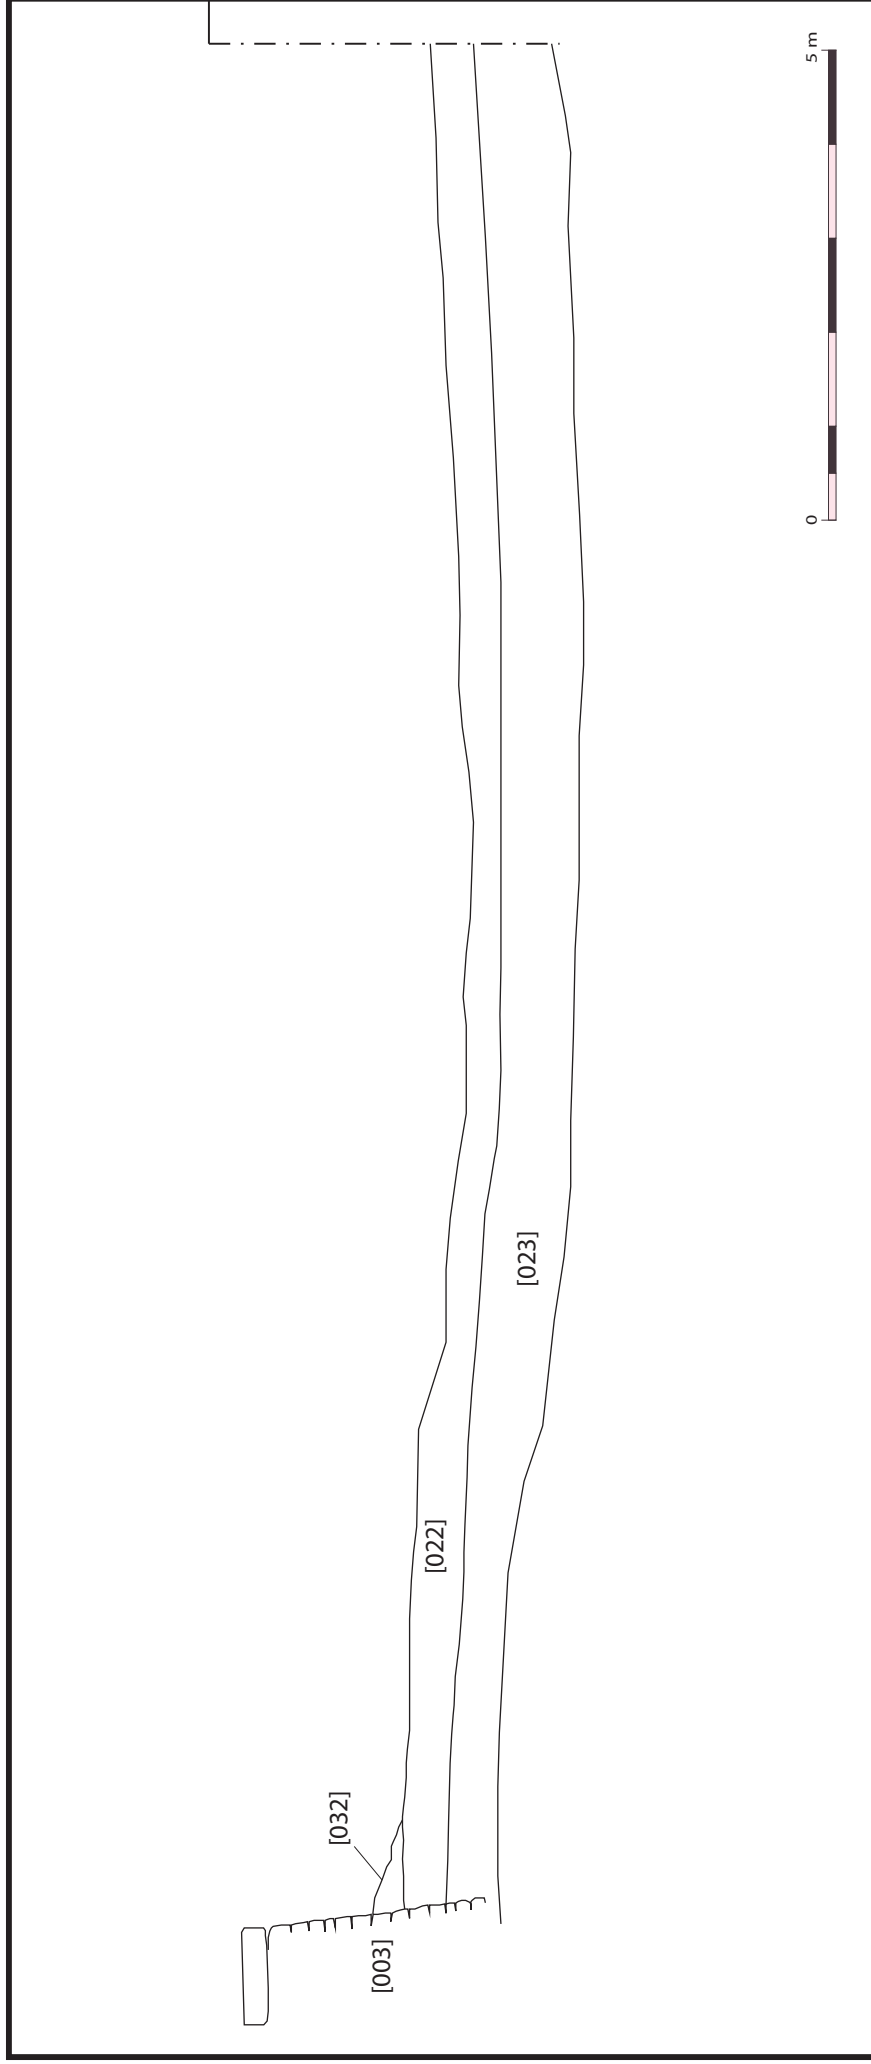
Figure 11 - W-facing section of canal basin deposits derived from level information

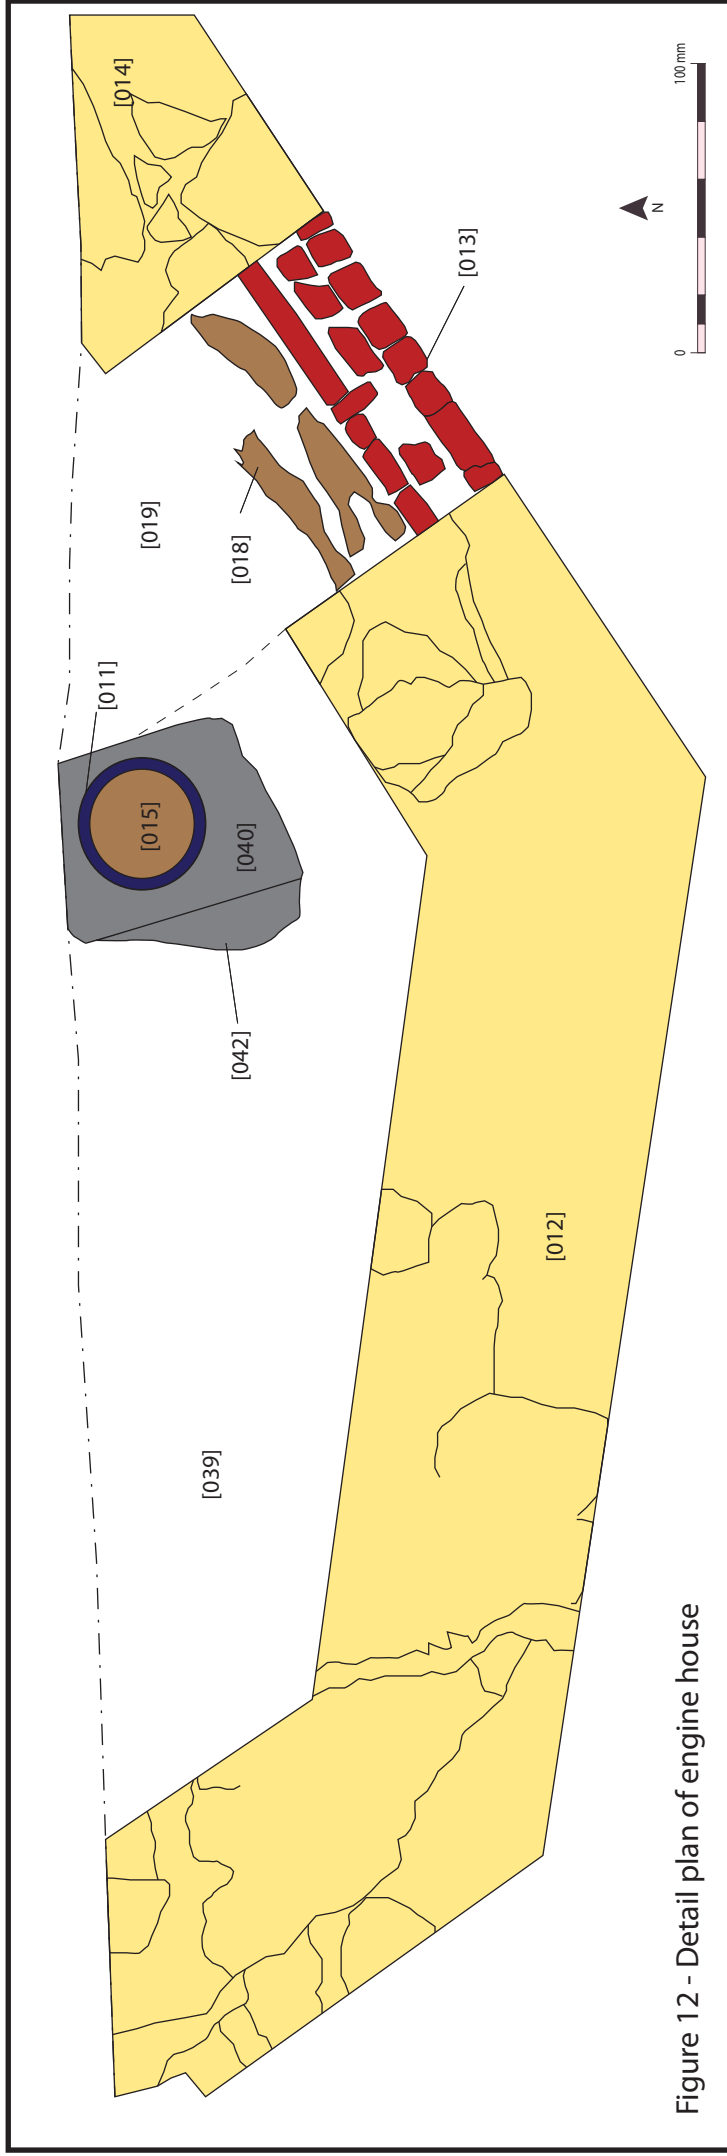
Figure 12 - Detail plan of engine house

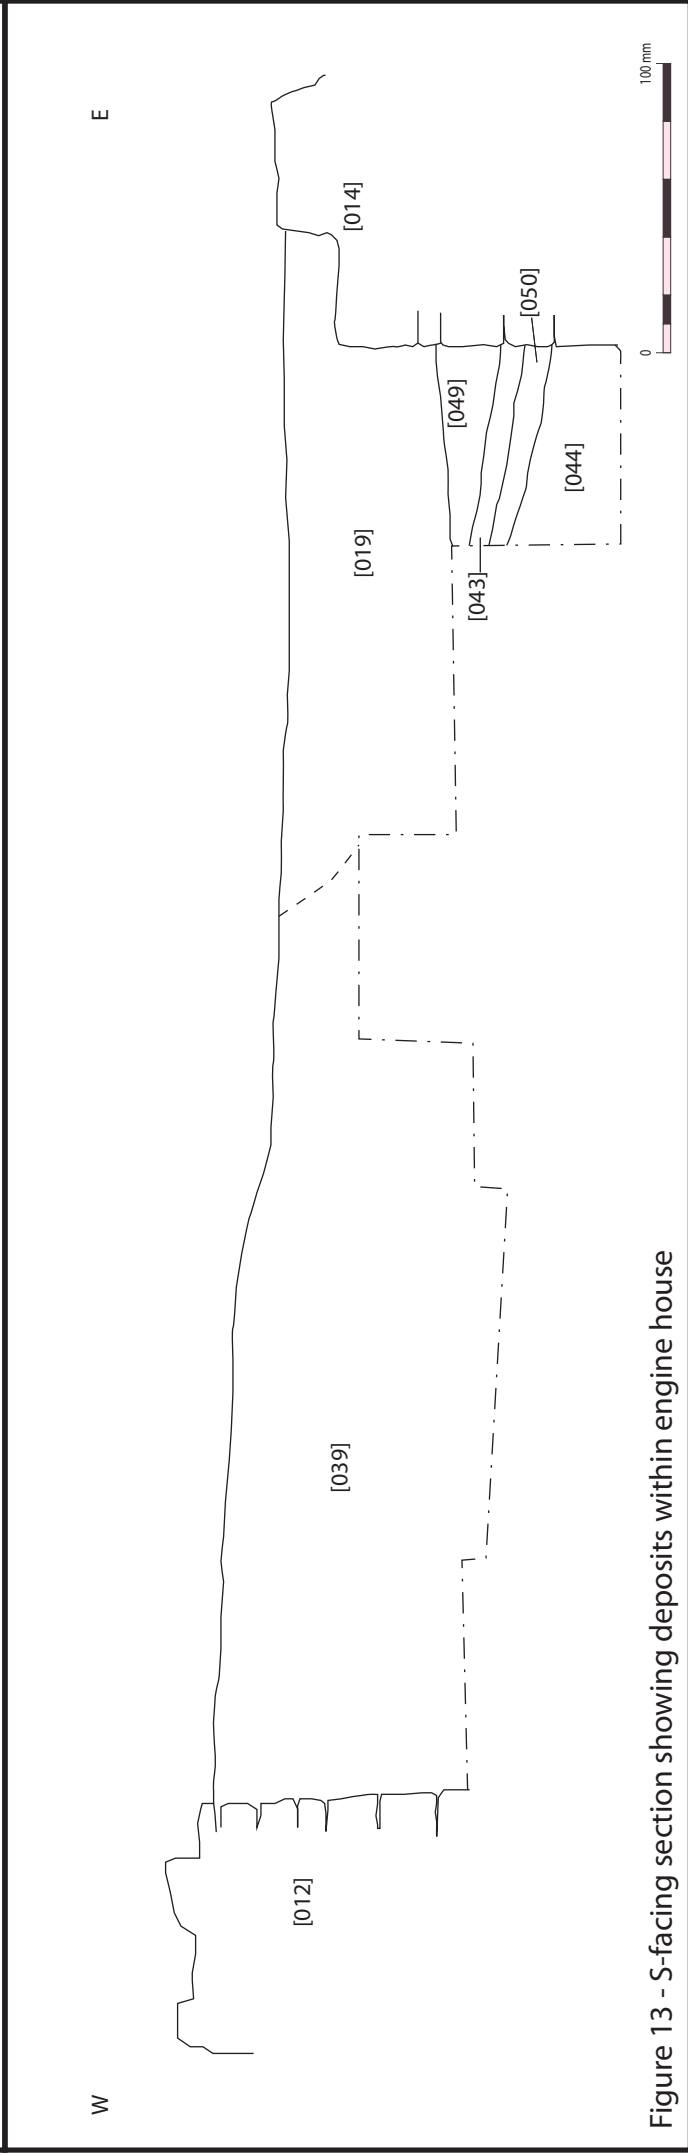
Figure 13 - S-facing section showing deposits within engine house
