6 Couper Street, Leith: Archaeological Watching Brief Report

*AOC Project 22957
31st August 2015*

On Behalf of:	Chamberlain Bell 3/29 Portland Gardens Edinburgh EH6 6NY
National Grid Reference (NGR):	NT 26627 76560
Planning Application No:	14/04514/FUL
OASIS No:	222197
AOC Project No:	22957
Fieldwork by:	Hana Kdolska Zana Stepka Diana Sproat Steven Watt Alan Duffy
Prepared by:	Diana Sproat Hana Kdolska
Date:	31 st August 2015

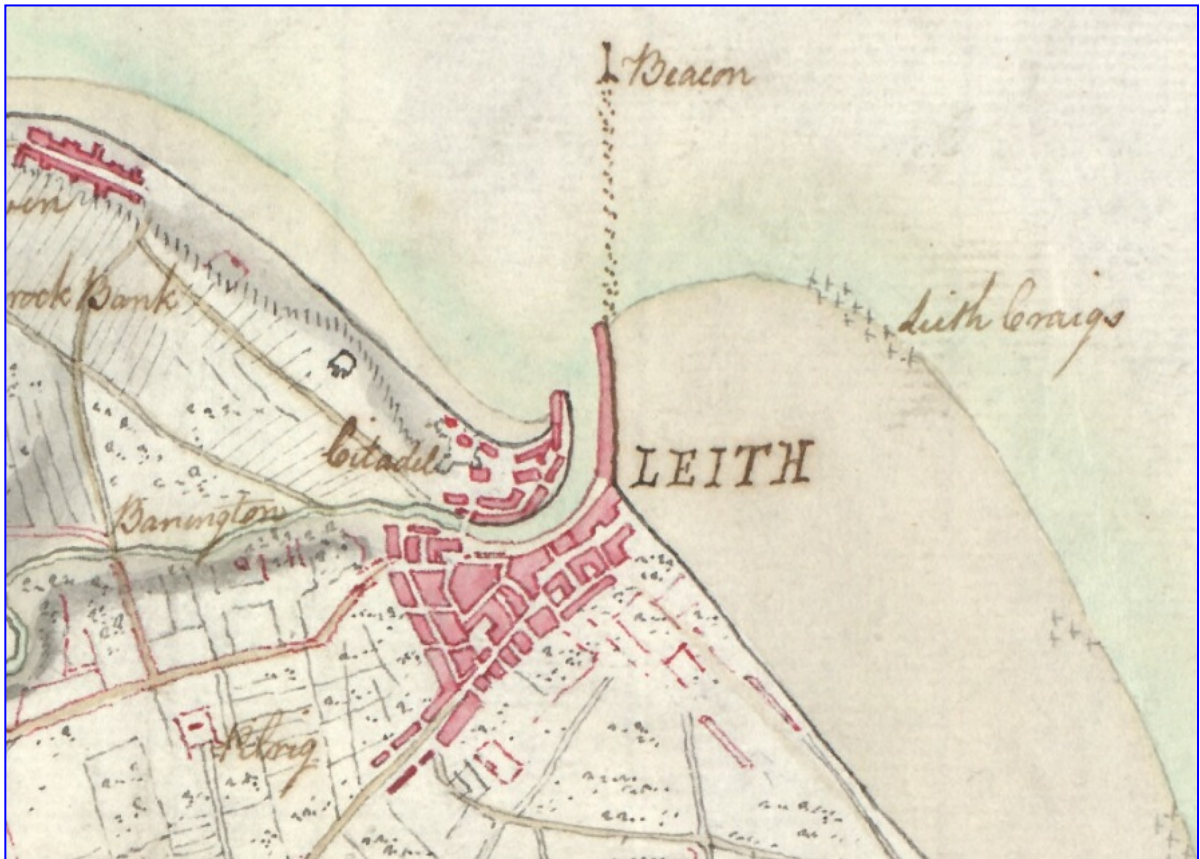
Figure 2: Extract from Board of Ordnance Plans ca. 1709 – 1755

1.3.1 Couper Street lies within an area known to have contained or been near the Citadel, built in 1656 by Oliver Cromwell's troops for use as a headquarters in Scotland. The Citadel formed the north edge of a much larger ditch and rampart fortification that surrounded Leith at this time and is clearly shown on the Board of Ordnance Plans from ca. 1709 – 1755 (Figure 2) and in more detail in the much later GPO map of 1807 (Figure 3). Prior to the creation of the Citadel, the site was also close to the location of an earlier bastion related to the 16th century fortifications surrounding the town. Remains of the ditch related to these fortifications were located in excavations conducted in 1994 (Collard & Lawson 1994) at Coburg Street to the south-east of Coburg Street and an evaluation completed there in 2004 revealed part of the course of the Leith Citadel, comprising a ditch and revetment wall (Hindmarch 2004).

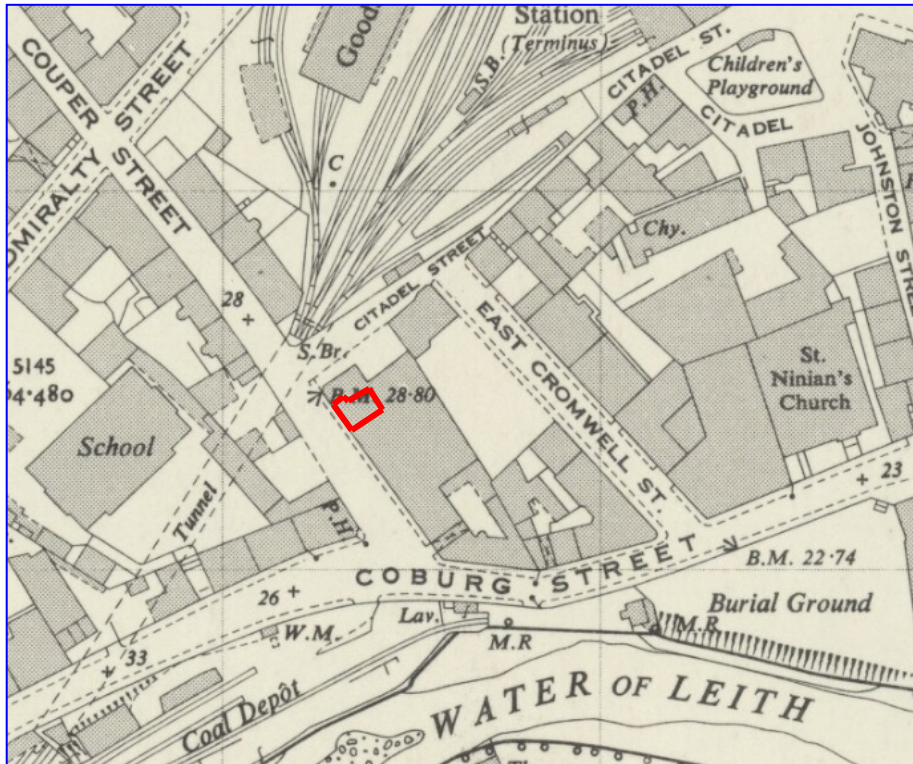
Figure 8: Extract from the Ordnance Survey map, 1949

1.3.3 Further expansions to this side of Couper Street occurred into the 20th century looking at the 1933 Ordnance Survey map (Figure 7), and the development site is still occupied by this time, although is unannotated. By the 1949 Ordnance Survey map (Figure 8), the site is blocked as one main building, possibly a much later development after demolition of the 19th century buildings.

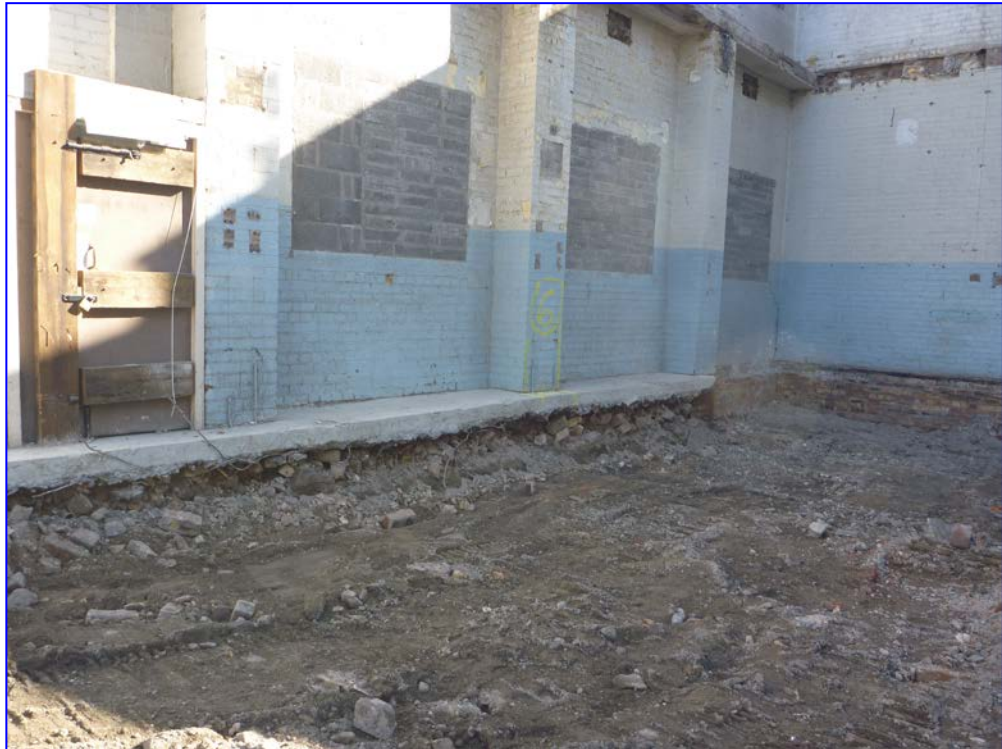
Plate 1: General view of the excavation of the concrete floor slab from the south showing made ground rubble (000) over the site prior to the excavation of the test pits

- Appendix 1 Context Register
 - Appendix 2 Photographic Register
 - Appendix 3 'Discovery and Excavation in Scotland' (DES) entry
- 4.2 The modern concrete floor slab overlay a layer of modern rubble (000), a make-up layer for the reinforced concrete surface (Plate 1). Given the requirements of the contractor's schedule, and in agreement with the CEC Archaeology Service, 9 test pits were excavated within the site to determine the level of the survival of remains (Figure 9). The test pits uncovered a series of sandstone walls, brick walls and sandstone surfaces, as well as some later more modern concrete walls and floors associated with much later occupation. No features were identified in Test Pit 1, which consisted of a midden deposit (001) identified below the rubble layer (000) consisting of a compact dark-greyish silty clay with occasional oyster shells, rusty metal fragments, animal bone fragments and degraded mortar. The deposit was 0.40m in depth and overlay a highly compacted dark greyish/black homogenous clay (002).

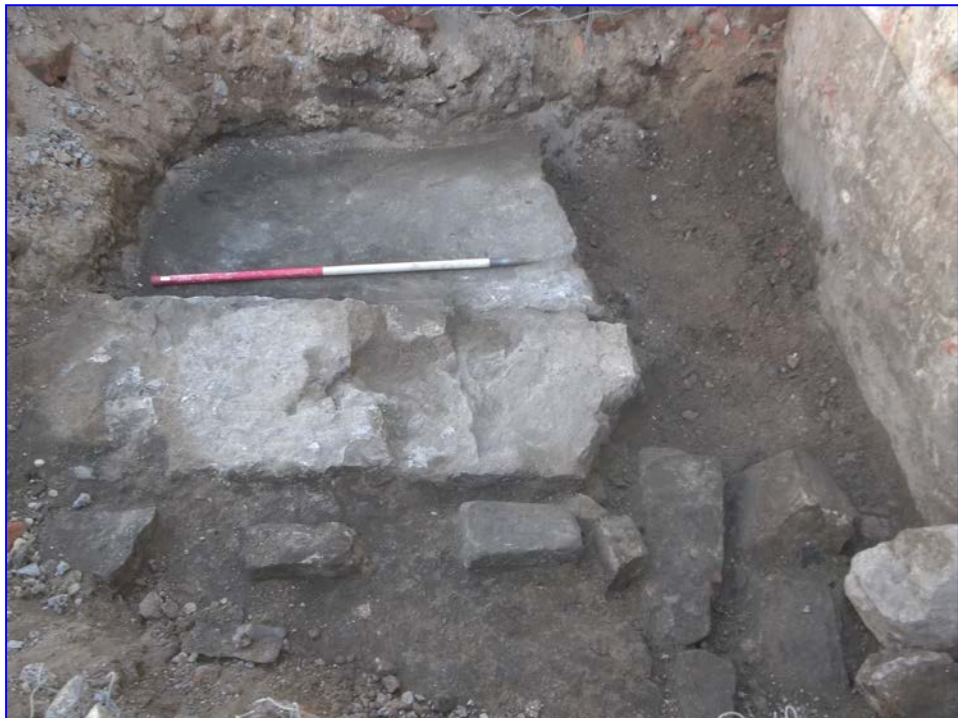
Plate 2: General view of Test Pit 2 from the south-west showing Wall [005] with possible floor surface [007] to the north-east and the foundation cut for the adjacent building to the south-east (right)

- 4.3 In Test Pits 2 and 3, a sandstone floor was identified – [006], [007] and [008] - with an additional north-west/south-east orientated sandstone wall [005] seen in Test Pit 2 (Plates 2 - 5). The south-east edges of these features had disappeared due to the foundation cut for the adjacent building to the south-east.

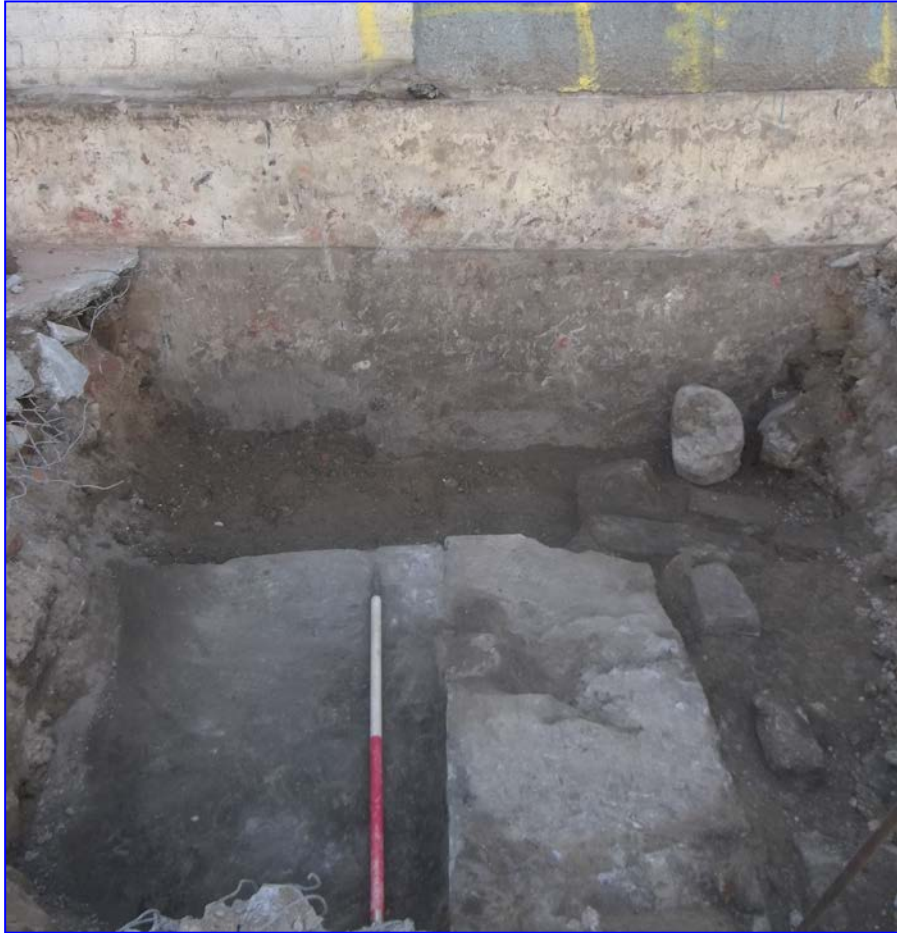
Plate 3: General view of Test Pit 2 from the north-west

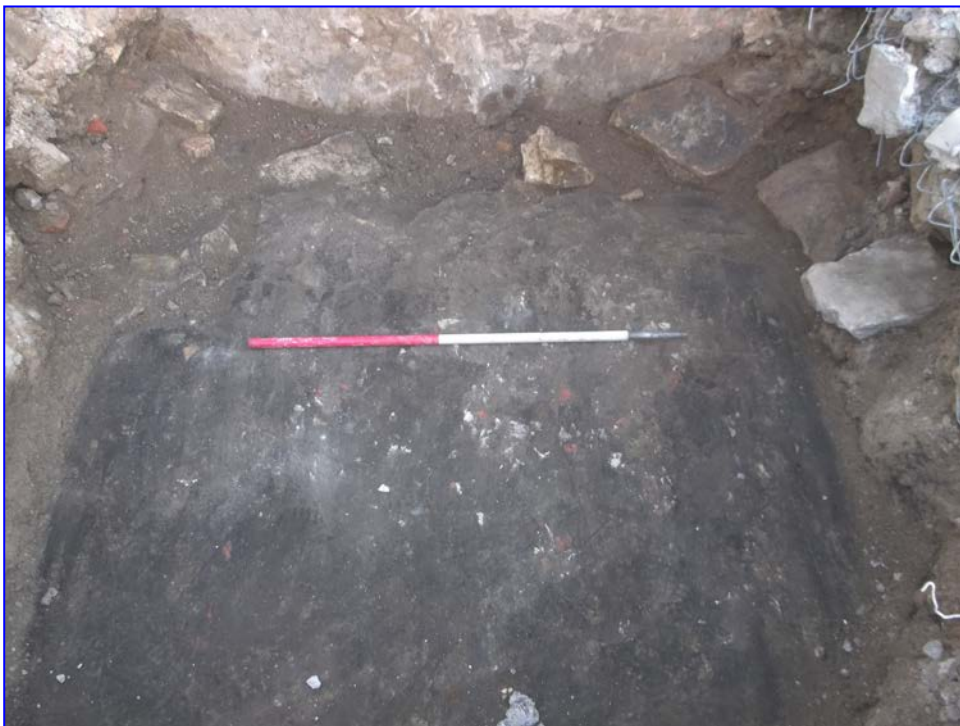
Plate 4: General view of Test Pit 3 from the north-west showing floor surface [008], a continuation of floor surface [007] from the south-west

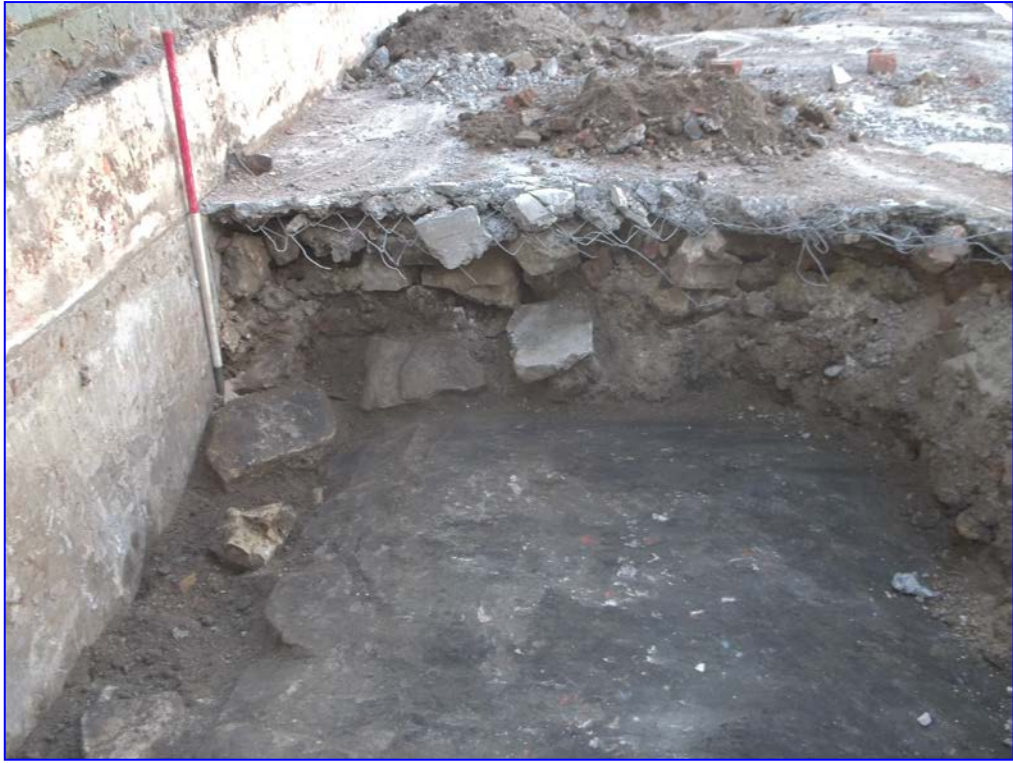
Plate 5: General view of Test Pit 3 from the north-east showing the depth of the modern rubble and floor slab (000) over the earlier floor surface [008]

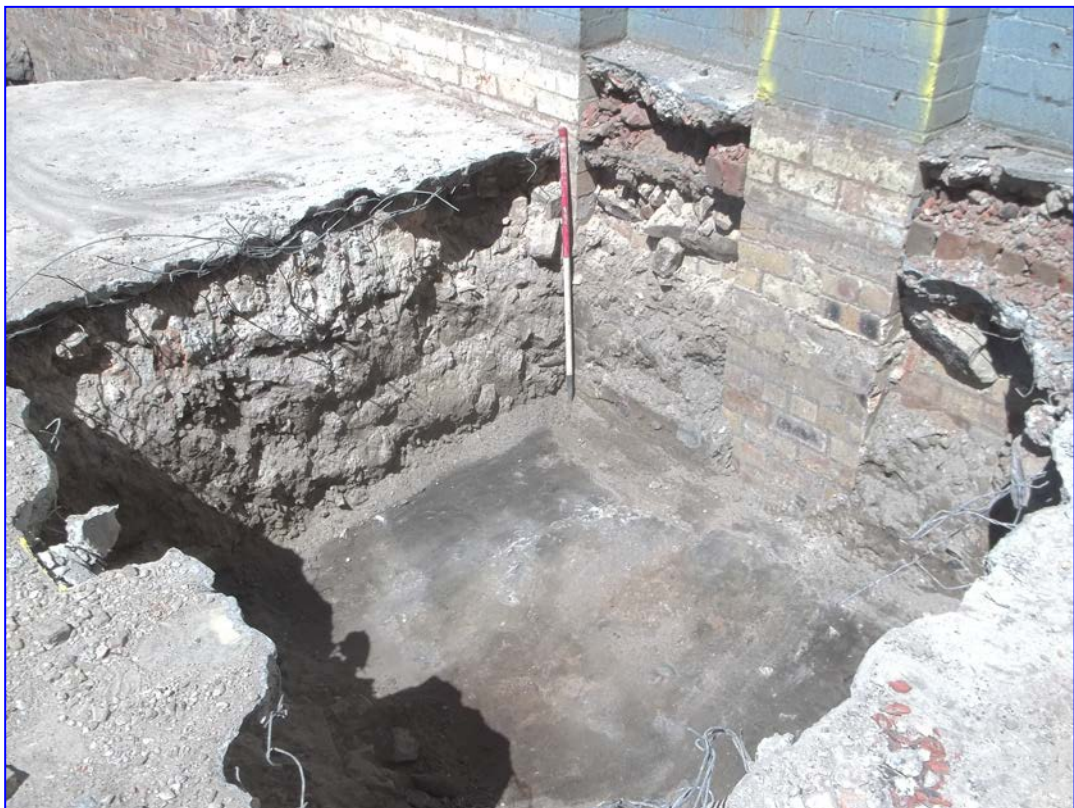
Plate 6: General view of Test Pit 4 from the south showing concrete surface [009]

- 4.4 Test Pit 4 exposed nothing but a hard concrete surface [009] identifying that any earlier structures here to the north-east of the site had already been removed by previous development (Plate 6).

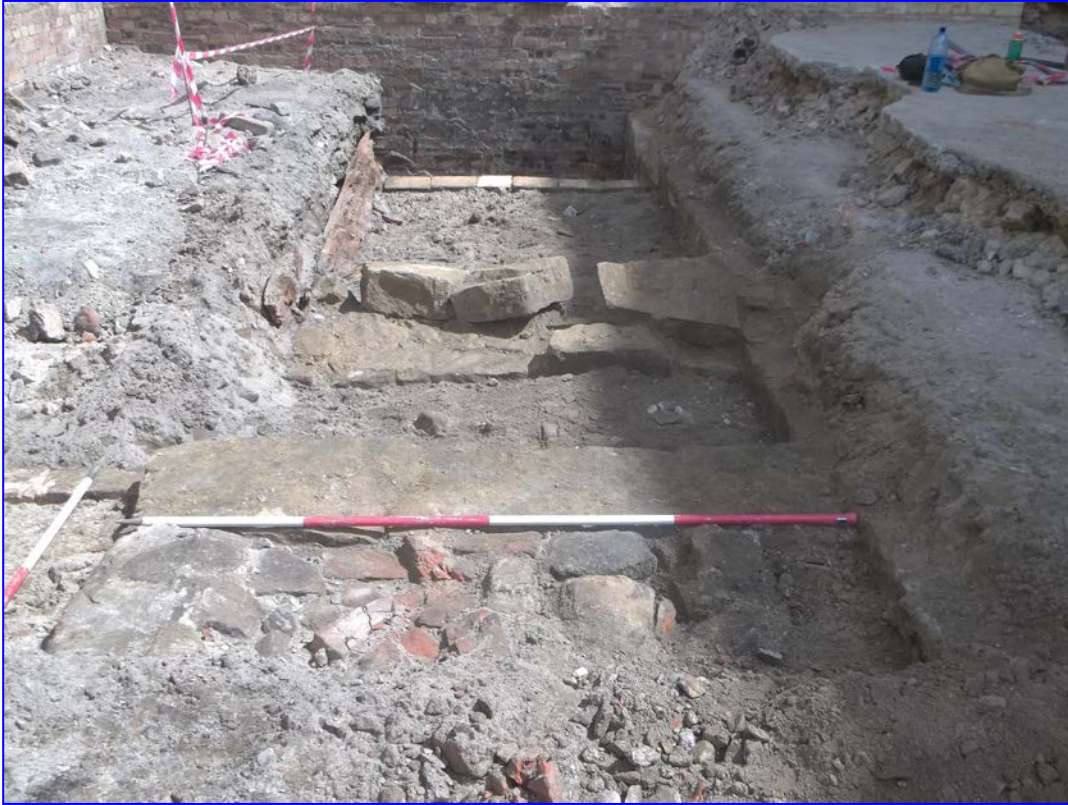
Plate 7: General view of Test Pits 5 and 6 from the south-west showing the remains of Wall [010] to the south-east (right) and Wall [018] to the foreground

- 4.5 In Test Pits 5 and 6, a long stretch of sandstone walling [010] was located with two wider north-west/south-east orientated sandstone walls, [012] and [018], to its north-west (Plates 7 - 9). Some further stone and brick partition walls were also located associated with the structure, [011] and [016], together with another small stretch of wall [016] to the north-west. A large stretch of timber [013], presumably a former floor beam, had also survived to the north-west of Wall [010] along the same orientation (Plate 10). Further to the south-west, Test Pit 7 identified a number of partial wall survivals, all orientated north-west/south-east (Plate 11). They consisted of two large stretches of wall [020] and [023] with small stretches [021] and [025]. To the north-east of this were two distinct rubble layers, (022) and (027) containing rubble and brick fragments.

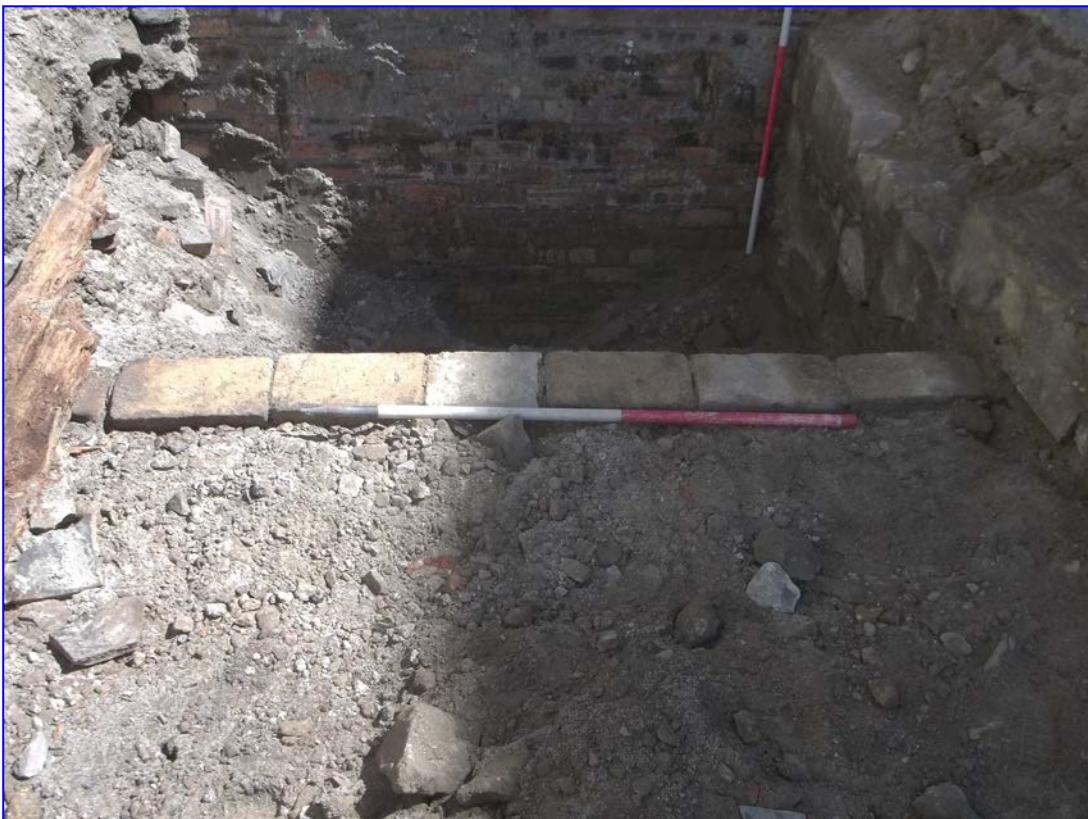
Plate 8: Detail of Wall [011] in Test Pit 5 from the south-west - note brick wall of existing building to the north-east

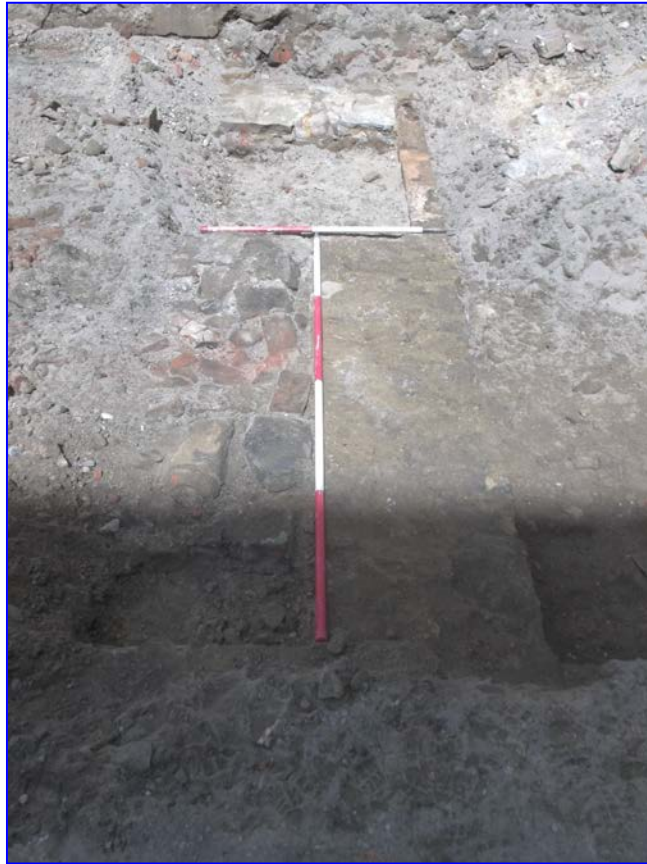
Plate 9: Detail of Wall [018] and brick rubble deposit (019) from the south-east

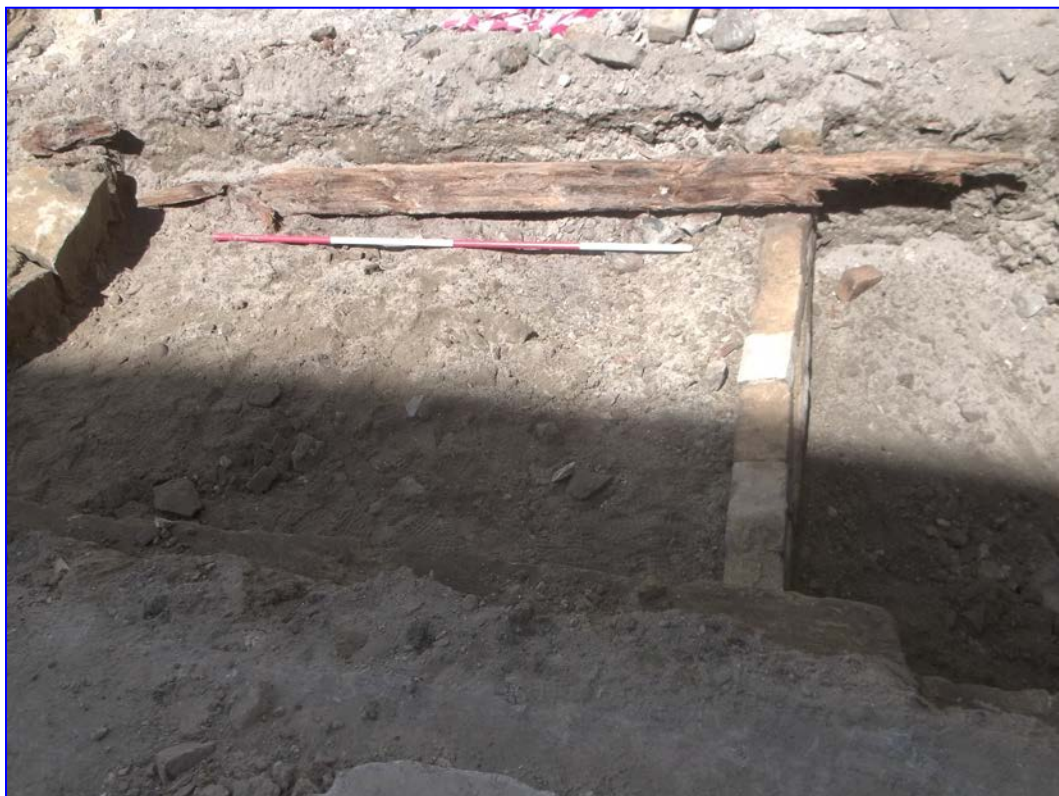
Plate 10: Detail of timber [013] in Test Pit 5 from the SSE, resting over wall [011]

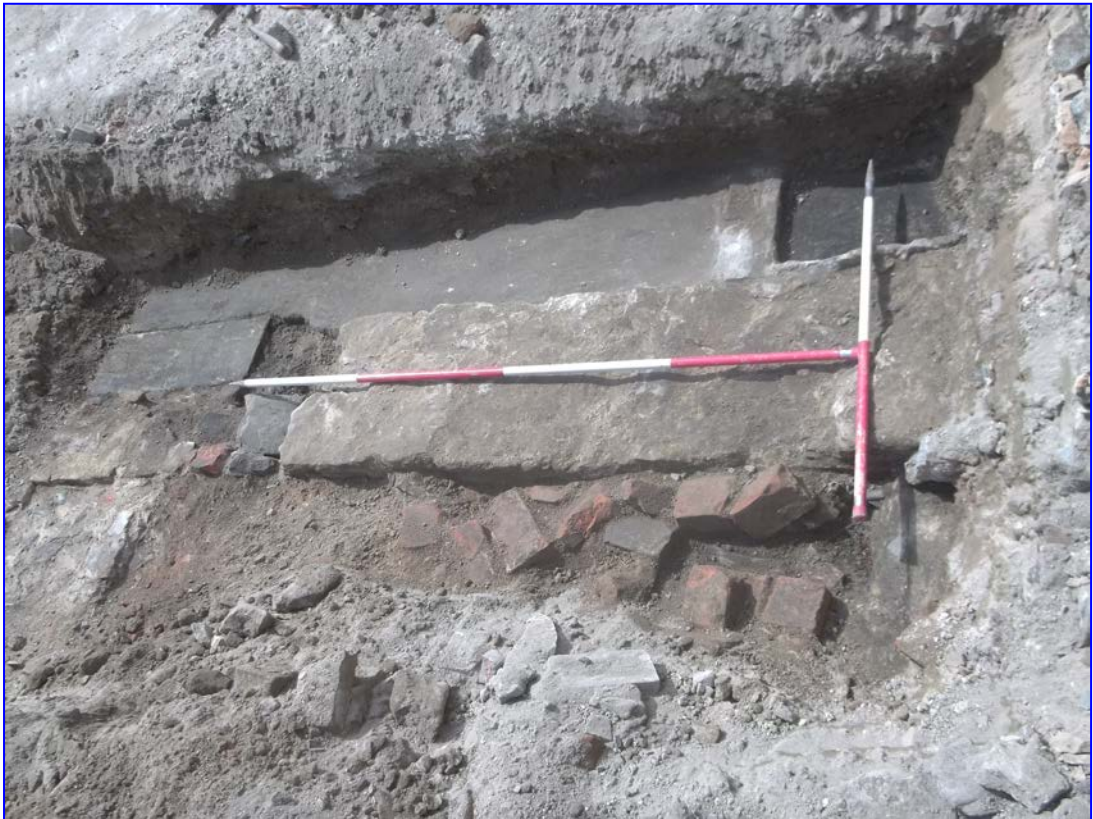
Plate 11: General view of Test Pit 7 from the north-east showing Wall [020] to the centre with brick rubble deposit (022) to the north-east (in front)

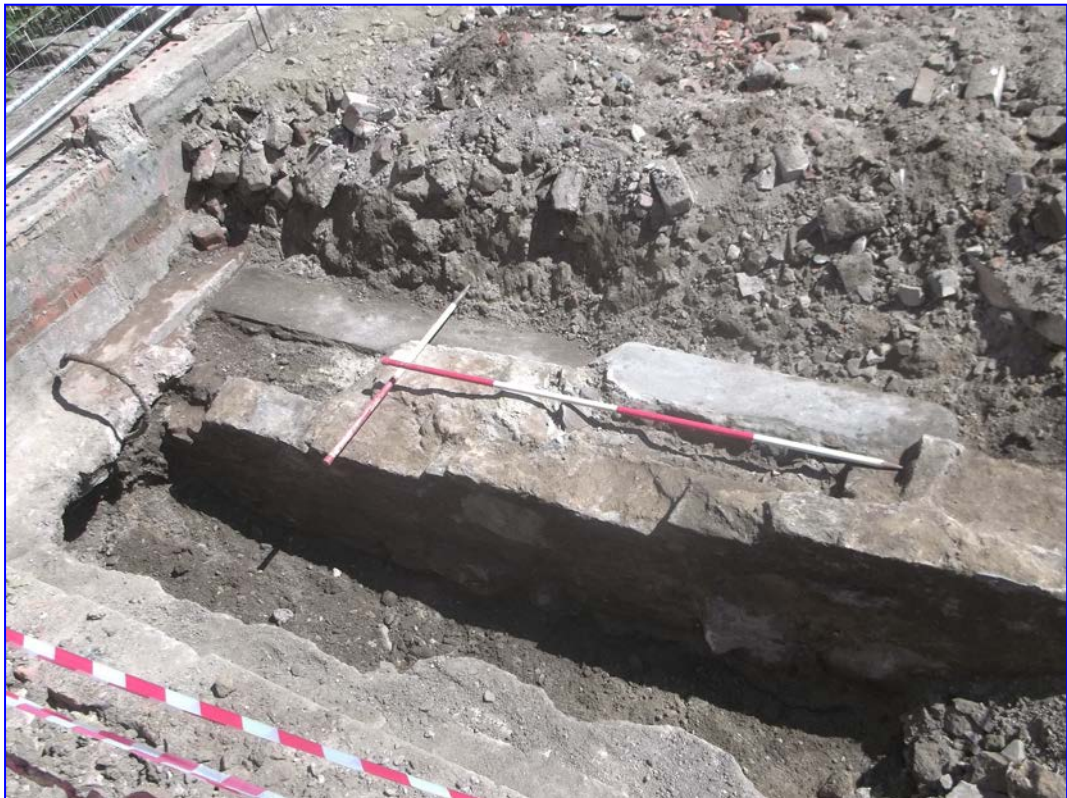
Plate 12: General view of Test Pit 8/9 from the west showing Wall [029]

- 4.6 Finally, Test Pits 8 & 9 (originally two test pits, later merged into one) were located to the north-west of the development site and also revealed another stone wall orientated north-east/south-west (Plate 12). However, this wall had later being heavily disturbed by later concrete founds, presumably for the adjacent building to the north east and its associated groundworks.

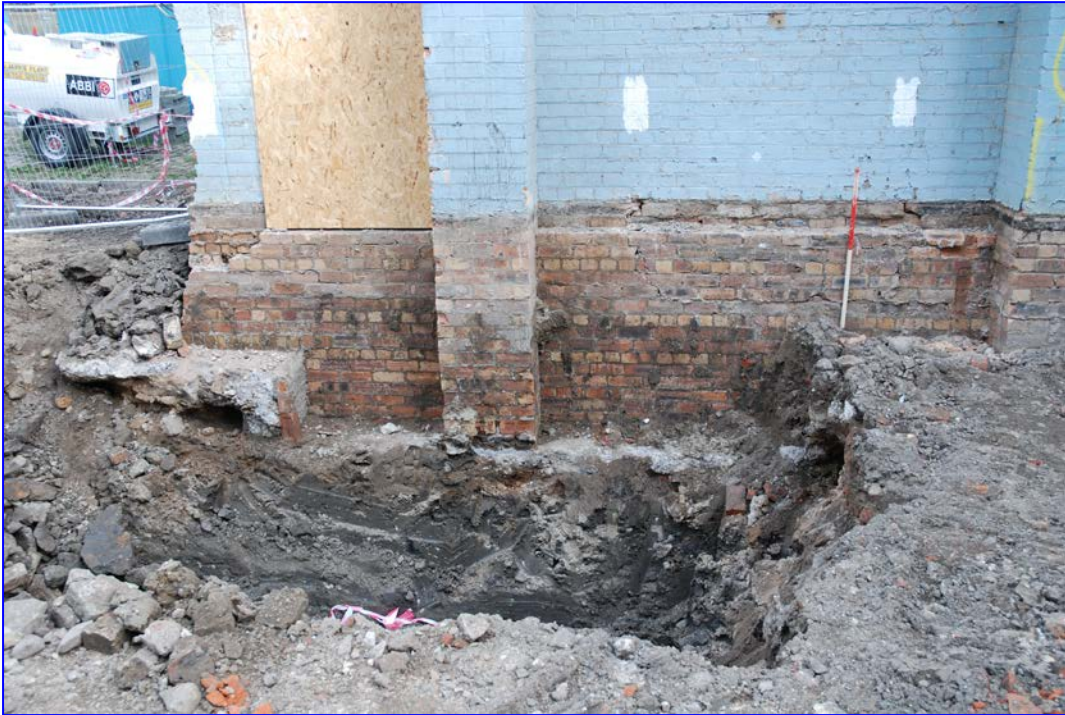
Plate 13: General view of excavations during the later watching brief in the area of Test Pit 7 showing the rubble deposits and features (now removed) resting over the highly compact black clay deposit (002)

- 4.7 Further observation of the ground-breaking works to the rest of the development area exposed little in the way of features, much of it being deep made ground associated with the demolition, presumably of the 19th century buildings, to make way for the later 20th century structures. The depth of the made ground here was between 0.50 – 1m in depth and was located over the very compact black homogenous clay (002), the full depth of which was not excavated as it continued below the area of excavations for the development (Plates 13 & 14). The only feature of note identified in the watching brief was a small well [034] which was preserved *in situ* and defined by sandstone rubble. It reached a depth of ca. 0.24m, but continued going down beyond the depth of excavations (Plates 15 & 16). After recording, the top 1m of the well was removed, then filled with a clean material then capped with concrete (Plate 17).

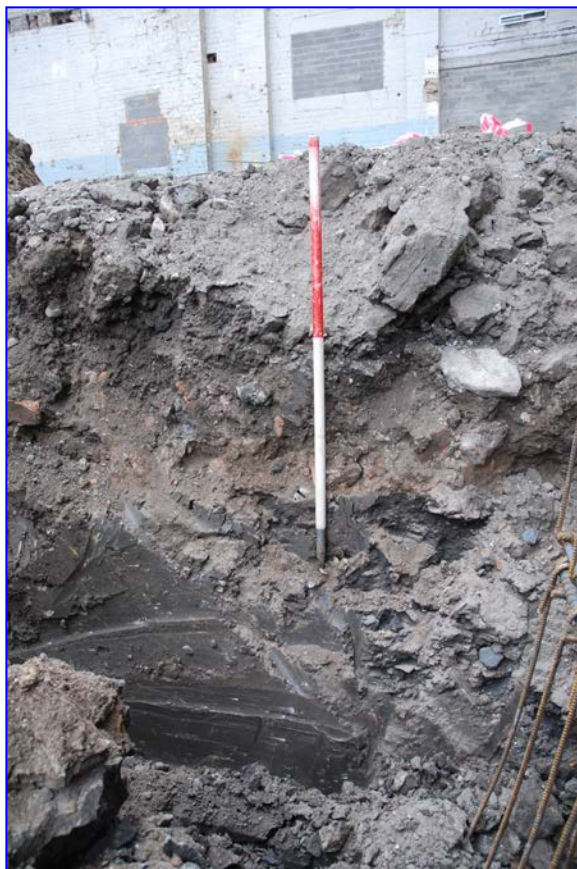
Plate 14: Detail of section through a slot undertaken as part of the later watching brief showing the rubble deposit overlying the highly compact black clay deposit (002)

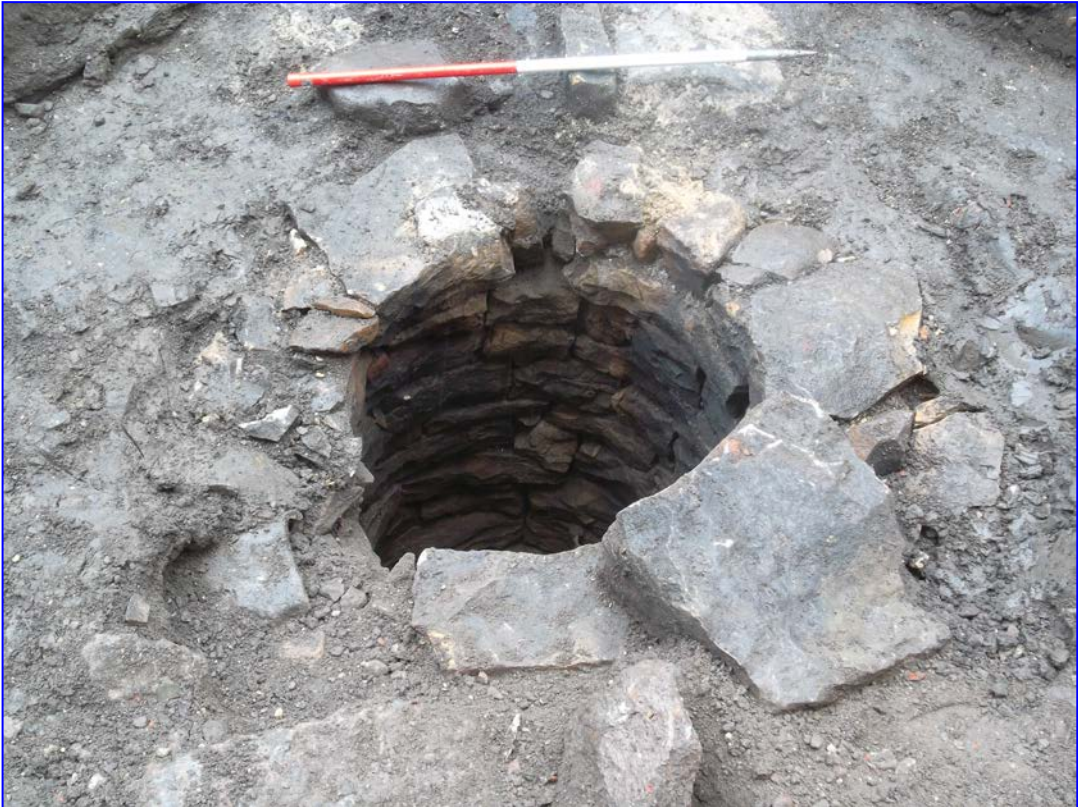
Plate 15: Detail of Well [034] discovered during the later watching brief, from the south

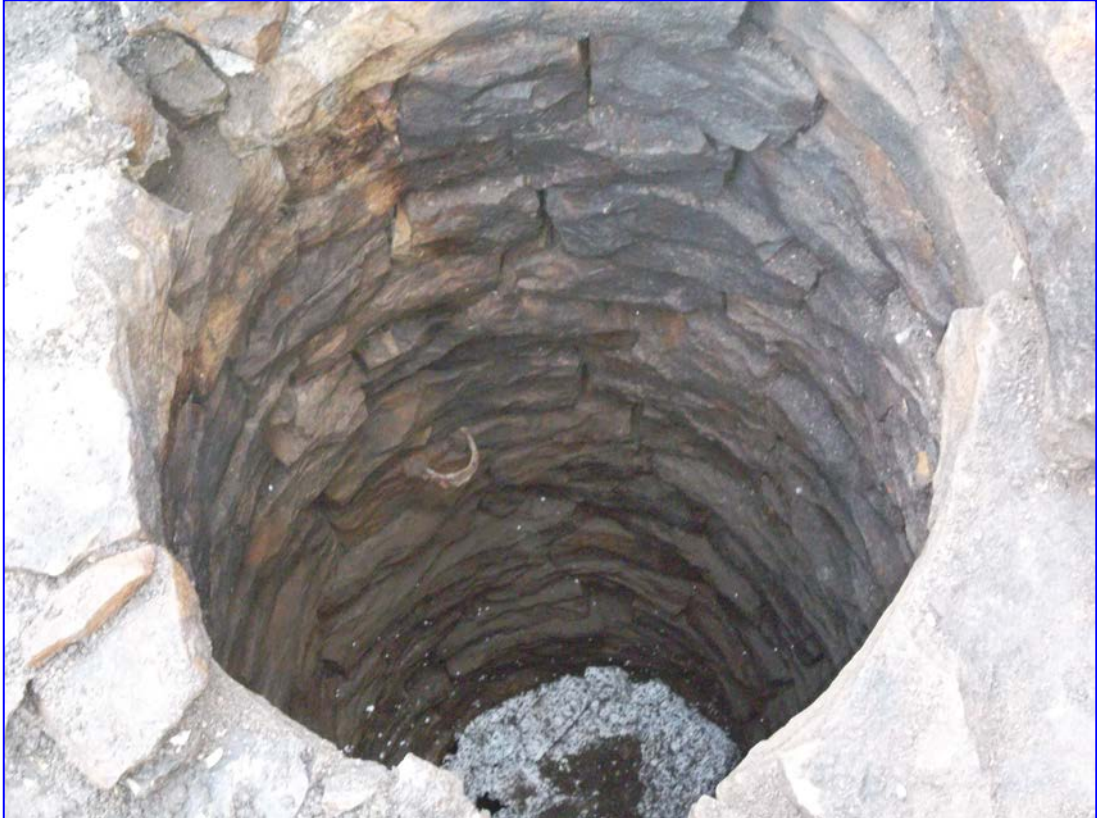
Plate 16: Detail of Well [034] from the south showing its construction and depth

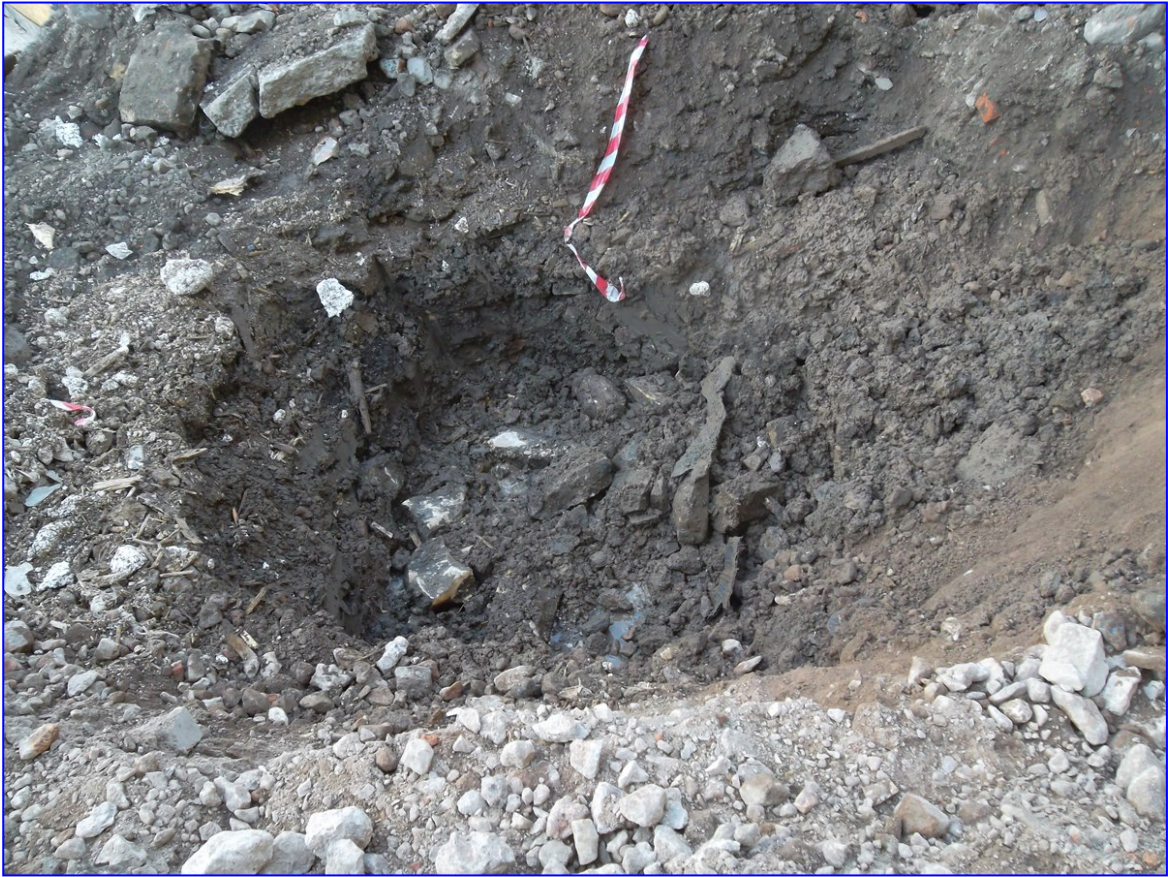
Plate 17: General view after removal of the top 1m of the well which was then filled in and later capped with concrete
