# India Quay Development, Fountainbridge, Edinburgh Archaeological Evaluation Report

## Archaeological Evaluation Report

On Behalf of:	The EDI Group Limited, 7 North St David Street, Edinburgh EH2 1AW
National Grid Reference (NGR):	NT 24734 72755
AOC Project No:	23107
Planning Application No:	14/02814/PPP
OASIS No:	224583
Fieldwork by:	Alan Duffy Hana Kdolska
Prepared by:	Diana Sproat
Date:	25 <sup>th</sup> September 2015

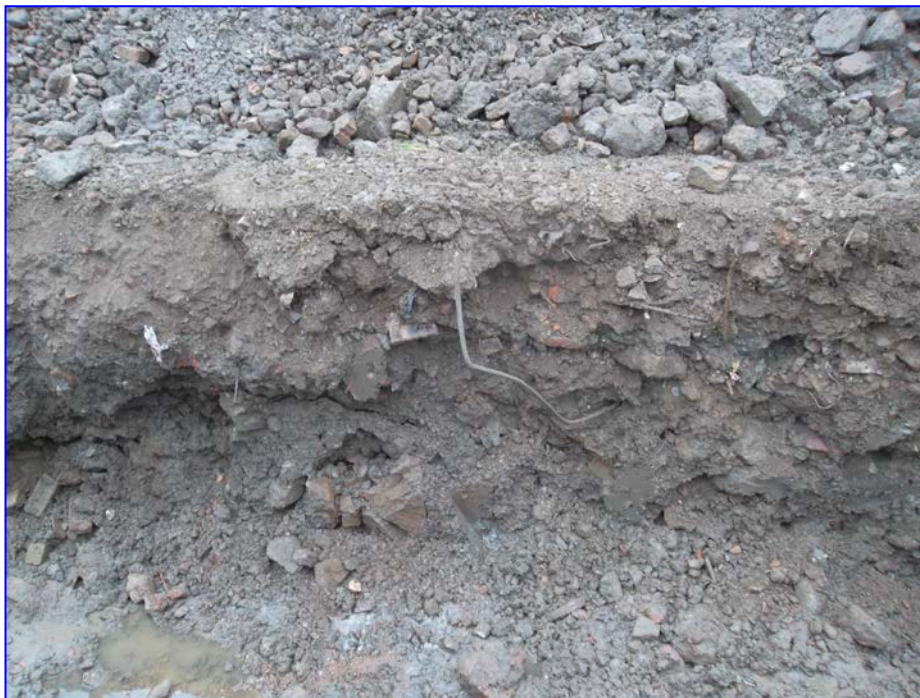
Plate 1: Trench 1, detail of made ground in section

- 5.3 At the time of the evaluation, the area was largely waste ground, after the demolition of the Fountainbridge Brewery. It is clear that this demolition had created a large amount of made ground on the site (Plates 1 & 2). All trenches were dug through a significant layer of made ground, ranging from 1.45 m – 3.0 m in depth. No evidence of the former 19<sup>th</sup> century or earlier 20<sup>th</sup> century structures were located, although several concrete founds, probably associated with the brewery, were found (Plate 3). The only brick feature was found in Trench 3, which consisted of a brick wall and another probable brick surface which possibly formed a former culvert (Plate 4).

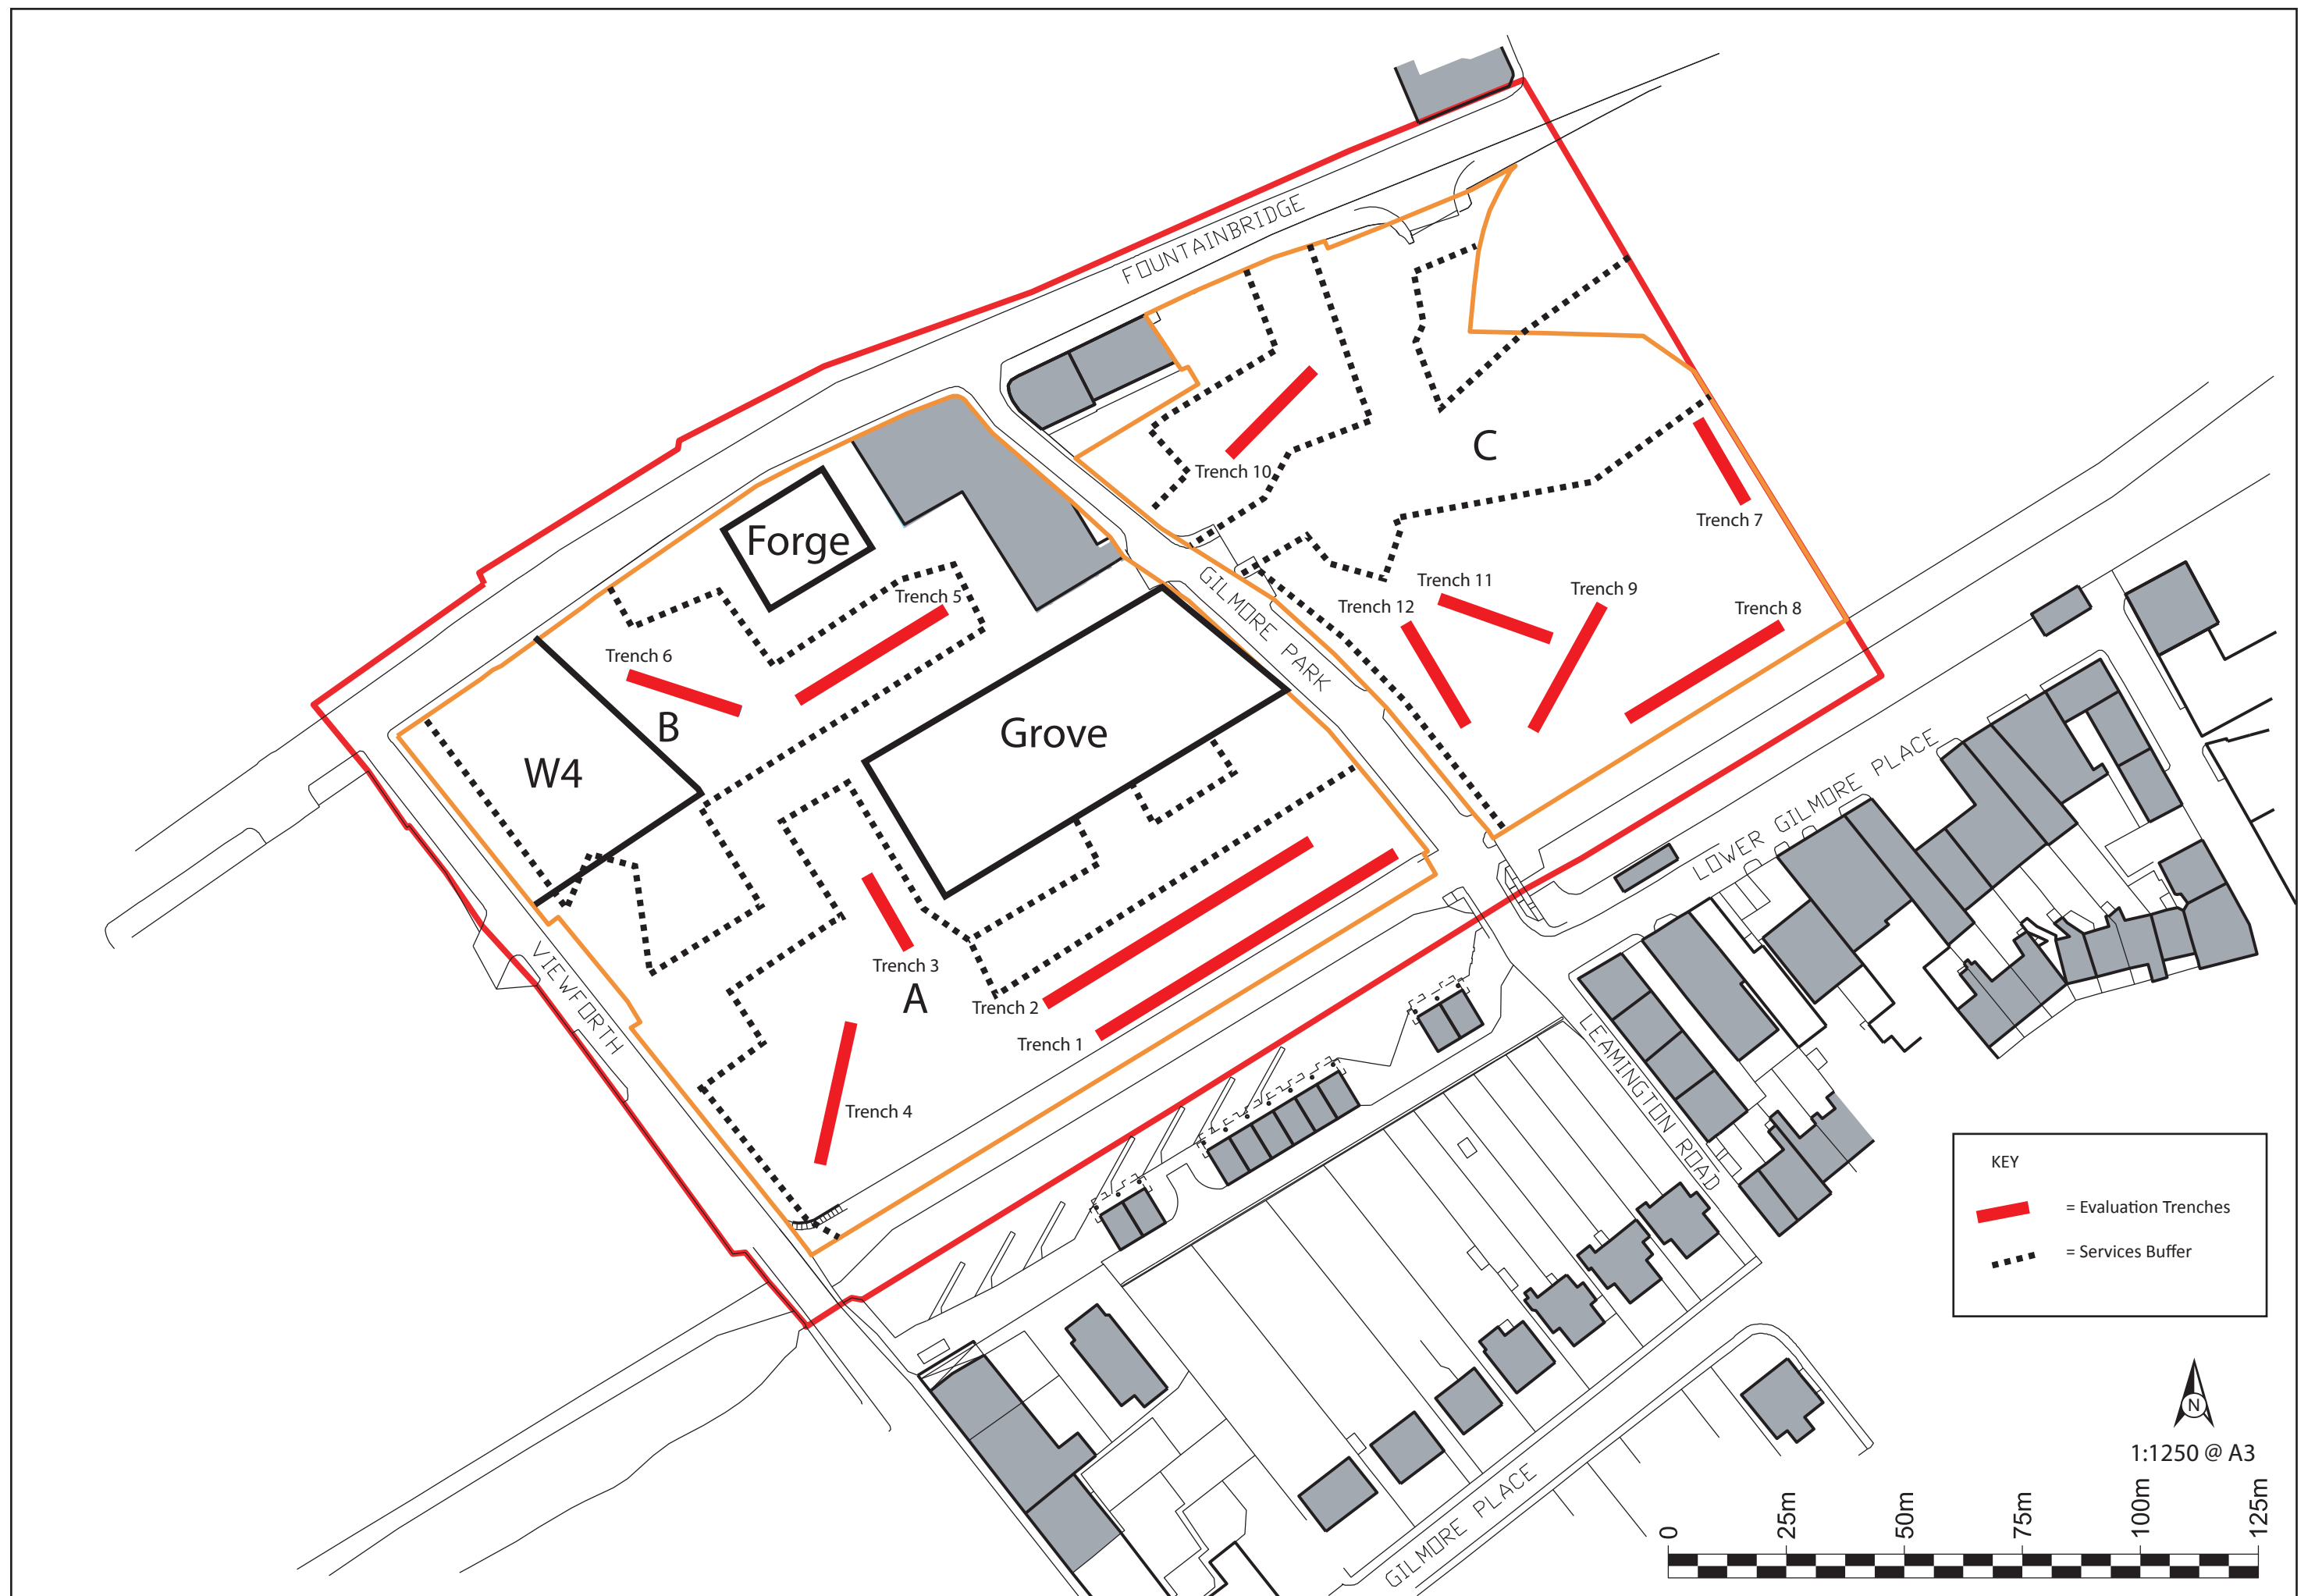
Figure XX: Site plan showing position of archaeological trenches

- 5.2 In total, 12 trenches were excavated in the site, which was divided up into three areas - A, B & C – as depicted on Figure 2. Area A was located to the south-west of the site in the area of the former Castle Mills, and contained Trenches 1 – 4. To the north of the site was the community plot called the Grove. Area B was located to the north-west of the site, also in the position of Castle Mills, and contained Trenches 5 and 6. The former offices dating to the late 19<sup>th</sup> century is still standing to the north-east of this area (fronting on to Gilmore Park and Fountainbridge), with another community plot – The Forge – to the west of with another community plot to the north-west corner. Area C was located to the east of Gilmore Park in the position of a number of 19<sup>th</sup> century industrial buildings and contained Trenches 7 – 12. This area was greatly disturbed to the centre of the plot due to the presence of live services.

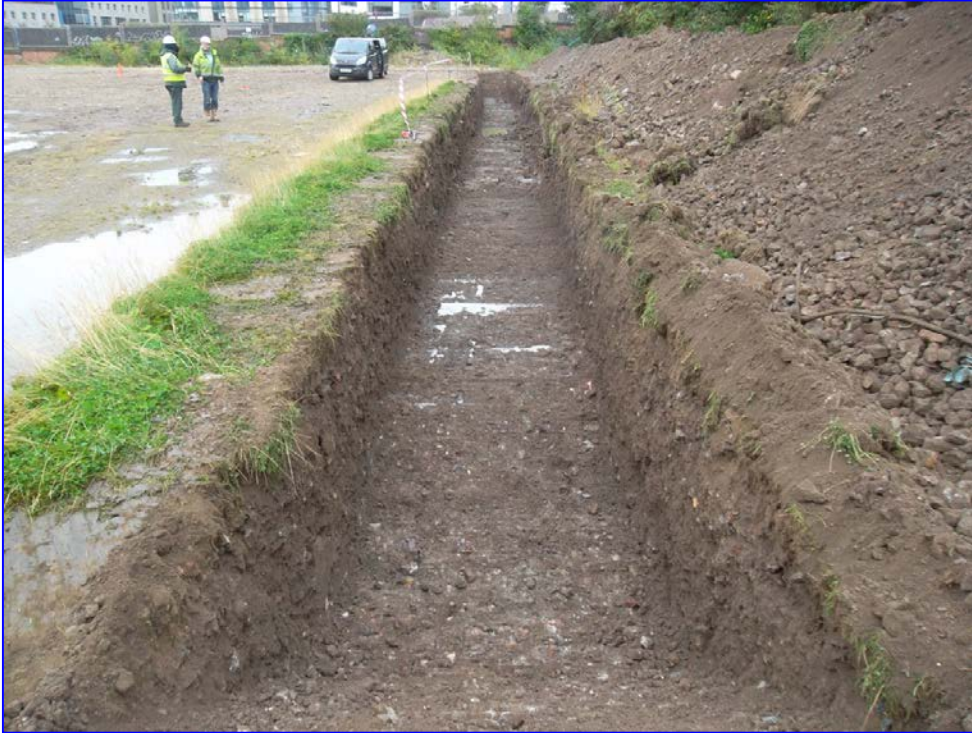
**Plate 2: Trench 5, general post-excavation view from the south-west**

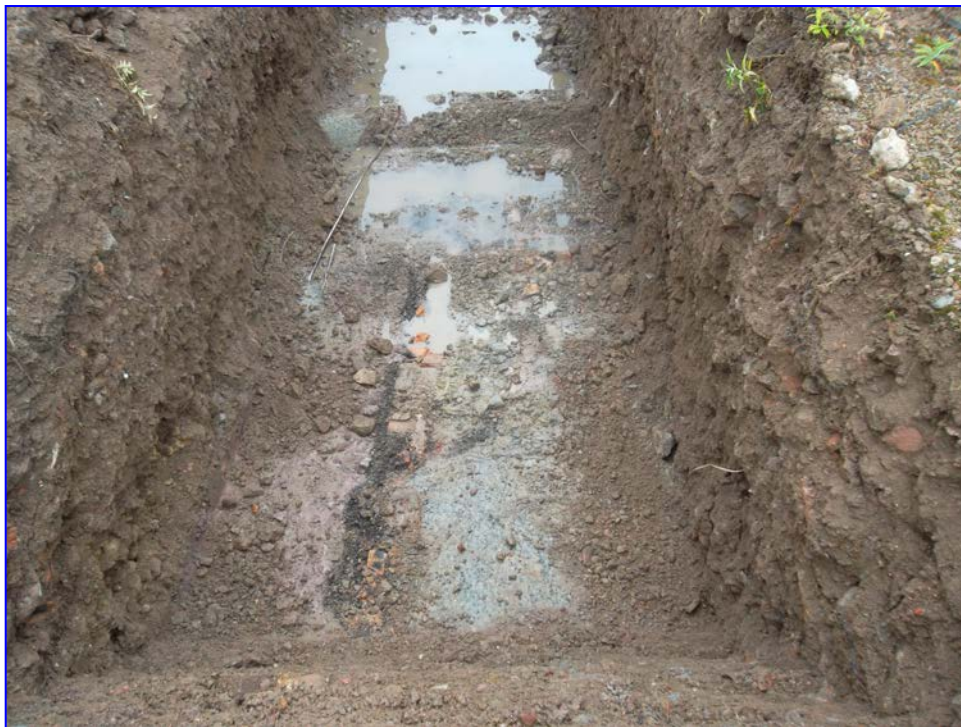
**Plate 3: Trench 1, detail of concrete founds at NE end**

Length	60m
Width	2.1m
Orientation	NE/SW
Top-soil Depth	N/A
Depth of Excavation	2.10m (natural not reached)
Significant Features	None
Other Features	Modern concrete founds with steel rods (probably associated with the Fountainbridge Brewery)
Finds	None

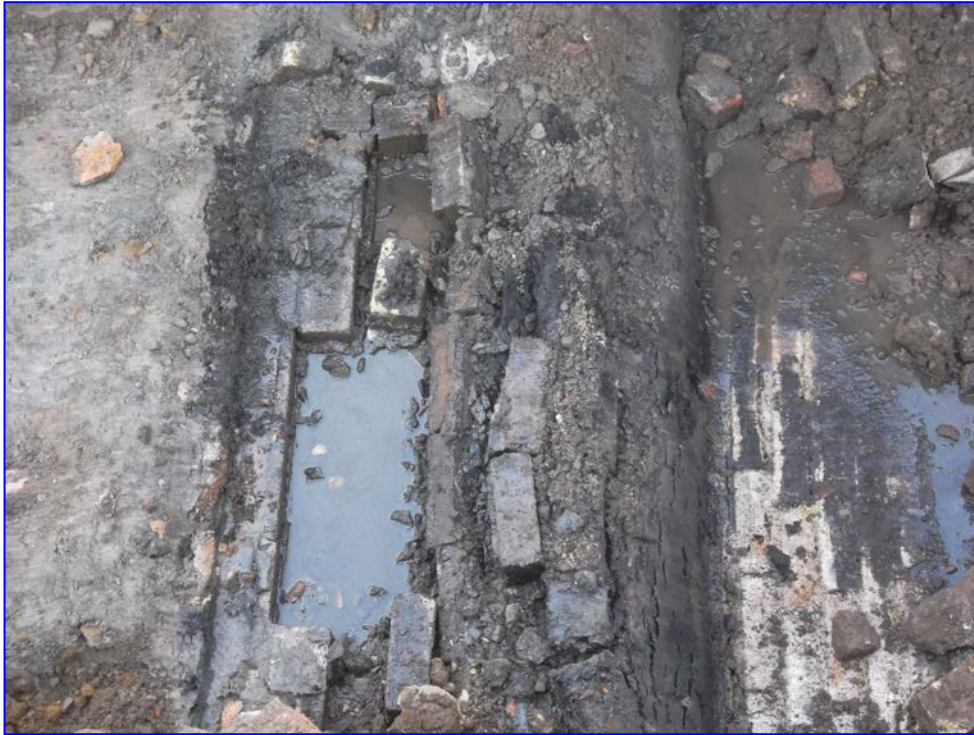
**Plate 4: Trench 3, detail of brick culvert from the west**

Length	14m
Width	2.1m
Orientation	NE/SW
Top-soil Depth	N/A
Depth of Excavation	2.40m
Significant Features	None
Other Features	Brick wall foundations located at 9.40m – 10m from the NE side of the trench and another brick surface located between 10m – 12m from the NE; concrete found located to the NNW end up to 5.50m along the trench (probably associated with the Fountainbridge Brewery)
Finds	None

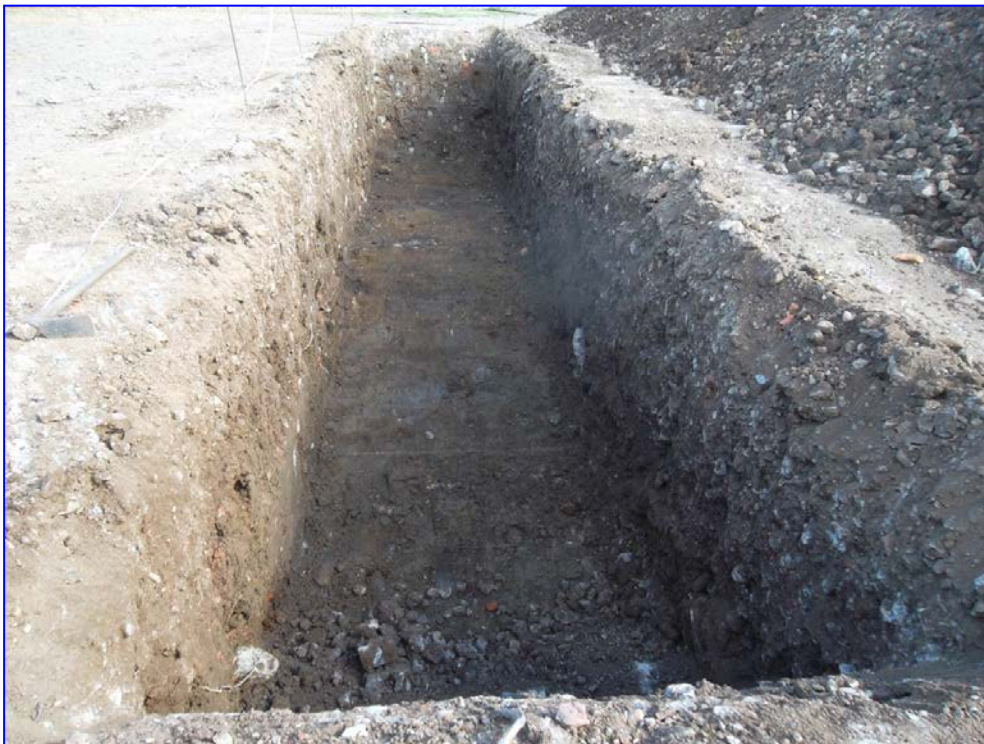
**Plate 5, Trench 6, general post-excavation shot from the east**

Length	25m
Width	2.1m
Orientation	E/W
Top-soil Depth	N/A
Depth of Excavation	3.50m
Significant Features	None
Other Features	Large concrete pile at 4.70m – 7.20m from W end of trench and another at 10.90 – 12.25m
Finds	None
