# Fort House Phase II, Leith: Archaeological Excavation Data Structure Report

AOC 22445  
2<sup>nd</sup> October 2015

**AOC Project No:** 22445

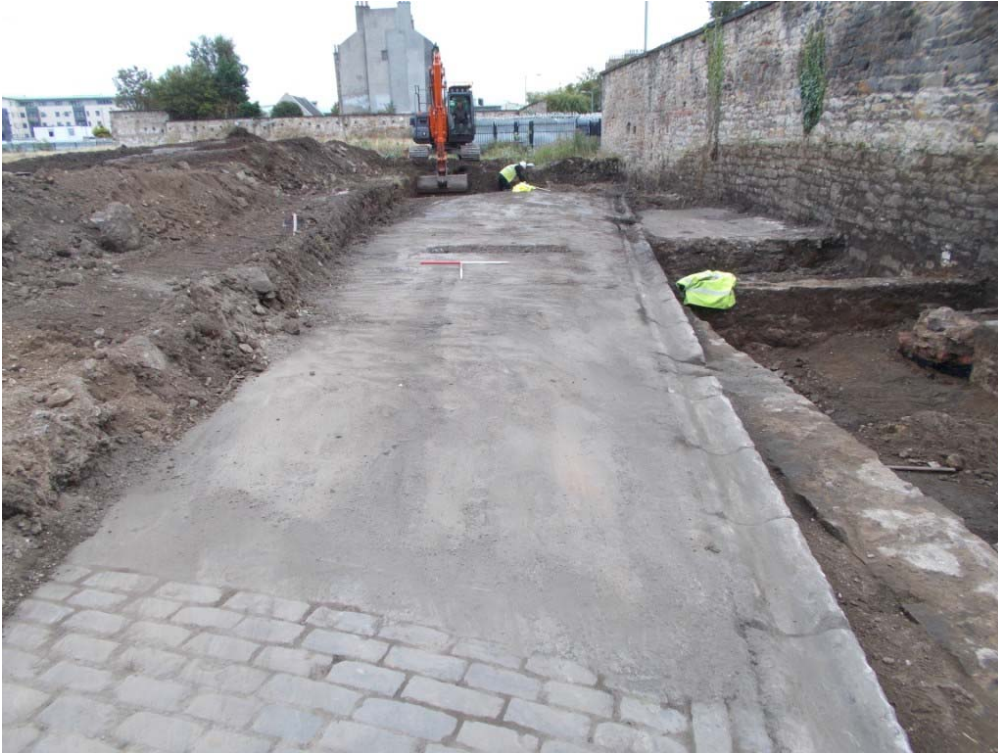
Plate 1 - View of modern road

5.2.3 Along most of the NW edge of the excavation area the topsoil directly overlay a modern road formed by tarmac surface [019] and cobble surface [018], lined by a sandstone gully [017] that measured 25 m long by 4 m wide where it was fully revealed (Plate 1). This road partly truncated the top of some of the fort walls in the area and a small section of a later cement floor [041] within Structure [046]. This modern imprinted cement layer was abutted by a concrete block [042] and overlay levelling deposit [045].

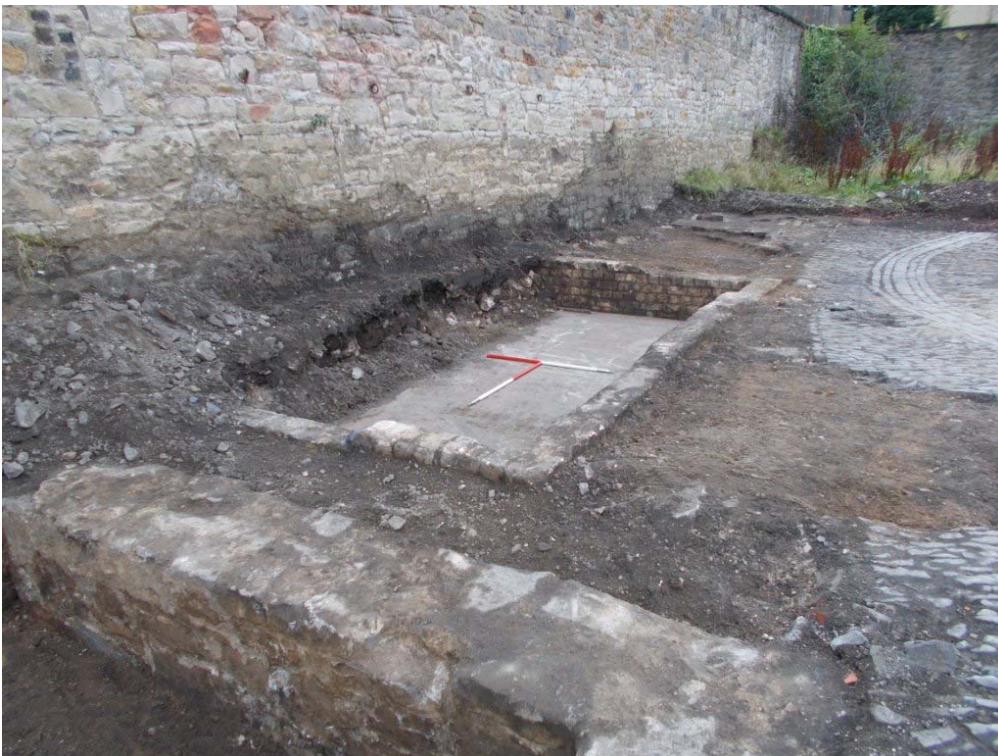
Plate 2 - View of brick structure [020]

5.2.4 Further SW of the road and abutting the perimeter wall was a U-shaped brick structure [020] measuring 5.06 m by 2.75 m. This structure survived to six courses of brick in height and contained a concrete floor (Plate 2).

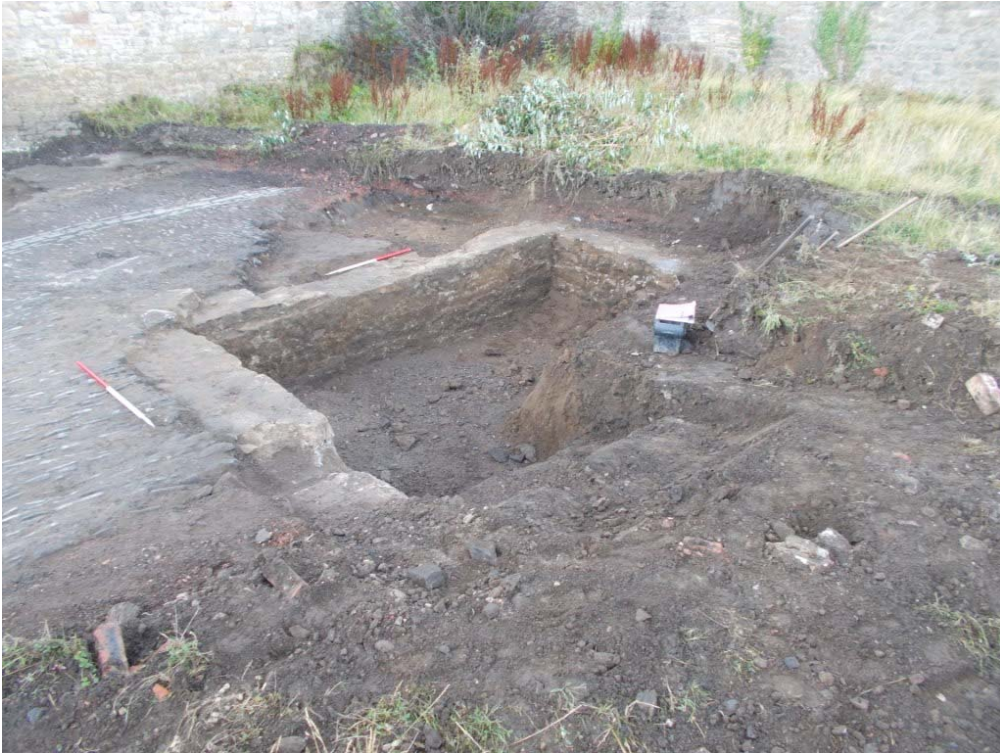
Plate 3 - View of stable walls [003]-[005]

5.2.6 In the western corner of the excavation area, part of the 19<sup>th</sup> Century stable block was revealed (Plate 3). This consisted of large sandstone walls [004] and [005] that formed the SE and NE walls of the stables respectively, along with a smaller internal wall [003] that abutted the NW face of wall [004] and was aligned NW-SE. The external walls measured 0.6 m wide whereas wall [003] was only 0.44 m wide. Made ground [002] abutted the internal and external faces of the walls with the walls having been constructed into buried soil [016].

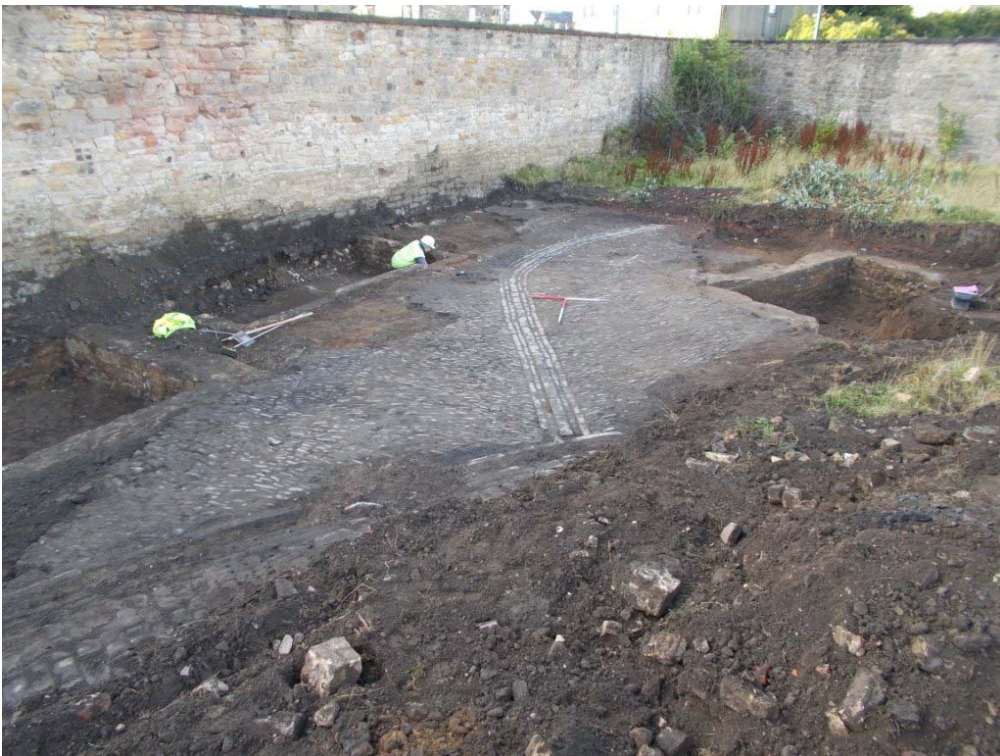
Plate 4 - View of cobbles [006]-[007]

5.2.7 Out with the stables to the NE and SE was a cobbled surface [006] mainly consisting of edge set granite cobbles set at right angles to a curving line of larger and more regular cobbles [007] that may have had a particular function within the courtyard (Plate 4). These surfaces were truncated to the NE by modern road gully [017], and abutted walls [009] and [013] to the SE. The cobbles were laid on top of made ground [002] and as they respect the stable walls and other 19<sup>th</sup> century walls to the SE are most likely related to the earliest use of the fort.

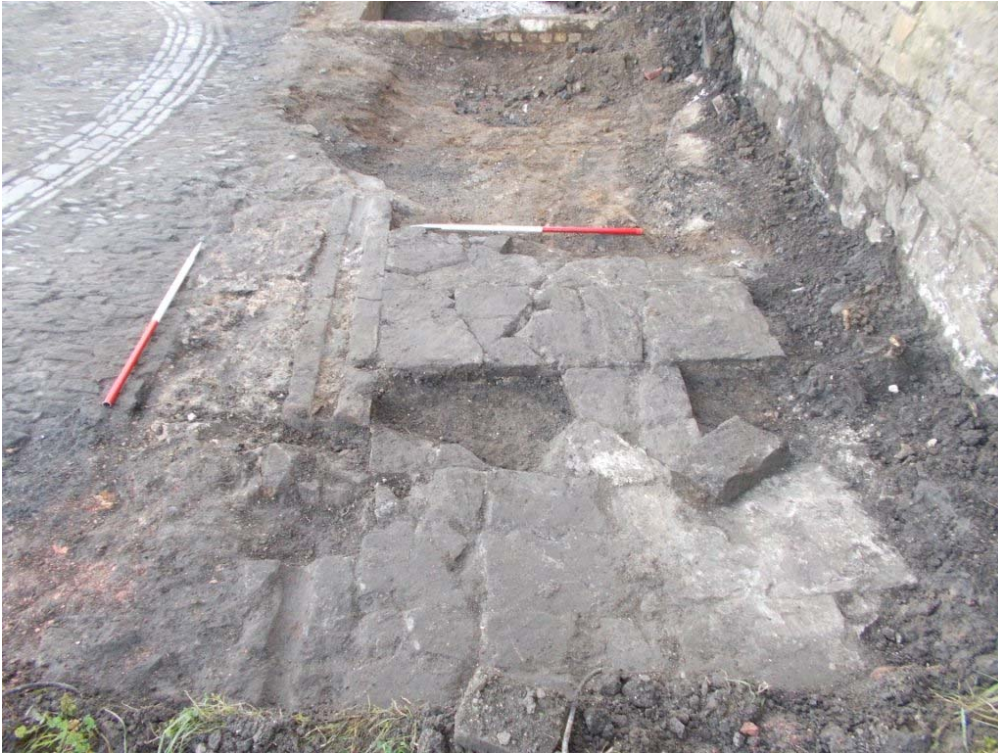
Plate 5 - View of Structure [011]: Shop 1

excavation area, Structure [011] (**Shop 1**), consisted of a truncated and fragmented sandstone flagstone surface [008], a sandstone drainage gully [010] and the base of a sandstone wall [009] (Plate 5). All of these features were contained within a 2.7 m long (SW-NE) by 3 m wide (NW-SE) area and would have continued further NE if modern services and brick structure [020] had not truncated it.

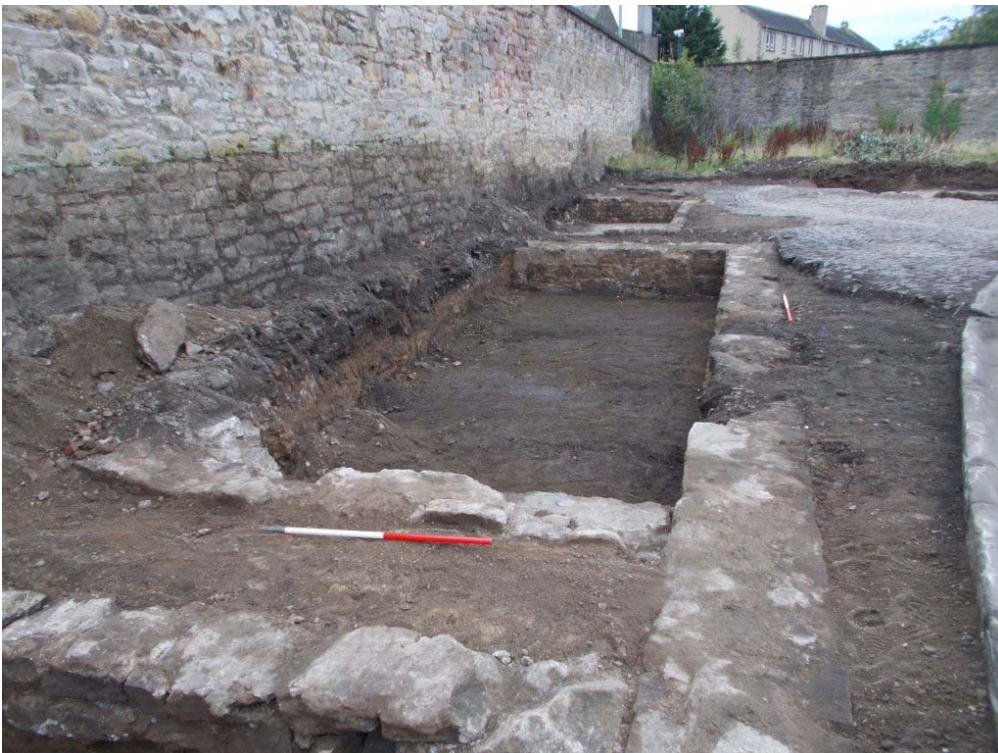
Plate 6 - View of Structure [015]: Shop 2

- 5.2.10 To the NE of this brick structure [020], a large and long sandstone wall [013] was revealed running parallel to the perimeter wall for over 30 m. This wall formed the NW edge of the other structures abutting the perimeter wall. It had sandstone wall [012] keyed into its SW end which also abutted the perimeter wall and formed the SW wall of Structure [015] (**Shop 2**). The NE end of this structure was formed by sandstone wall [014] giving internal measurements of 7.25 m by 3.8 m (Plate 6). No internal features were present within the walls.

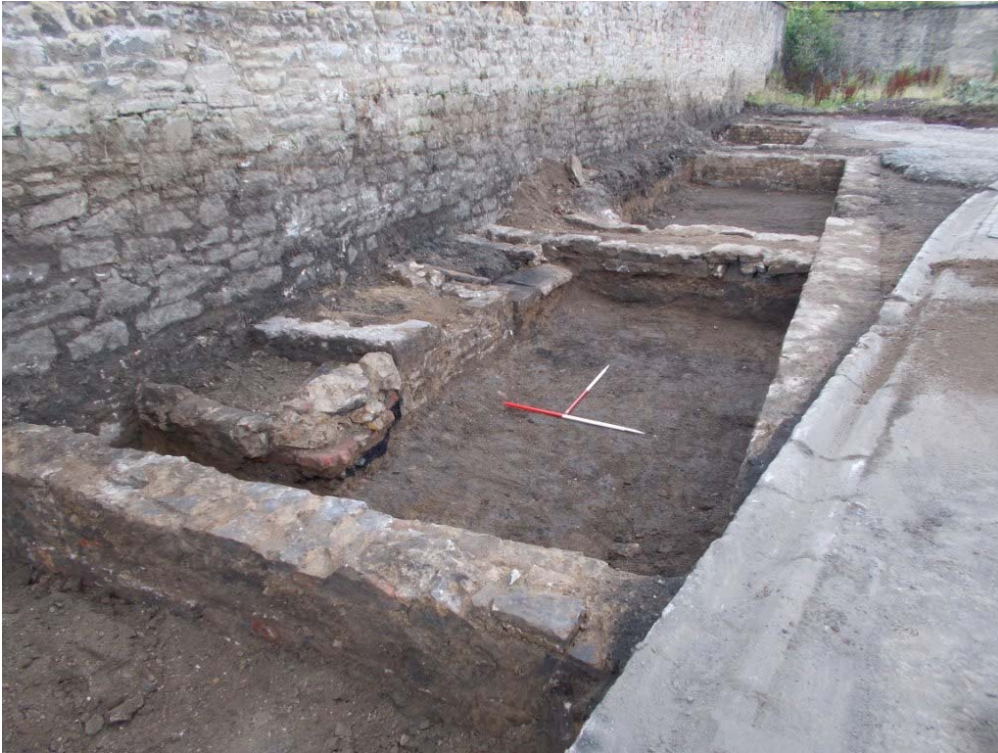
Plate 7 - View of Structure [039]: Shop 3

- 5.2.11 Wall [014] also formed the SW wall of Structure [039] (**Shop 3**) to the immediate NE of Structure [015]. This structure contained an internal wall [021], with the NE edge of the structure formed by sandstone wall [022], providing an internal space measuring 7 m by 3.8 m. This space is divided by internal wall [021] into a large room measuring 5.7 m by 3.8 m and a corridor measuring 1 m by 3.8 m to the SW. The large room contained three smaller structures [023], [027] and [028] that abutted the perimeter wall and extended 1.3 m into the internal space (Figure 7; Plate 7).

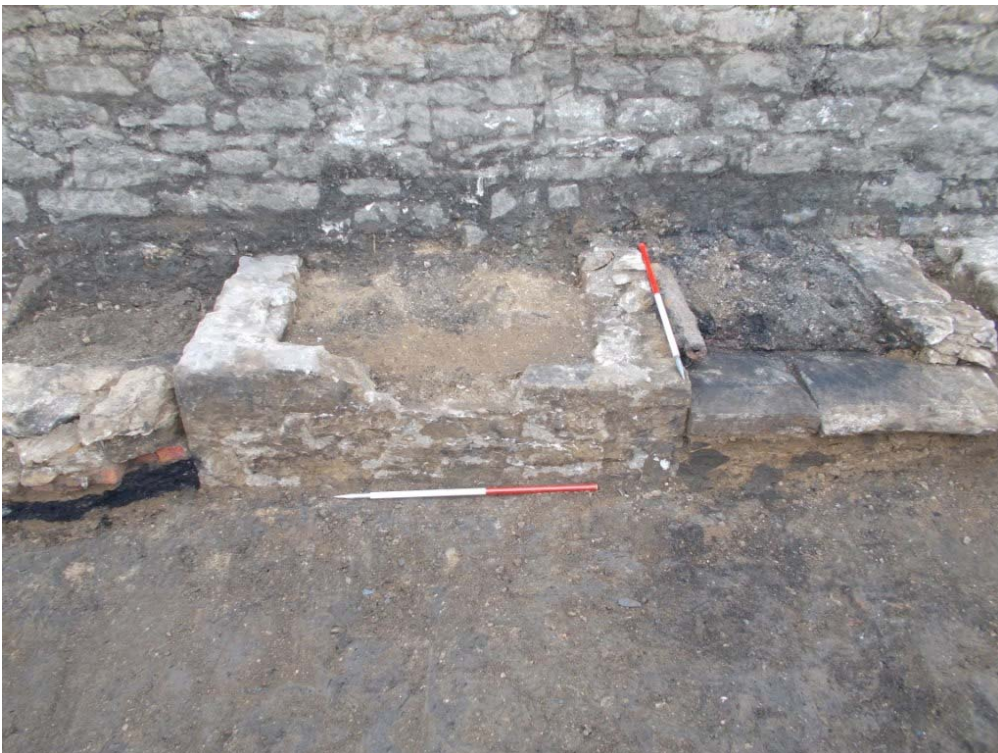
Plate 8 - View of Structure [027] within Shop 3

- 5.2.12 The three structures all abut one another with the central U-shaped sandstone structure [027] also forming the NE edge of Structure [023] and the SW edge of Structure [028]. This U-shaped feature measured 2.1 m by 1.3 m with the walls measuring 0.34 m wide (Plate 8). The internal space may have contained a floor surface, the remnants of which were recorded as deposit [035] that overlay made ground [002].

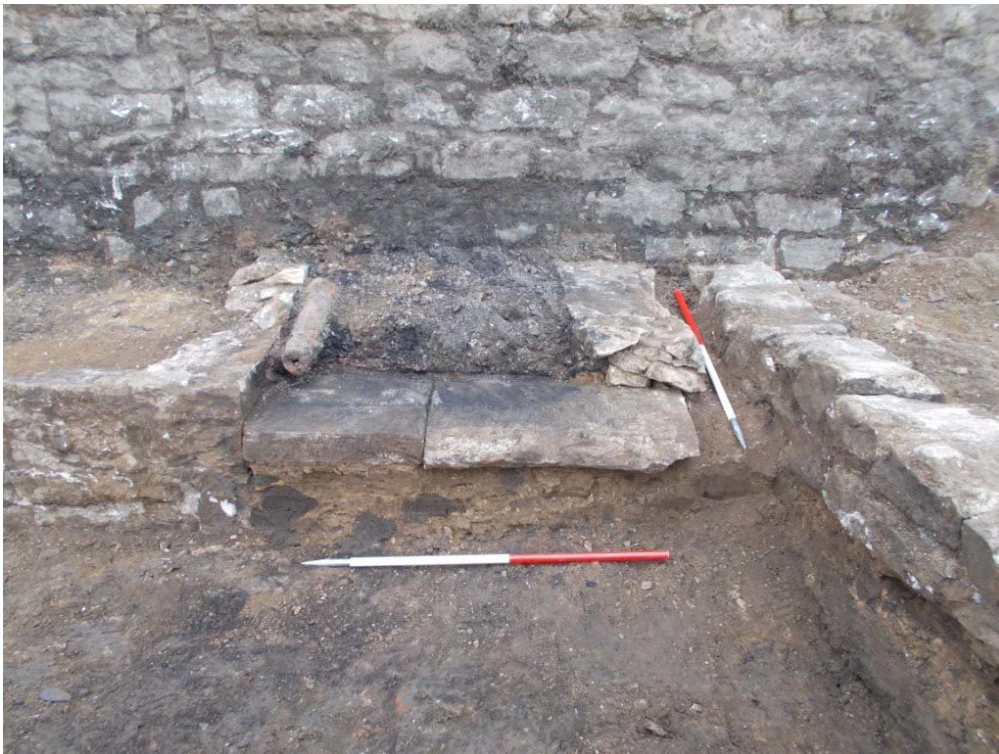
Plate 9 - View of Structure [023] with cannon in-situ

- 5.2.13 To the NE, Structure [023] consisted of a rubble sandstone wall [024] built into made ground [002] and overlying the SW edge of flagstone floor [025] (Plate 9). The NE edge of this floor abutted the SW edge of Structure [027] to form a rectangular space measuring 1.06 m by 1.3 m. The floor was sunken below any possible floor levels for the overall structure and was filled by ash and slag rich deposits [026] and [036], which contained several iron and copper objects as well as a small cannon or field gun (SF 25).

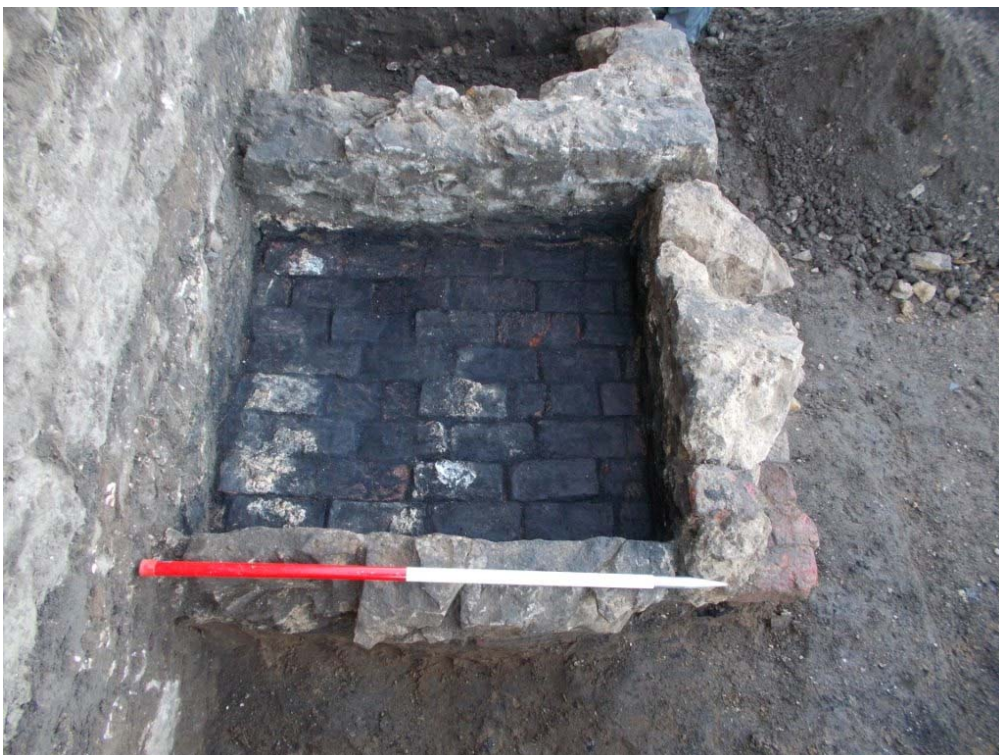
Plate 10 - View of Structure [028] showing brick floor [032]

- 5.2.14 To the SW, Structure [028] consisted of rubble sandstone walls [030] and [031] forming the NE and NW edges of the structure respectively (Plate 10). These walls sat on top of brick surface [032] and formed an internal space measuring 1.1 m by 1 m that was filled by 0.25 m of a rubble deposit [029] overlying 0.15 m of a heat affected mortar and soot deposit [034]. The brick surface [032] measured 1.48 m by 1.2 m and overlay a levelling sand deposit [048] and layer of coarse black ash [033] that measured 1.1 m by 0.8 m.

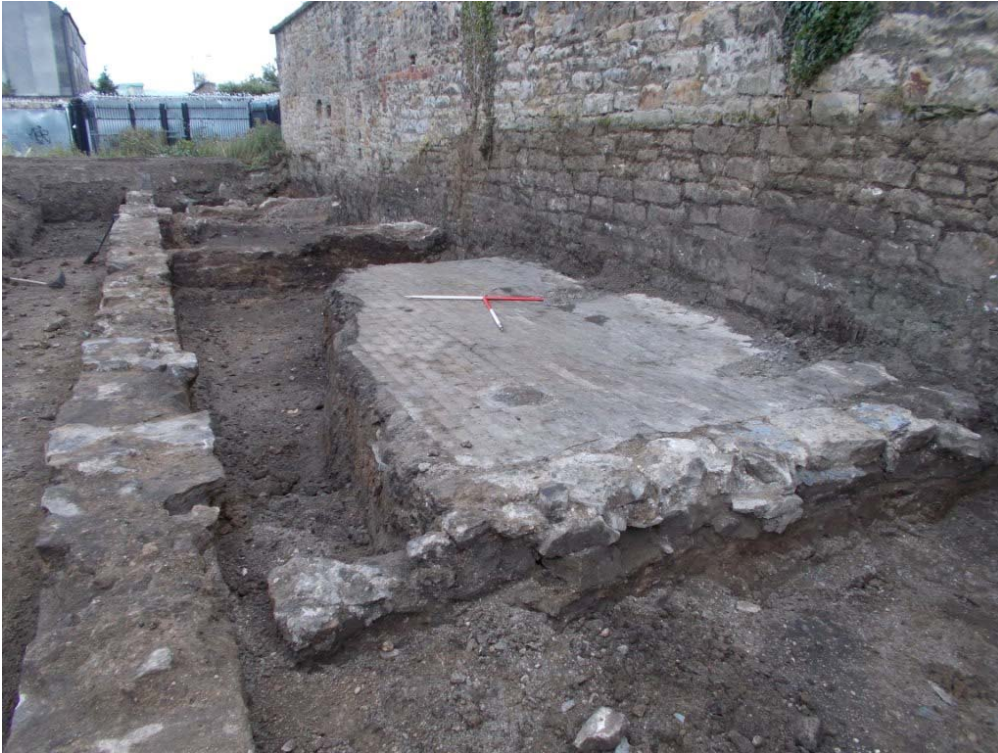
Plate 11 - View of Structure [046] showing modern floor [041]

- 5.2.15 To the NE of Structure [039] the modern levelling and floor deposits [041] and [042] were later additions to the earlier Structure [046] (**Shop 4**). This structure was a rectangular shaped room or building formed by sandstone walls [022] and [043]. The space within the structure was divided into two by internal rubble wall [040] with the floor [041] contained to the NE of wall [040] in a space measuring 7.6 m by 3.8 m (Plate 11). The space to the SW of wall [040] measured 2.2 m by 3.8 m with no floor surfaces surviving.

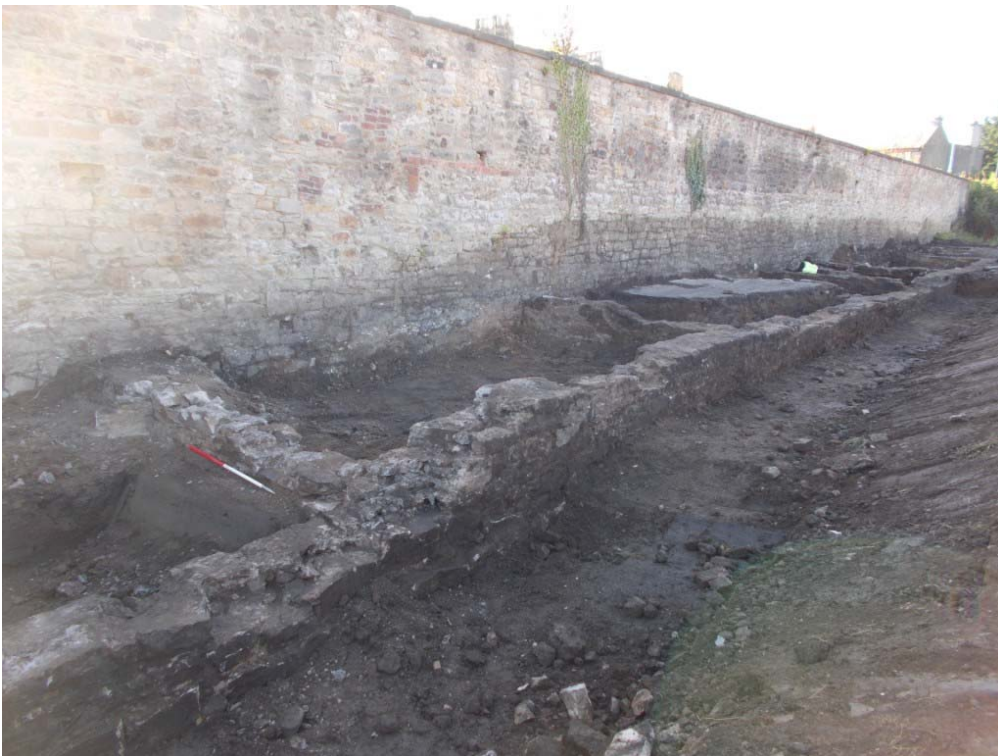
Plate 12 - View of Structure [049]

- 5.2.16 To the NE of this structure was another room or building, Structure [049] (**Shop 5**), formed by sandstone wall [043] to the SW and sandstone wall [044] to the NE. This structure measured 7 m by 3.8 m and contained the remnants of a brick floor [050] that only survived as five bricks measuring 0.82 m by 0.25 m (Plate 12).

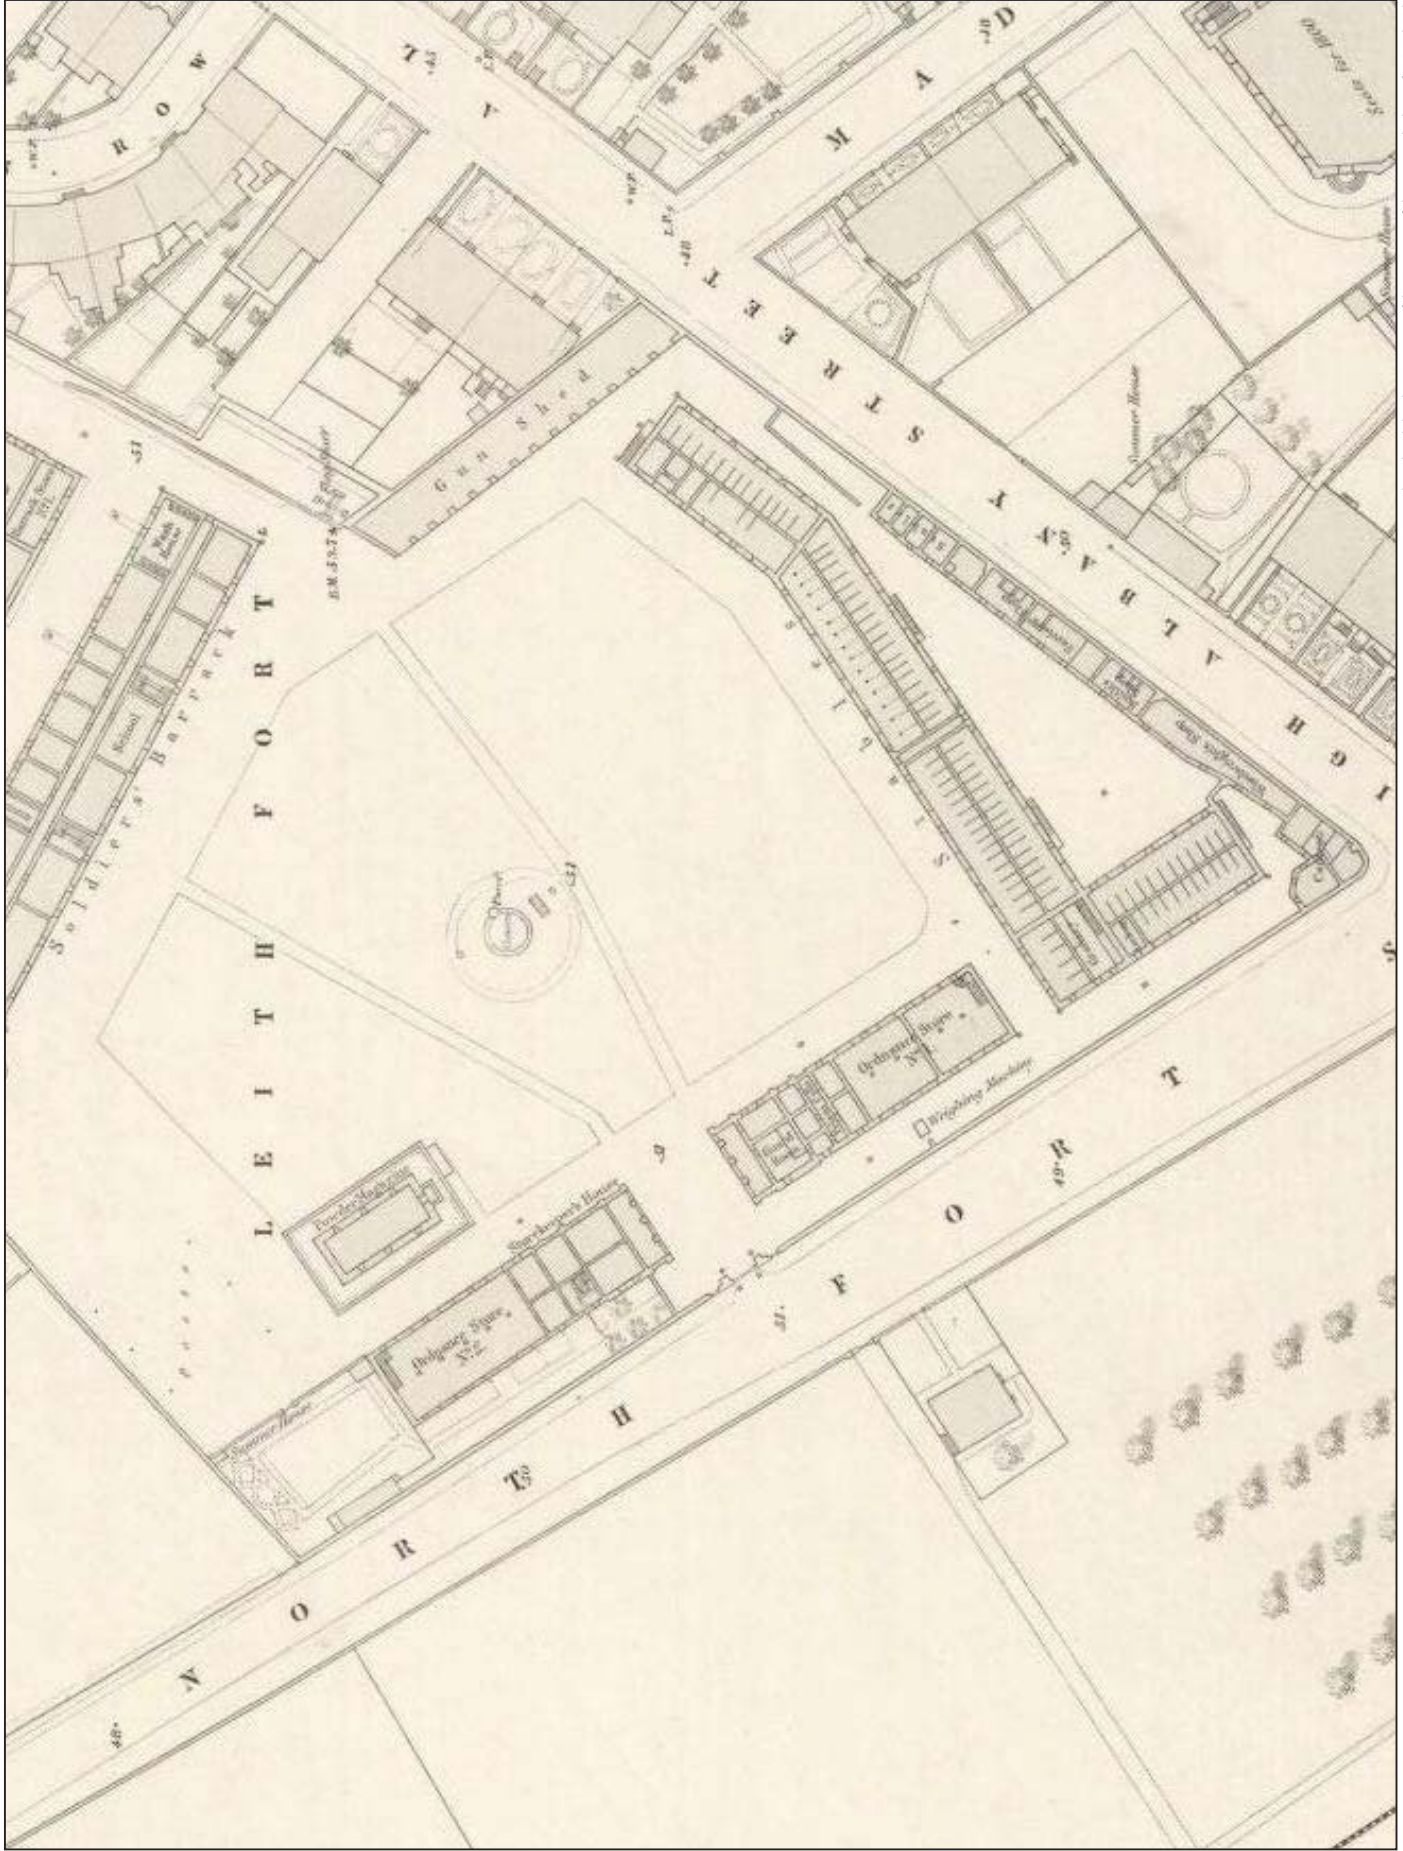
Figure 3 - Extract from OS Map 1852

1.3.5 Later OS maps (1852; Figure 3) show that the layout of the buildings had changed slightly towards the NW edge of the 'new ground' with the stable block being removed from next to the boundary wall. Furthermore, the rectangular building north of the gate house is now labeled as a powder magazine and is enclosed by a separate wall. The remainder of the fort buildings within the 'new

6.2 Comparing the excavation results with the map evidence it is clear that the walls and structures revealed tie in to the earliest phases of the fort buildings. Furthermore, from the 1852 OS map, it is possible to determine the function of each of the structures found along the perimeter wall. Shop 1 and Shop 2 are indicated to be part of a 'Wheelwrights Shop', with Shop 1 possibly forming an external courtyard and Shop 2 being the internal work shop.

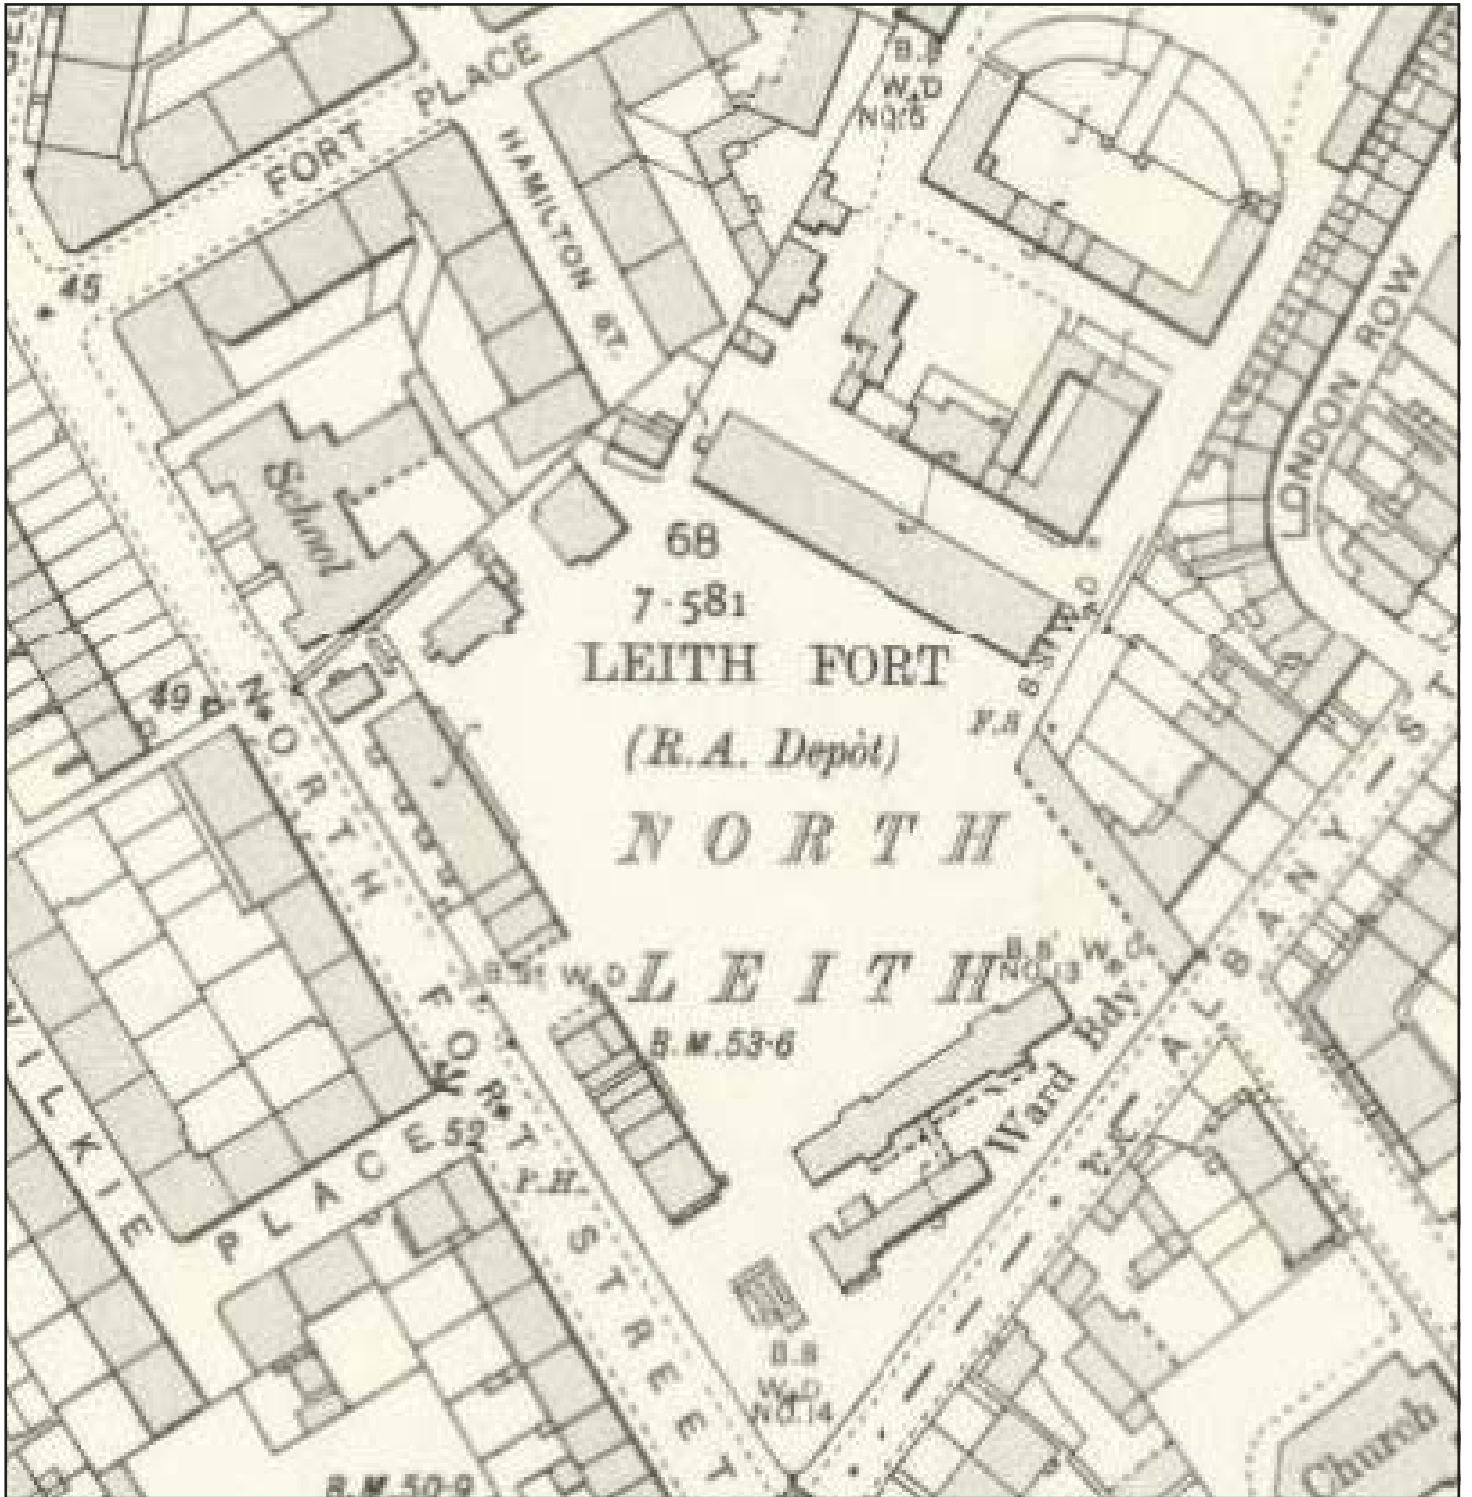
Figure 4 - Extract from OS map 1906

- 1.3.6 Significant changes are made to the buildings by the time of the OS Map in 1906 (Figure 4) with the SE stable block being removed and two smaller but similarly aligned structures taking its place. Further modifications are made to the buildings to the NW, with the enclosed building no longer present and additional buildings erected along the NW wall. The gate houses remain unchanged and the fort continues in this layout until 1955 when it is demolished and a council housing scheme is built on the site. The gate houses with annexes removed and the boundary wall are left intact and are now B-Listed buildings.

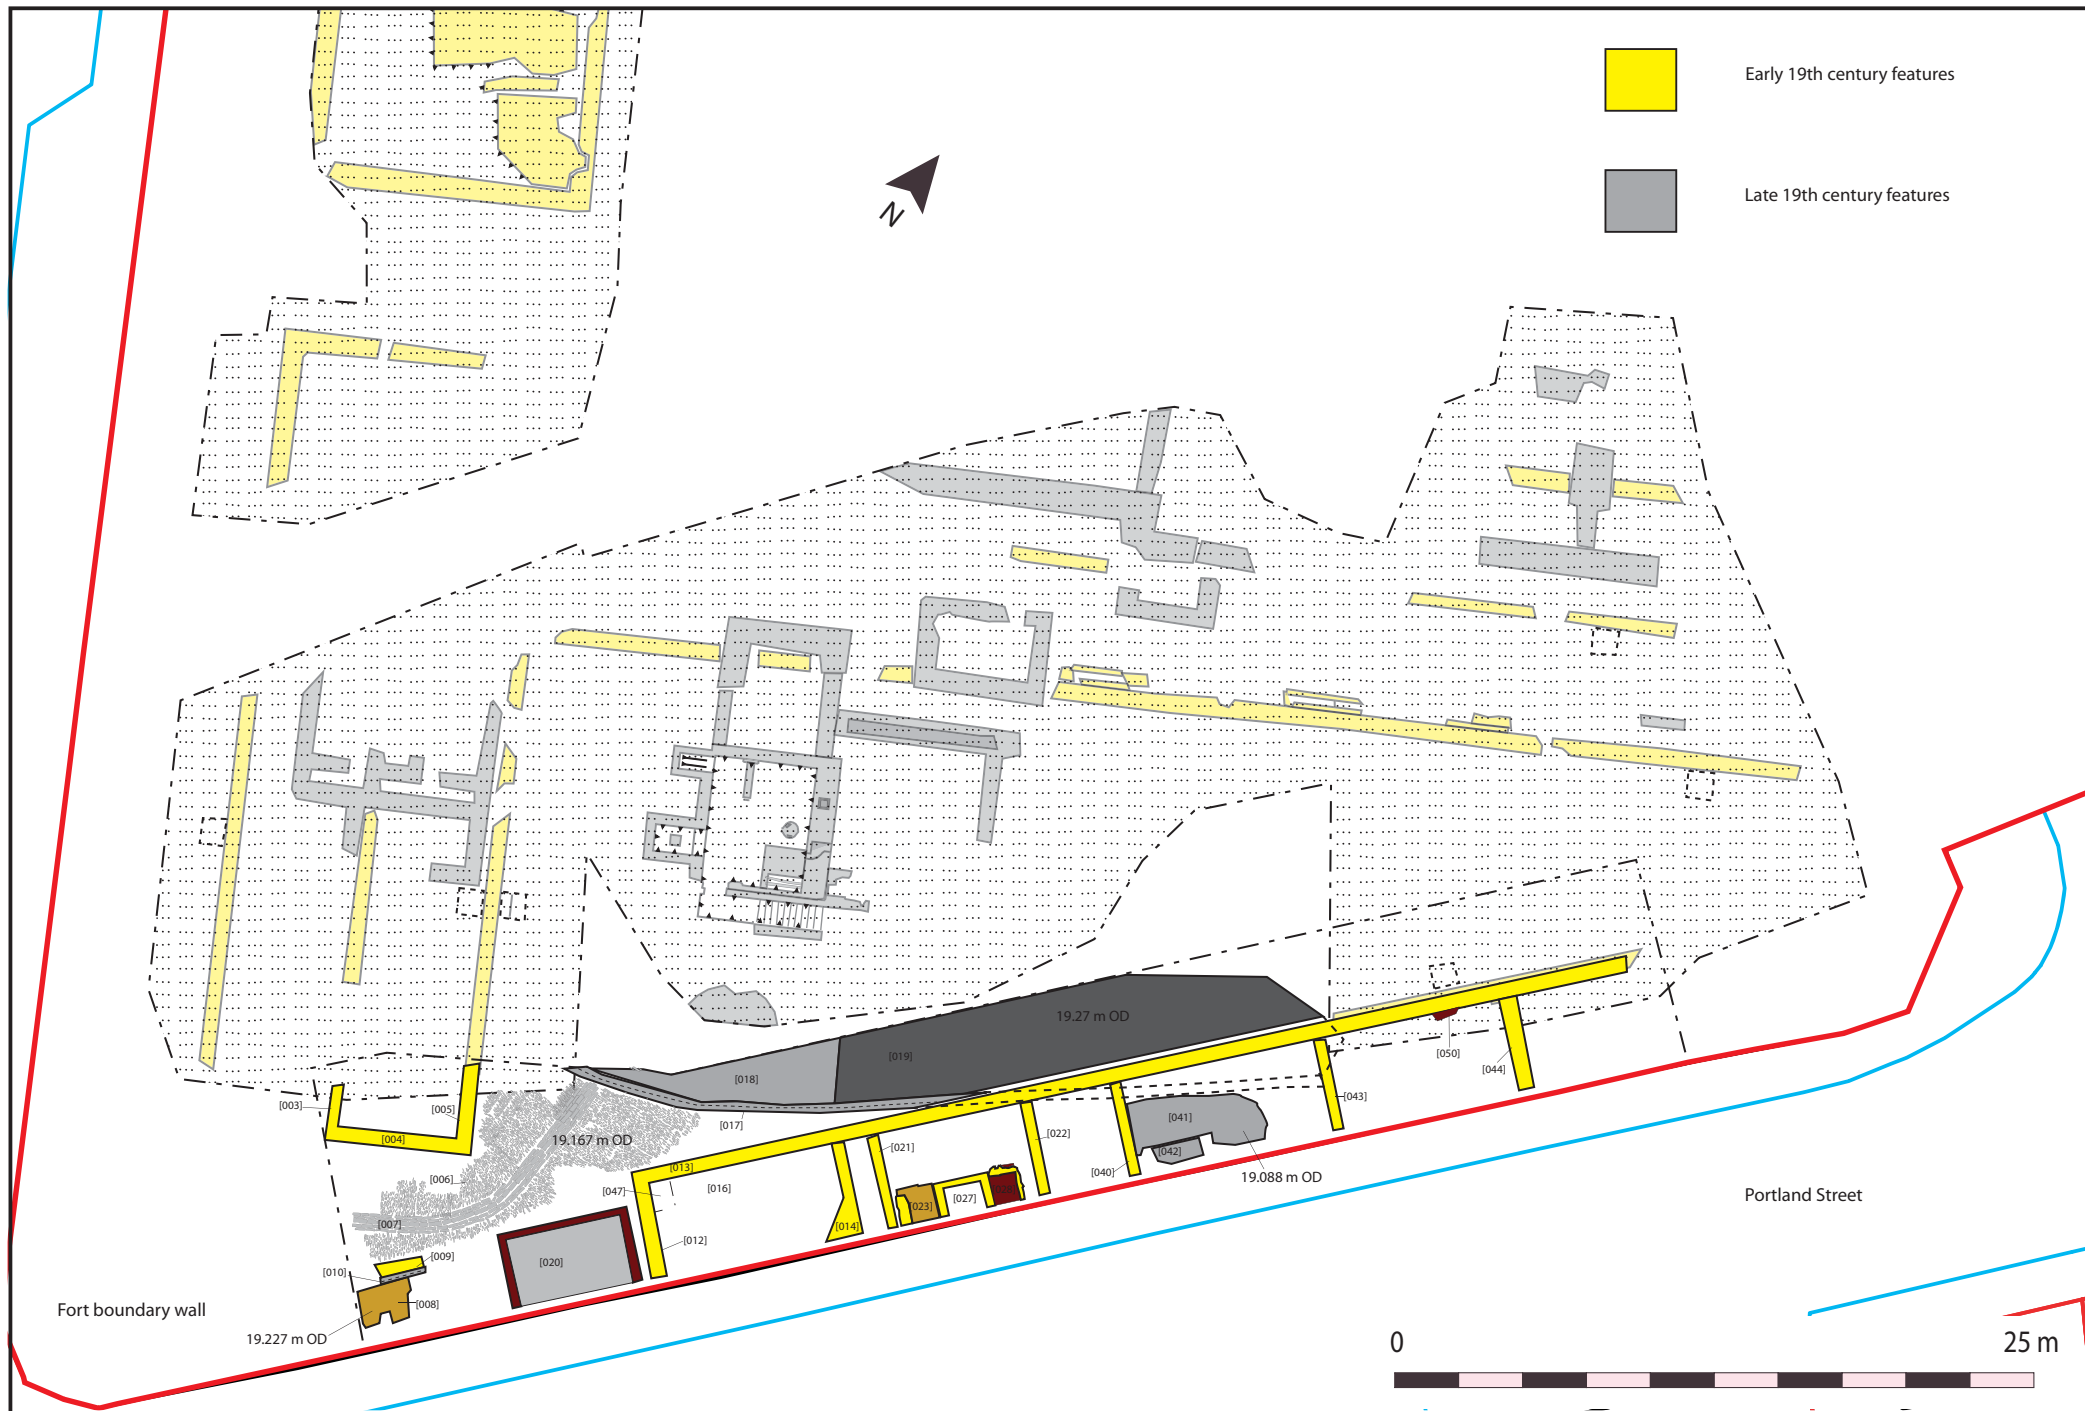
Figure 6 - Plan of features in Area A

5.2.1 This area was located along the SE perimeter wall of the fort and measured 500 m<sup>2</sup> in total (Figures 5 & 6). The area was covered by modern imported topsoil [001] containing modern demolition rubble and red blaes that directly overlay the entire area and measured 0.2 m to 0.7 m thick.
