## SUMMARY

*An archaeological watching brief and Historic Building Record was undertaken by AOC Archaeology Group during November 2006 at the northern end of Smithick Hill, Falmouth, in advance of redevelopment. Various stone structures were recorded: a set of steps, a stone wall and a stone floor were all present, and appeared to all be of post-medieval date. The limited finds were porcelain, suggesting a 19<sup>th</sup> century date at least for some of the features, which may have been part of the same structure: the wall and floor surface associated with one another, and the stone steps accessing the upper floors.*

### Site Location (Figures 1 & 2)

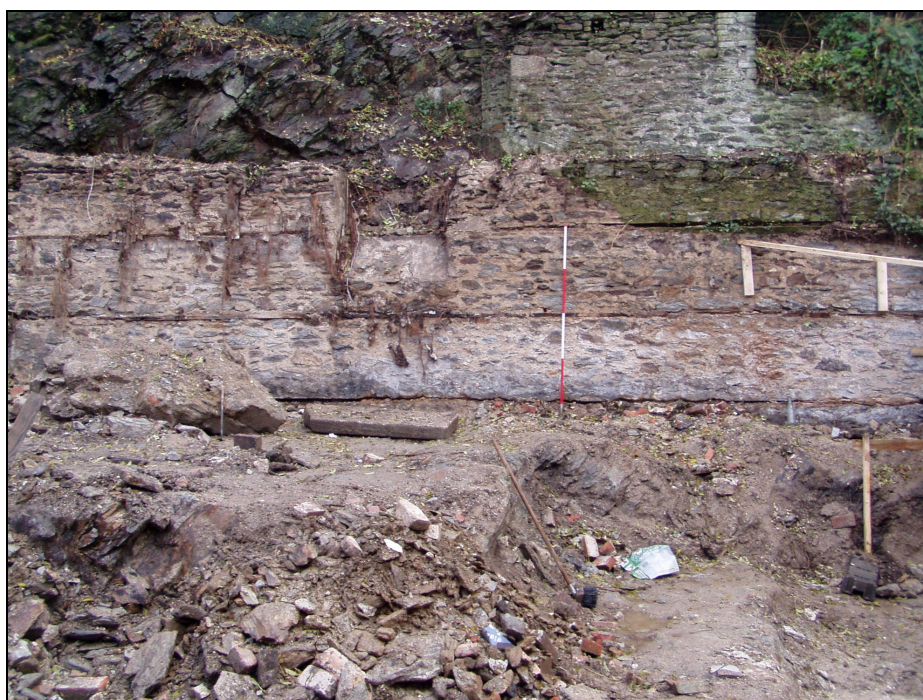
Plate 2: The stone wall

- 4.2 Set next to the western face of the quarry were the remains of a stone building (005). The remains consisted of a wall running parallel to the quarry face, standing up to 2.98m high, for a length of 11.32m. At the northern and southern ends of the wall, partial returns were evident, but had largely been truncated. There was no remnant of an eastern wall to fully define the extent of the building.

- 4.3 The width of the wall could only be determined through measuring the north and south remnant walls. That to the south was 0.60m wide, that to the north 0.54m wide, so it is thought likely that the main wall is of similar thickness. Part of this wall is to be retained *in situ* after the development. The wall appeared to be built directly upon bedrock at the base of the quarry cut rather than within a specific construction trench, but without demolishing the structure, this could not be confirmed. The southern and northern walls of the building were both at right-angles to the main wall.

- 4.4 Each part of the wall of the building was built in the same manner, being roughly coursed blocks of local stone bonded with lime mortar that contained limited hair and few visible coarse components. The stone blocks were roughly squared, measuring up to 420mm by 240mm by 200mm, although many were smaller. The wall may have been repointed, since there was little sign of erosion or weathering.

- 4.5 At intervals of 0.94m (3'1") were horizontal wooden beams each 0.10m square, set flush with the face of the wall. These were in poor condition, and a maximum of four were present across the 2.98m height of the wall. These were not string courses, but rather studs which had boards 0.20m (8") wide nailed to them, forming panelling. The boards were in very poor condition, only four fragments of panelling surviving.

- 4.6 Because the wall is retained *in situ* within the development, dating the structure is very difficult. However, the nature of the mortar suggests a date of possible 18th century manufacture: there is no apparent coal ash/dust in the fabric which suggests that the lime was made in a flare kiln where fuel was

- 5.3 The oldest of the structures is likely to be the stone wall that nestles in the shadow of the quarry. The height of the surviving wall is sufficient to show the cavities where joists may have lain, but no evidence was forthcoming. Possibly, then, either this was a high-ceilinged building, or more simply, there were joists oriented north-south, in which case the evidence would not be present.

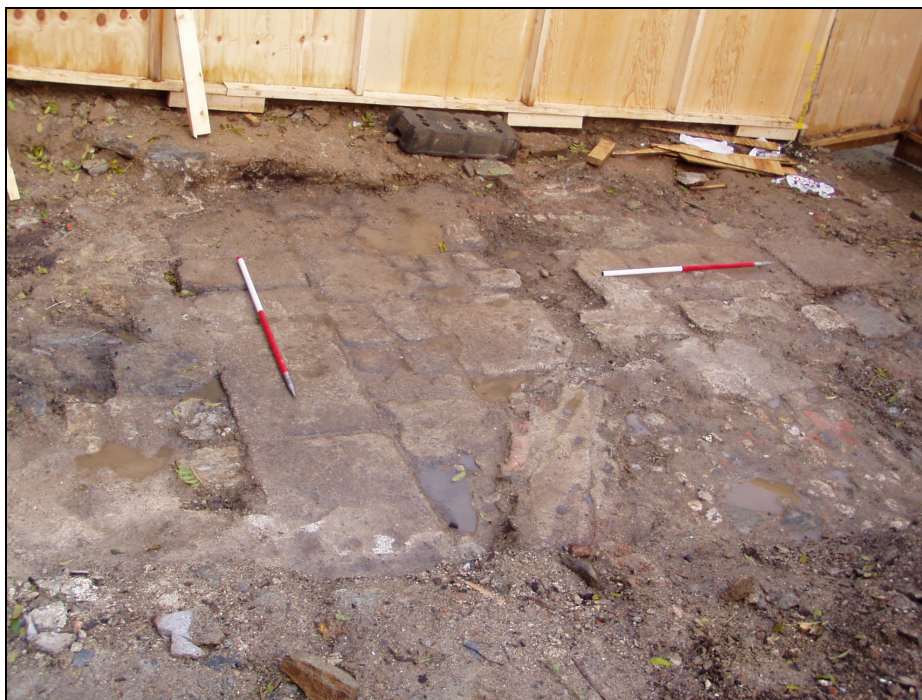
Plate 3: The floor surface

- 4.7 To the east of the site was a floor made from flagstones, cobbles and bricks (004). It had no direct relationship with the stone wall, but given its proximity, some form of relationship seems likely. The floor was set within what appeared to be a small fault in the geology, but may equally be part of the cut of the quarry (008).

- 4.8 The materials forming the floor were bedded upon a layer of very dark brown silty sand that contained weathered stone fragments (006). This could only be studied in a small area, because the floor itself lies below the construction level and is retained *in situ*. Within the silty sand were fragments of china and porcelain that indicate a post 1780 date for construction, and seem to be of late 19<sup>th</sup> century character.

- 4.9 The floor covers an area 5m by 3m, and was oriented at right-angles to Smithick Hill, so clearly respected the line of the road. The most common material for the floor was rectangular flagstones 0.60m wide and 0.05m thick, made of sandstone. The second most frequent floor covering was mortar that overlay patches of bedrock. This mortar is unlikely to have been the finished surface, and must therefore have been the bedding for lost materials: either further flags or tiles. Granite cobbles were also used within this floor, accounting for most of the rest of the materials. These cobbles varied in size from 0.20m square to 0.08m, which were little more than granite pebbles. Each of the cobbles was rounded. Red bricks and half-bricks made up the rest of the floor, giving an impression of a very piecemeal construction. Possibly, this is all evidence of gradual repair to a well-used and well-worn surface. There did not appear to be any regularity to the areas of repair, apart from two lines of flagstones, one running roughly east-west, the other north-south.

- 5.4 An 'old' meeting house was referred to on Porhan Hill – now Smithick Hill – in 1744, so it is possible that this wall, surviving to 2.98m high represents this Meeting House which could, conceivably have had high ceilings. If it is considered that the building which this wall represents filled much of the area of the site, then the stone floor may directly relate to the wall. The use of disparate and different materials in the floor may therefore be evidence of a long-lasting building that was subject to periods of repair. It may also be considered that the flagged area represent excessively worn patches of the floor, perhaps indicating that they mark main circulation zones.

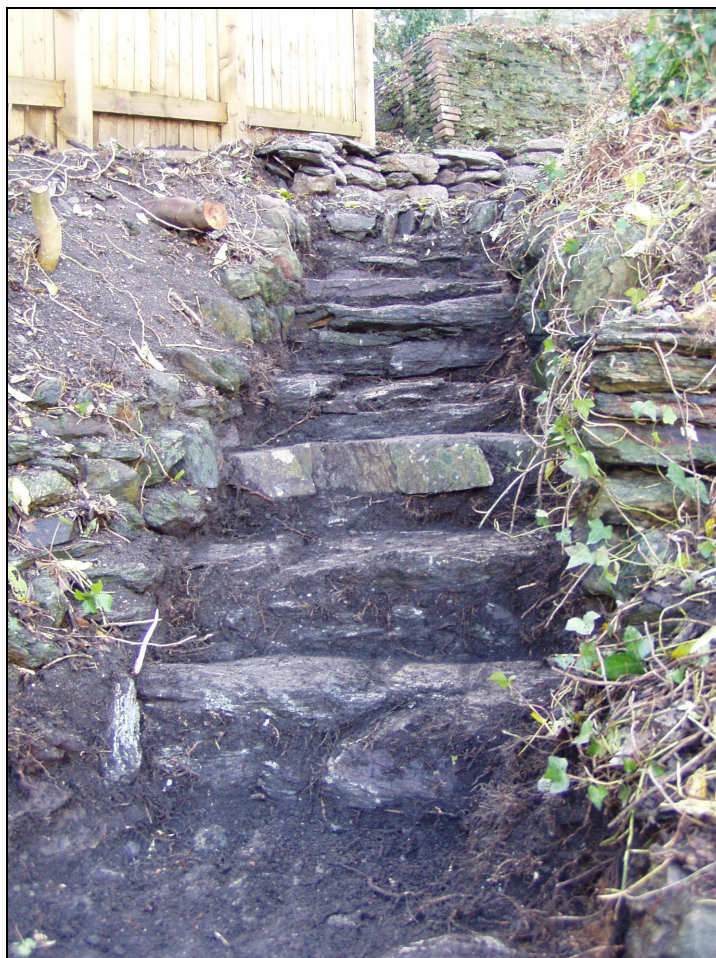
Plate 4: The stone steps

- 4.13 A set of stairs that lead down from the upper terrace of the site before terminating near the steep quarry face were also recorded on the site, and were the primary point of interest at the beginning of the project. The steps were constructed of smooth slabs of local stone, and each step's riser was between 0.18m and 0.33m, resulting in a very irregular flight (002).

- 4.14 The steps run roughly west for eight treads, before gradually turning northwards and finishing suddenly above the cut quarry edge. They lie in a channel cut into the cliff-edge, and the majority of this channel is lined with thin slabs of local stone set on edge with no bonding material evident. The stone itself is somewhat weathered. The steps were slightly obscured by accumulated silty sand that contained occasional fragments of 19<sup>th</sup> and 20<sup>th</sup> century pottery.

- 4.15 The top step is at 18.41mOD, and the bottom step is at 14.49mOD. The flight's lowest step is almost directly above the southwest corner of the Stone Wall recorded in the face of the quarry, and strongly indicates a probable direct relationship.

- 5.8 The steps at the top of the quarry that lead down into it (or up away from it) are of slightly enigmatic function. It seems unlikely that they pre-date the quarry, so must therefore relate to one of the buildings on the site. Their position almost directly above the southwest corner of the building with the Stone Wall suggests that they may have led to an upper storey of this building, but since the later brick building also lay within the same area, then the steps could equally be of more modern date.
- 5.9 Beyond those features recorded, the base of the quarry did not reveal any further archaeological material, being simply the bedrock. If there had been further surviving features, they may have been lost when the burned property at the foot of Smithick Hill was demolished and the site generally cleared.
