Kilvickeon Church, Ross of Mull: Archaeological Monitoring Data Structure Report

AOC Project 70003
25th April 2015

National Grid Reference (NGR): NM 41199 19622

Scheduled Monument No. 7454

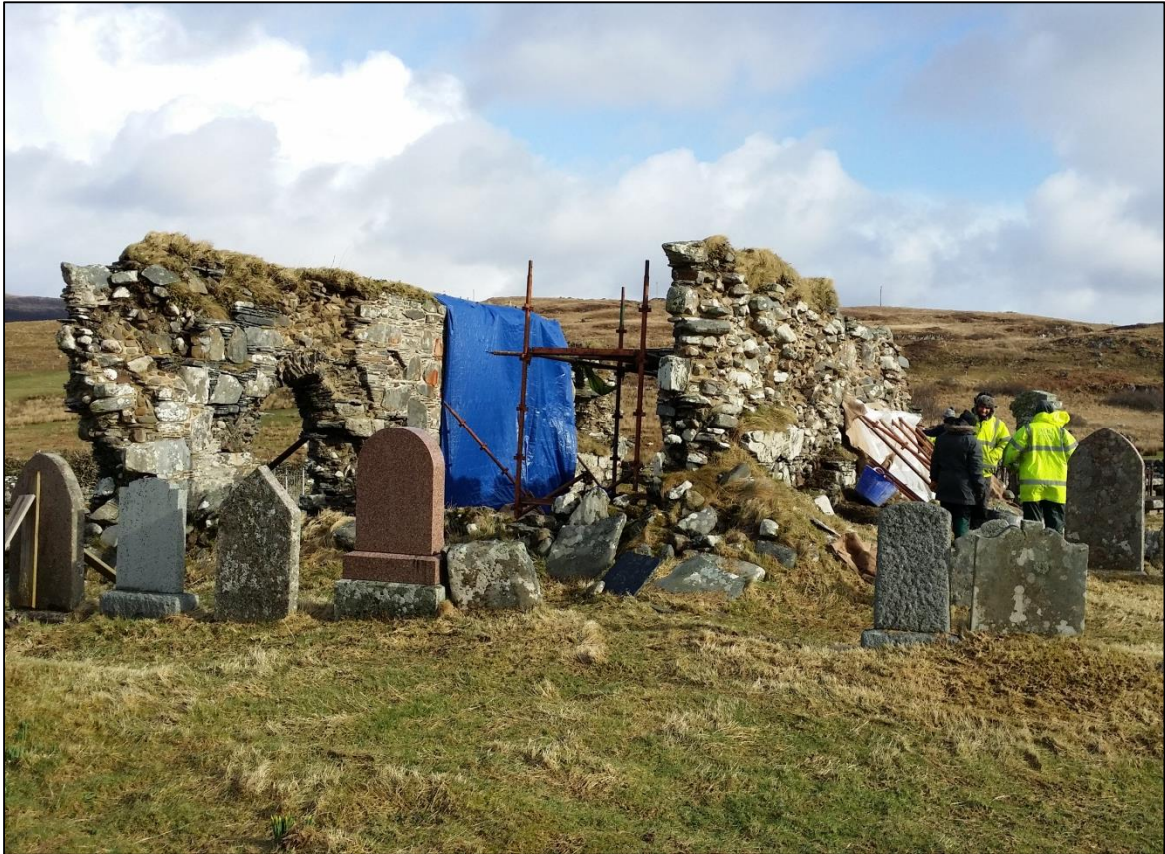
Plate 1: Kilvickeon Church, during the 2015 conservation works

The first stage of work on site was the removal of rubble around the collapsed walls of the church to make them safe to visitors to the site. This was carried out by Graeme Brown Stonemasons under archaeological supervision. No finds of archaeological significance were made within the removed rubble. Once the walls had been made safe, additional new mortar was applied by the stonemasons to safeguard the remaining stones of the walls.

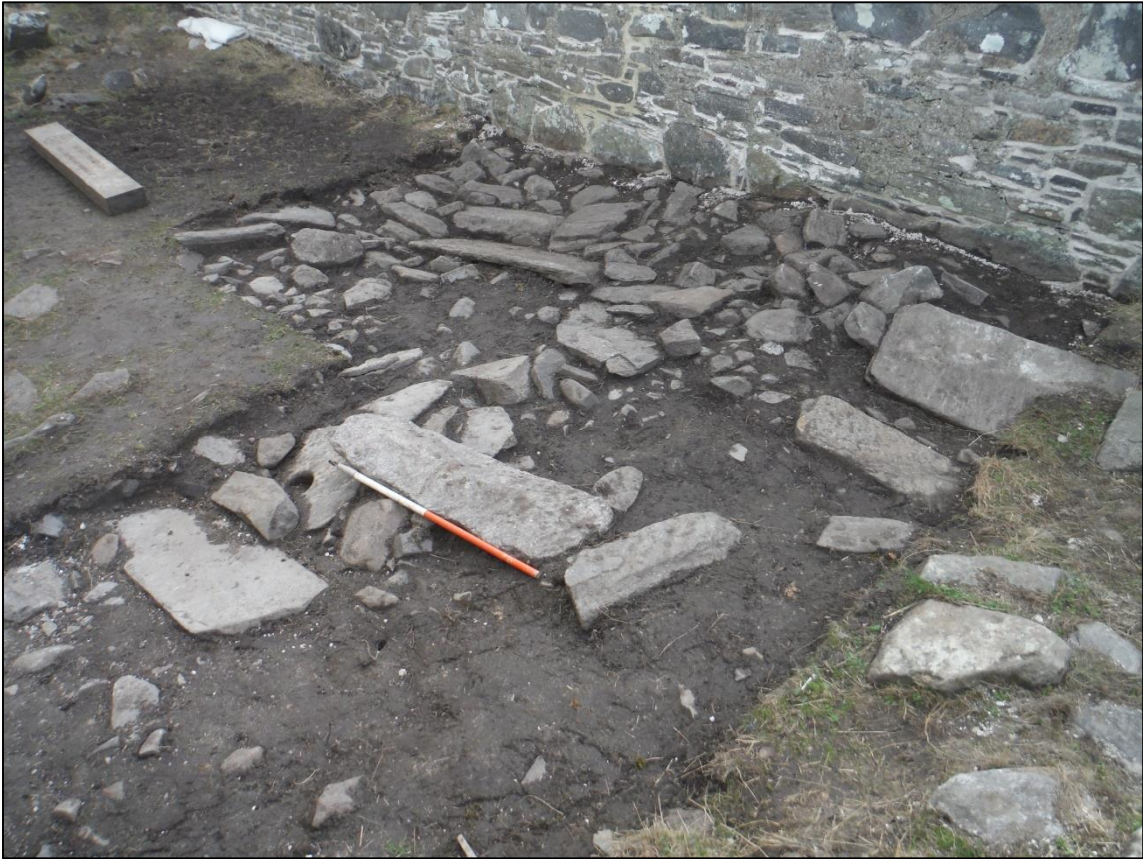
Plate 3: Stone layer [002] inside the church

- 4.2.2 Below the topsoil at a depth of around 0.1m was a concentrated layer of irregular sized and shaped rocks [002] (Figure 3). This lay directly below the topsoil but displayed little or no mortar to suggest that it was tumble from the church walls. In amongst this material were two partially exposed round worked stones with central holes believed to be broken mill stones, [003] and [004]. On top of and amongst this material were also several large flat flagstones or capstones [005], [006], [007], [008], [009] and [012]. The largest of these [007] measured 1.5m by 0.5m and was surrounded by some edge set stones suggesting that it may be a cover stone for a burial. In addition there were two clear voids, [010] and [011], within the stones each measuring approximately 1m by 1m which may represent feature cuts into the layer. Due to the discoveries, work on site was halted at this point as it was clear that the stone layer [002] represented an in-situ surface within the church, possibly a disturbed floor layer with associated burials and worked stone.

- 5.1 The stone surface uncovered inside the church comprised an intermittent layer of irregular stones interspersed with flagstones and grave capstones. There was no evidence that the stone derived from collapsed building rubble. The irregular nature of the layer is not unexpected given that there will have been disturbance associated with subsistence of burial pits and other unknown factors. As only minimal excavation was required in the trench the layer may not have been fully exposed. However, while the interpretation is uncertain, the presence of the mill stones, so commonly seen re-used in Iron Age and medieval walls and floors, strengthens the possibility that this layer formed a floor surface inside the church. The mill stones themselves showed evidence for considerable use, having been worn and broken and later making their way into the church.

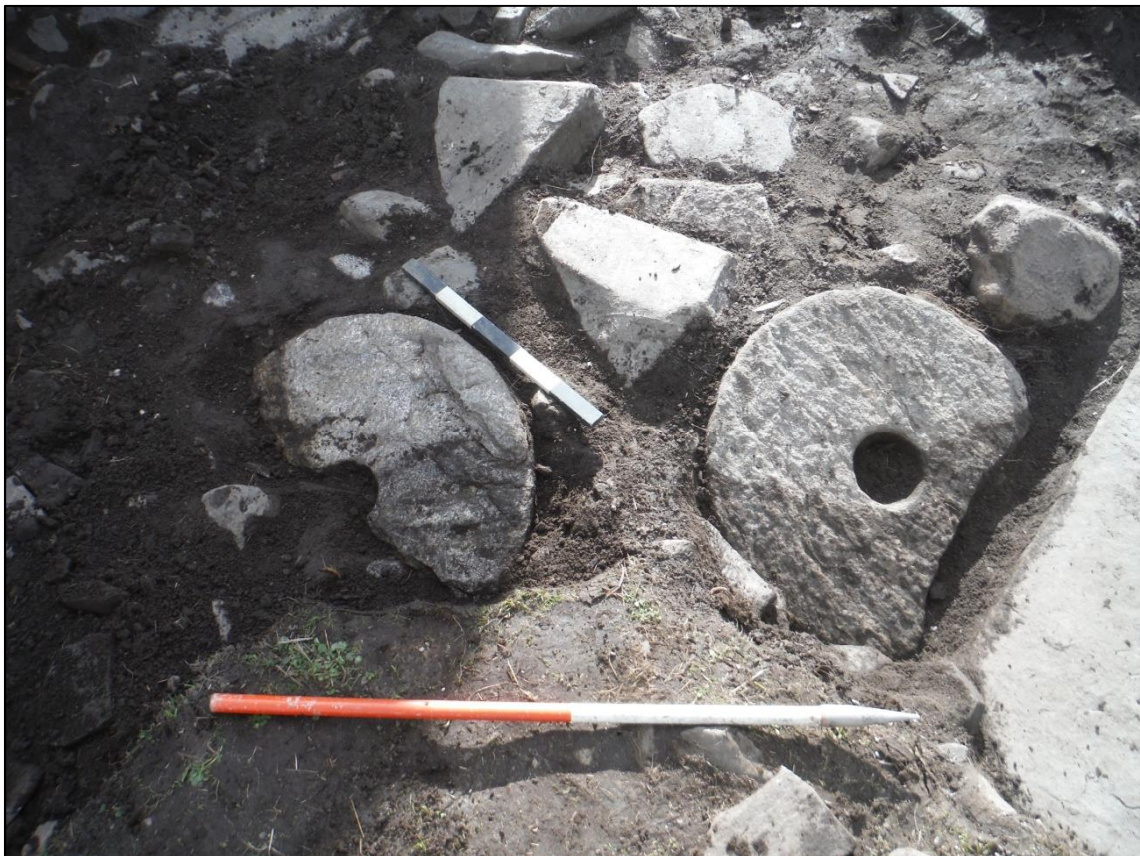
Plate 4: Mill stone [003] and [004] within layer [002]

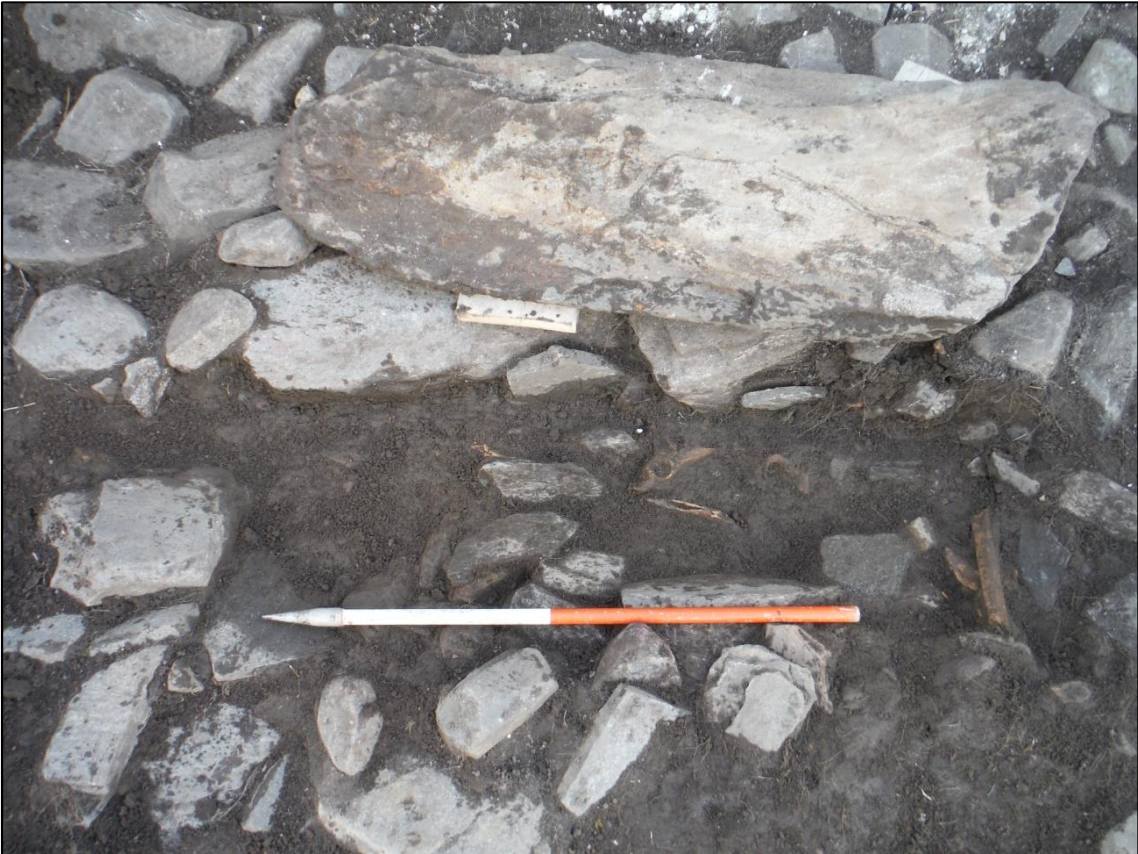
Plate 5: Inhumation below [007]

4.3.3 The final task of the fieldwork was to re-set slab [007] to a flat angle for its incorporation into the new gravel surface. The overlying stones around [007] were removed and the stone was carefully lifted by hand. The stone was then laid to the south to allow for investigation beneath it. It was immediately apparent that, below the slab, there was a clear cut [016] through surface. It measured around 1.6m long by 0.4m wide with at least two edge set stones along its south side (Figure 4). A careful clean of the material [014] within this cut uncovered some fragmentary human remains with a collection of skull fragments. material which has been removed and stored. The remains of human long bones were identified at the west end of the burial pit with the pelvis in the middle of it. Further disarticulated bone fragments were recovered from the east end of the grave. As with the previous discoveries, no further excavation was required and no further comment can be made as to the state of the burial other than some disturbance seemed likely. To preserve the remains in-situ a thick layer of soft sand was laid inside the grave cut to level it for the re-setting of the slab.

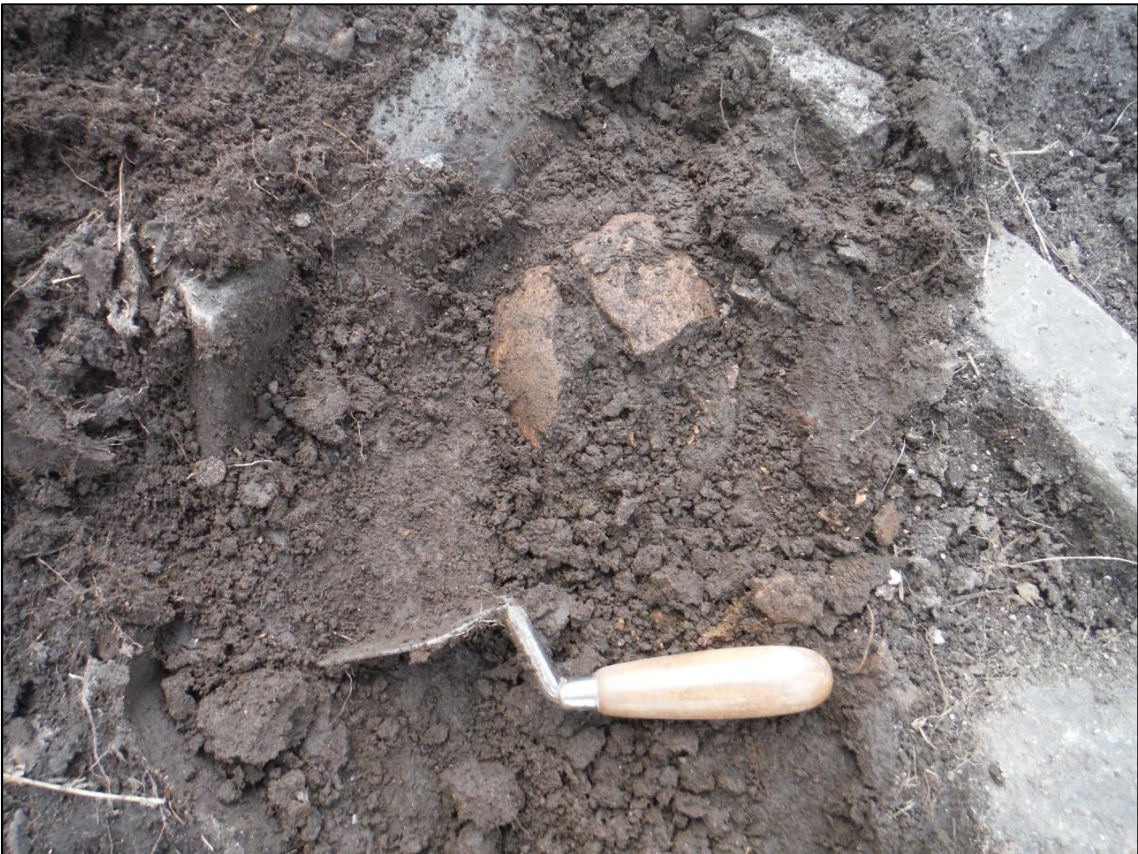
Plate 6: Human skull remains below stone [012]

- 4.3.2 Upon the removal of stone [012] a concentration of human bone composed of skull fragments and degraded vertebrae was partially uncovered. This appeared to be the remains of a burial or charnel pit, possibly relating to the voids [010] and [011], which lay directly adjacent on either side. The deposits were preserved in-situ as no further excavation was required and the full nature of the

remains was not uncovered. In addition a layer of sand was deposited across this area to protect it prior to the further ground build-up works.

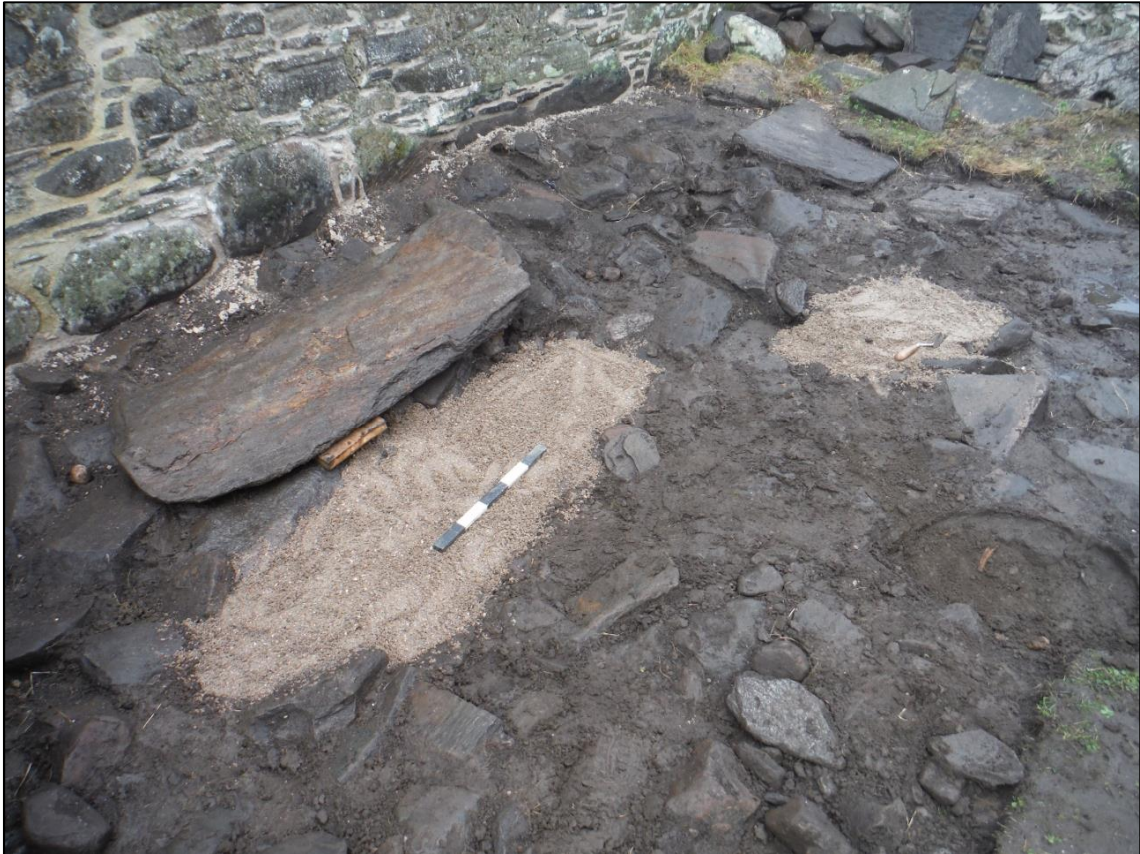
Plate 7: Probable burials inside the church, protected with sand

- 5.2 Prior to excavation of the trench, visible evidence of stone-lined settings inside the church had been recorded. The presence of the burials inside the church is not unexpected, this being a typical practice of the medieval period. The presence of at least two burials below stone slabs indicates that the building likely contains numerous graves. As the methodology for the fieldwork did not require further excavation, the burials have been preserved in situ.

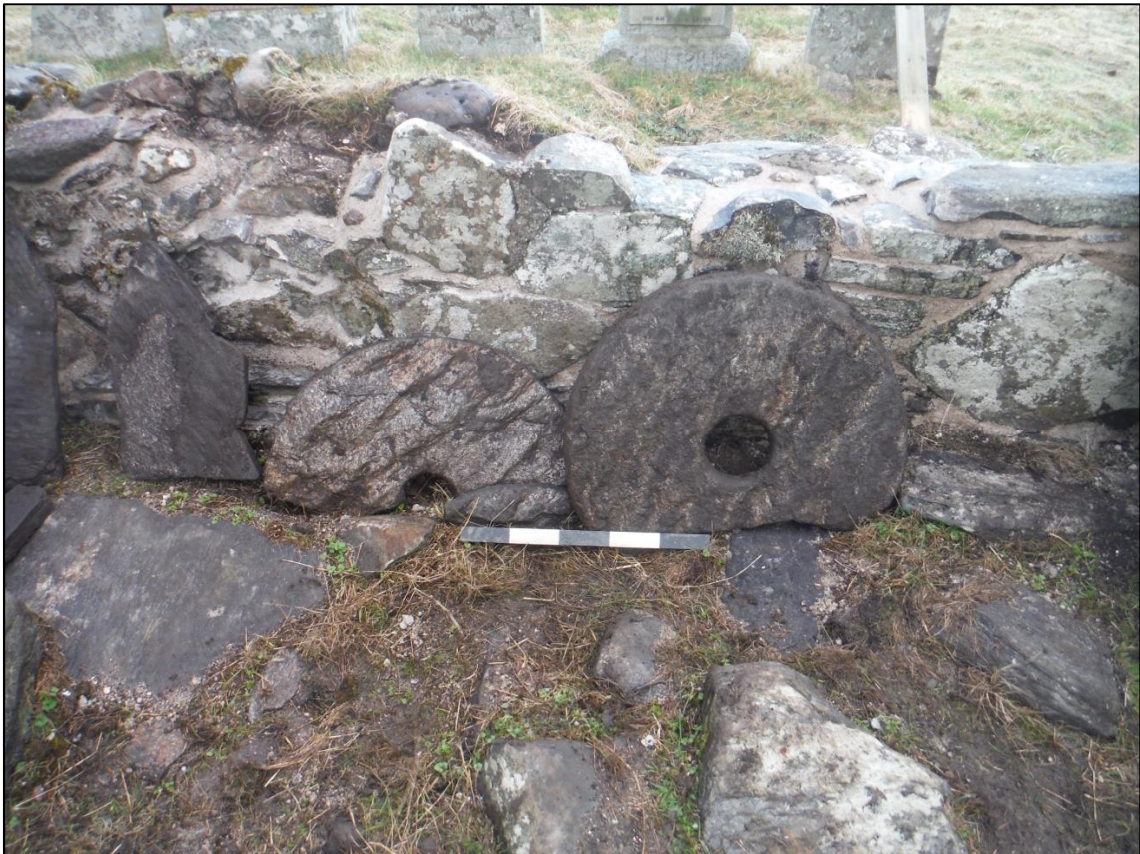
Plate 8: Mill stones [003] and [004] post removal

- 4.3.1 After a site visit by John Raven of Historic Scotland in the interim period, a further programme of work was agreed. The work included the recovery of the mill stones [003] and [004], the removal of several of the upper slabs from [002], the removal of flagstones [006] and [012] and the re-setting of stone [007] at a better angle. The first mill stone [003] was fairly complete with only a fragment missing from the bottom. The stone measured approximately 0.68m in diameter with a central hole measuring 0.14m in diameter with a maximum thickness of 0.08m. The surface of the stone was fairly smooth with very shallow worn grooves running across it suggesting that it had seen significant use. Mill stone [004] was of similar dimensions but was far more fragmentary with less than half of the stone surviving. No significant finds were discovered beneath either stone. The removal of several stones from [002] likewise produced no finds of archaeological significance, although underneath stone [006] a single ceramic fragment was discovered.
