University of Stirling, Stirling: Metal Detecting Survey & Archaeological Evaluation Data Structure Report

AOC Project 23298
18th December 2015

On Behalf of:	Faithful & Gould Canning Exchange 10 Canning Street Edinburgh EH3 8EG
National Grid Reference (NGR):	NS 80736 96079
AOC Project No:	23298
Planning Application No.	15/00523/FUL
OASIS No.	236692
Prepared by:	Kevin Paton
Date of Fieldwork:	17 th December 2015
Date of Report:	18 th December 2015

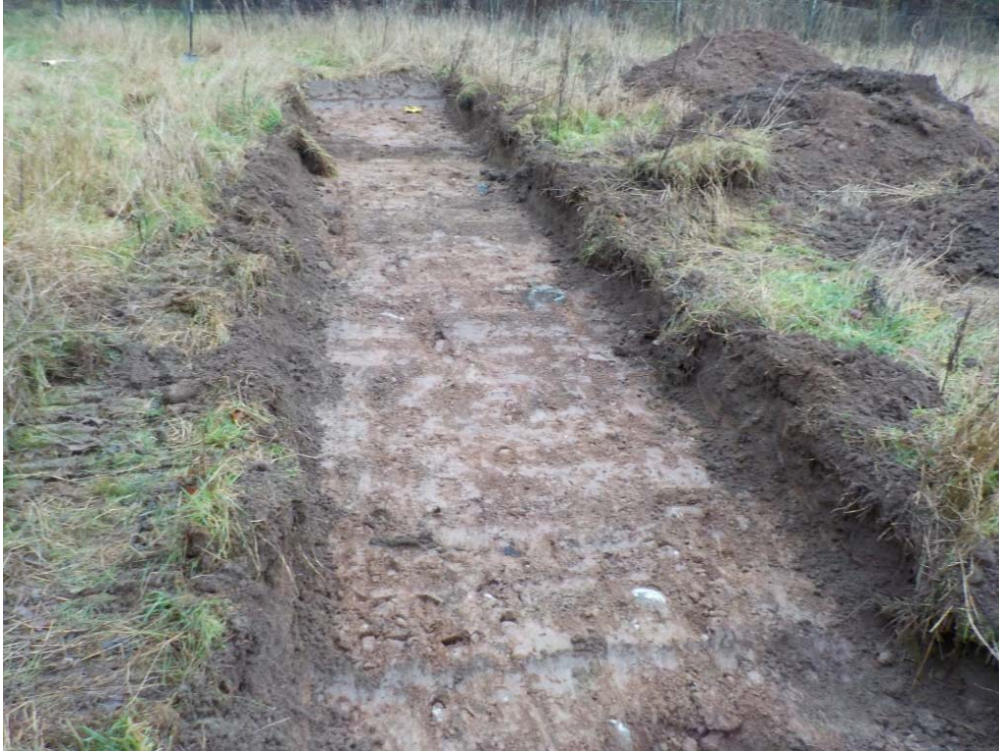
Plate 1 - General view of Trench 1

<i>Dimensions</i>	10 m by 2 m
<i>Total Area</i>	20 m ²
<i>Excavated Orientation</i>	E to W
<i>Soil Make-up</i>	Topsoil – mid brown clay loam - 0.31 m
<i>Significant Features</i>	None
<i>Other Features</i>	None
<i>Natural Subsoil</i>	Pale orange sandy clay and occasional large stones
<i>Finds</i>	None

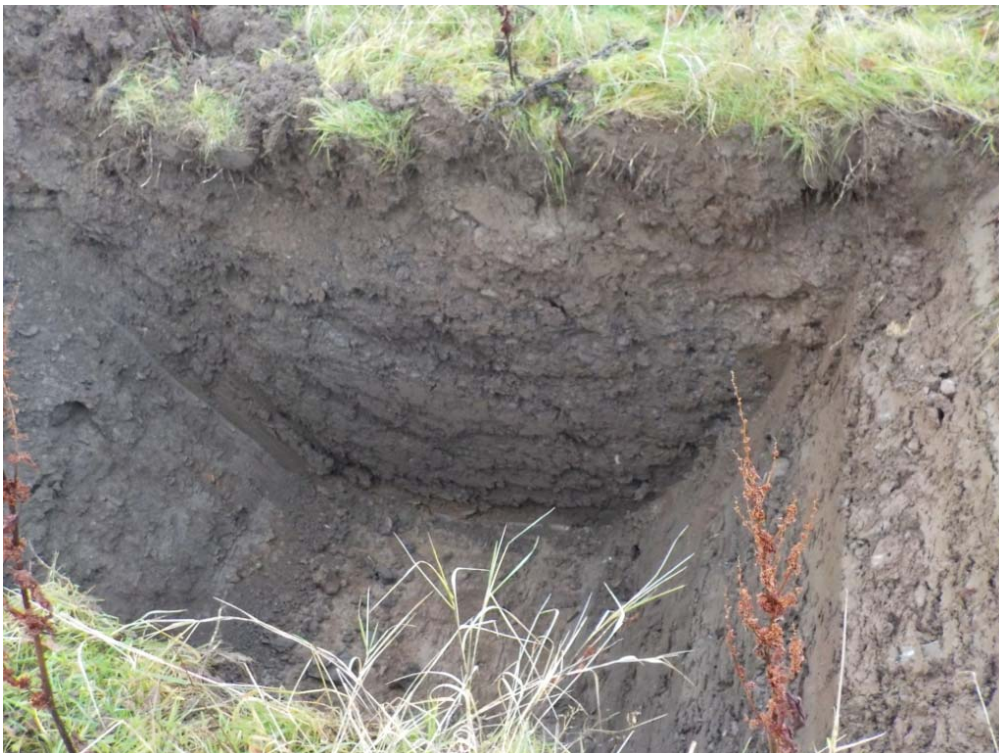
Plate 2 - Made ground depth in Trench 12

- 4.3 It had been known from previous work within the university that the site had been used as a dumping area for material from the Stirling Court Hotel extension (circa 2009). However, it was not known to what extent the area had been used, but the trenches excavated suggest the majority of the site had been stripped and dumped on.

<i>Dimensions</i>	4 m by 2 m
<i>Total Area</i>	8 m ²
<i>Excavated Orientation</i>	NE to SW
<i>Soil Make-up</i>	Made ground – mid brown sandy clay and dark grey clay and stone - 2 m
<i>Significant Features</i>	None
<i>Other Features</i>	None
<i>Natural Subsoil</i>	Pale orange sandy clay and occasional large stones
<i>Finds</i>	None

- 5.1 From the trenches excavated it has been demonstrated that the development area has been previously truncated by stripping and dumping related to the Stirling Court Hotel extension. As for the access road area the current car park and woodland would most likely have removed any potential archaeology in these areas as well.
- 5.2 No further archaeological works are deemed necessary within the development area. This recommendation will require the approval of the Planning Officer (Archaeology) for Stirling Council.
