# David Livingstone Centre, Blantyre, South Lanarkshire: Archaeological Watching Brief Data Structure Report

*AOC Project 23245  
2<sup>nd</sup> February 2016*

## David Livingstone, Blantyre, South Lanarkshire: Archaeological Watching Brief Data Structure Report

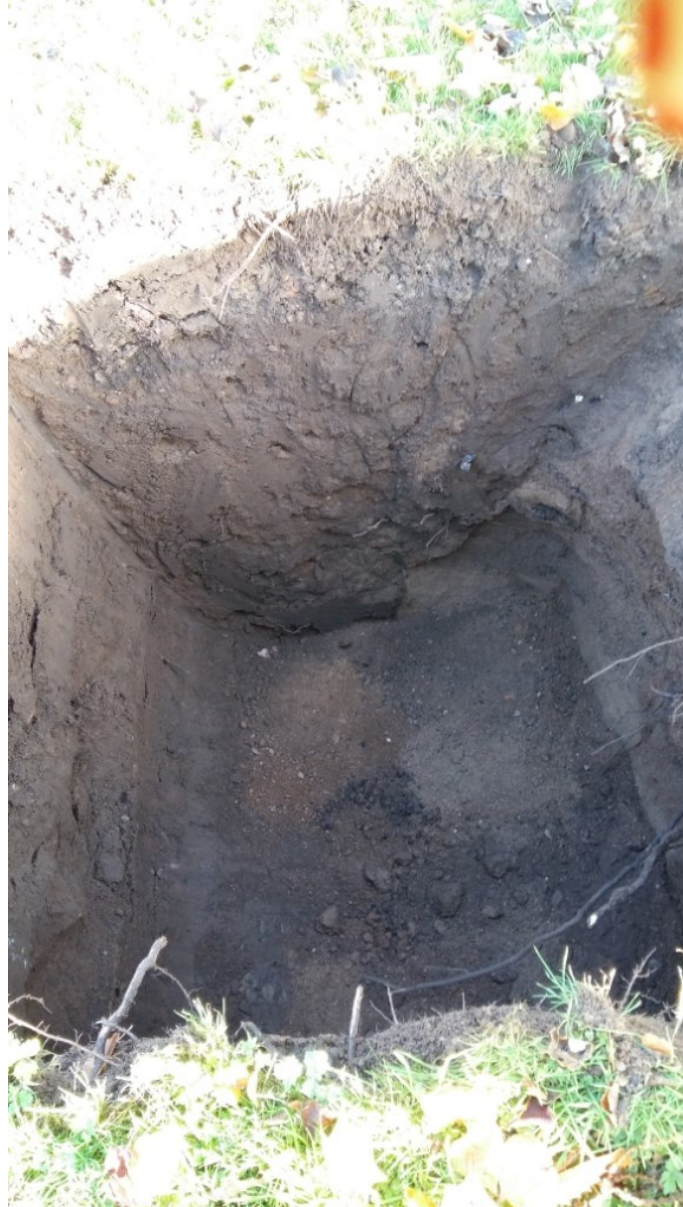
Plate 1 - E-facing section of deposits in TP 6

consisted of 0.95 m of road build up over the natural subsoil. In TP 3, TP 5, and TP 6 the made ground deposits were between 0.25 m and 1.6 m deep overlying the natural orange sand (Plate 1).

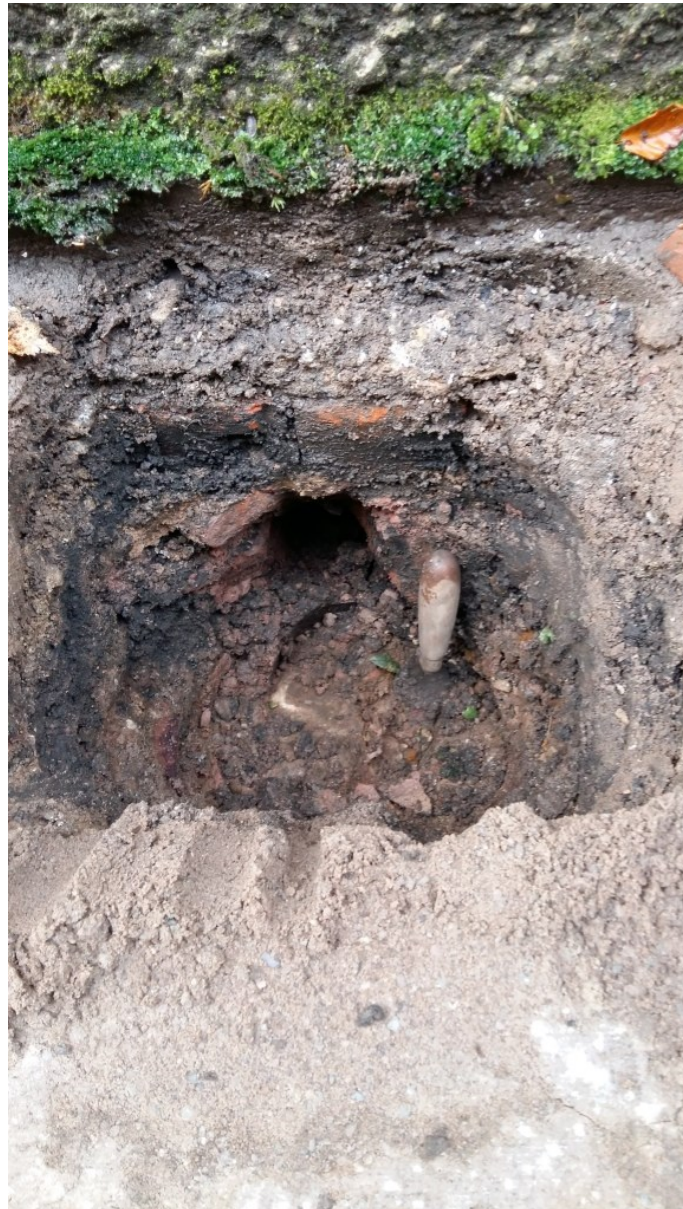
Plate 2 - View of foundation pit

- 4.3 The hand excavated foundation pits were conducted to show the depth of the current building foundations within the natural subsoil. Most of these pits were excavated to around 0.5 m through made ground and showed that the building foundations were built on top of the natural orange gravel in this area (Plate 2).
- 4.4 No archaeological features or artefacts were uncovered during the works.
