102 St Leonard's Street, Edinburgh: Archaeological Evaluation & Excavation Report

102 St Leonard's Street, Edinburgh:

Archaeological Evaluation & Excavation Report

AOC Project No: 22968

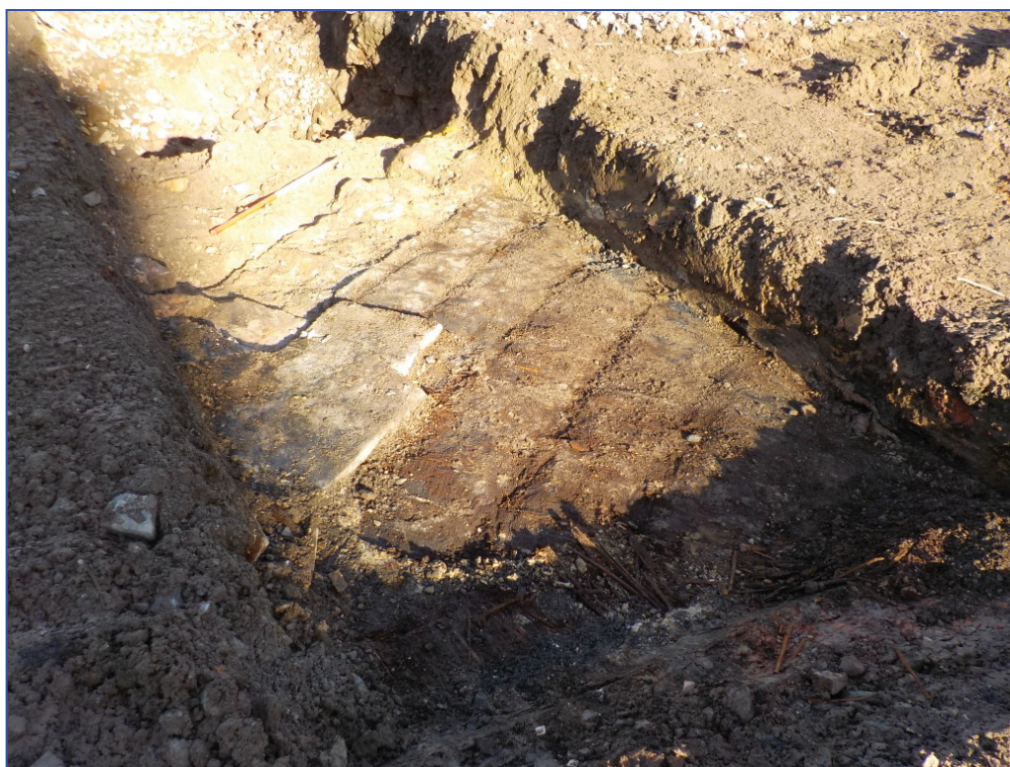
Plate 1: Trench 3, general view of floor surfaces and wall [301]

5.2.2 Trench 3, positioned to the south-east of Henry Street revealed a bitumen and wooden floor surface [301], with some sandstone flagstone [306] bounded by a north-east/south-west-aligned sandstone wall [302] (Plate 1). To the immediate N of this wall was a cellar area with wall [305] in the W edge of the trench, with another NW-SE aligned wall [304] at the northern end of the trench that had been excavated into the natural subsoil. Due to these findings an excavation around these features was required.

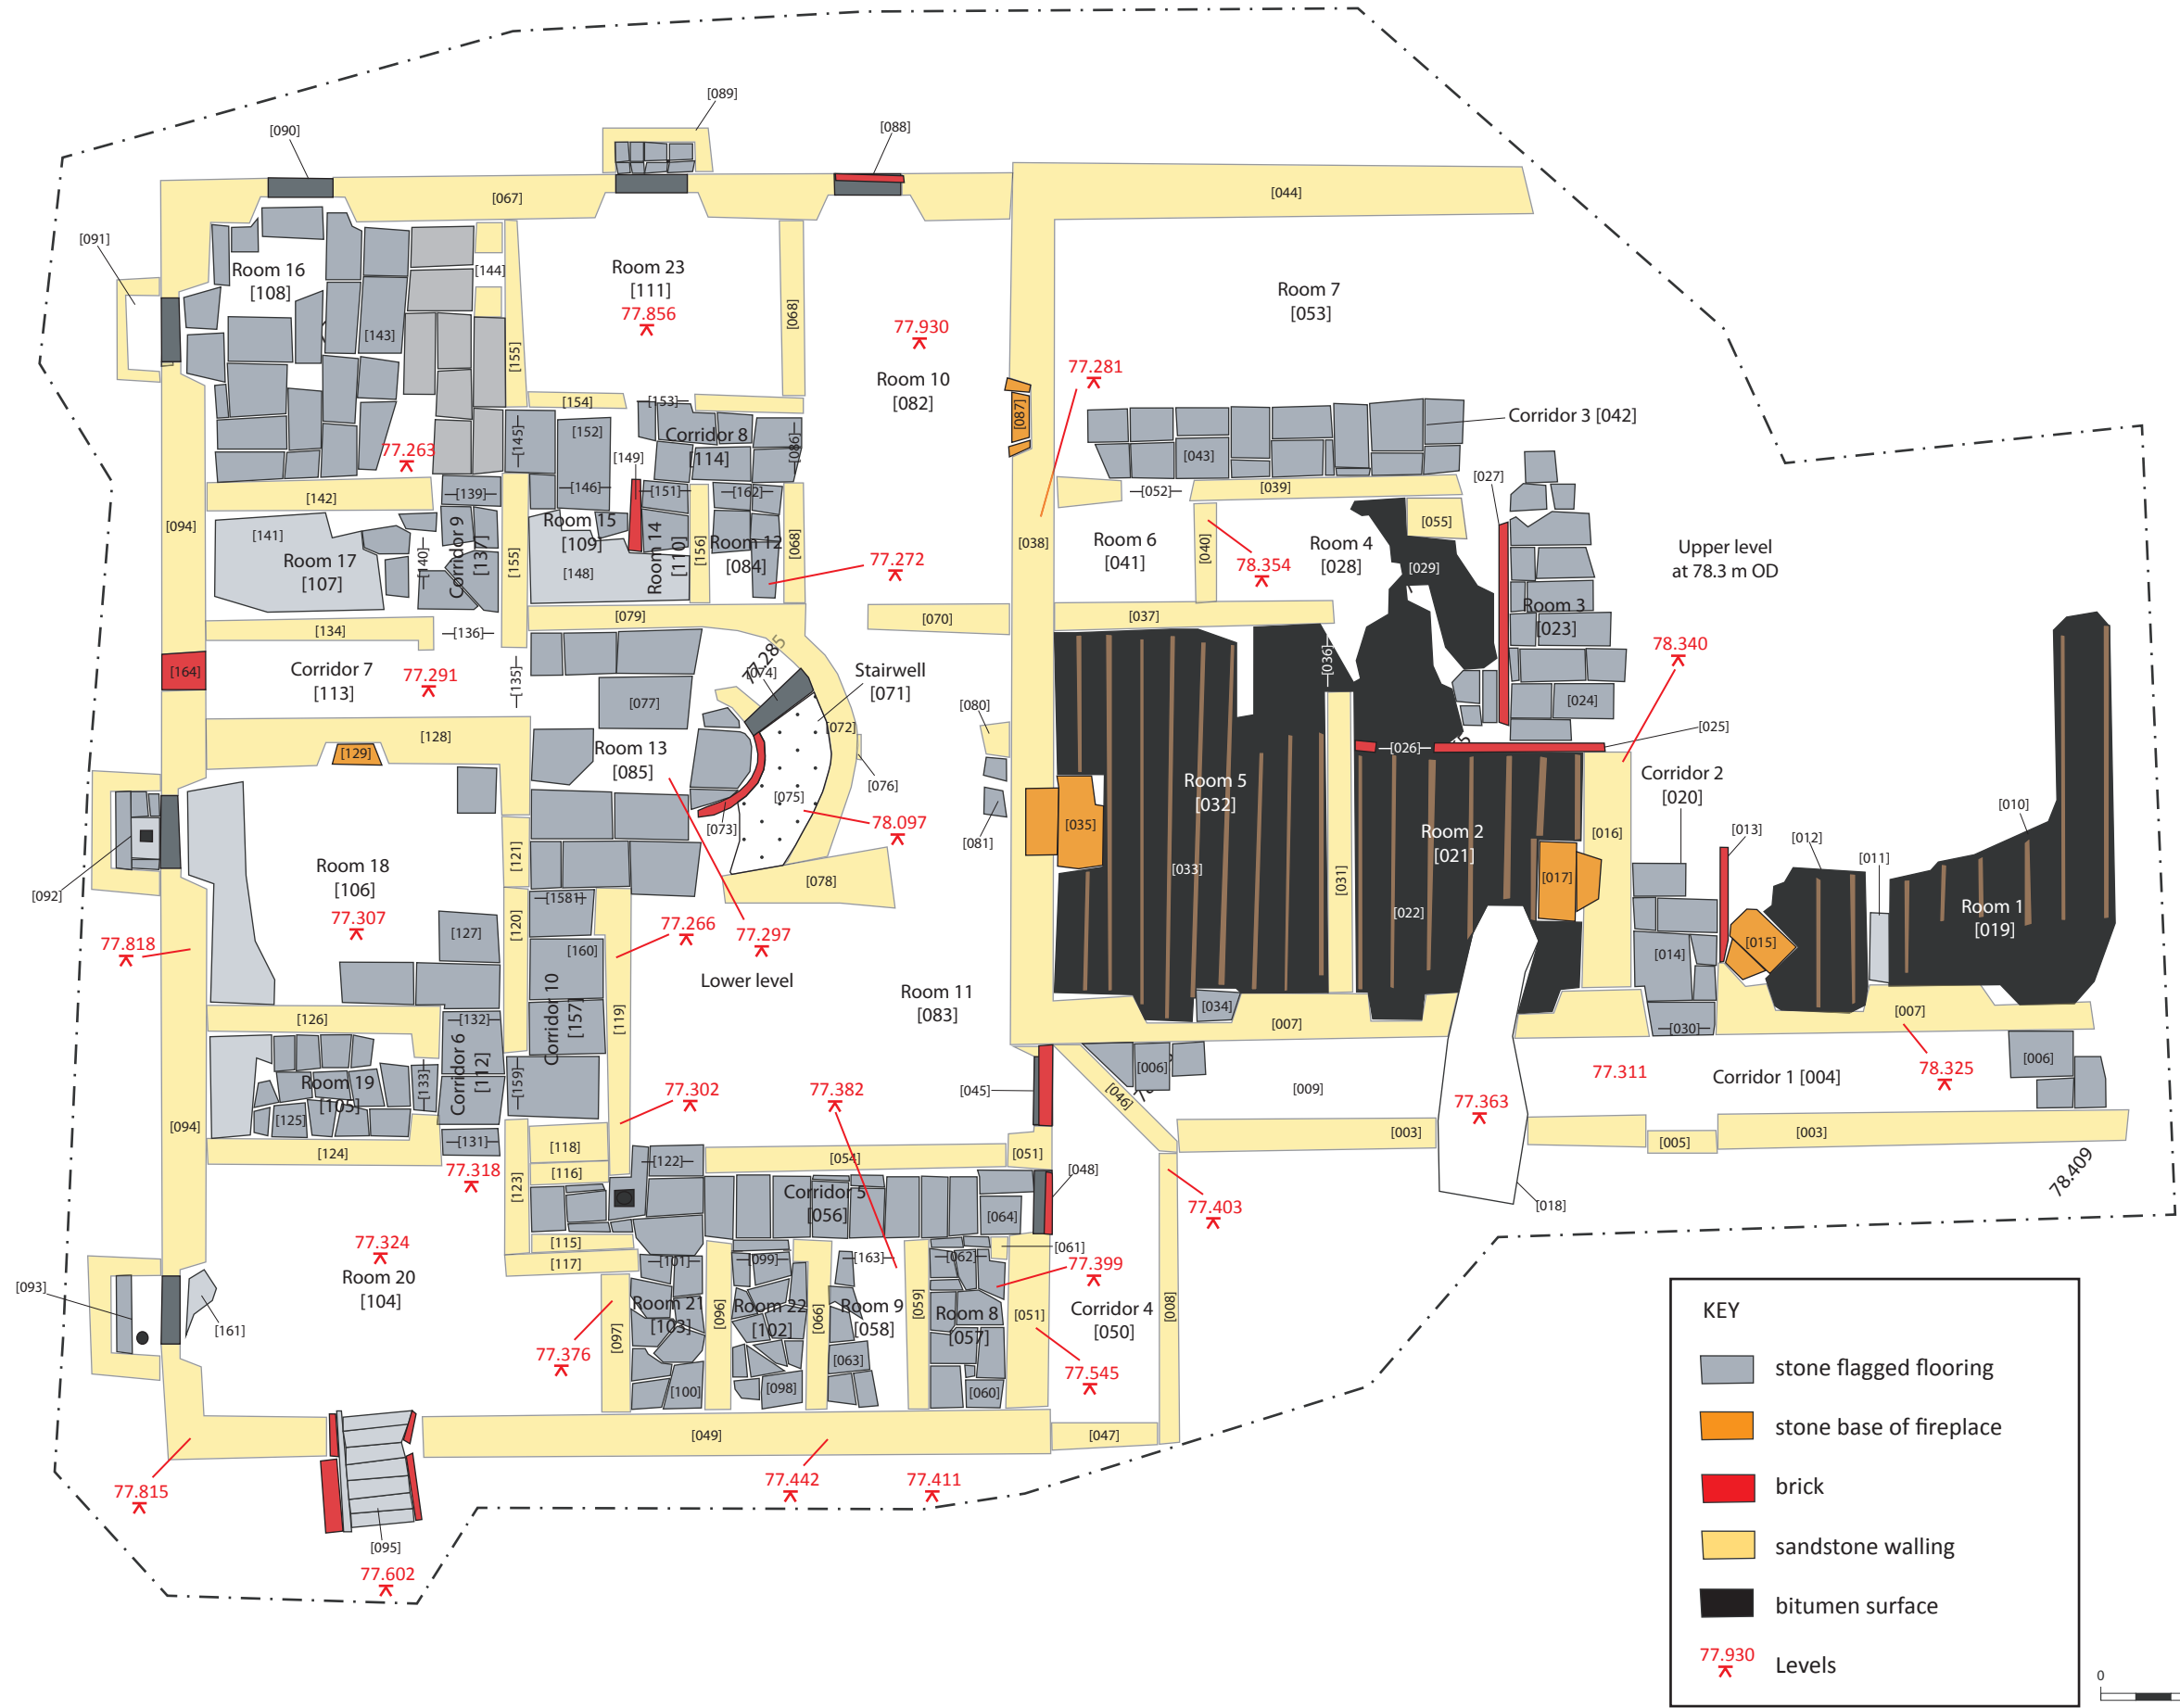
Figure 16: Plan of excavation area **AOC** Archaeology Group

5.3.2 The Upper Level contained seven rooms that were contained by outer walls [044] and [007] to the north-east and south-west respectively (Figure 16). The south-east edge had been truncated by the previous development, and the north-west edge was bounded by wall [038], that also formed the south-east wall of the Lower Level. The total size of the remains of this level measured 15m by 11m with the walls surviving to 0.4m in height in some places, constructed into the natural clay subsoil.

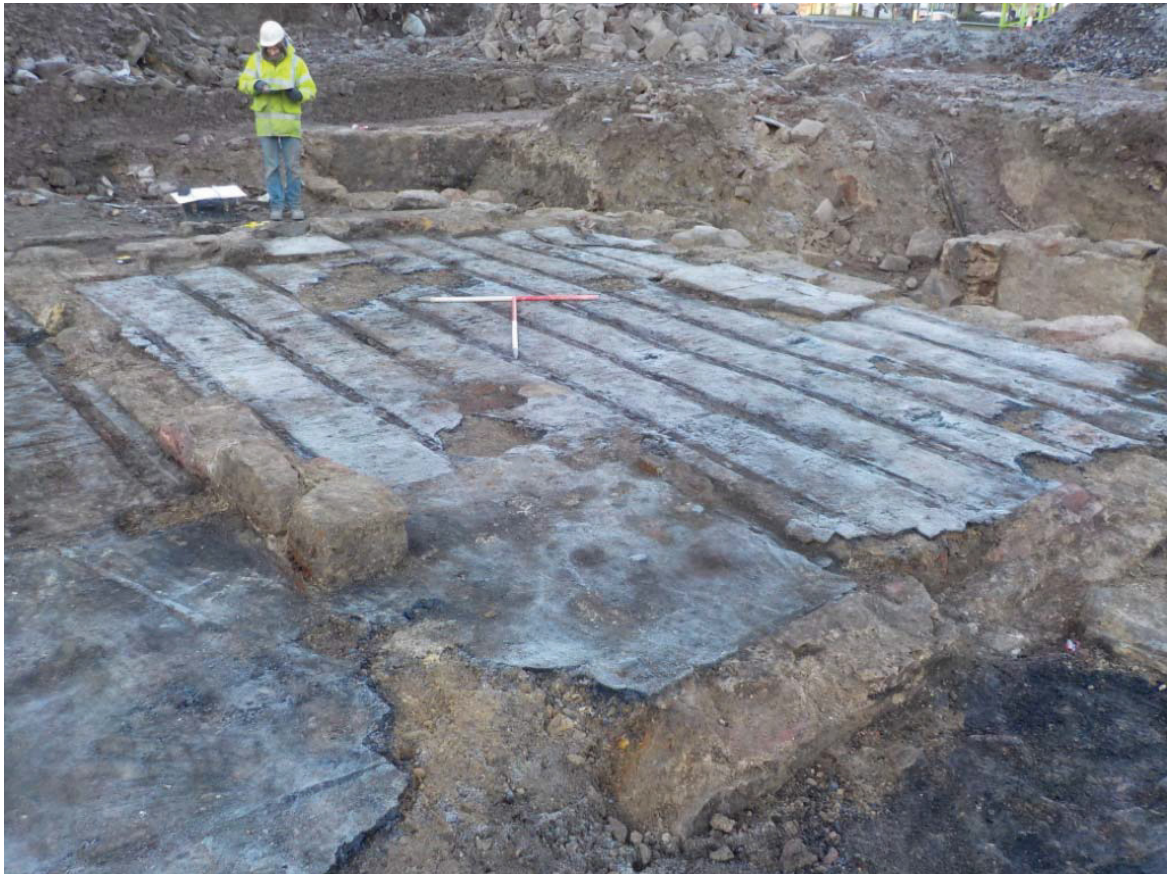
Plate 9: Upper Level, general view of Room 5

5.3.7 Room 5 was the largest room set in the western corner of the Upper Level, bounded by walls [007] to the south-west, [038] to the north-west, [037] to the north-east, and [031] to the south-east, measuring 5.3m by

4m (Plate 9). Like Rooms 1 and 2 it was floored by bitumen and timber surface [033] and contained a hearth or fireplace [035] set within wall [038]. This room also contained one recess within north-west wall [007] that contained a square flagstone block [034] with ceramic pipes next to it that had truncated the original wall line indicating a later addition.

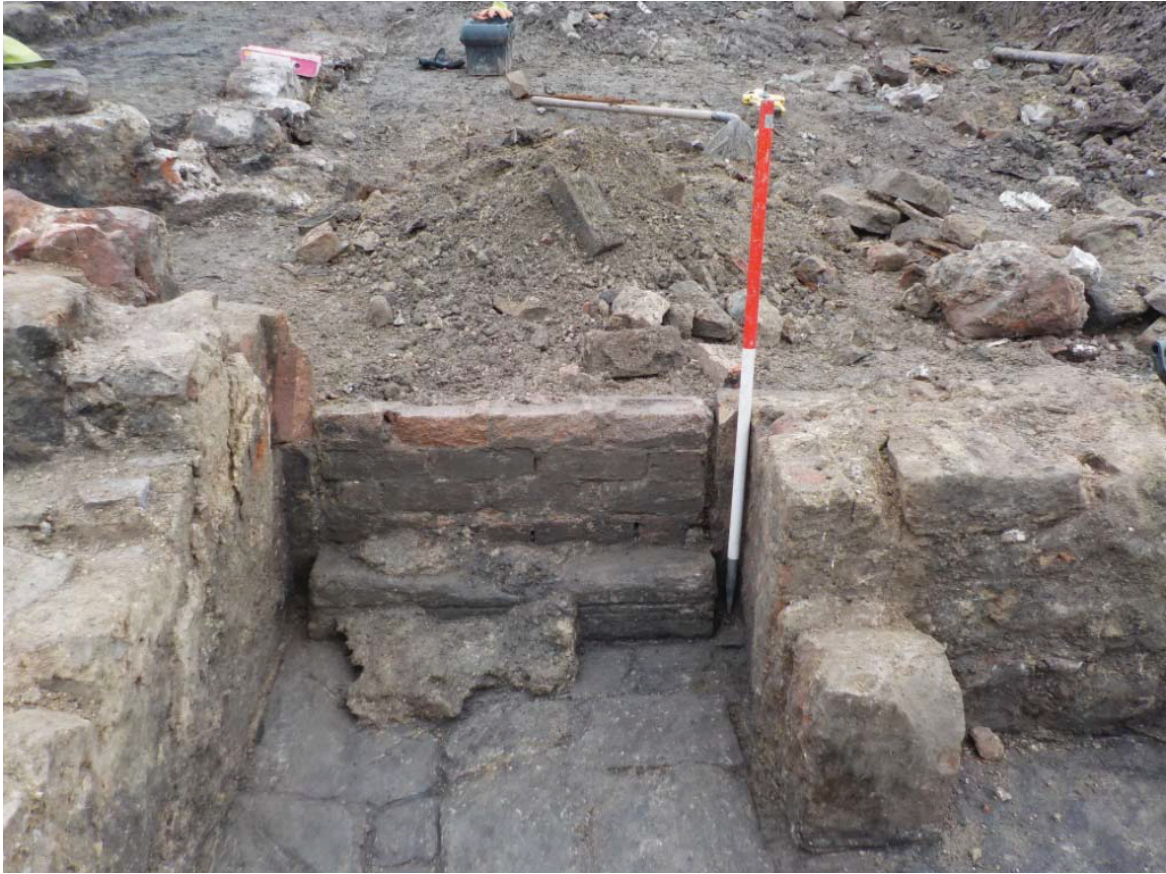
Plate 11: Lower Level, detail of blocked doorway [048]

- 5.3.10 Access to this level was gained from three different locations. Firstly, an external corridor (Corridor 4 [050]) located outside the southern corner of the Lower Level would have provided access to rooms along the south-west edge. This corridor was formed by Walls [046] to the north-east, [047] to the south-west, [008] to the south-east, and [051] to the north-west. It measured 5.5m by 1.53m and no longer contained a floor surface. Doorway and stairs [048] were set within wall [051] to allow access from external Corridor 4 into internal Corridor 5 [056], but this was later blocked up with brick (Plate 11).

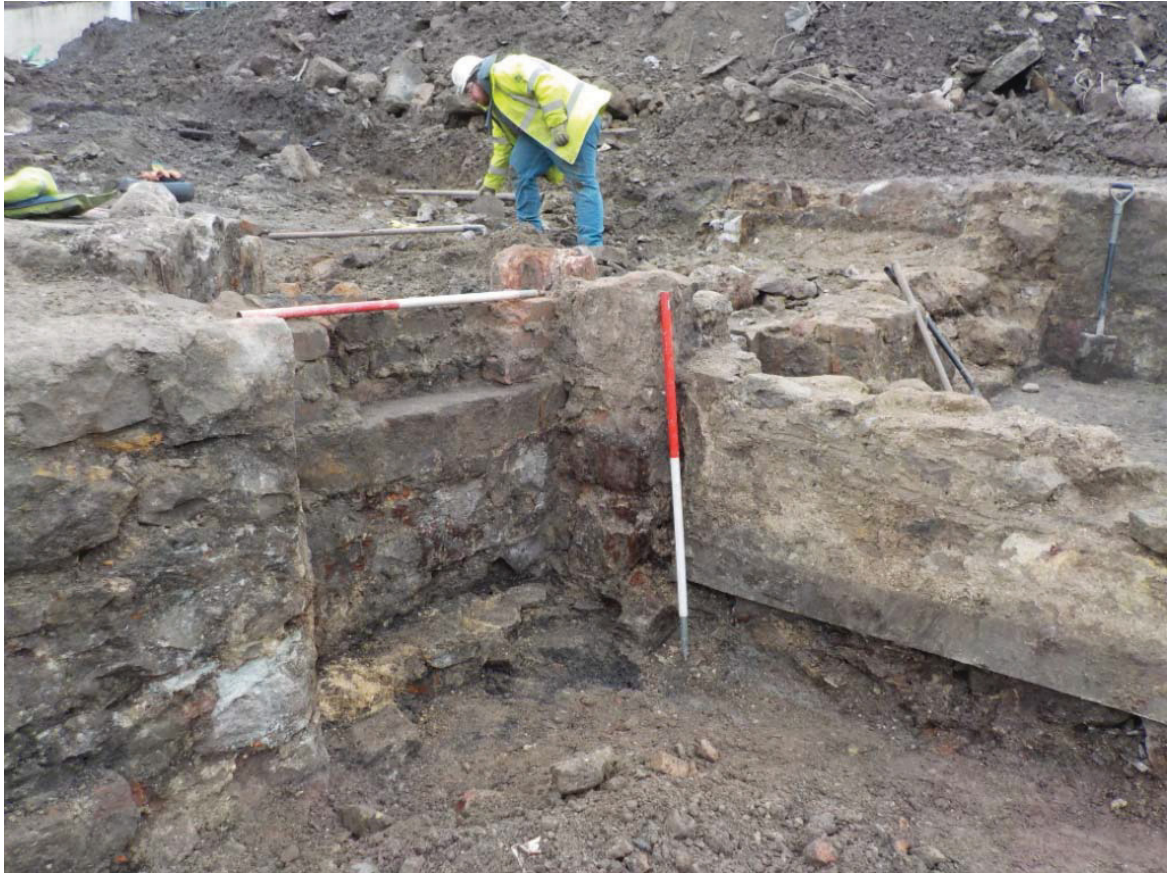
Plate 13: Lower Level, detail of window [045]

- 5.3.12 Room 11 contained light well [045] in the southern corner consisting of a large stone lintel placed between walls [007] and [051] (Plate 13). The stone lintel and the bay area below have been rendered in concrete in more recent times. Other evidence of modern repairs and re-use within this room is the removal of the floor [081], which only survives as two truncated flagstones abutting wall [038] in the eastern corner, and the presence of a concrete strap at the face of the base of Wall [054]. The north-east edge of the room appears to continue into Room 10 [082], although wall remnants [080] and [076] may have formed a now demolished north-east division. To the north-west edge of the room, the boundary wall is a curving sandstone wall that forms the outer edge of stairwell [071]. The other side of the stairwell is within Room 13 [085] that joins Room 11 in its western corner.

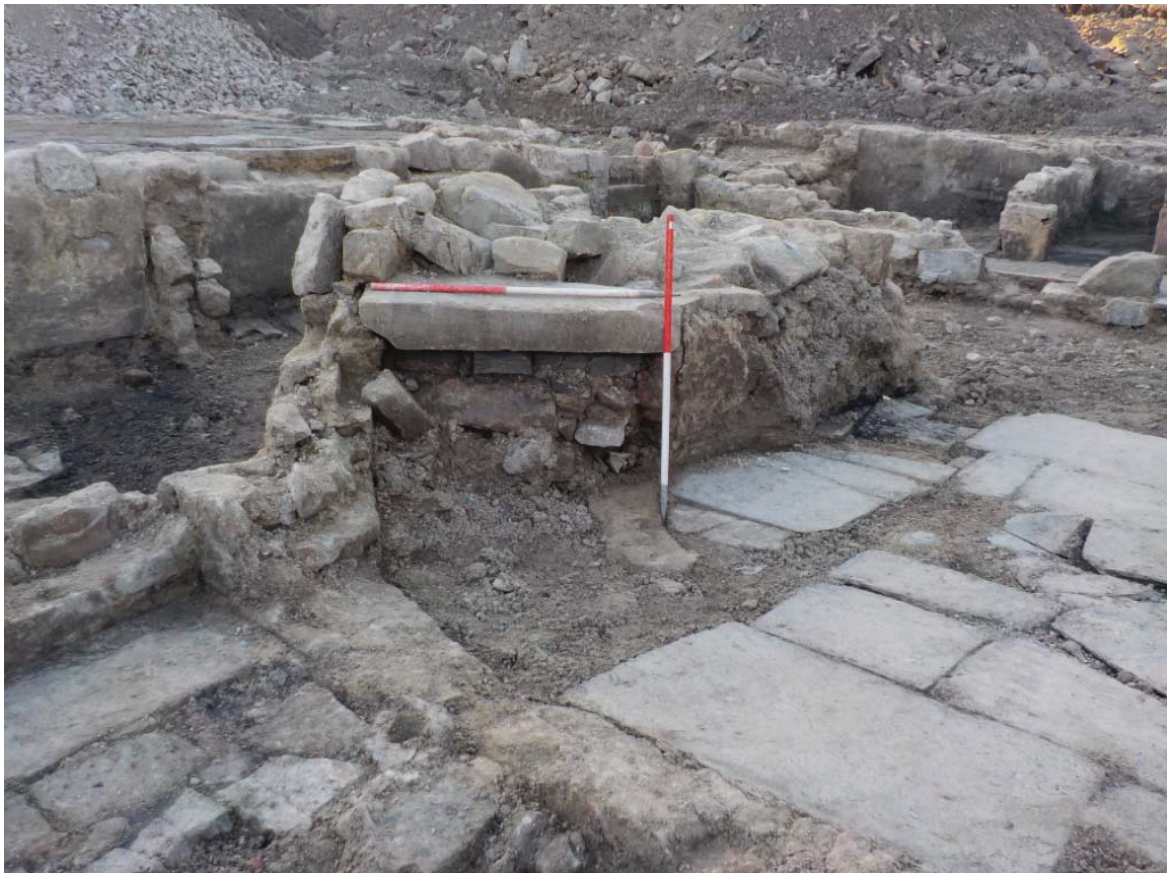
Plate 14: Lower Level, detail of stairwell [071]

- 5.3.13 This is where the second access point to the Lower level would have been, via the central spiral stairwell [071] (Plate 14). The stairwell consists of curving sandstone outer wall [072] and inner sandstone and brick wall [073] that contained a rubble core [075]. The large stone steps [074] were laid upon this rubble core and the internal faces of the two walls, with only one step surviving intact. A large supporting wall [078] (now

mainly demolished) is present at the south-west end of the stairwell. The stairwell would have measured 1m wide internally and led from an upper floor level into the north-east edge of Hallway/Room 13 [085].

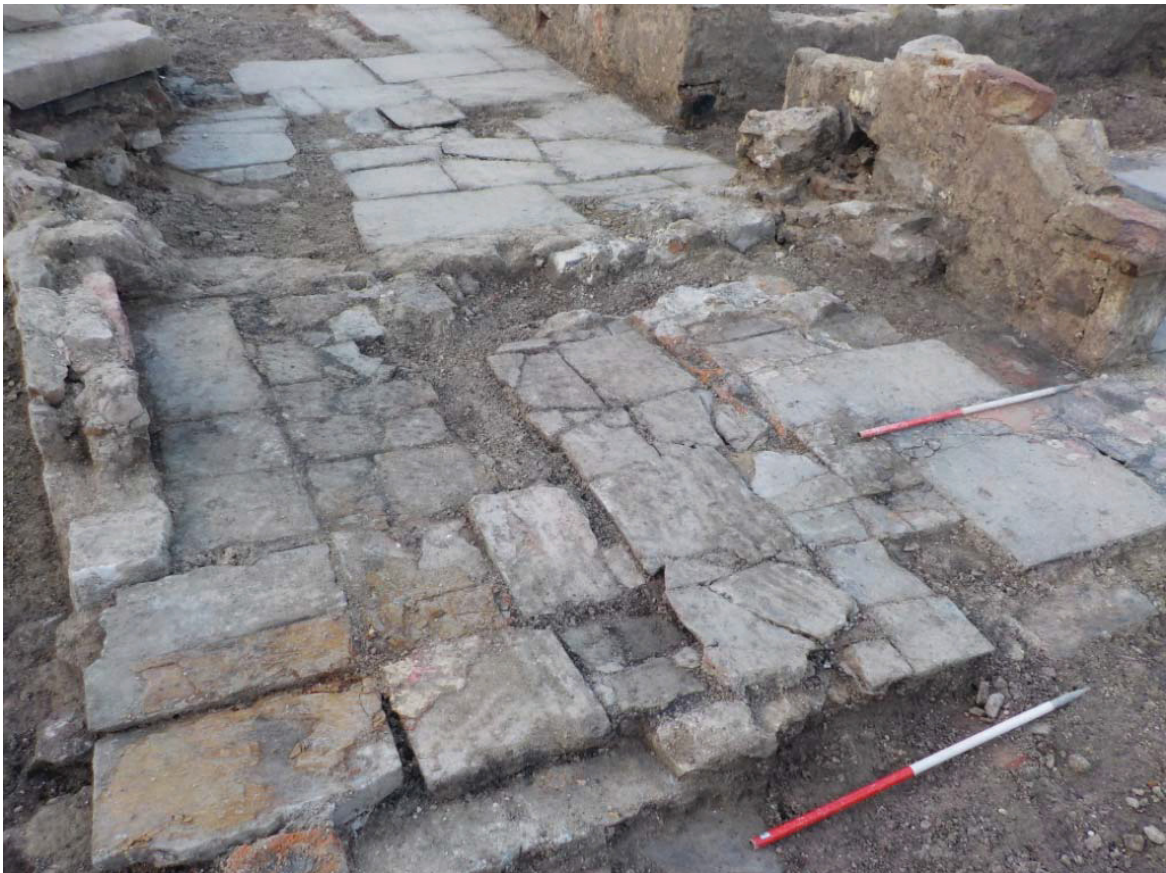
Plate 18: Lower Level, general view of Corridor 8 and Rooms 12, 14 and 15

- 5.3.18 Across to the south-west of Corridor 8, the three rooms in this area are of varying sizes truncated by a large modern emplacement [148] (see Plate 18). The least truncated of the rooms is Room 12 to the south-east end of the corridor that is accessed via doorway [162] and contained an irregular flagstone floor surface

[069], measuring 1.7m by 1m. To the north-west - and divided by truncated wall [156] - is Room 14 that had some irregular flagstones [150] surviving but have been removed to the south-west end of the room. This room measured 1.7m by 0.74m and was accessed via doorway/threshold [151]. At the north-west end of the corridor, and divided from Room 14 by brick partition wall [149], was Room 15 that had little of its floor intact and was mainly filled with the modern concreted mass [148]. It would originally have measured 1.7m by 1.48m and was accessed via threshold [146].

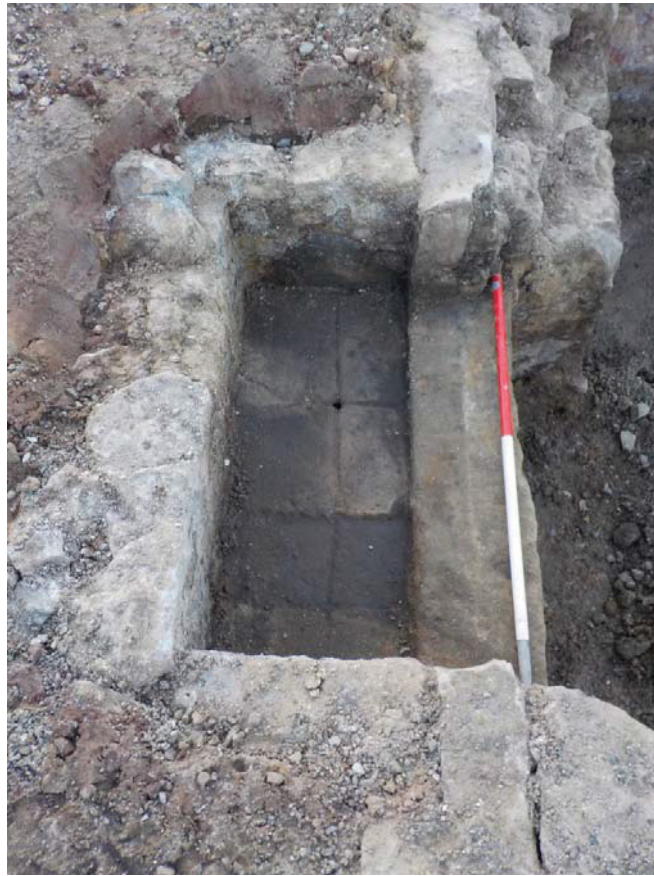
Plate 19: Lower Level, detail of window [089]

- 5.3.17 Within Wall [155] to the south-east of Room 16 there was access to Corridor 8 [114] through doorway [145]. This corridor divides Room 23 [111] to the north-east from Room 12 [084], Room 14 [110] and Room 15 [109] to the south-west. It also led into Room 10 [082] at its south-east end and was floored with large squared flagstones [152], measuring 3.97m by 1m (Plate 18). Room 23 to the north-east of Corridor 8 was accessed through doorway [153] within wall [154] that also forms the south-west boundary to the room. The other walls forming the room are [155] to the north-west, [068] to the SE and [067] to the north-east, the room dimensions measuring 3.6m by 2.51m. No floor surface survived within Room 23 although it would have been lit by window [089] which had survived intact and unblocked. The window was outside the main wall [067] and consisted of a rectangular space formed by thin sandstone walls consisting of rough-edged sandstone blocks and floored by small, square sandstone flagstones that sat approximately 0.05m below the window sill/lintel. The base of the well measured 1.15m by 0.46m, with a small hole within the corner of four of the flagstones in the floor to the south-east of centre that would have allowed for drainage of water within the well (Plate 19).

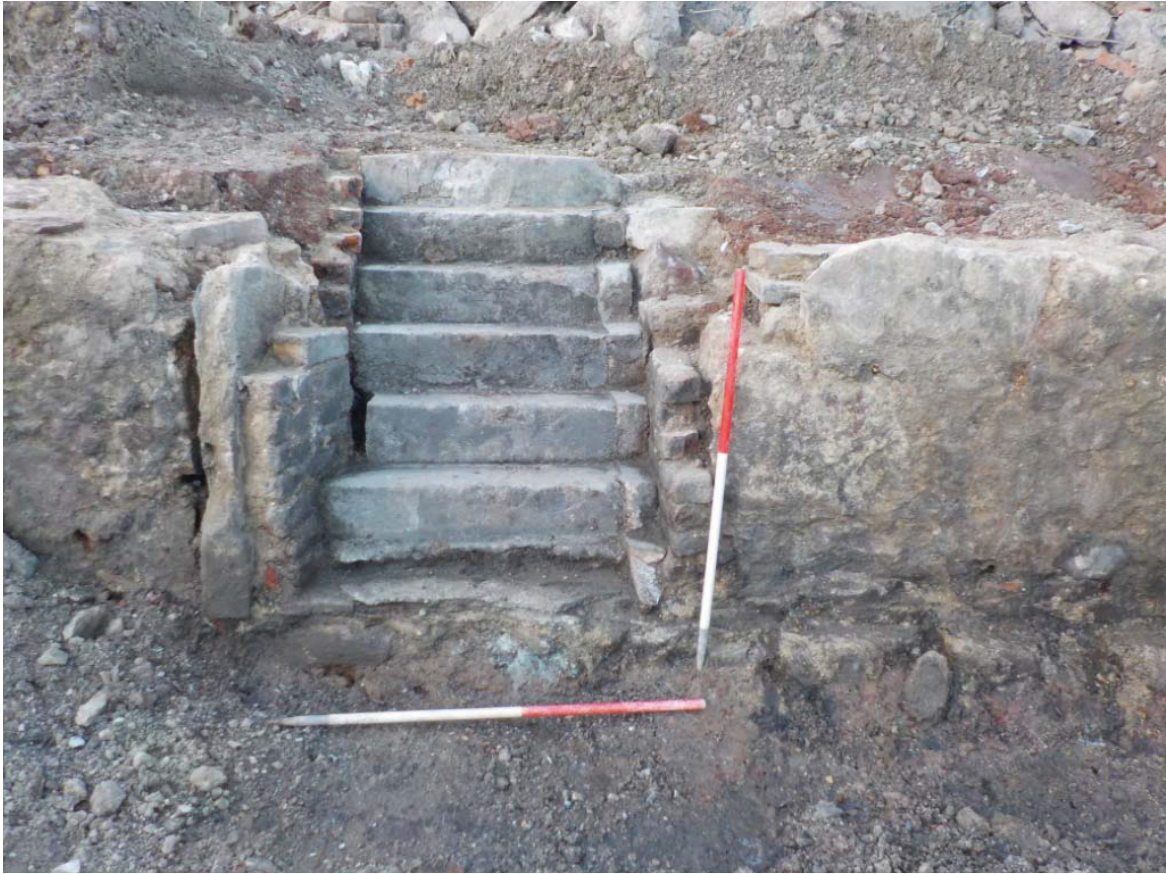
Plate 21: Lower Level, detail of staircase [095]

- 5.3.20 The final and most recently constructed access to the Lower Level would have been via staircase [095] set within the north-west end of wall [049] (Plate 21). This staircase was constructed through Wall [049] with brick used to repair the truncation and the seven steps that survived made from poured concrete. The stairs were 0.98m wide and descended steeply from a height of 1.17m over a length of 1.4m. The steps entered into Room 20 [104] which contained a small remnant of flagstone floor [161] and was latterly used as a storage area containing stacks of ceramic tiles and slates (Plate 22). The room was a broad L-shape bounded by walls [123]/[097] to the south-east, [049] to the south-west, [094] to the north-west, and [124] to the north-east and measured 5.58m by 3.38m (Plate 23). It contained an intact window [093], set within wall [094] that was similar in size to window [089]. The construction of the window differed as the back wall had angled sandstone flagstones as the wall face and a ceramic tile drain in the base of it (Plate 24). Room 20 would formerly have been accessed via Corridor 6 through doorway [131] which is formed by the south-east end of wall [124] and wall [123]. This corridor was floored with large squared flagstones [130] and led into Rooms 19 [105] and 18 [106], as well as stairwell [071] within Room 13.

095	Lower	Set of concrete steps (seven) set within wall [049] near its NW end. Stairs measure 0.98 m wide with a course of bricks on either side of steps to repair the truncation through wall [049]. Staircase into Room 20
096	Lower	Sandstone wall aligned NE-SW consisting of irregular, roughly hewn sandstone blocks bonded with pale brown sand and lime mortar. Abuts wall [049] to the SW. Measures 2.1 m by 0.3 m by 1 m. Dividing wall between Room 21 and Room 22
097	Lower	Sandstone wall aligned NE-SW consisting of irregular, roughly hewn sandstone blocks bonded with pale brown sand and lime mortar. Abuts wall [049] to the SW and wall [117] to the NE. Measures 1.8 m by 0.24 m by 1 m. Dividing wall between Room 21 and Room 20
098	Lower	Irregularly sized flagstones within Room 22 abutting walls [066], [096], and [049]. Measures 2.2 m by 1.1 m. Floor of Room 22
099	Lower	Formal gap formed by wall [066] and wall [096] measuring 0.88 m wide. Doorway from Corridor 5 to Room 22

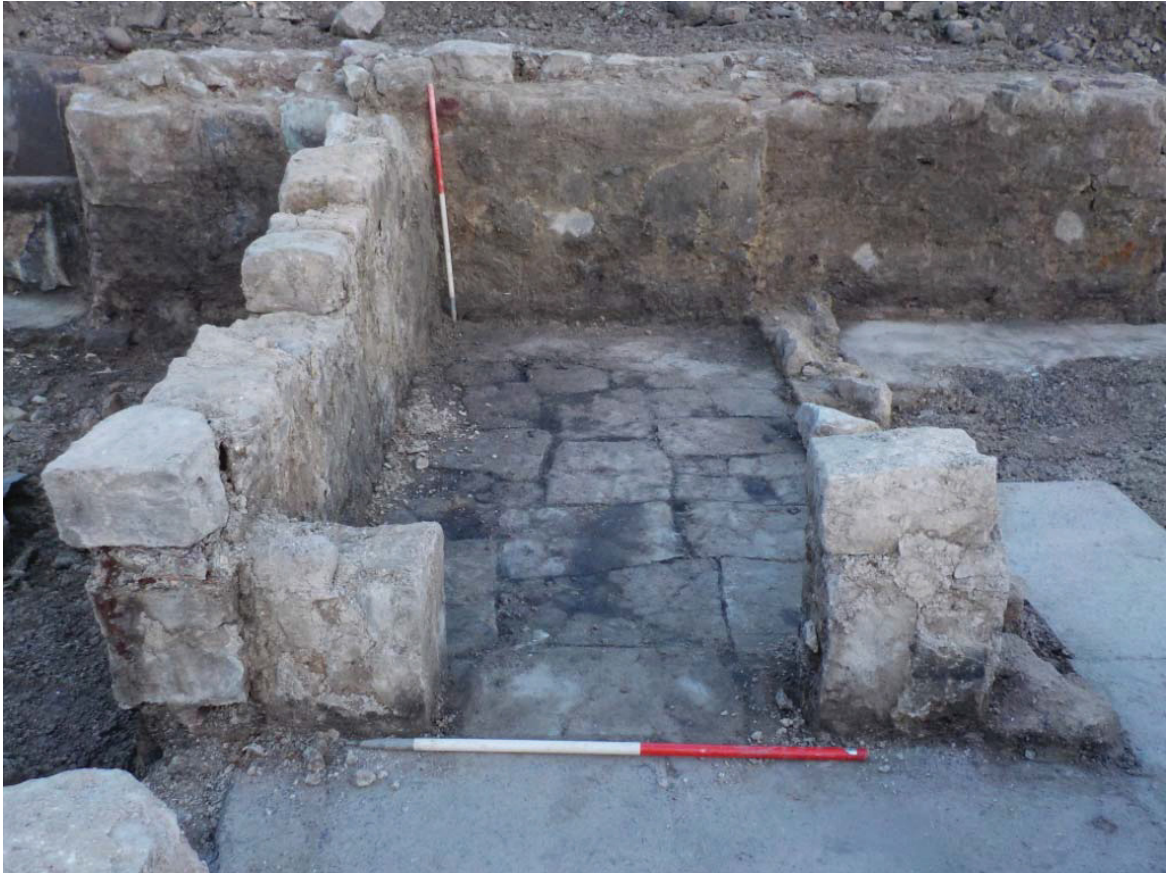
Plate 25: Lower Level, general view of Room 19

- 5.3.21 Room 19 was a narrow rectangular room formed by wall [094] to the north-west, [124] to the south-west, and [126] to the north-east, measuring 2.94m by 1.47m (Plate 25). It was accessed via doorway [133] at the south-east end of Walls [124] and [126] and was floored by irregular sandstone flagstones [125]. Room 18 was another large square-shaped space measuring 4.18m by 3.38m and formed by wall [120] to the SE, [094] to the NW, [126] to the SW and [128] to the NE (Plate 26). The room is accessed through doorway [132] between the south-east end of Wall [126] and Wall [120], and was floored by large squared flagstones [127] that had been truncated by concrete in the north-west half of the room.
