# Gleann Casaig Hydroelectric Scheme, Loch Lomond & The Trossachs National Park: Archaeological Mitigation Report

*AOC Project 23361  
23<sup>rd</sup> May 2016*

## Archaeological Mitigation Data Structure Report

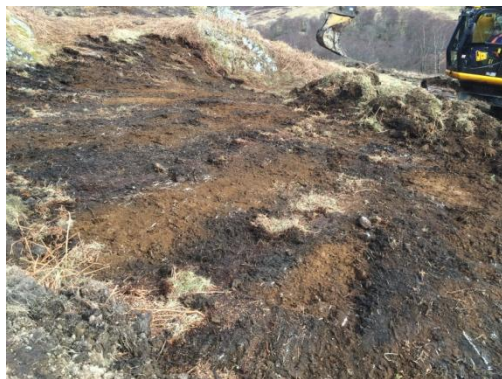
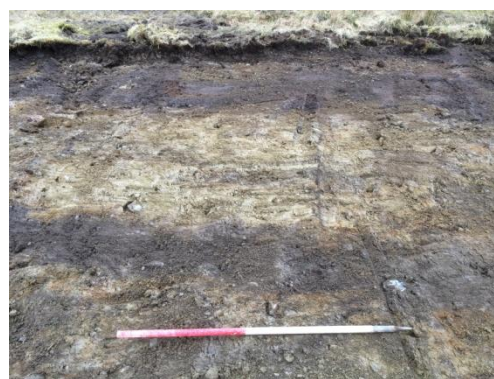
- 4.1.2 The topsoil stripping of an access track for a borrow pit revealed the truncated remains of several cultivation furrows. These had been heavily affected by bracken roots. The furrows were aligned NW/SE and were spaced at 1.0 m interval. Excavation of the furrows revealed widths ranging from 0.4 m to 0.9 m and depths of 0.06 to 0.10 m (Plates 1 and 2).

*Plates 1&2 Rig & Furrow remnants revealed during borrow pit work*

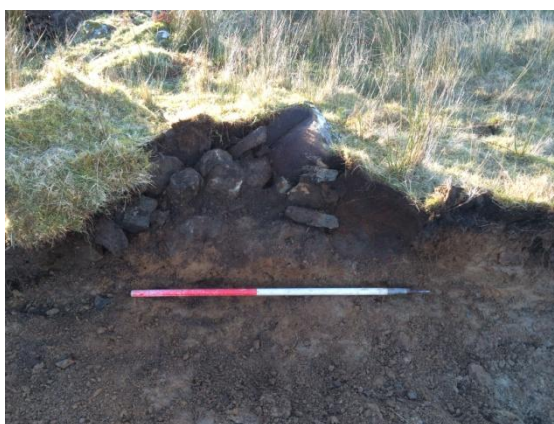
- 4.1.3 The access track to the borrow pit included the widening of the existing track-way close to CH1. This existing track had previously crossed the line of a stone dyke. The widening of the track allowed further investigation of the dyke with the section being cleaned and recorded (Plate 3).

*Plate 3 Stone Dyke crossed by track excavation, east facing section*

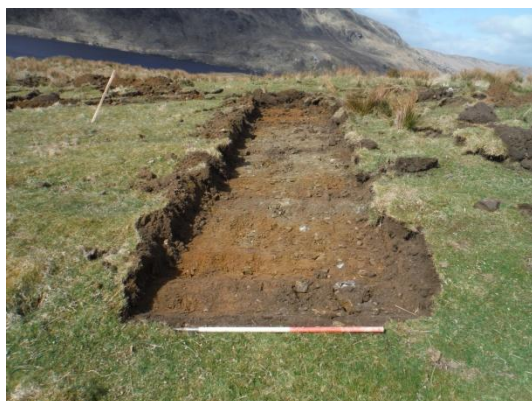
*Plate 4 Trench 5 post-excavation from west*

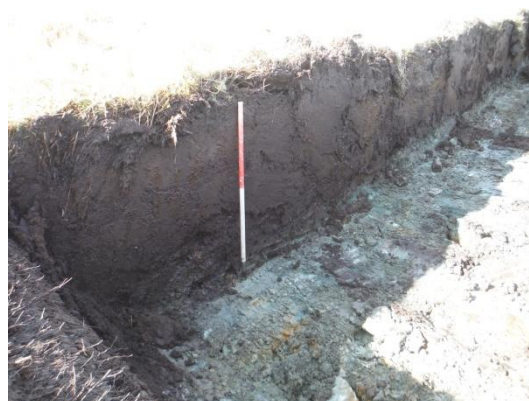
*Plate 5 Trench 2 post-excavation showing peat depth*

- 4.2.1 The Archaeological Evaluation was undertaken on the 23<sup>rd</sup> April 2016. Ten targeted 10 m by 2 m trenches were opened along the route of the contractors pipeline to the north-east of the watching brief area (Figures 2 and 3).
- 4.2.2 The evaluation revealed 0.10 m of peaty top-soil. With the exception of Trench 2 this deposit directly overlay natural drift geology of glacial clays. The excavation of Trench 2 revealed a deposit of peat 1.1 m in depth (Plate 5).
- 4.2.3 No archaeological features were present in the evaluation trenches.

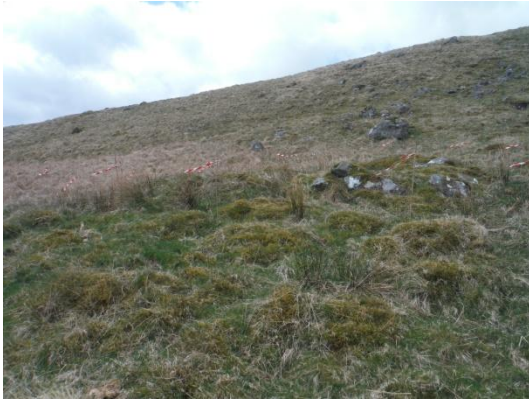
- 3.1 The possible collapsed dry-stone structure CH4 (NGR; NN 2539 7104) was marked out with temporary fencing in advance of construction work, and a buffer of 10 m placed around the structure in order to avoid any accidental damage. A site visit immediately prior to commencement of ground works identified a further two archaeological sites representing possible shieling remains CH5 (NGR; 253899 710284) and CH6 (NGR; 253852 710214) in the vicinity of the proposed development. The locations of these two sites were recorded with GPS. They were subsequently photographed and appropriate buffer zones established (Plates 6 and 7).

Plate 6 Possible shieling CH5

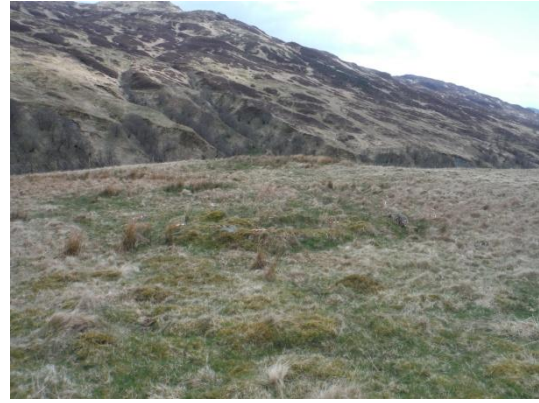
Plate 7 Possible shieling CH6
