Bath Road, Holbeck, Leeds:
Watching Brief Data Structure Report

AOC Archaeology Project No: 20454

NON TECHNICAL SUMMARY

This report presents the results of an archaeological watching brief undertaken by AOC Archaeology Group on ground subject to redevelopment at Bath Road, Holbeck, Leeds.

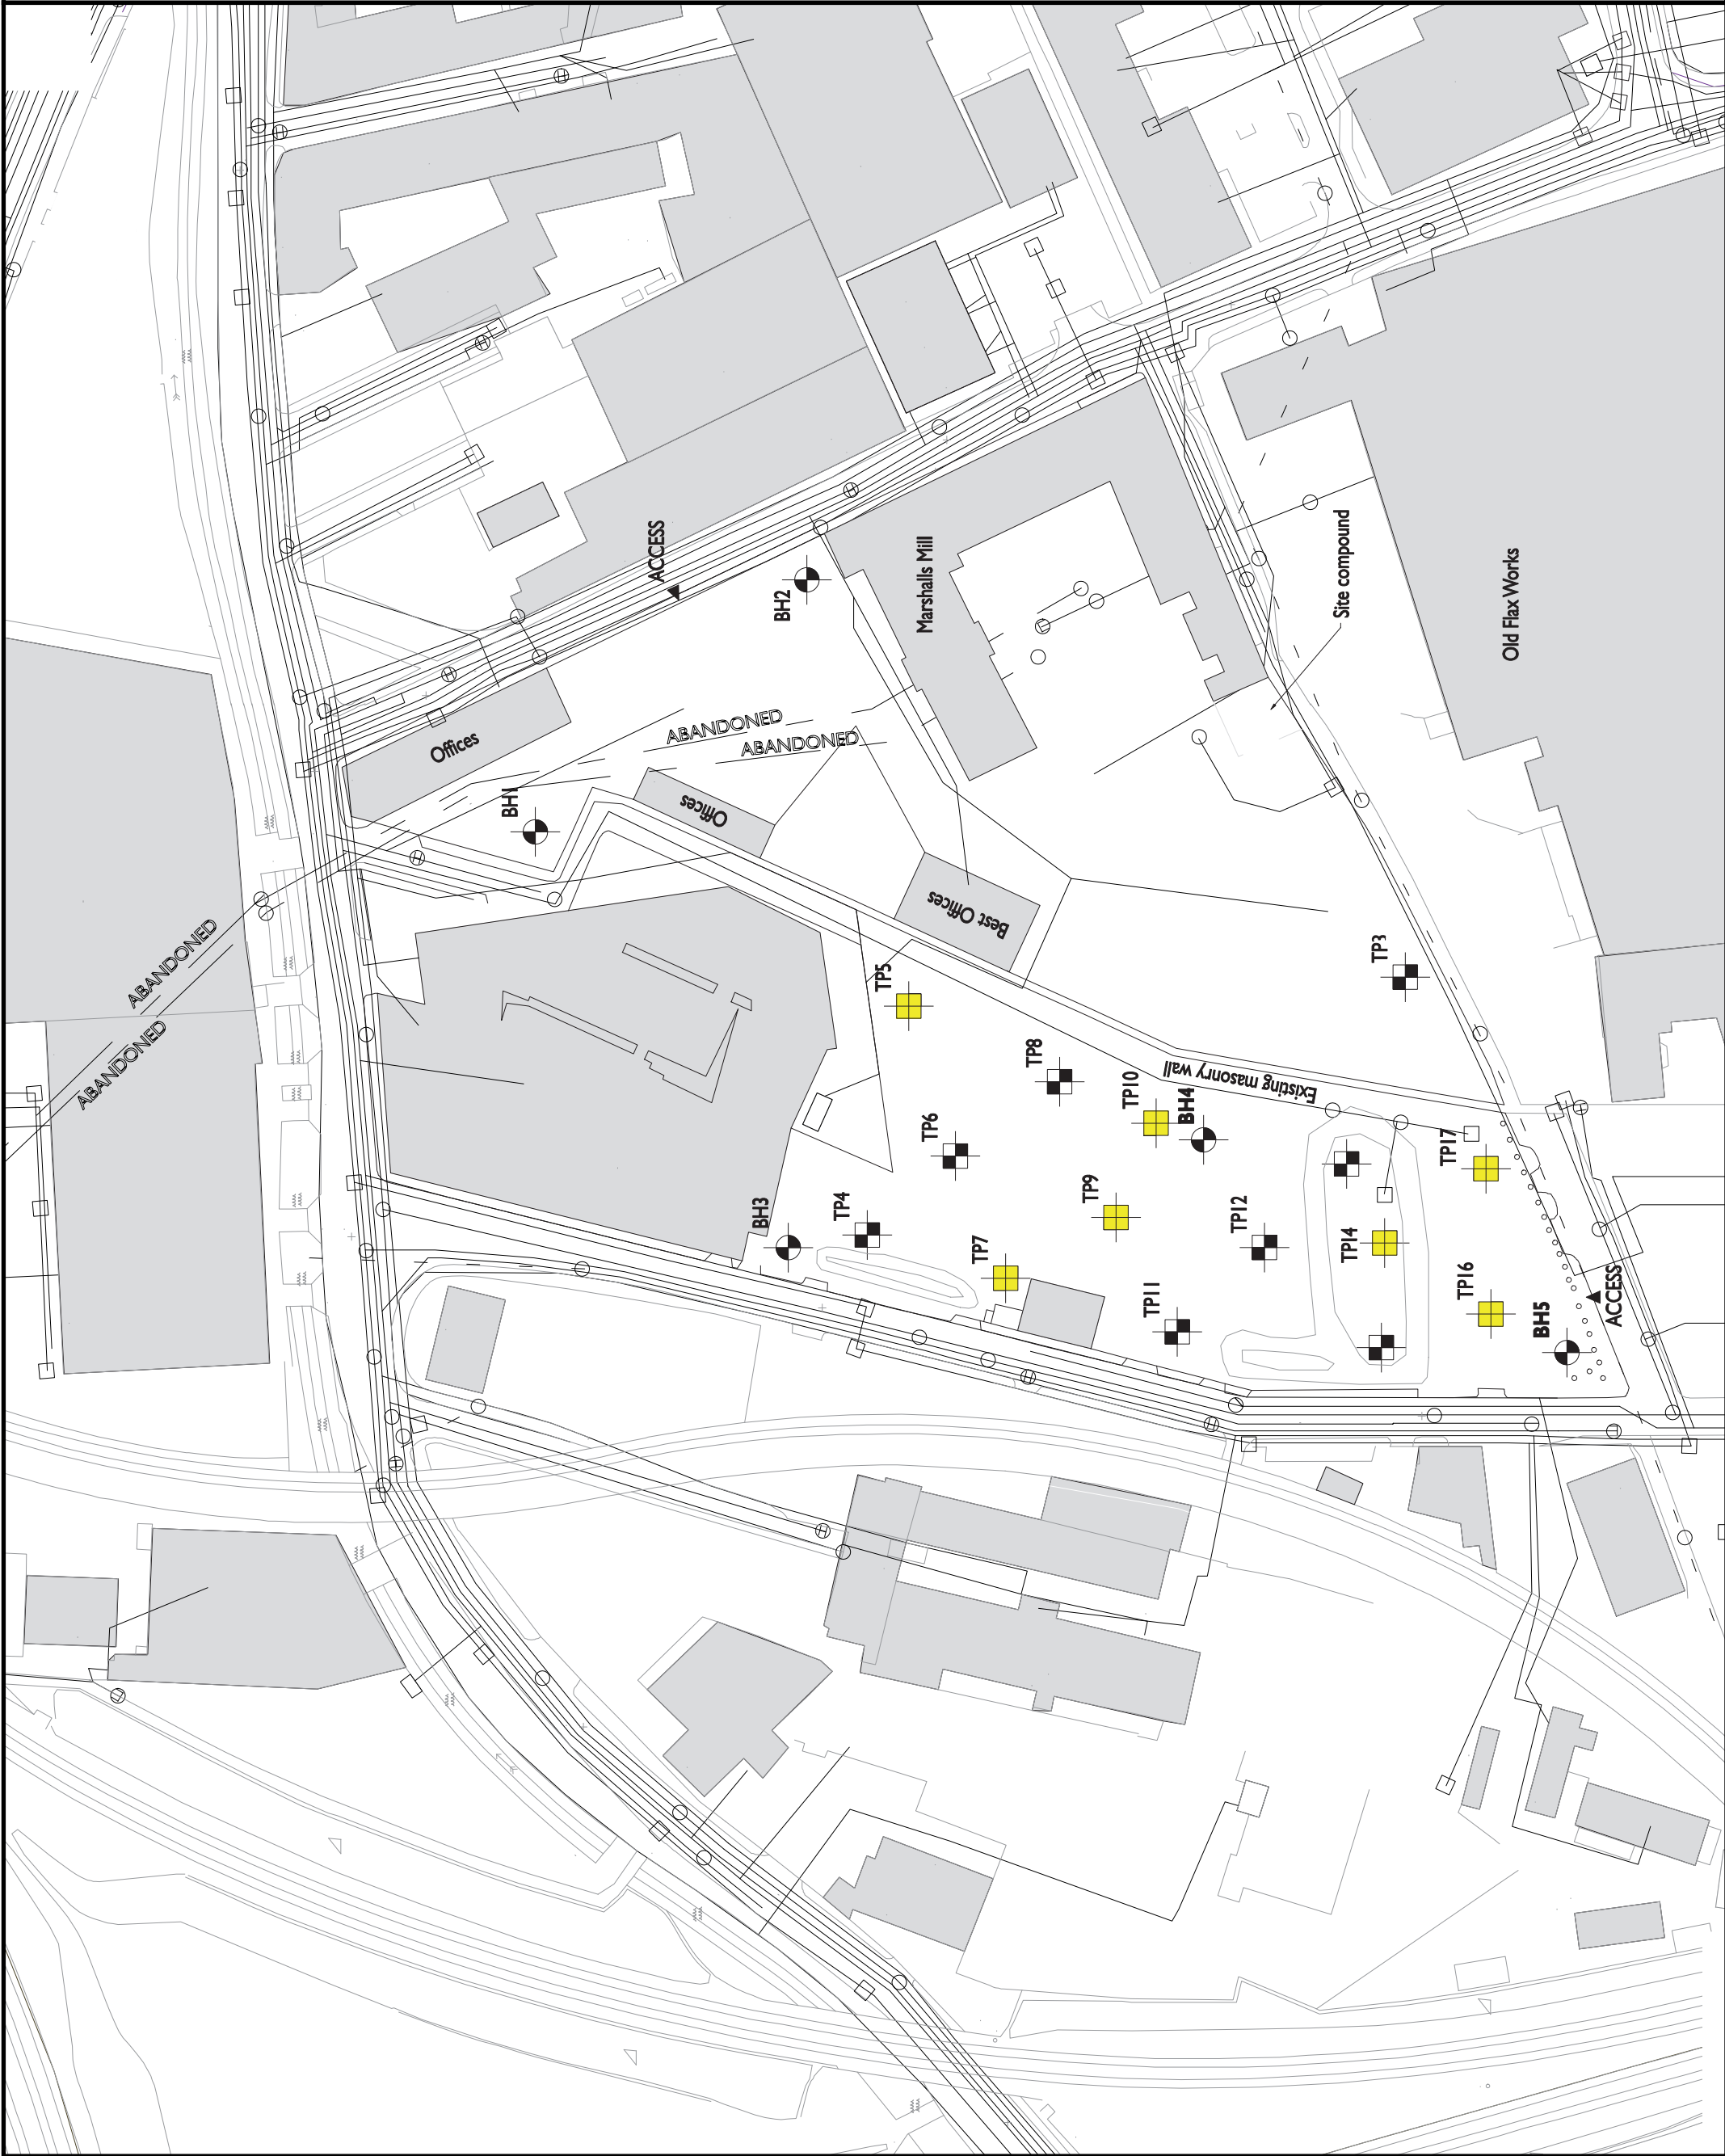
Figure 3: Plan of Test Pit 5

5.2.1 This Test Pit was dug through the edge of a dump of fly tipped soil (501) with a depth of 0.6 m. Directly below this imported deposit was a surface

constructed from stone setts/cobbles (502) which extended westwards for a distance of 1.4 m.

- 5.2.1 The extent of this surface marked the edge of the fly tipping and beyond this extent excavation continued through the overlying top soil (503) which contained a large amount of displaced similar cobbles to (502) indicating that the cobbled surface once extended further. Patches of cobbling can be seen on the present ground surface else where on site. Deposit (503) had a depth of 0.7 m and overlay natural alluvial deposits of soft brown clay 2.4 m in thickness which in turn overlay further natural deposits of sand and gravel.

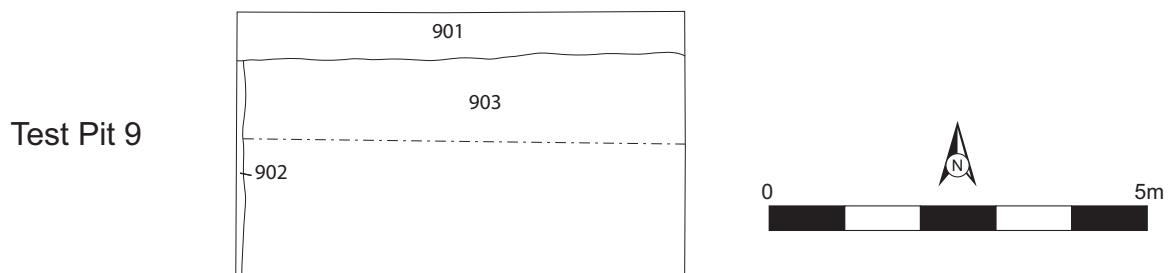
Figure 4: Plan of Test Pit 9

- 5.4.1 Directly below the turf and topsoil (900), which had a depth of 0.25 m were seen the remains of two brick built walls (901) and (902). Wall (901) was aligned east to west with wall (902) aligned north to south and appeared to tie in to the south side of wall (901). Excavation of the test pit was shifted 0.5 m to the south of wall (901) in order to minimise damage. Excavation showed that these walls cut the underlying natural geology of clay (903) to a depth of 0.4 m below the base of (900). Excavation of the test pit continued through the clay for a further 2.05 m where the top of the underlying sand and gravels were encountered. In house dating based on brick typology dates these walls to the 19th century

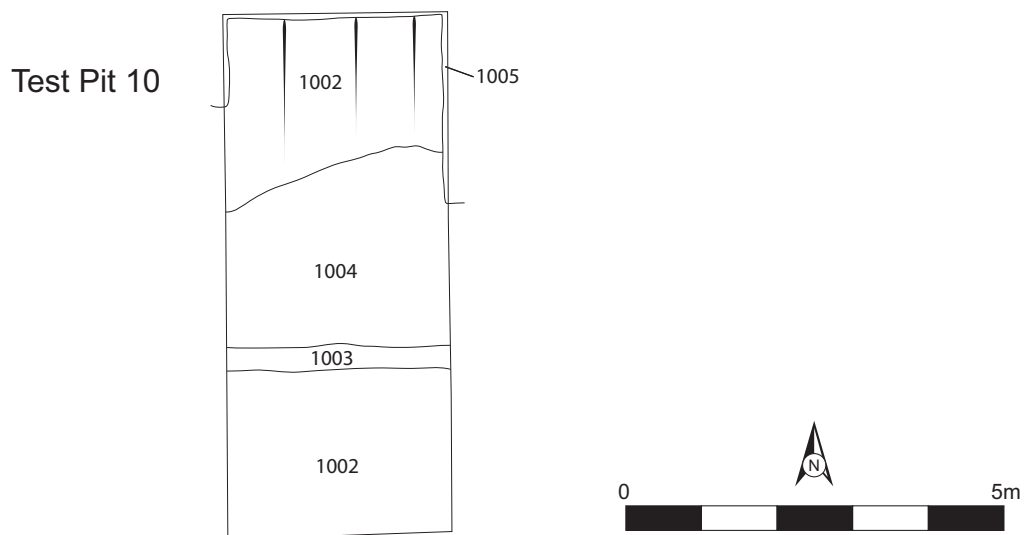
Figure 5: Plan of Test Pit 10

- 5.5.1 The layer of turf and topsoil (1001) was seen to have a depth of 0.05 m. This was seen to overlie a deep layer of brick rubble (1002) which was seen to have a depth of 1.8 m. at which point the remains of a sandstone flagged floor (1004) was encountered. Deposit (1002) was split by a brick wall (1003) aligned east to west across the pit which continued down to the floor (1004).

- 5.5.2 Collapse of the unstable sides of the trench (1002) revealed that the trench was positioned over a small basement room bounded by brick built and plastered walls (1005). The walls had a depth of 1.8 m with the room measuring 1.2 m east-west and 1.9 m. north south. A door way was seen in the eastern wall indicating further basements in this direction. Unfortunately wall (1001) collapsed but it showed how this wall was not tied into wall (1005) and was probable a later addition. From observations elsewhere on site it is clear that this basement cut through the underlying natural clay.
