# Allt Tarruinchon Hydro Scheme, Loch Tummel, Perth and Kinross Archaeological Walkover Survey Report

AOC 70124  
19<sup>th</sup> May 2016

# **Allt Tarruinchon Hydro Scheme, Foss, Loch Tummel, Perth and Kinross**

## **Archaeological Walkover Survey Report**

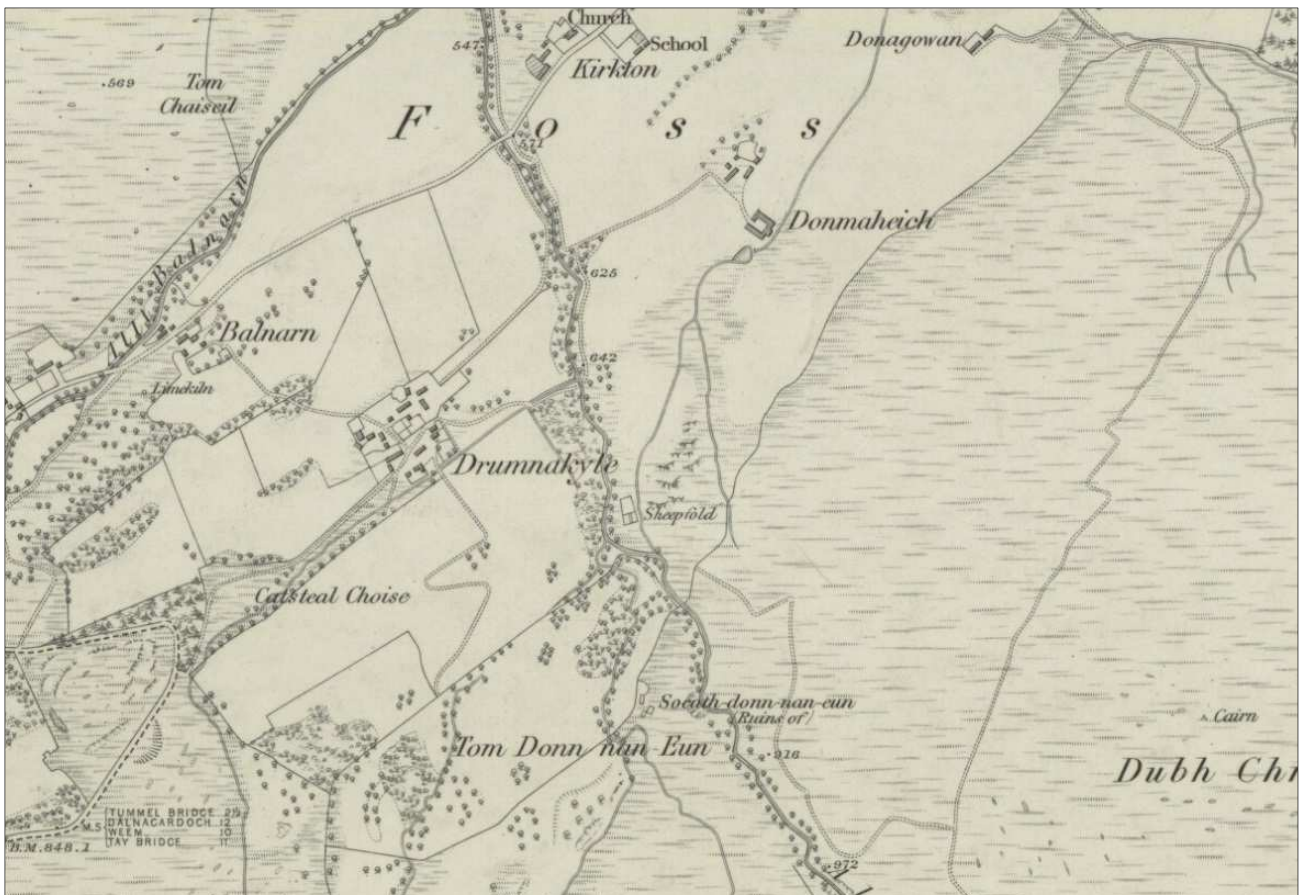
Figure 2 Excerpt of the 1<sup>st</sup> edition 1867 Ordnance Survey map © NLS

This map (**Figure 2**) shows the U-shaped roofed farmstead at *Domnaheich*, along with five smaller roofed outbuildings to the north side of it. A track runs from the farm to the small settlement at *Kirkton*, where there is a church and a school. To the southwest of the farmstead, a *sheepfold* is shown as comprising three compartments and a run, and while a lengthy dyke runs to the south, marking areas of improved ground to the northwest and rough moorland to the southeast. The ruins of a small settlement at *Socath-donn-nan-eun* are shown to the west side of the burn.

The only sites shown along the hydro scheme are the sheepfold and the boundary dyke at the south end.

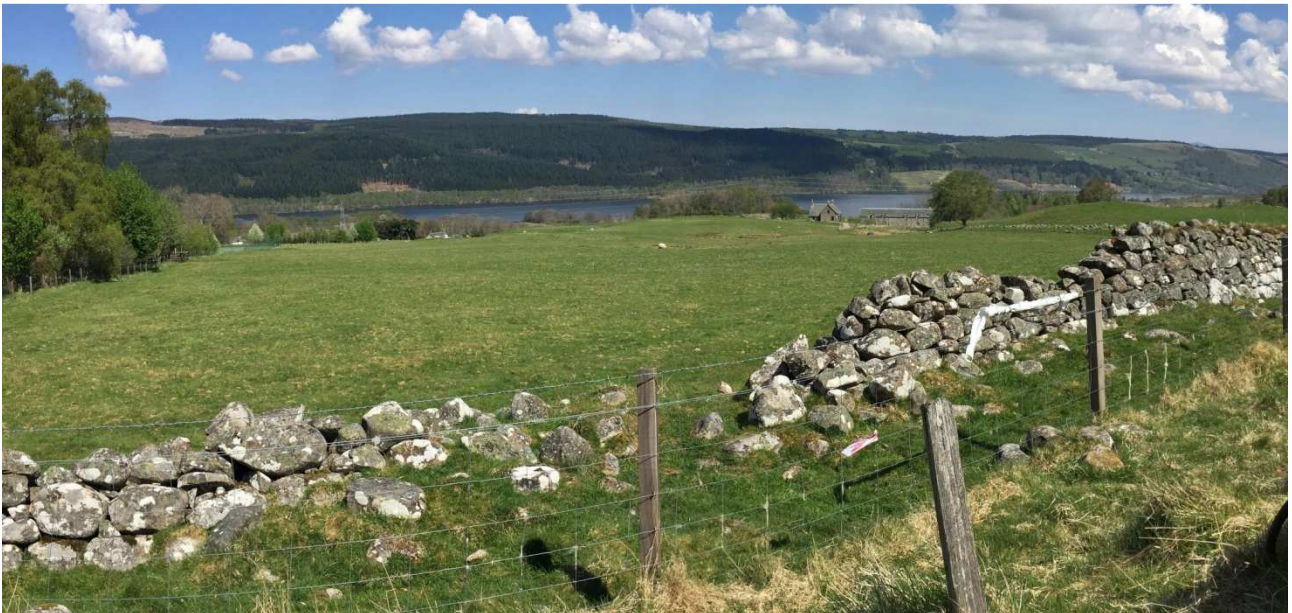
*Plate 1 Location of the north half of the survey area, looking N over Site 3*

4. The landscape situation of the survey area runs upslope from north to south at 180m to 230m OD, with the Allt Torruinchon running to the west side. It crosses improved fields across the north half of the area (**Plate 1**) after which it passes into open, grass-covered ground with extensive stone and boulder spreads, on the east of the sheep fank. The southern end of the route rises more steeply and terminates near the location of a disused sluice on the burn. The underlying geology of the area comprises glacial deposits of sand and gravel overlying a combination of Atholl dark limestone and schist, consisting of metalimestone and pelite, and Killicrankie schist, consisting of semipelite and micaceous psammite (BGS 2016).

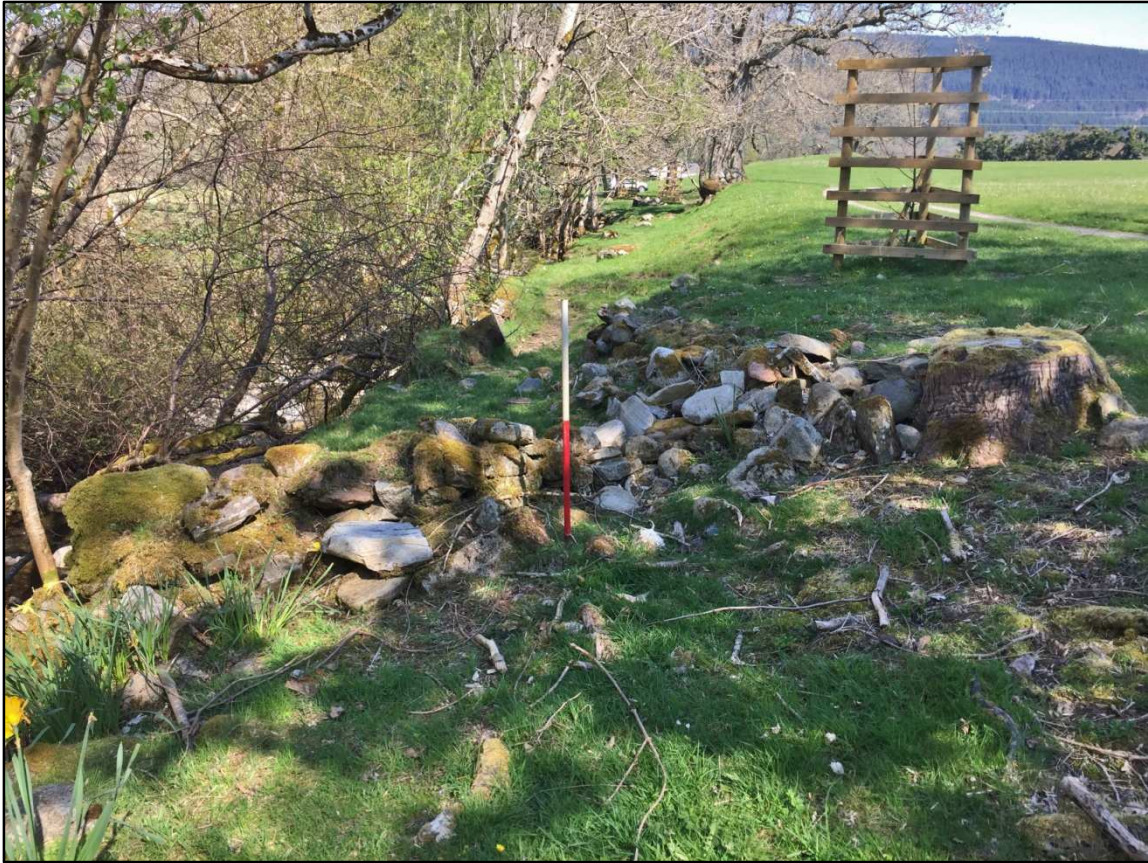
*Plate 2 Looking N over Site 1, a section of stone-built dyke*

Site No.	Site type	Description	Alignment	Condition	Period	Ht OD (m)	Easting	Northing
1	Wall	An L-shaped section of drystone wall abuts the W side of the burn, with 4-5 courses visible on the N side; the wall stands up to 0.6m high and measures up to 0.8m wide; the N tag of wall is partially revetted into the hillside next to the road	NE-SW	Degraded	Post-medieval	200	278980	757813
2	Bank	A grass-covered rubble bank of stone comprising mostly small-medium cobbles appears to have been constructed along the edge of the upper burn terrace; measures up to 1.2m spread and stands 0.3m high max; it appears to run out at the S end and may join up with Site 6. Very degraded.	NW-SE	Very degraded	Unknown	220	279027	757653
3	Dyke	A well-built drystone dyke stands 1m high and measures 1m wide at base and 0.5m wide at top; it consists of large rounded cobbles and clasts	WNW-ESE	Well preserved	Post-medieval	220	279087	757571

16. All of the sites, with the exception of Sites 4, 5, 10 and 13, appear to correlate with post-medieval settlement patterns. Five of the recorded sites appear to form remnants of field boundaries. Site 1 consists of a small section of drystone-built walling (**Plate 2**) on the west side of the track above the burn and probable relates to an estate field boundary shown on the 2<sup>nd</sup> Edition OS map. Site 2 appears as a low, stony bank above the river terrace that may have formed a field boundary and may relate to Site 6, which is similar to it in quality and condition. Site 6 appears to represent the field boundary shown on the 2<sup>nd</sup> Edition OS map. Site 3, a well-preserved drystone dyke (**Plate 1**), is also represented as a field boundary, having been constructed prior to the 1898 survey. Site 12, located near the south end of the route, is formed by a group of low stone/turf banks (**Plate 3**). They appear to be in the location of the substantial boundary dyke shown on the 1<sup>st</sup> Edition OS map. This indicates that it was constructed prior to the 1861 survey.

- ❖ Sites 1, 3, 12 – it is normal practice for all elements of the archaeological landscape, to include boundary dykes, to be avoided by a 5m buffer. As this will not be possible for Sites 3 and 12, it is recommended that disturbance to the structures be kept to a minimum. It is requested that vehicular movement be conducted to avoid crossing over these features where possible, and that reinstatement be considered upon completion of works. This is important for maintaining the character of the archaeological landscape. Sites 2 and 6 are considered to be in such a degraded state that machine movement over them would be unlikely to result in the loss of any material of archaeological significance.

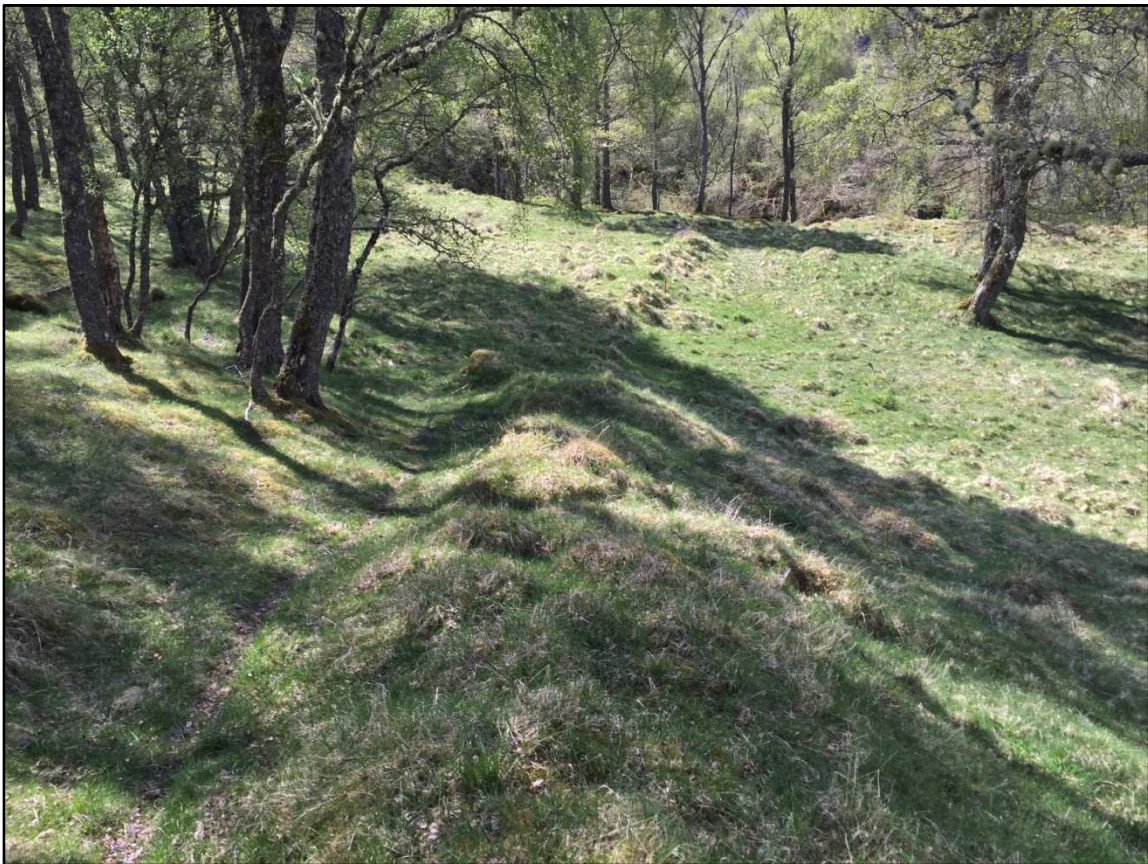
*Plate 3 Looking SW over Site 12, a turf/stone boundary dyke*

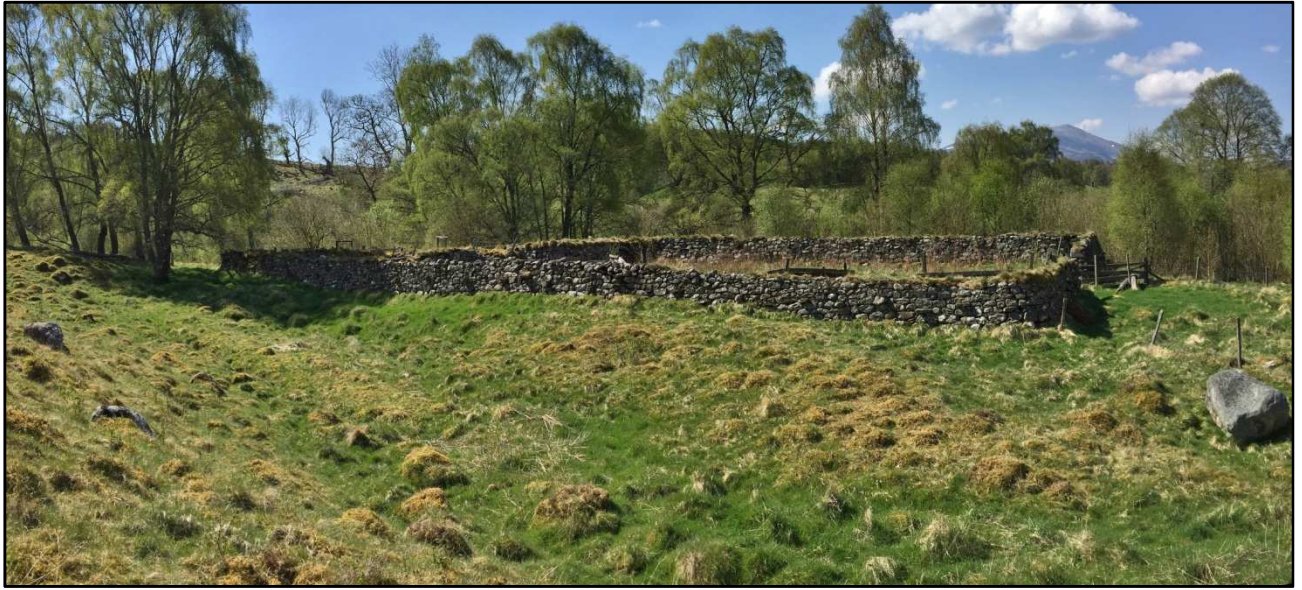
17. The well-preserved sheep fank, Site 7 (**Plate 4**), comprises four internal enclosures and a linear run along the south half. Shown on the 1<sup>st</sup> Edition OS map, it would have been built prior to this time. Interestingly, on the south side of it, Site 9 consists of a small, square stone-built structure containing a large iron cauldron (**Plate 5**) to the south side of the fank. Another unexpected site was a turf and boulder-built U-shaped structure, Site 8 (**Plate 6**), located in-line with the survey route. Definitely a built structure, its use is unknown, but may relate to livestock management. To the east of the sheep fank was a subrectangular, stone-filled hollow, Site 11, which may represent a disused sheep dip pit or milking area.

*Plate 4 View SW over the sheep fank, Site 7*

- ❖ Site 7 - It has been made clear that the sheep fank will not be affected by the works. The recommended buffer of 5m has been shown constricted to respect the planned route.

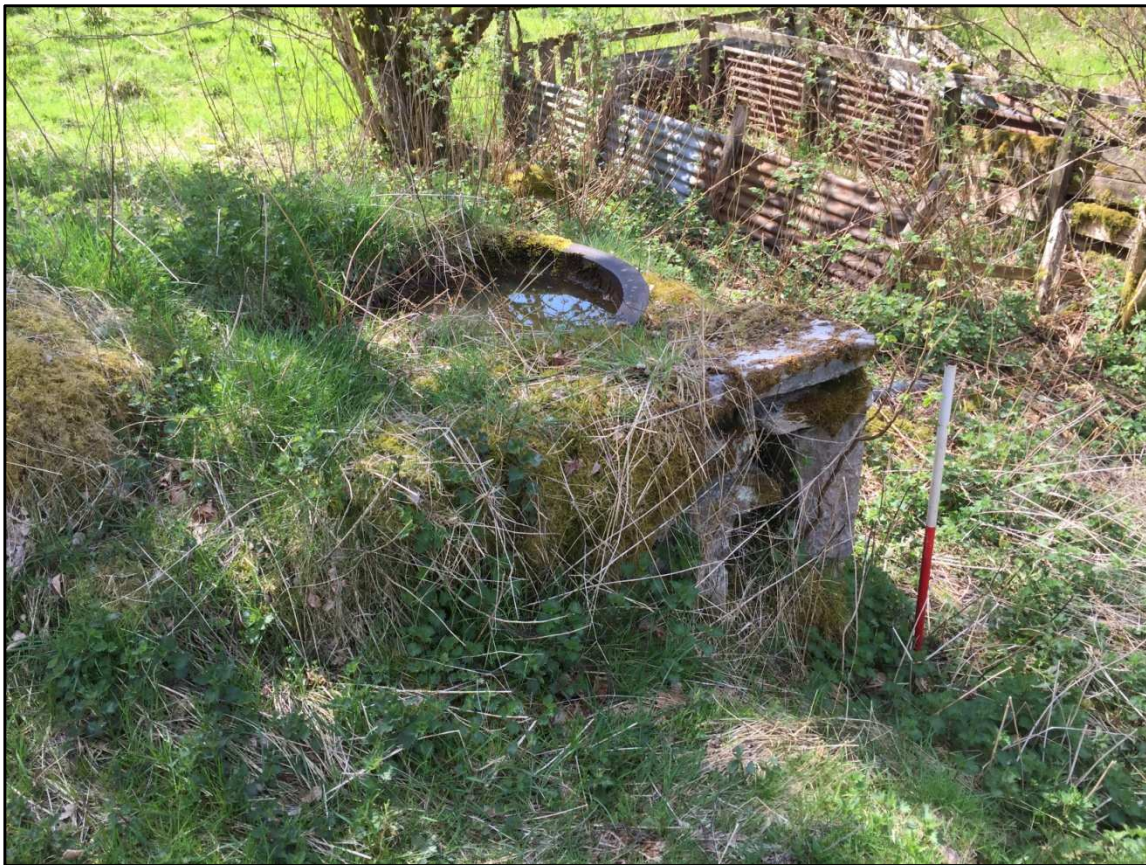
*Plate 5 Site 9, stone-built structure containing cauldron, facing SW*

Site No.	Site type	Description	Alignment	Condition	Period	Ht OD (m)	Easting	Northing
9	Tank	A stone-built square walled structure measuring 1.8m across and stands up to 1.1m high. Located to the S side of tank Site 8, it comprises large dressed sandstones probably robbed from another site. Contains a large iron tankard measuring 1m in diameter is found inside the structure.	-	Ruinous	Unknown	220	279050	757461
10	Grave	A grave slab reads <i>M.A.N.P., APO, 13.10.1923, 4.8.2009</i>	-	Well preserved	2009	220	279094	757456
11	Pit	Subrectangular-shaped hollow has been infilled with stone. It measures 4m E-W by 3m and its use is unknown.	-	Degraded	Unknown	220	279099	757495
12	Dyke	Grass-covered stone/turf banks forms probable remnants of field dykes standing 0.3-0.5m high max and spread 1-1.2m wide.	NW-SE	Very degraded	Unknown	230	279121	757438
13	Weir	A concrete slab and block structural footing measuring about 2m long x 1.4m appears to be remnants of a bridge or sluice across the burn.	-	Ruinous	Post-medieval	230	279108	757372

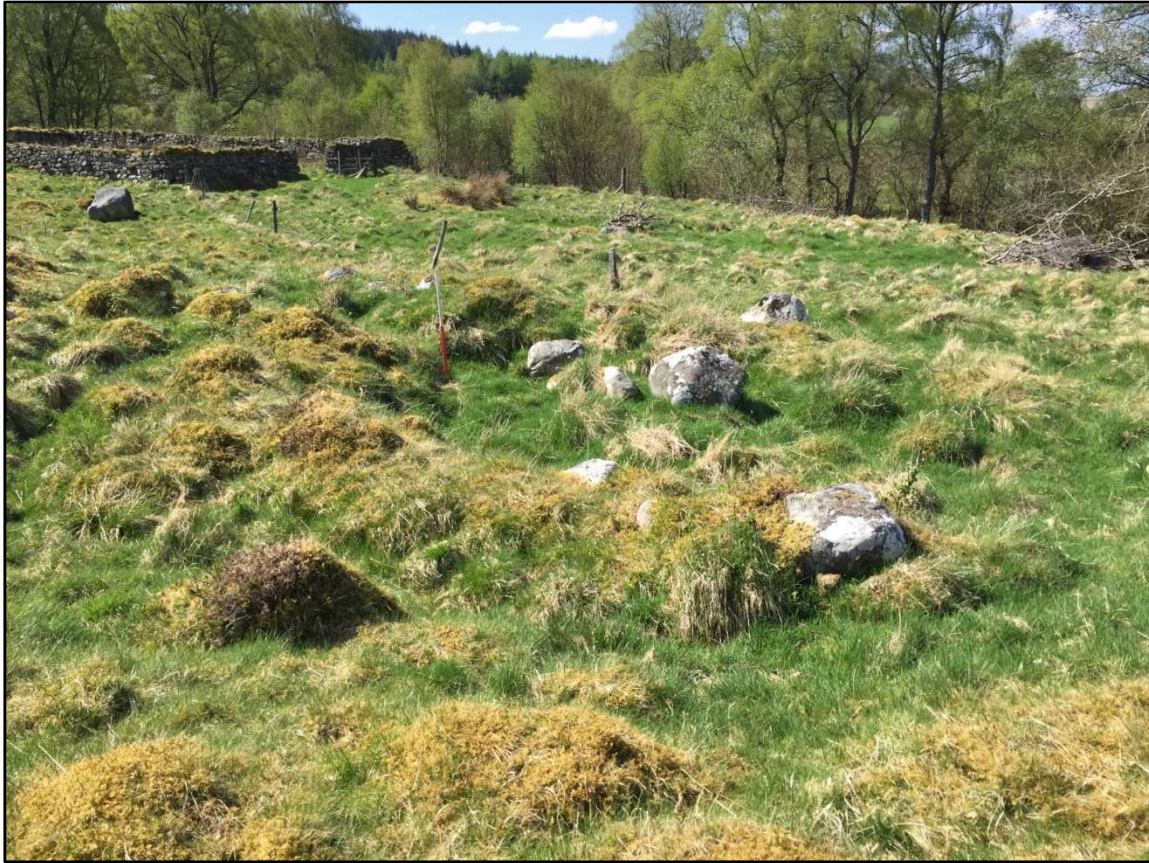
*Plate 6 U-shaped turf/stone structure, Site 8, facing SW*

8	Structure	A grass- and moss-covered boulder/stone and turf U-shaped structure measures 4.5m N-S by 2.5m internally. The banks stand up to 0.7m high and spread up to 1.5m wide. It is located in an area of extensive stone spread that has not been cleared for cultivation.	N-S	Degraded	Unknown	220	279068	757534

- ❖ Site 8 – This site consists of a U-shaped structure of unknown significance and date. It is recommended that the site is marked out with orange mesh fencing to prevent destruction or damage to it. If appropriate mitigation cannot be put in place to avoid destroying the site, it is recommended that archaeological evaluation is conducted in advance of the start of works. This will allow the site to be evaluated for its function and date and for a full record to be completed prior to its removal.

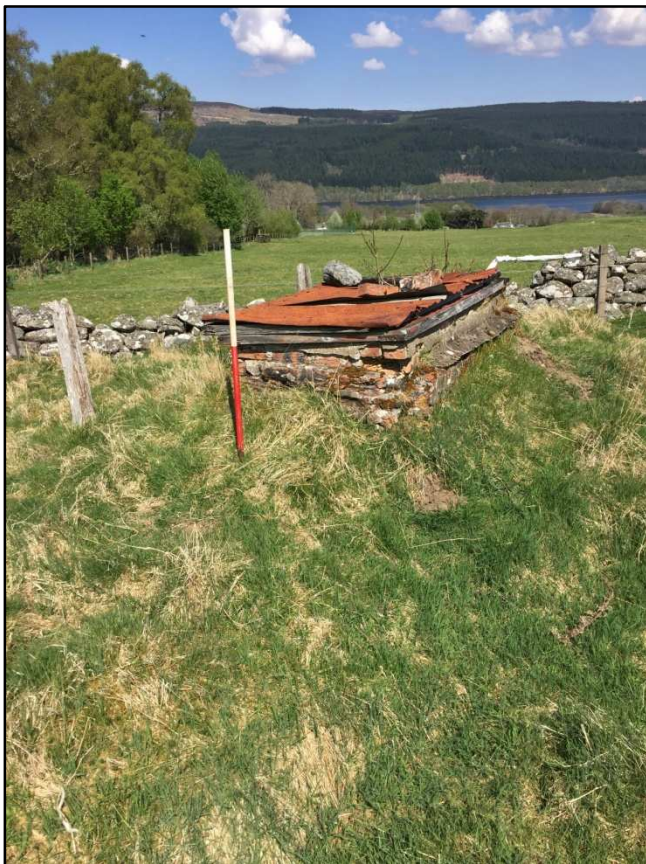
*Plate 7 Looking S over brick-built tank, Site 4*

4	Tank	A brick built tank or well with a timber frame and iron lid measures 1.8m NE-SW by 1.1m and stands 0.8m high above ground level.	-	Well preserved	Post-medieval	230	279065	757559
5	Tank	A concrete and brick-built tank (water?) measures 3.3m NE-SW by 1.8m and stands 1m high above ground. There is a dug-out channel running NW from the W side of it.	-	Well preserved	Post-medieval	220	279064	757547
6	Bank	The low-remains of a grass-covered bank with some stone visible is spread up to 1.5m wide and stands up to 0.25m wide. It may be a continuation of Site 2. Very degraded.	NW-SE	Very degraded	Unknown	215	279054	757549
7	Fank	A drystone built complex of walls with internal rounded corners forms a sheep fank enclosure. The walls stand up to 1.2m high and are of single course construction 0.3-0.5m wide. There are horizontal slabs extending through the wall at scattered intervals.	N-S	Ruinous	Post-medieval	220	279040	757487

- ❖ Sites 4-5, 13 – It has been indicated that the tanks, Sites 4 and 5, and the sluice, Site 13, will be removed. This is not considered to be detrimental to the archaeological record as the present survey has made a record of these probable late 19<sup>th</sup> – early 20<sup>th</sup> structures.

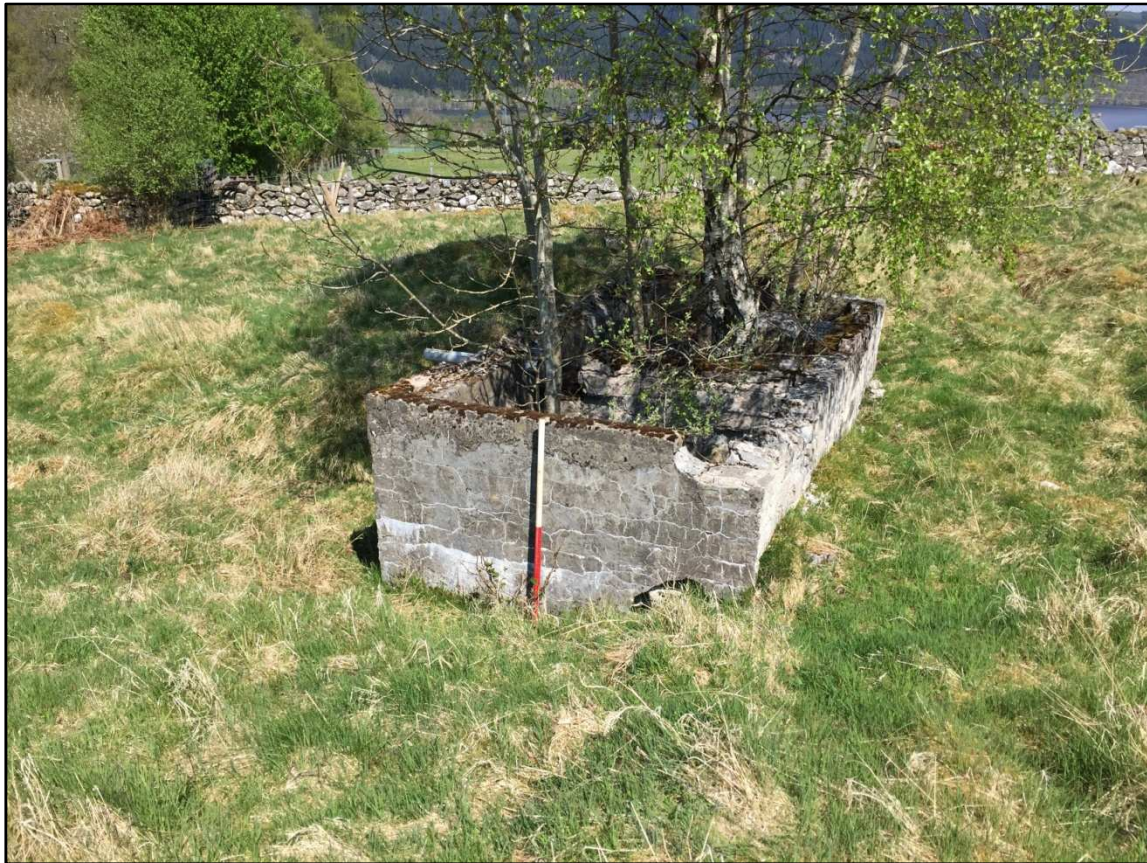
*Plate 8 Looking S over concrete-built tank, Site 5*

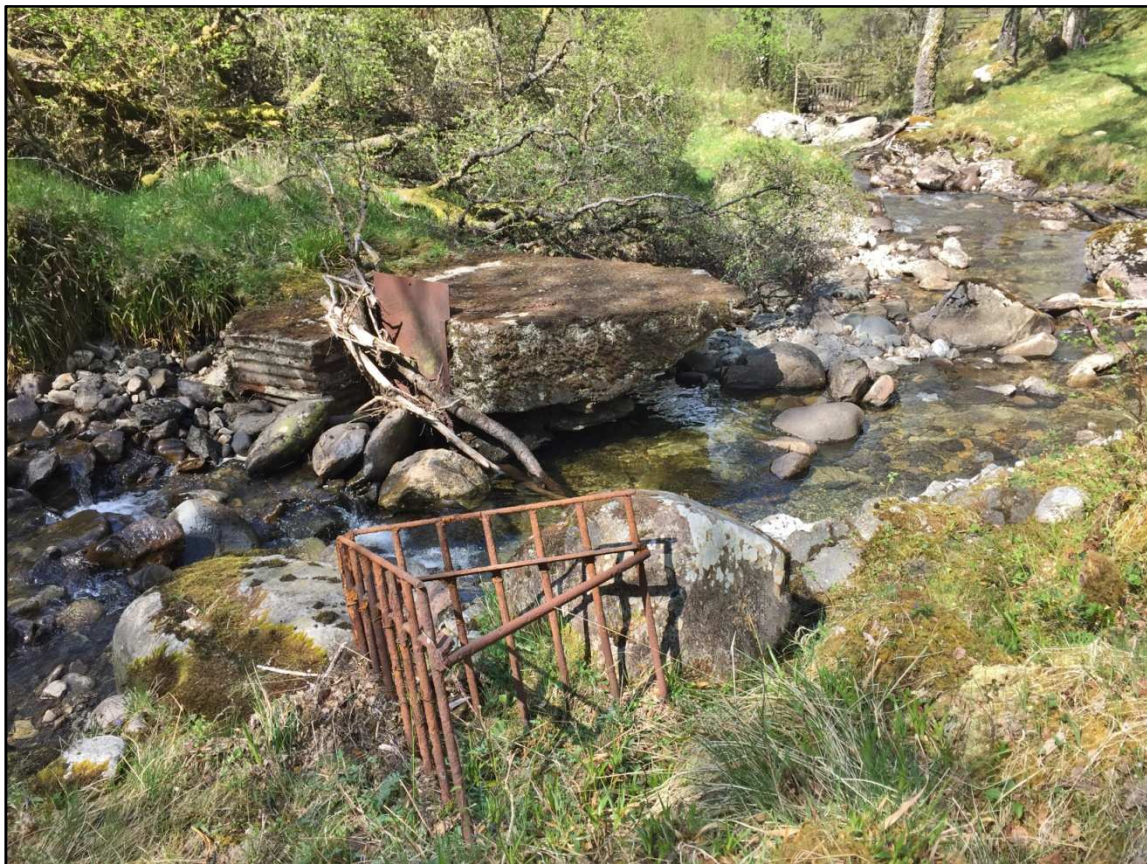
18. Other sites recorded during the survey include two tanks associated with water management, Site 4 (**Plate 7**) and Site 5 (**Plate 8**), and a disused sluice, Site 13 (**Plate 9**). A burial to *M.A.N.P.*, erected in 2009, Site 10, was also recorded. A small, possible stone cellular structure (Site 14) at the south end of the route, was of inconclusive interpretation due to the extensive stone spread around it. It is likely of limited, if any, archaeological significance.

*Plate 9 NW view over disused weir, Site 13*
