Saughton Hall, Edinburgh: Archaeological Recording of Site Investigation Trenches Data Structure Report

AOC Project 22747
30th May 2016

Data Structure Report

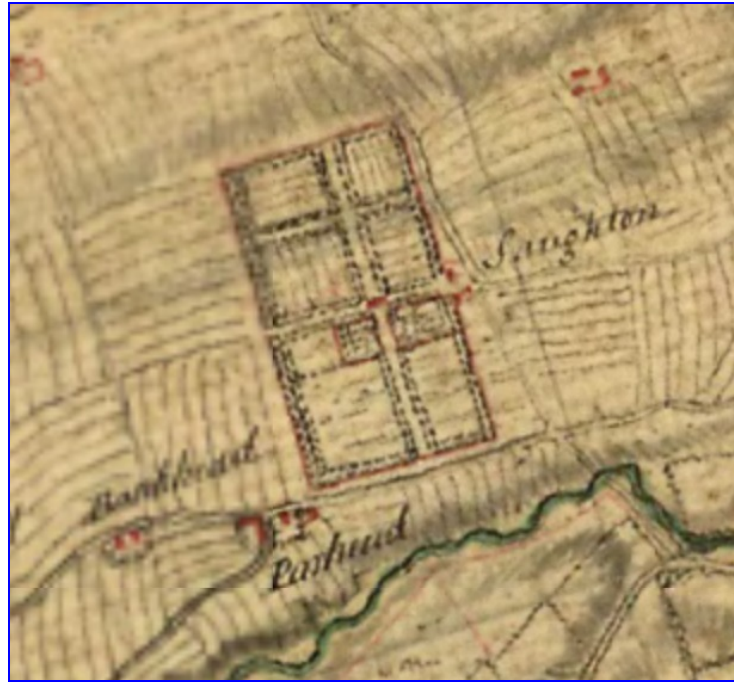
Figure 4: Extract from Roy's map, ca. 1747 - 55

1.3.5 The maps throughout the 18th century show the general layout of the estate, including the mansion house and its gardens, with Roy's Military Map of Scotland from ca. 1747 – 55 showing the house and grounds in a rectangular plot of land roughly orientated NNW/SSE (Figure 4). This is clearly a slightly earlier form of layout than is seen later in the 19th century, which stretches to the east and west of the house.

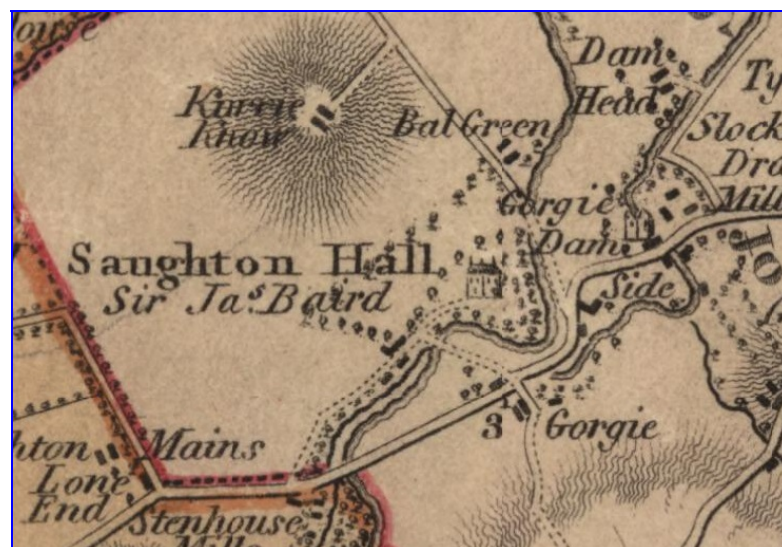
Figure 5: Extract from Knox's plan, 1816

- 1.3.6 Into the 19th century, the mansion house and gardens appear much the same. James Knox's 1816 plan even annotates the estate as belonging to Sir Ja[m]es Baird, indicating that the estate remained in the hands of the Baird family from the 17th century to this time (Figure 5). In 1824, the house was leased to the Institute of the Recovery of the Insane - essentially a 'private' lunatic asylum for those of higher ranks - admitting over 100 patients from 1824 – 1840. The 1855 Ordnance Survey map details the mansion house and estate, including the extent of its outbuildings and the sundial in the garden (Figure 6). The grounds are extensive with paved walkways bounded by rows of mature trees and with an open expanse of land to the south where the estate meets the Water of Leith. Two large mill complexes have also sprung up to the north-east (Gorgie Mills) and to the south-west (Saughton Mills).

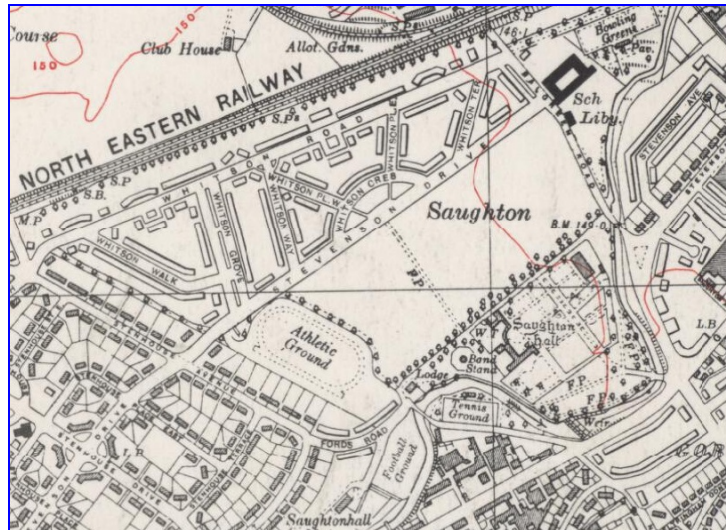
Figure 9: Extract from Ordnance Survey map, 1944 (surveyed in 1938)

1.3.9 The Edwardian period was the hey-day of public parks on the outskirts of major cities and Saughton was no exception. Considerable investment was put into maintaining and caring for the gardens throughout the early part of the 20th century. In 1920, it was host to another event, the Royal Highland Show Fair, after which time much of the estate (forming mainly the golf course to the north) was used to construct the Whitson Council Housing Scheme. The 1944 Ordnance Survey map (surveyed in 1938) shows the extent of the neatly laid out new housing estate with Stevenson Drive forming the boundary to the site on the north side (Figure 9).

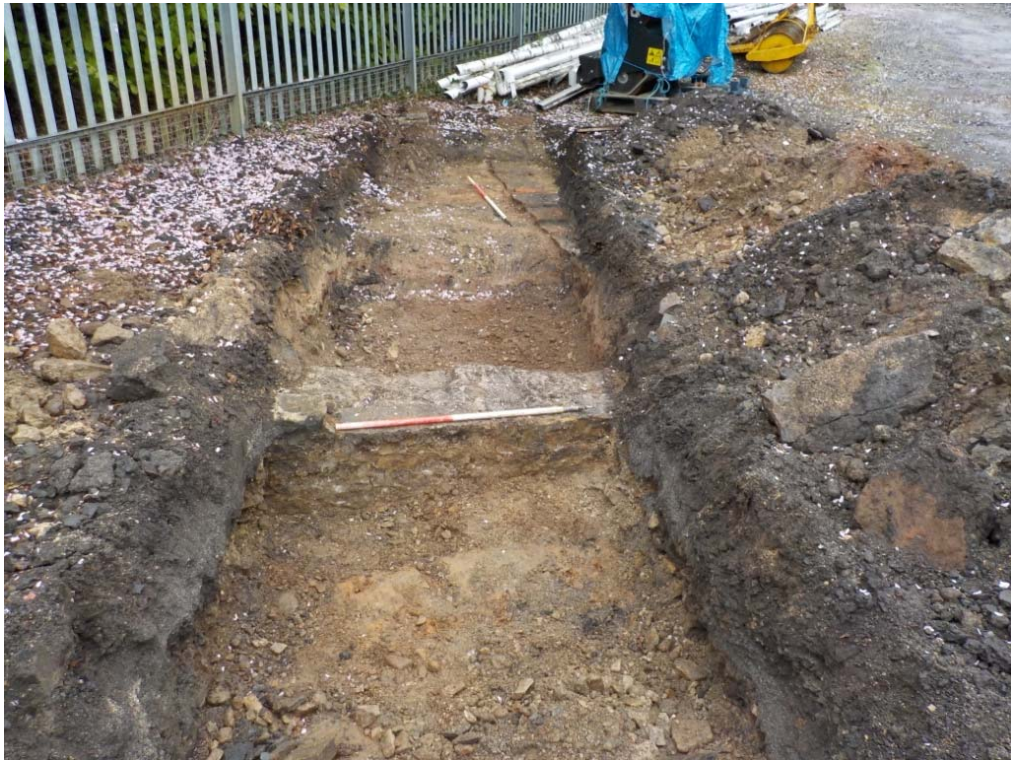
Plate 1 - View of Trench 1

4.2.1 Two sandstone walls [101] and [102] were revealed within this trench (Figure 11; Plate 1). The first of these was angled at NW-SE and was at least two courses high measuring 0.32 m wide. The uppermost course of the wall was unusual in that it did not have any mortar on its upper surface and it first resembled the cap of a culvert. The second wall revealed is the main N wall of the house and measures 0.6 m wide and has a foundation excavated over 1 m into the natural subsoil. Neither of these walls were removed by the site investigation works.

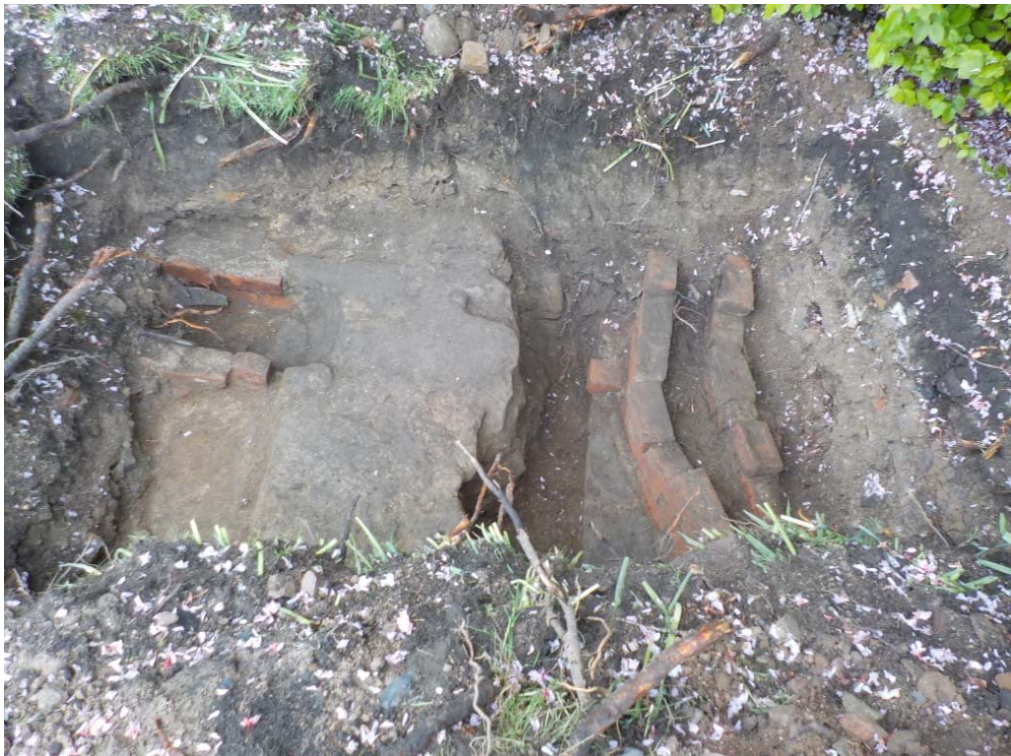
Plate 2 - View of Trench 2

4.3.1 A sandstone wall [201] and the remains of four culverts [202], [203], [204] and [209] were revealed within the trench that suggest various phases of use (Figure 11; Plate 2). The wall is similar in construction to wall [102] and is most likely a continuation of the external wall of the house. Culvert base [204] represents the earliest phase of the house construction with culverts [203] and [209] using the base as a partial foundation. From the frogged nature of the bricks it is most likely that culvert [202] is also contemporary with these later culverts. None of these features were removed by the Site Investigation works.

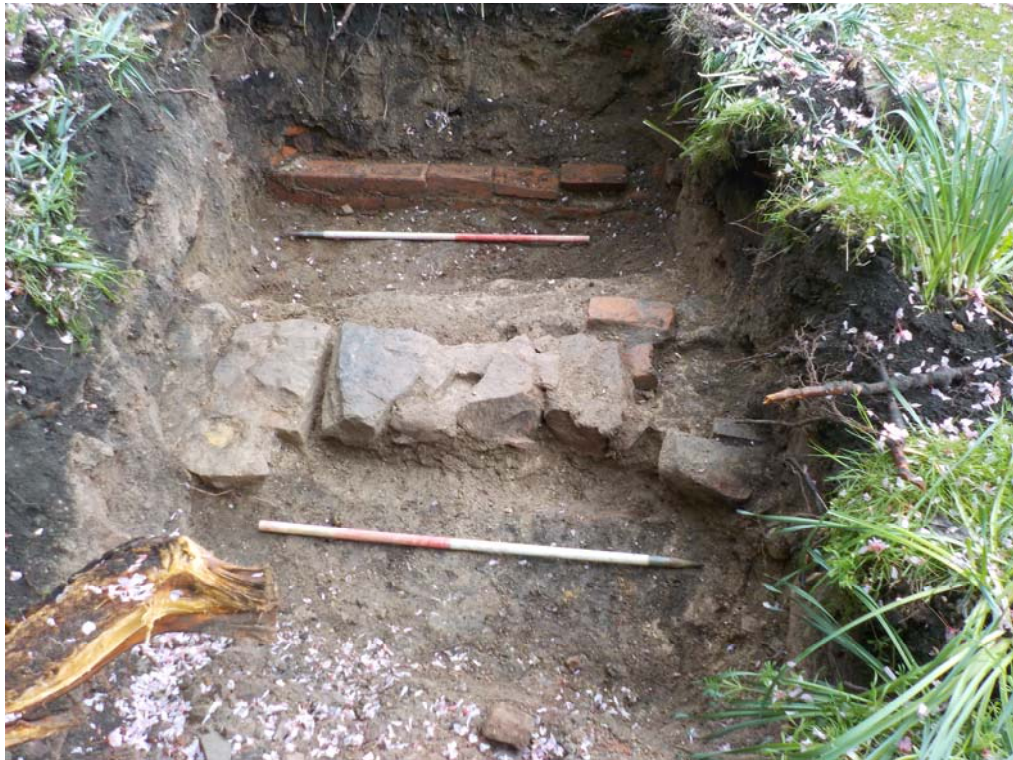
Plate 3 - View of Trench 3

4.4.1 A small sandstone wall [301] and the edge of a brick culvert [303] were revealed within this trench (Figure 11; Plate 3). The wall is only one course high and sits within a shallow construction cut [302] that is only visible within made ground [305]. This suggests that the overlying made ground and mortar deposit [304] could have been a levelling layer for a floor surface that would have formerly abutted wall [301].

4.4.2 Only the culverts W edge was visible within the trench, with the alignment possibly suggesting that it may be related to culvert [209] within Trench 2. The culvert was within a visible construction cut [307] that cut through deposit [306] suggesting a large amount of levelling had taken place in the area during construction of the house. The wall [301] and part of the culvert [303] were removed by the Site Investigation works.

- 6.1 The archaeological excavations conducted ahead of the Site Investigation works was able to fully record several features related to Saughton Hall. Only part of wall [301] and culvert [303] were truncated by the Ste Investigation works. These features have been preserved in record and the information gained can be added to any future excavations due to take place within the development area. The full scope and scale of future works would be defined by City of Edinburgh Council, with the detailed methodology for their undertaking set out in further Written Schemes of Investigation.
