Invergarven School, Girvan, South Ayrshire: Archaeological Evaluation Data Structure Report

AOC Project No: 23446

Date of Fieldwork: 26th May 2016

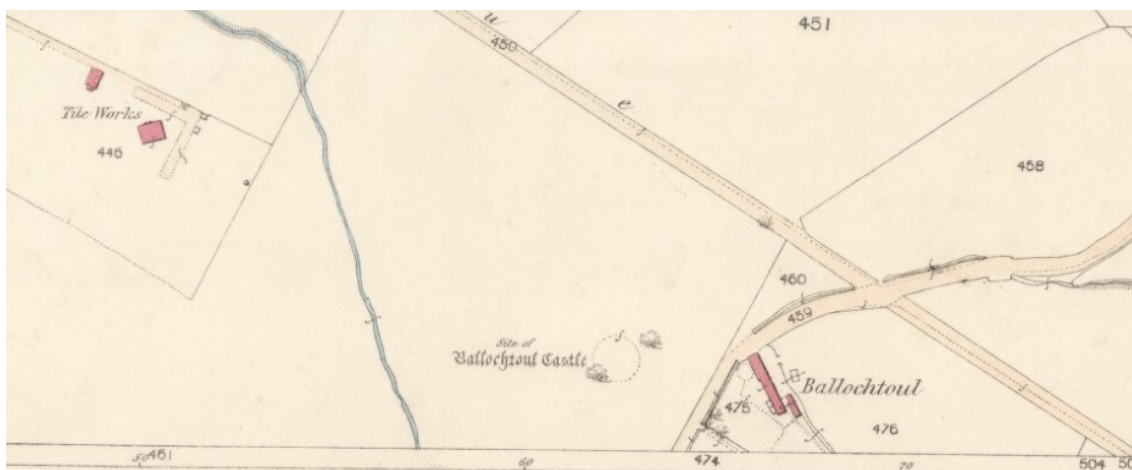
Figure 2 – Extract from 1856 Ordnance Survey

1.3.1 The site of the proposed new school extension falls within the general location of the reputed site of Ballochtout Castle represented on the 1st edition OS map of 1856, although removed by this date (Figure 2). The castle was described as a five story structure set within corn fields with no associated orchard or garden. It is possible that the castle was the remains of a tower house or a representation of an earlier structure. The castle was recorded as belonging to the Grahams of Knockdoliane in the 16th century (Paterson 1863). The place name appeared on the Roy Military Survey map of 1747-1755. Roy showed the presence of several structures including two rectilinear enclosure walls (Figure 3).

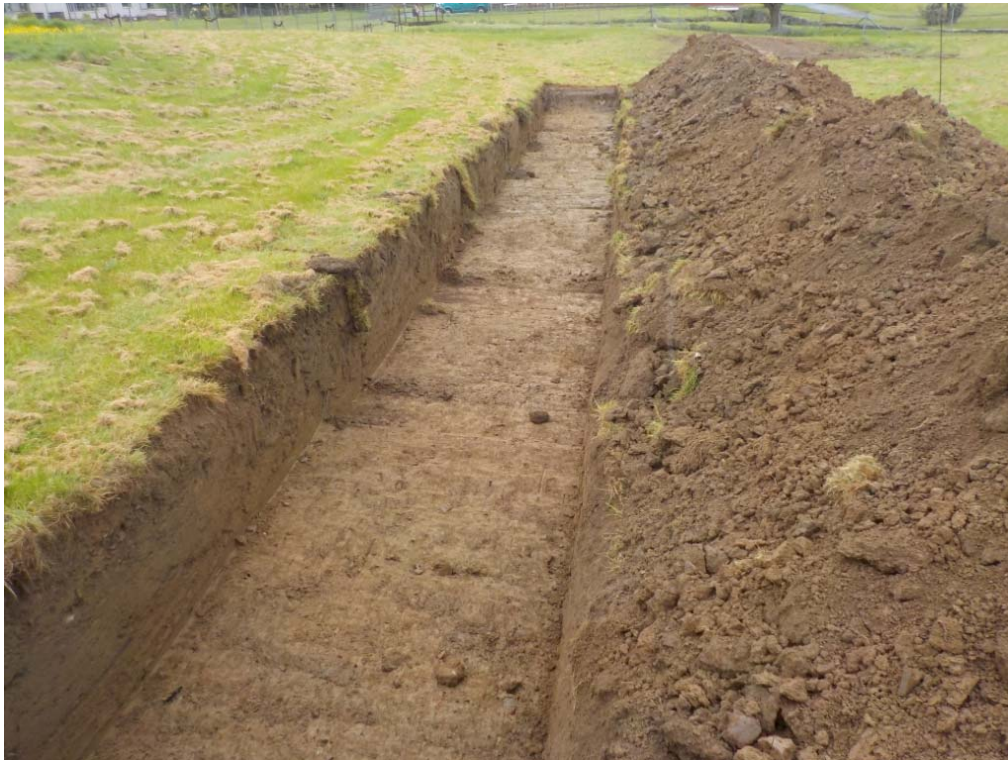
Plate 1 - General post-ex view of Trench 4

- 4.3 Within the other five trenches and test-pits the topsoil was an imported mid brown sandy clay most likely representing re-deposited subsoil, measuring 0.6-0.9 m thick. In Trench 3 & 4, this made ground overlay a pale brown and grey clay subsoil (Plate 1). In test-pits 2, 5 & 6 it overlay a dark grey silty clay containing decomposing grass and occasional modern material that was 0.3 m thick in Test-pit 5, 1.4 m in Test-pit 6 and 1.8 m in Test-pit 2. This in turn overlay a grey and brown gravel deposit (made ground) that was 0.7 m thick in Test-pit 5, but was not fully excavated in Test-pit 2 & 6 due to the depth of the trench.

<i>Dimensions</i>	20 m by 1.6 m
<i>Total Area</i>	32 m ²
<i>Excavated Orientation</i>	S to N
<i>Soil Make-up</i>	Imported topsoil – mid brown sandy clay with frequent stone inclusions – max. depth 0.9 m
<i>Significant Features</i>	None
<i>Other Features</i>	None
<i>Natural Subsoil</i>	Pale brown and grey clay
<i>Finds</i>	None

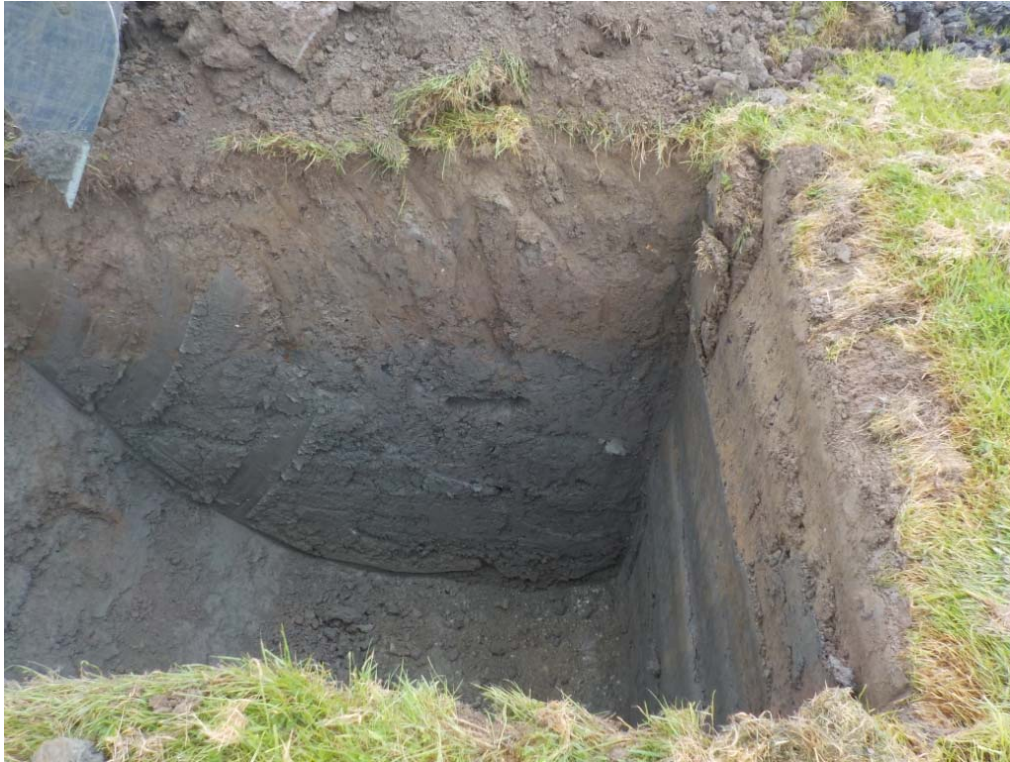
Plate 2 - W-facing section of Trench 6

<i>Dimensions</i>	3 m by 1.6 m
<i>Total Area</i>	4.8 m ²
<i>Excavated Orientation</i>	N to S
<i>Soil Make-up</i>	Imported topsoil – mid brown sandy clay with frequent stone inclusions – depth 0.7 m; Made ground – dark grey silty clay with abundant grass and occasional modern material – depth 1.4 m; Made ground – dark grey and brown gravels – not fully excavated
<i>Significant Features</i>	None
<i>Other Features</i>	None
<i>Natural Subsoil</i>	Not reached
<i>Finds</i>	None
