# 18a/18c Jamaica Street Lane (North), Edinburgh: Historic Building Recording Report

AOC Project: 23467

7<sup>th</sup> June 2016

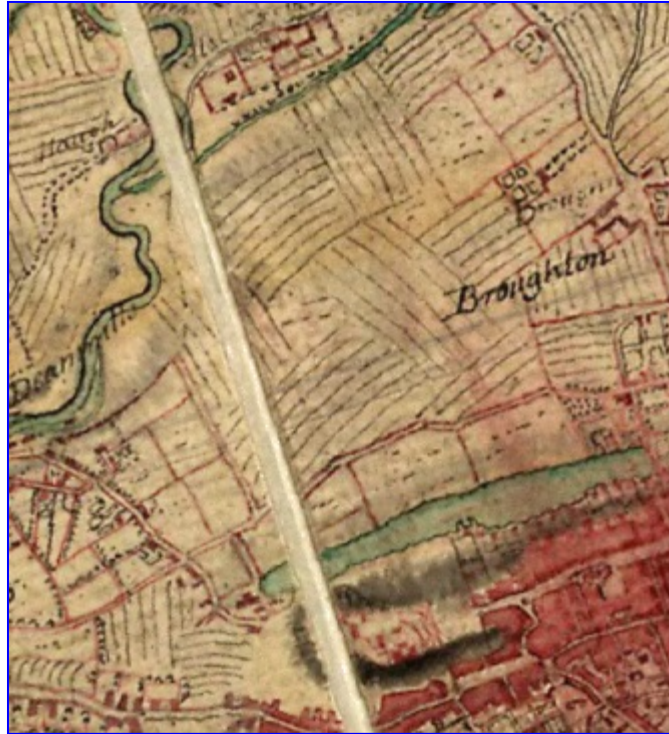
Figure 2: Extract from Roy's map, ca. 1747 - 1755

- 4.1 Prior to the establishment of the New Town of Edinburgh in the late 18<sup>th</sup> century, the site of the future Circus Place and its associated tenements was, as with much of the rest of the New Town, cultivated fields as we can see on Roy's map of ca. 1747 – 1755 (Figure 2). Unfortunately, publicly accessible town plans of the development of the New Town in the late 18<sup>th</sup> century tend to focus on the area around Princes Street and George Street, although John Laurie's 1786 map shows that the development appeared to be restricted to these areas by this time (Figure 3). By the beginning of the 19<sup>th</sup> century, the Circus had been created, together with its associated tenements. Although schematic, Ainslie's 1804 map shows houses well established at Jamaica Street and facing the Circus, together with their mews houses to the rear of the plots (Figure 4). This identifies, looking at the historic mapping alone, that No 18a/18c was constructed between 1786 – 1804.

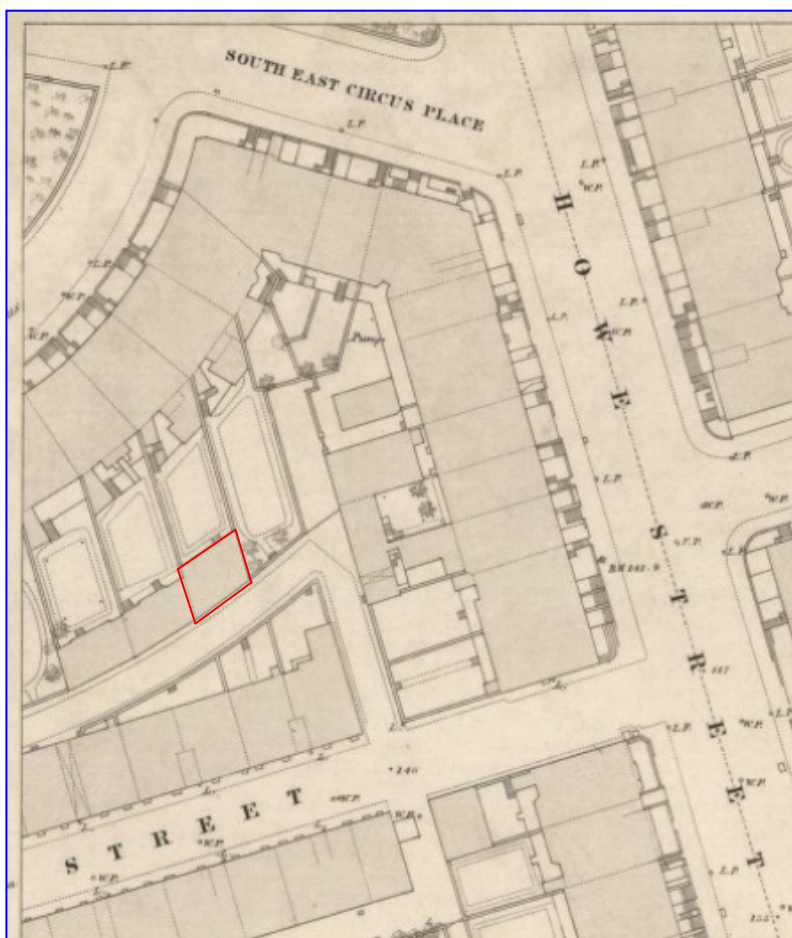
Figure 5: Extract from Ordnance Survey map, 1851

- 4.2 The later more detailed Ordnance Survey Town plans of 1851, 1881, 1894 and 1950 show the building from the mid-19<sup>th</sup> century and 20<sup>th</sup> century as the easternmost building at Jamaica Street Lane (Figures 5 – 8). By the 1894 map, the building is also shown as divided horizontally. The houses located to the east of No 18a/18c (Nos 12 & 14) today are a later modern construction.

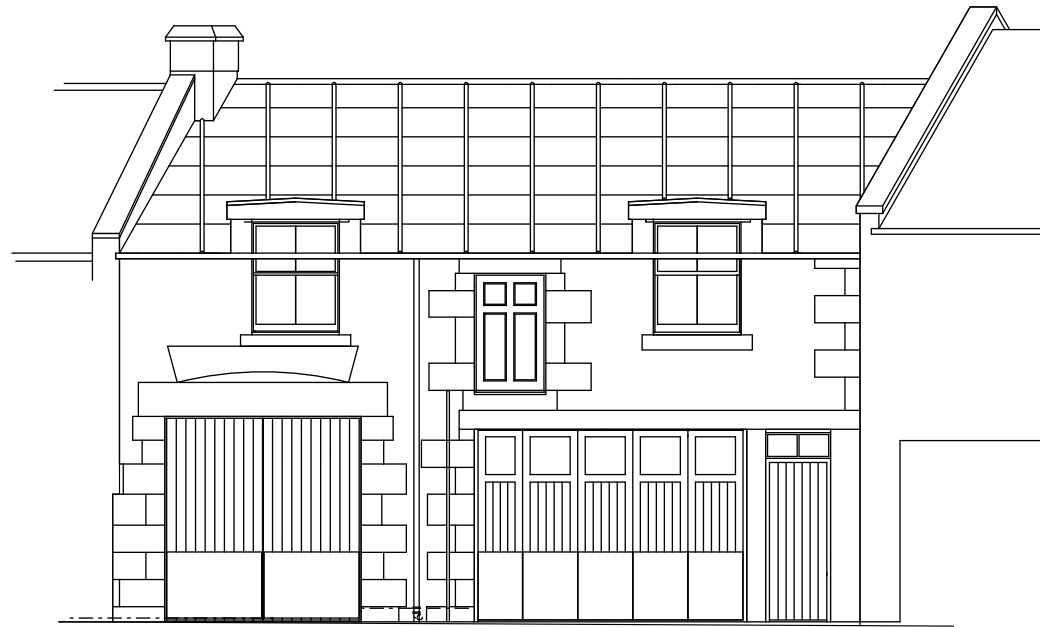
Figure 9: South Elevation

- 5.1.1 The south elevation facing Jamaica Street Lane (North) is a three-bay two-storey terraced building in coursed dressed rubble with a pitched rolled zinc roof (Figure 9; Plates 1 – 3). The ground floor has two wide openings with a small pedestrian door to the east side (Plate 4). The westernmost double door has a large chisel dressed stone lintel with a stone relieving arch over and comb-dressed rybats (Plate 5). The adjacent five-panel door is wider with a large steel lintel; the comb-dressed rybats only exist to the east side. To the first floor there are two dormers which look to be later inserted windows given the lack of surrounds (Plates 6 & 7). To the centre is an original loading door with nice comb-dressed rybats and a four timber-panelled door (Plate 8).

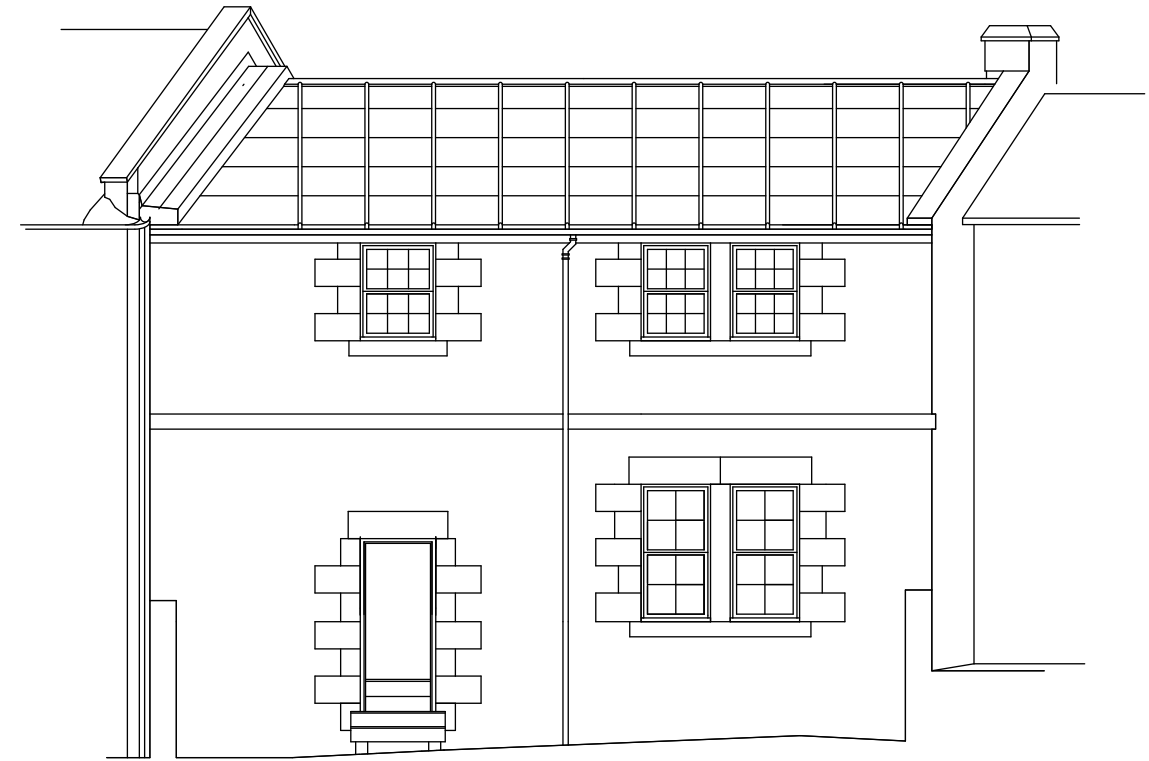
Figure 10: North Elevation

- 5.1.2 The north elevation was only accessed from No 5 Royal Circus and formed a two-storey elevation of dressed coursed blocks with a neat string course, a much neater façade as it faces the main house (Figure 10; Plates 9 & 10). There is a small doorway to the eastern bay (Plate 11) with a double window opposite (Plate 12). The first floor has a single window above the doorway with an adjacent double window.

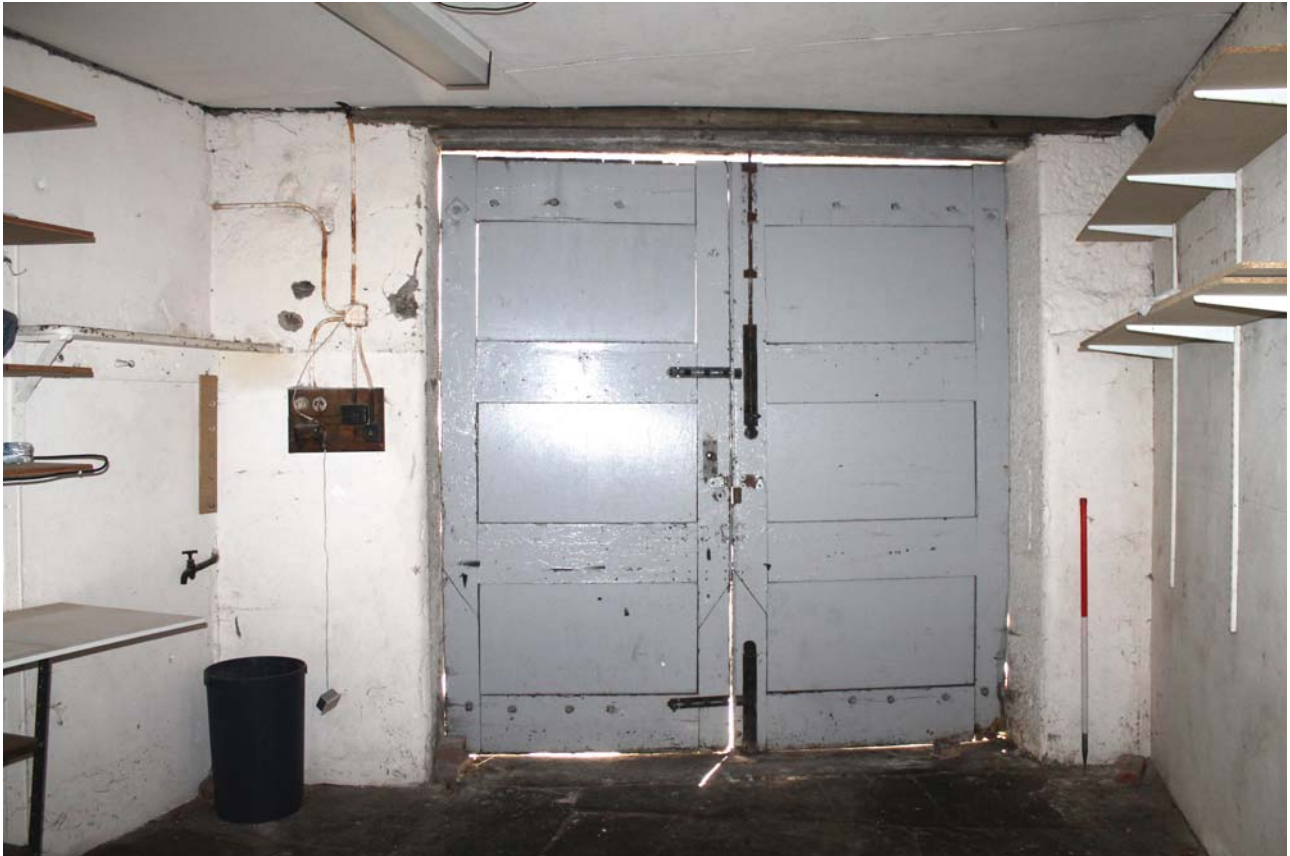
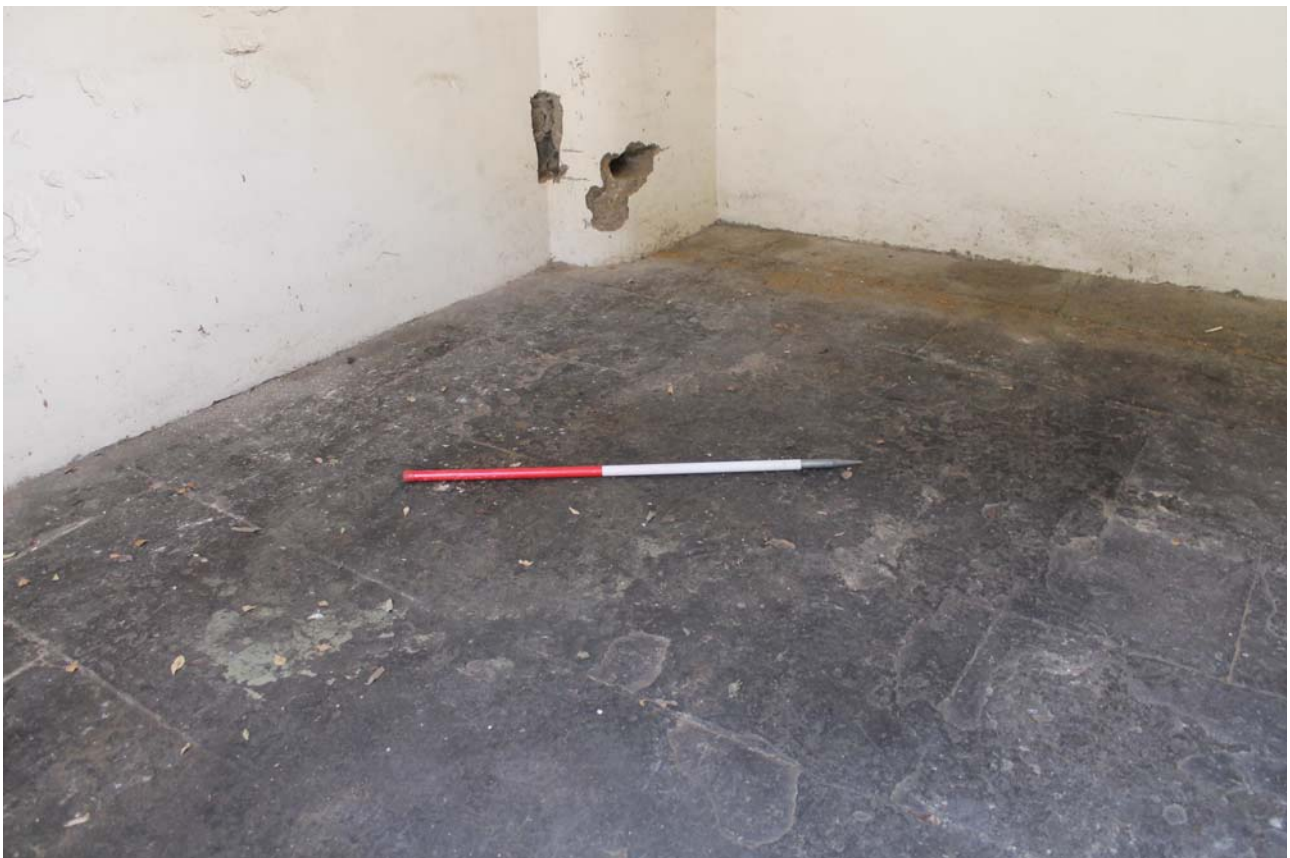
- 5.2.1 The ground floor latterly consisted of two garages, although of course were originally for the purpose of storage of the horses and carriages/carts (Figure 12). Room 0/1 has a stone-flagged floor, with an outward-opening double door in the south wall (Plates 13 & 14). The brick partition wall between has a blocked doorway, probably a relatively modern blocking (Plate 15). Behind Room 0/1 is a smaller storage room with the double windows on the north wall with shutters in place (Plate 16). The east side of the ground floor is another garage space with a concrete floor and another five-panel garage door to the south wall (Plate 17). The north wall has a blocked opening with another blocked door in the east wall through to stairwell 0/4 (Plate 18). The small straight stair to the east side of the building is a stone stair with the four-panelled door to the west wall (Plate 19).

- 6.2 The stone-flagged floor in the ground floor is possibly an original feature, with the later concrete floors added when the building was converted for use as a garage and workshop.

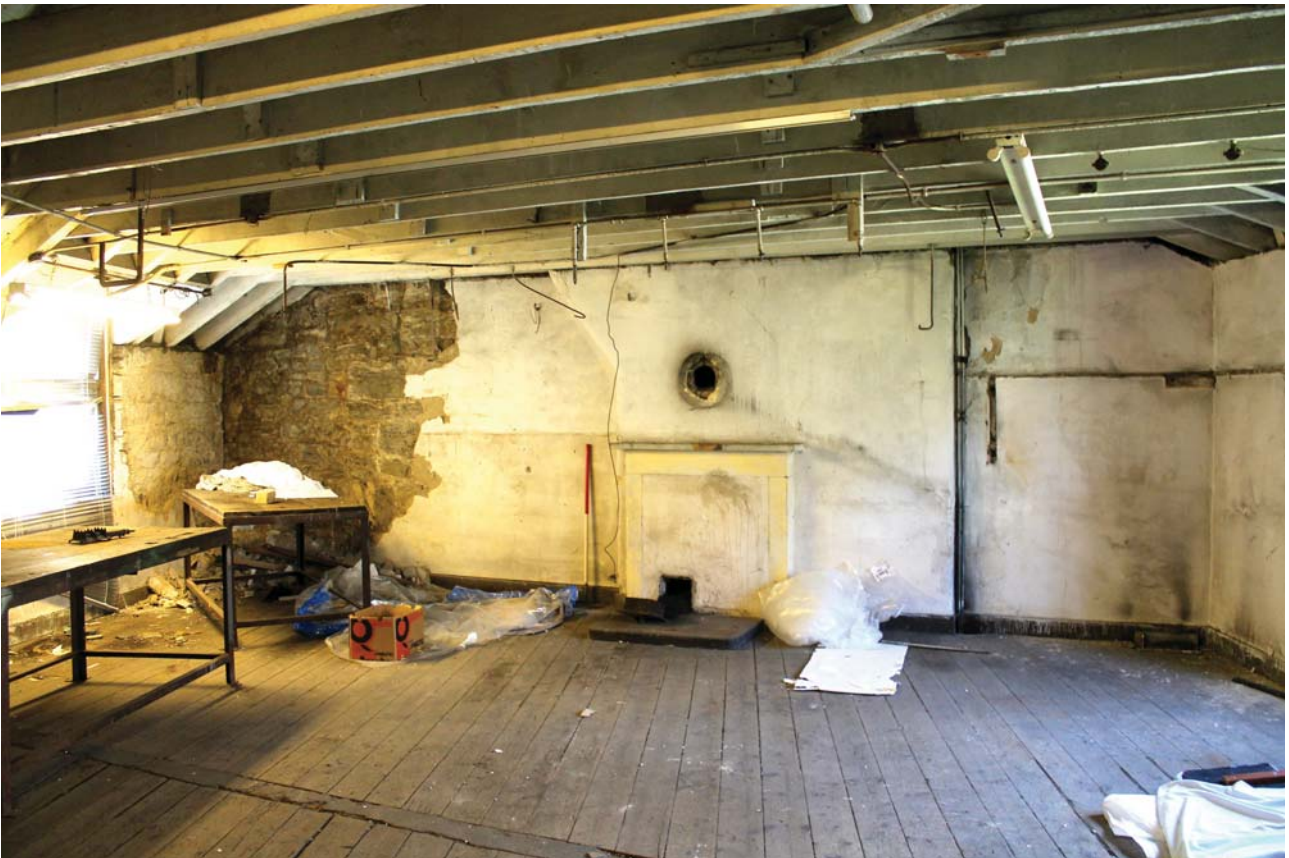
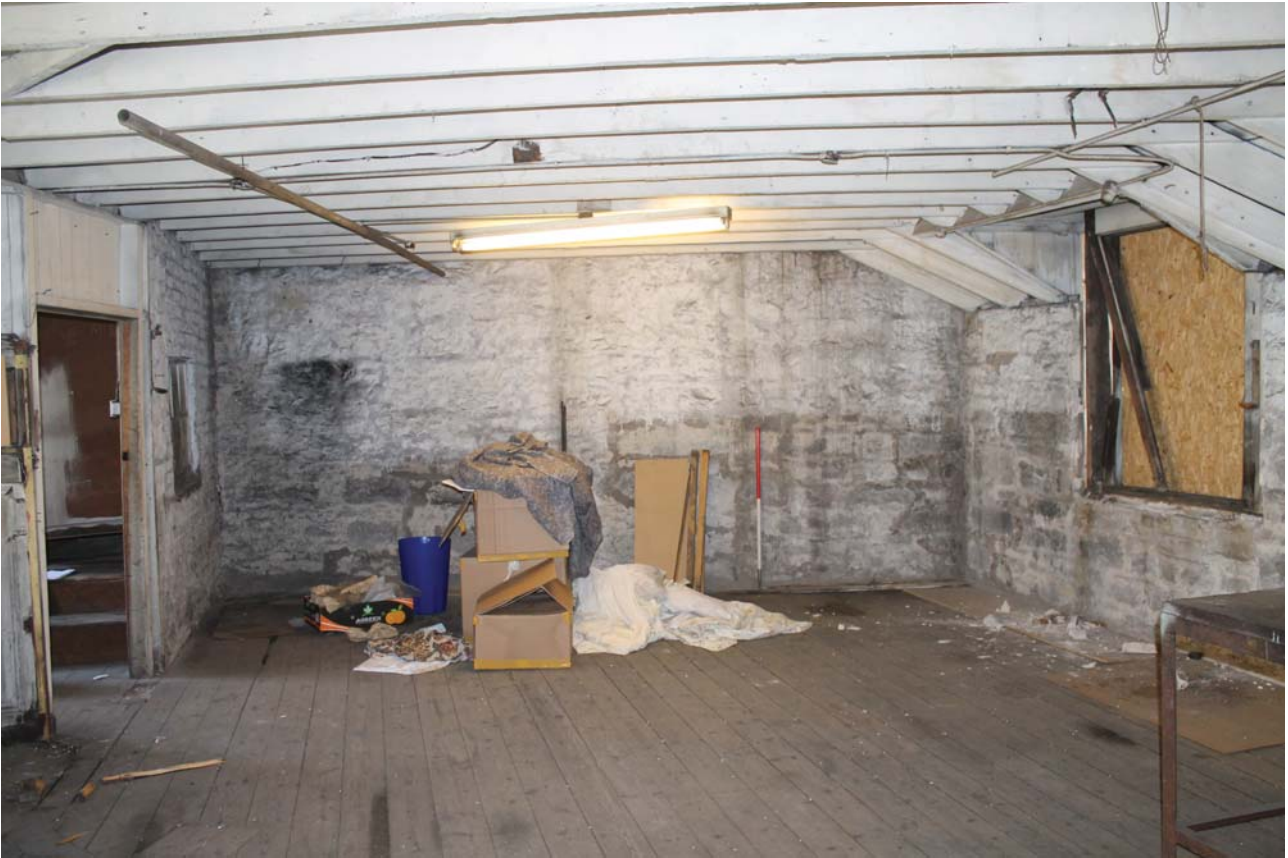
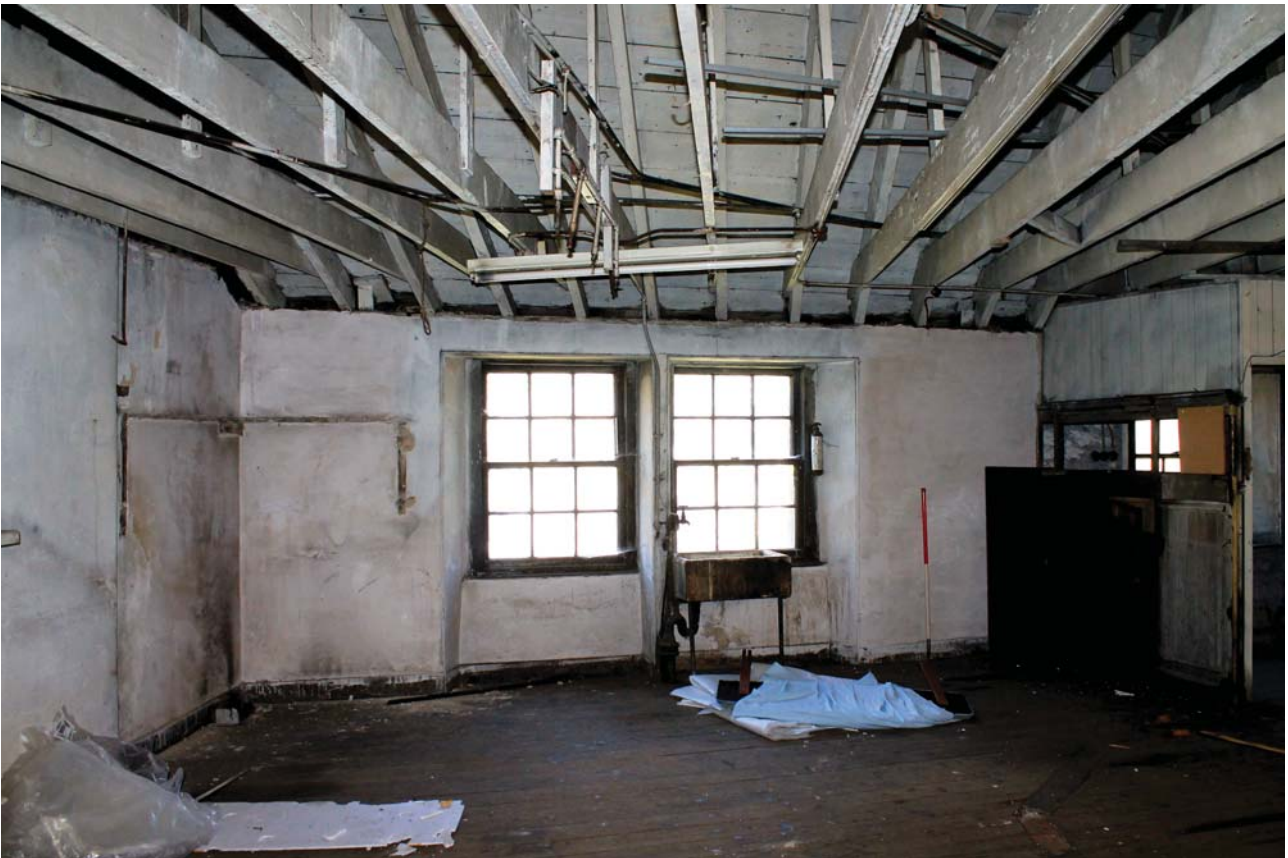
- 5.3.1 The first floor, accessed from stair 0/4 to the east, consists of one large room, 1/1, with timber floorboards (Figure 13; Plates 20 – 22). A former brick partition clearly once divided the space, but this has now been completely taken down. The west wall has a blocked fireplace with a dressed stone surround and a timber lintel (Plate 23). The south wall has the features identified in the south elevation - the two dormers flanking the central loading door, here a four timber-panelled door (Plates 24 & 25). The opposite north wall on the west side has the double window (Plate 26) and to the east side is a thin brick enclosure to the staircase with timber panelling to the west side (Plates 27 & 28). There is a small fixed pane window in the brick enclosure, which contains a small room at the top of the stair (Plates 29 & 30). Apart from this, the stairwell had a three-over-four timber sash-and-case window (Plate 31).
