Birmingham Resilience Project

Frankley Water Treatment Works, Frankley, Worcestershire:

Historic Building Recording Survey Report

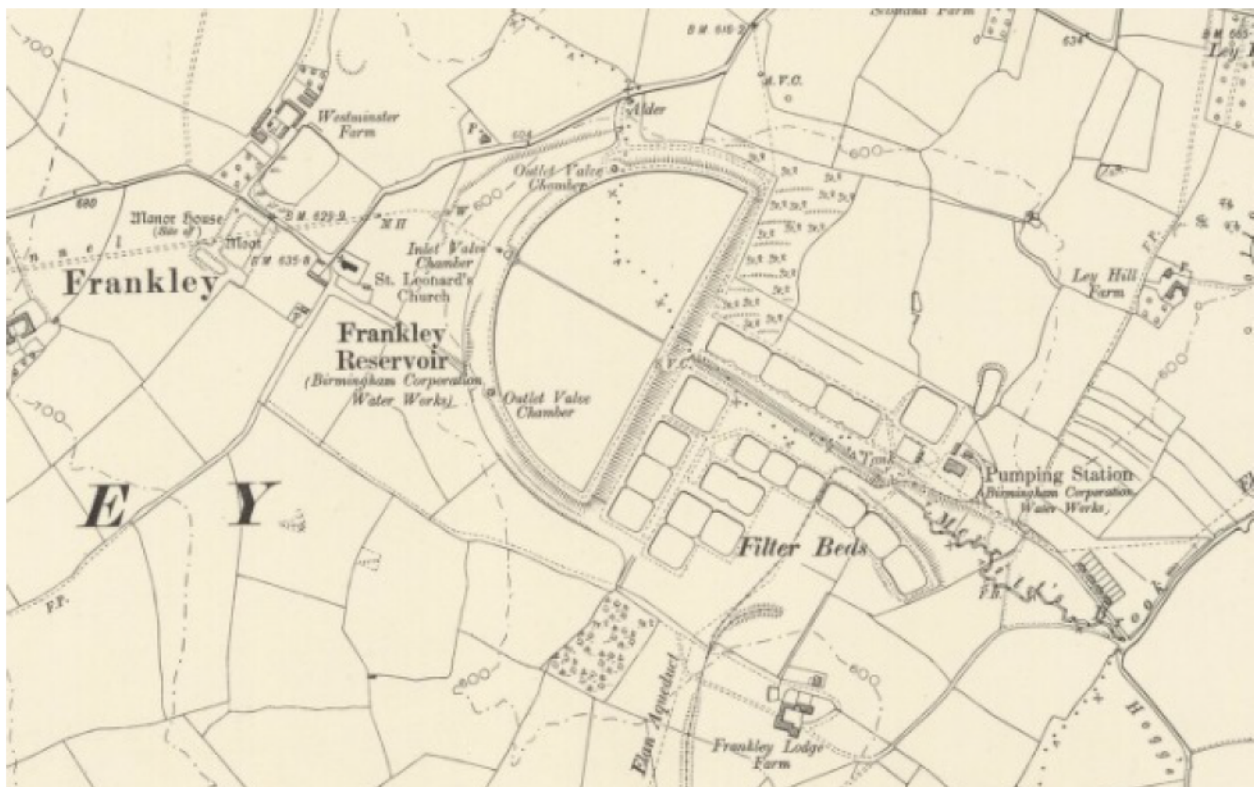
Figure 4: Extract from Ordnance Survey map, 1905, showing the Frankley Water Treatment Works for the first time cartographically

- 4.5 Frankley Water Treatment Works is first represented on the 1905 Ordnance Survey map (Figure 4). The woodland known as Cutler's Rough was partially truncated by its construction, the remains of which are still present today. The structures were designed by Abraham Kellett of Ealing, with a semi-circular reservoir constructed from concrete with brick above the water's surface. Little evidence is available in the archives relating to Kellett's career, however he is known to have completed similar types of construction works in the late 19th and early 20th centuries (Brooks & Pevsner 2007, 156). When full, the reservoir holds an area of 25 acres (101,171m²) to a depth of 30 – 35 feet (9.1m – 10.7m) containing 200,000,000 imperial gallons (909,218,000 litres). After a site visit in 1904, the Architect and Contract Reporter reported:

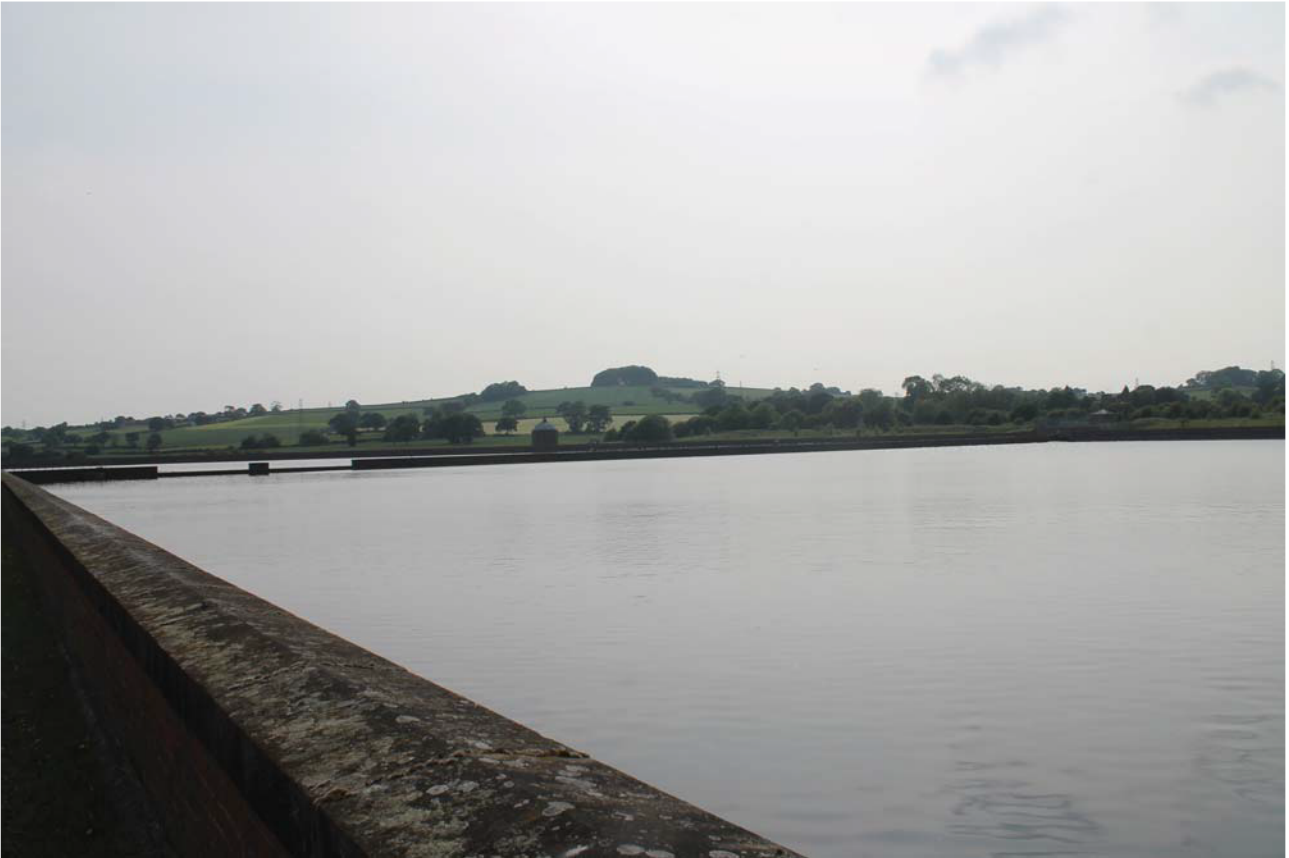
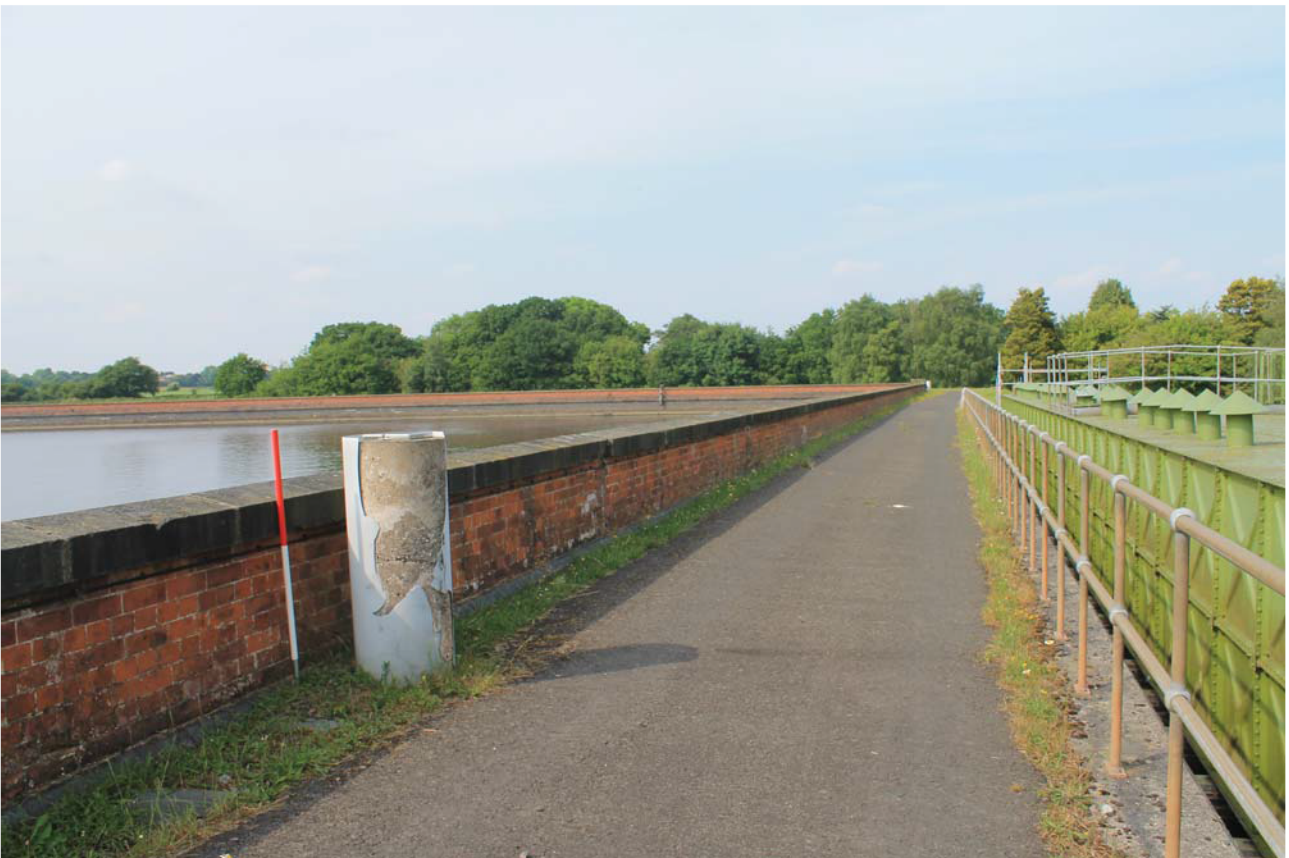
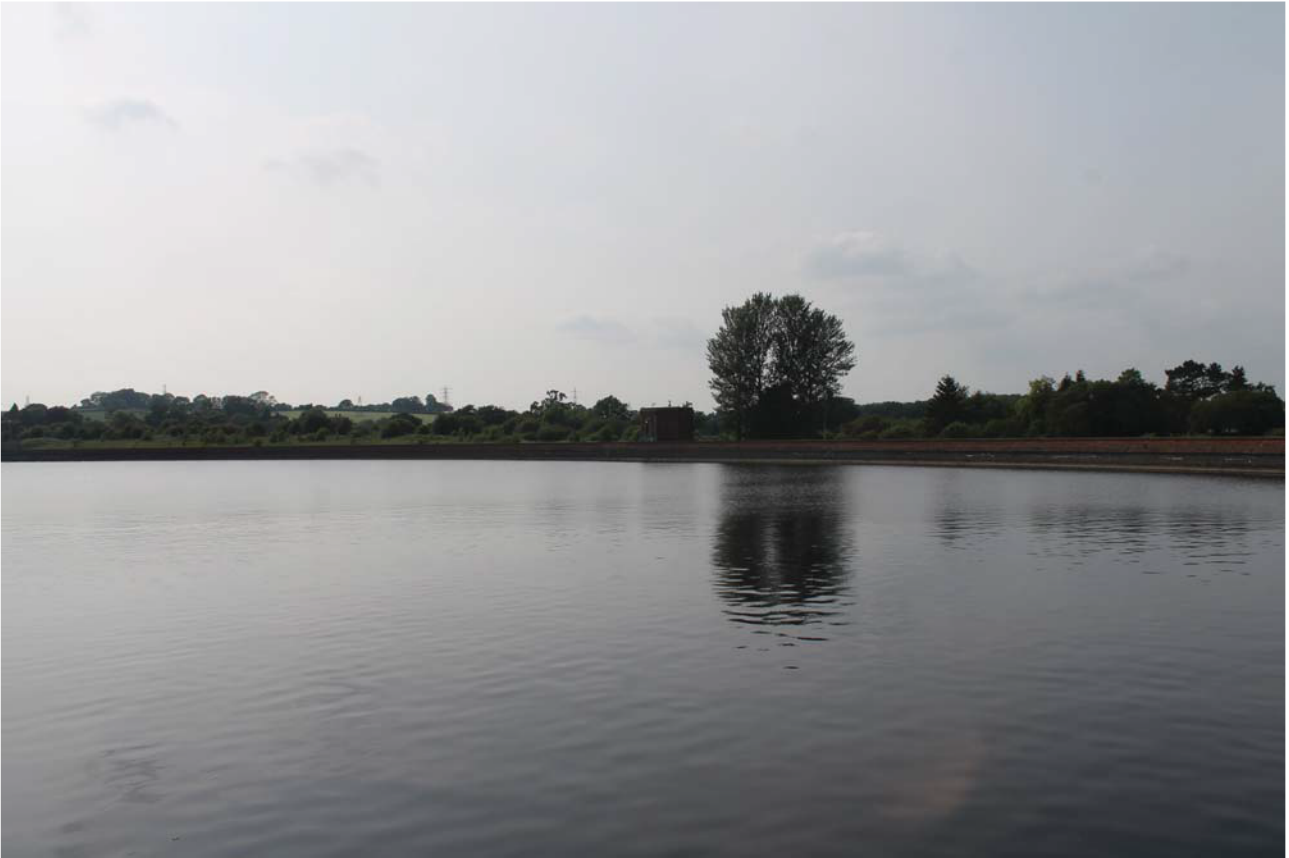
Plate 1: Reservoir, general view from the east

Plate 2: Reservoir, general view from the SSW

Plate 3: Reservoir, general view from the south-east

5.2.1 The Reservoir is constructed of concrete with a blue brick skim (Figure 2; Plates 1 to 3). The parapet wall is constructed in red brick in an English bond and set 120mm back from the blue brick, which is chamfered to its outer corner (Plates 4 and 5). The red brick parapet is straight vertical to the south-east side of the Reservoir, although to the semi-circular section the wall leans back to maximise the capacity of the structure (Plate 6). It rises to eight courses and has an overhanging pyramidal stone cap. In at least two places, the wall has been replaced/repared in a modern brick (Plates 7 and 8). The central division of the Reservoir is also constructed of blue brick with an overhanging flat cope with access via a stone stair to either side off-centred to the north-west side (Plates 9 to 12). There are several openings in the Reservoir parapet wall providing access to the water. There is a wide opening at the centre of the semi-circular north-west wall, with the top of the wall rising to a curve and a steel gate (Plate 13). Opposite this, to the straight south-east wall, is another similar wide opening (Plate 14). There are additional openings to the north-east and south-west sides of the straight south-east parapet wall, each with their own stone steps leading down to the water's edge (Plates 15 to 17).

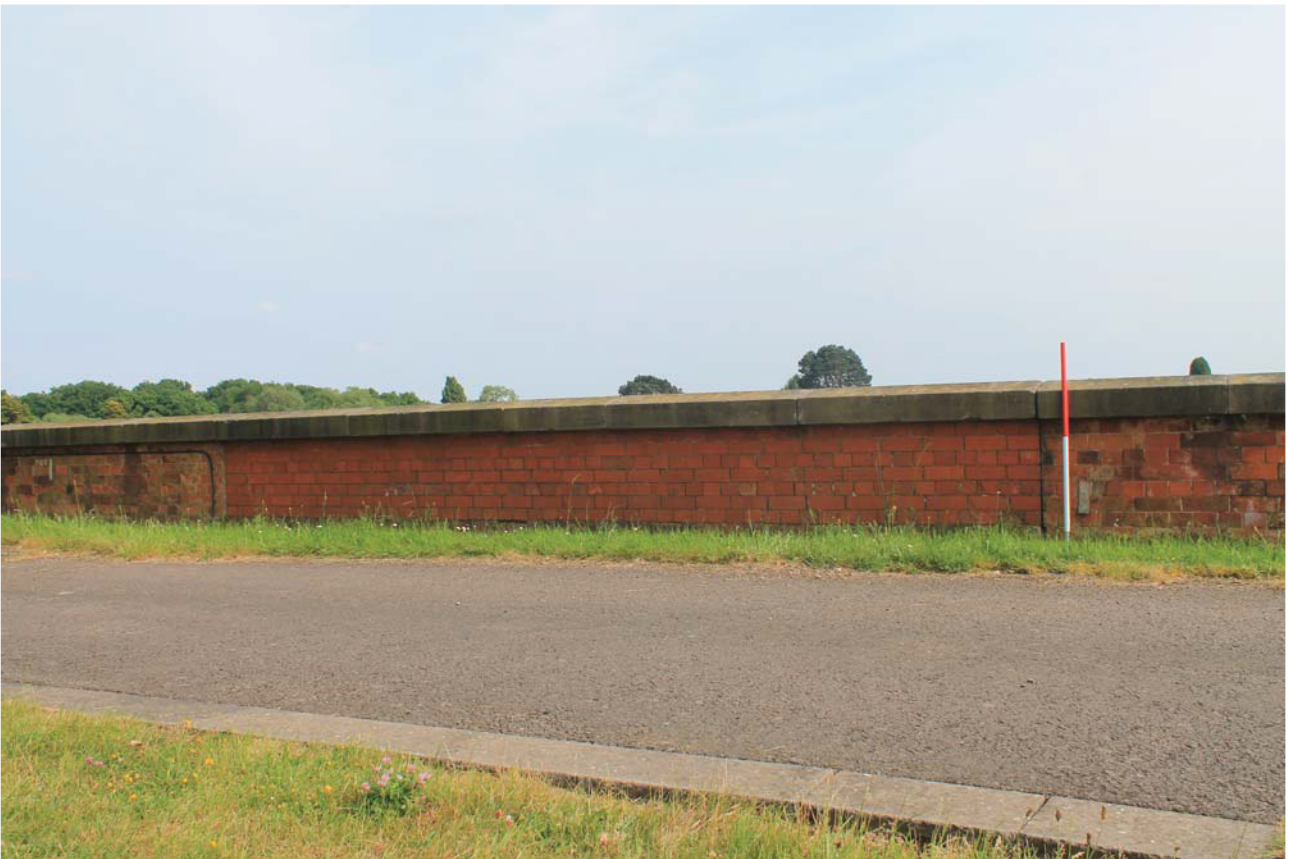
Plate 7: Reservoir, detail of brick repair on the north side from the north-west

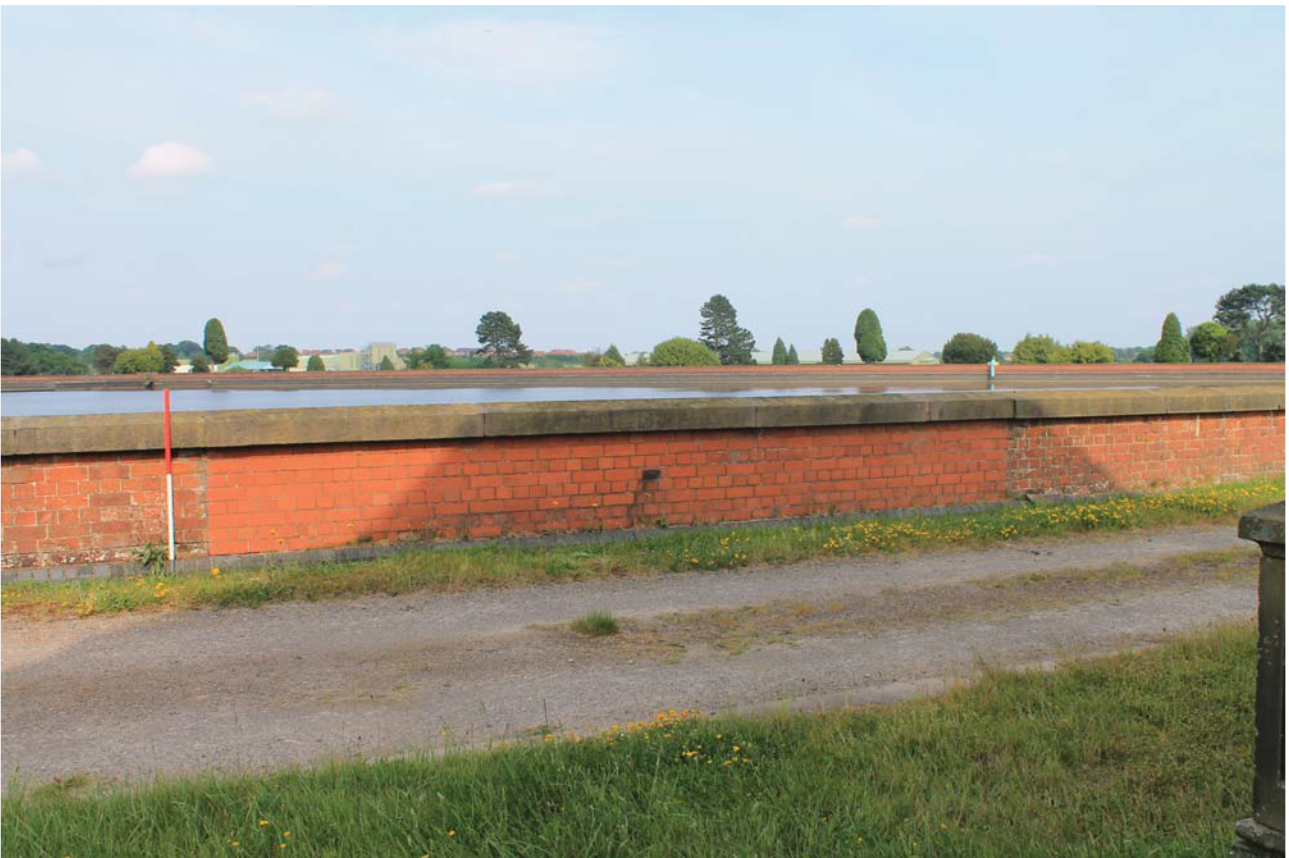
Plate 8: Reservoir, detail of brick repair on the north-west side from the north

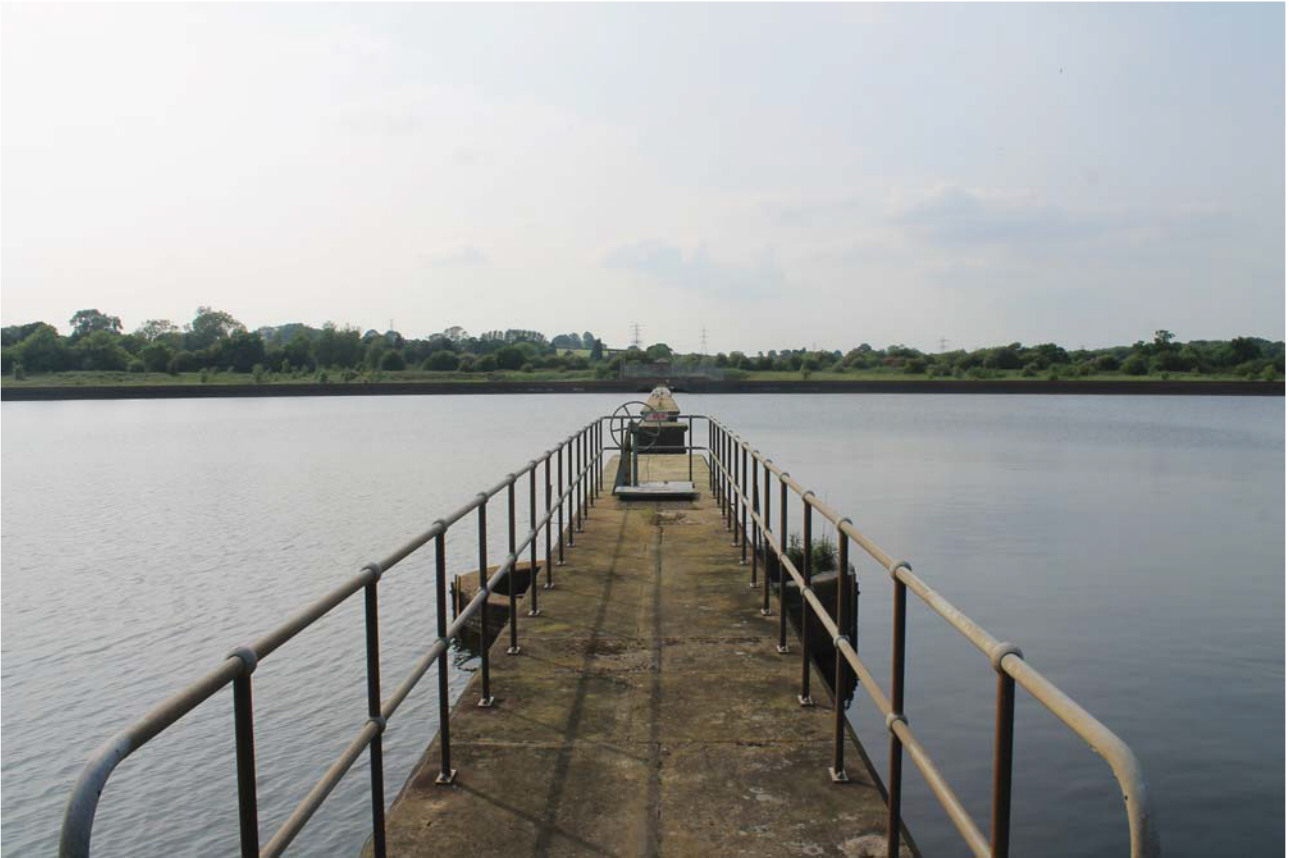
Plate 9: Reservoir, detail of central dividing wall from the north-west

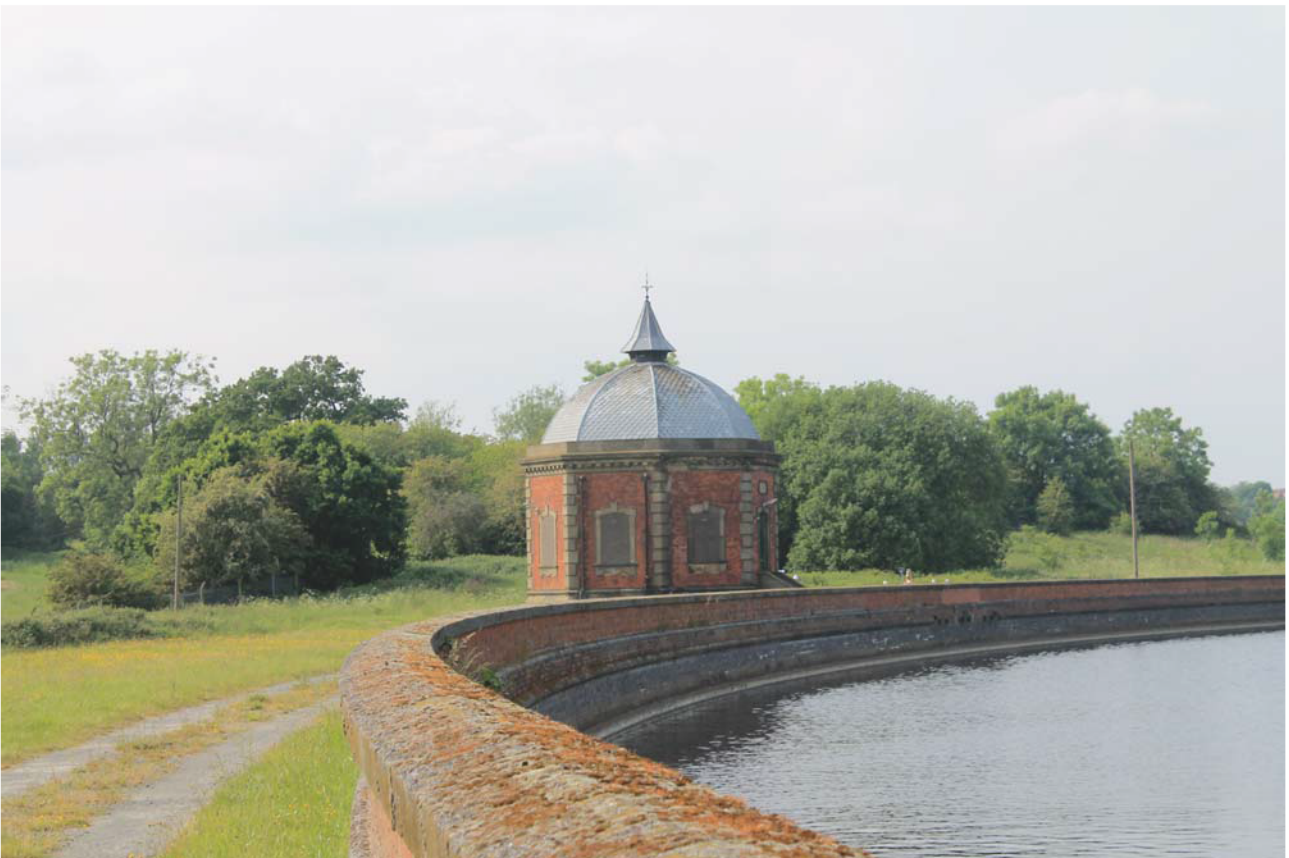
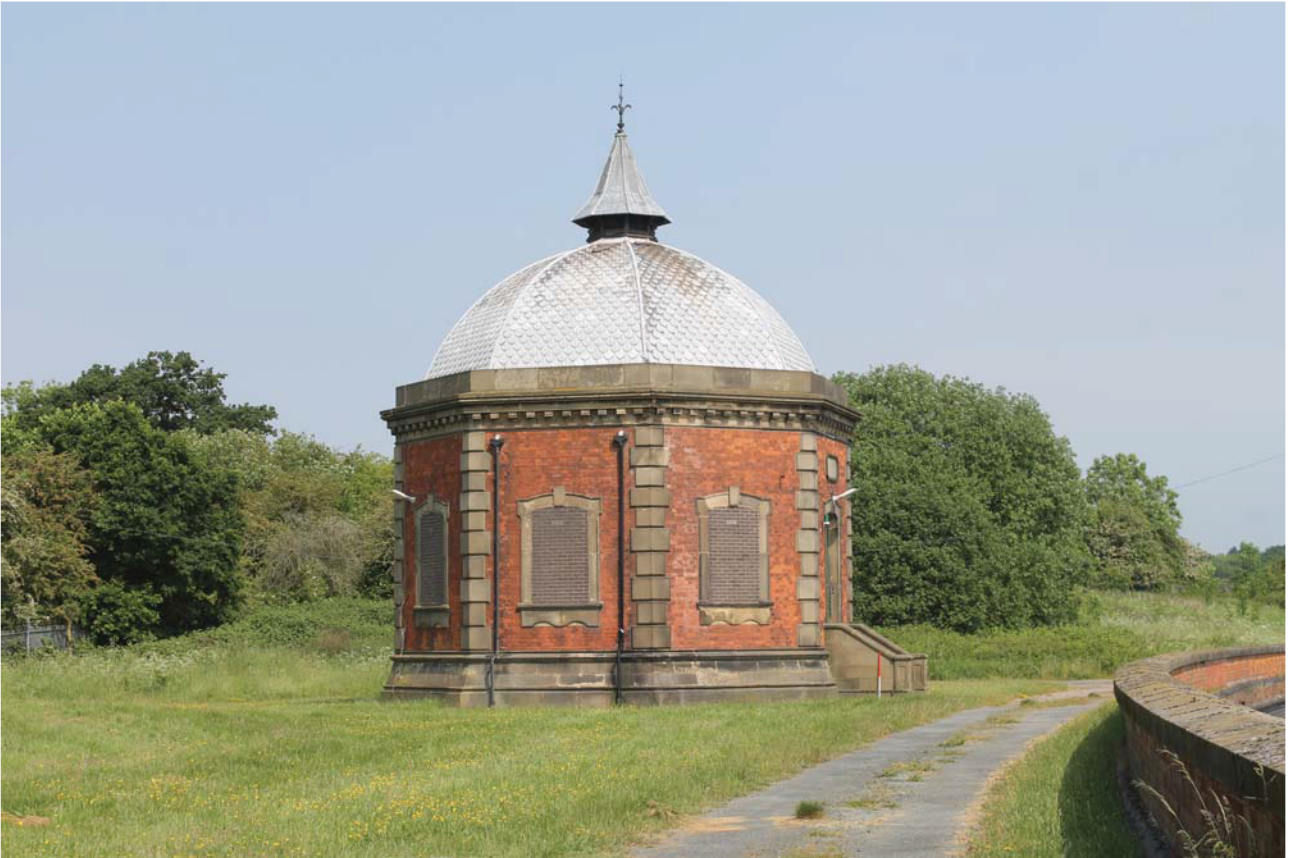
Plate 18: Outlet House 1, general view from the south

Plate 19: Outlet House 1, general view from the south

5.3.1 Outlet House 1 has seen very few changes to its original construction date of 1904. It is an octagonal red brick building in English bond with chamfered sandstone quoins, a deep sloping and moulded footing course and an ogee conical roof with a lead fish-scale design and weather vane (Figure 7; Plates 18 to 20). The wall rises to an upper sandstone band course (Plate 21) with a dentil cornice consisting of moulded corbels to each bay below a rising parapet above the eaves. The main entrance faces the Reservoir to the south-east side, approached from a set of stone steps with small parapet wall and set in a moulded segmental-headed doorcase with keystone and a blank sandstone plaque above (Plates 22 to 24). Each of the remaining seven bays has a tall window – blocked with blue brick (seemingly an original design matching the blue brick used in the Reservoir) – set in a moulded sandstone surround with keystone and shaped sill stone (Plates 25 and 26).

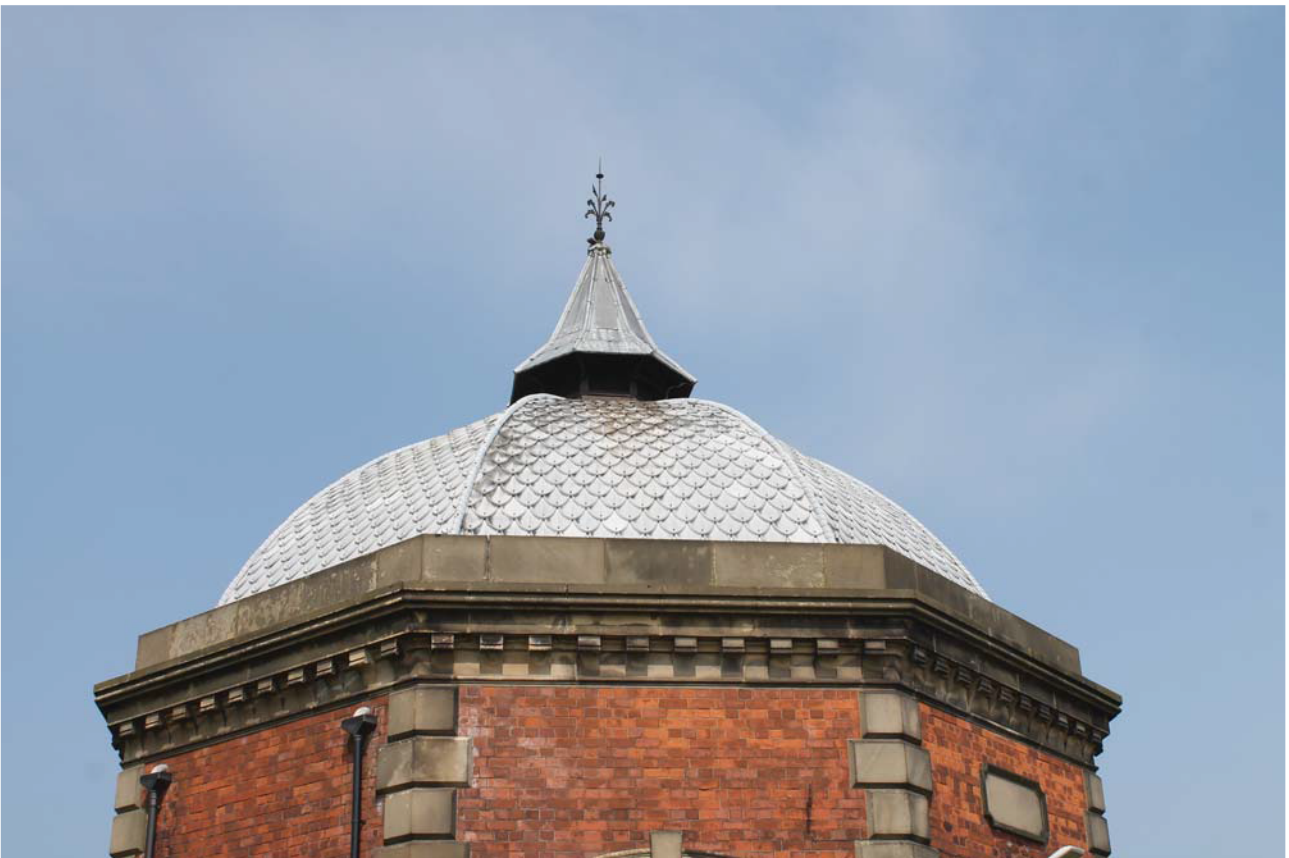
Plate 20: Outlet House 1, detail of roof from the south

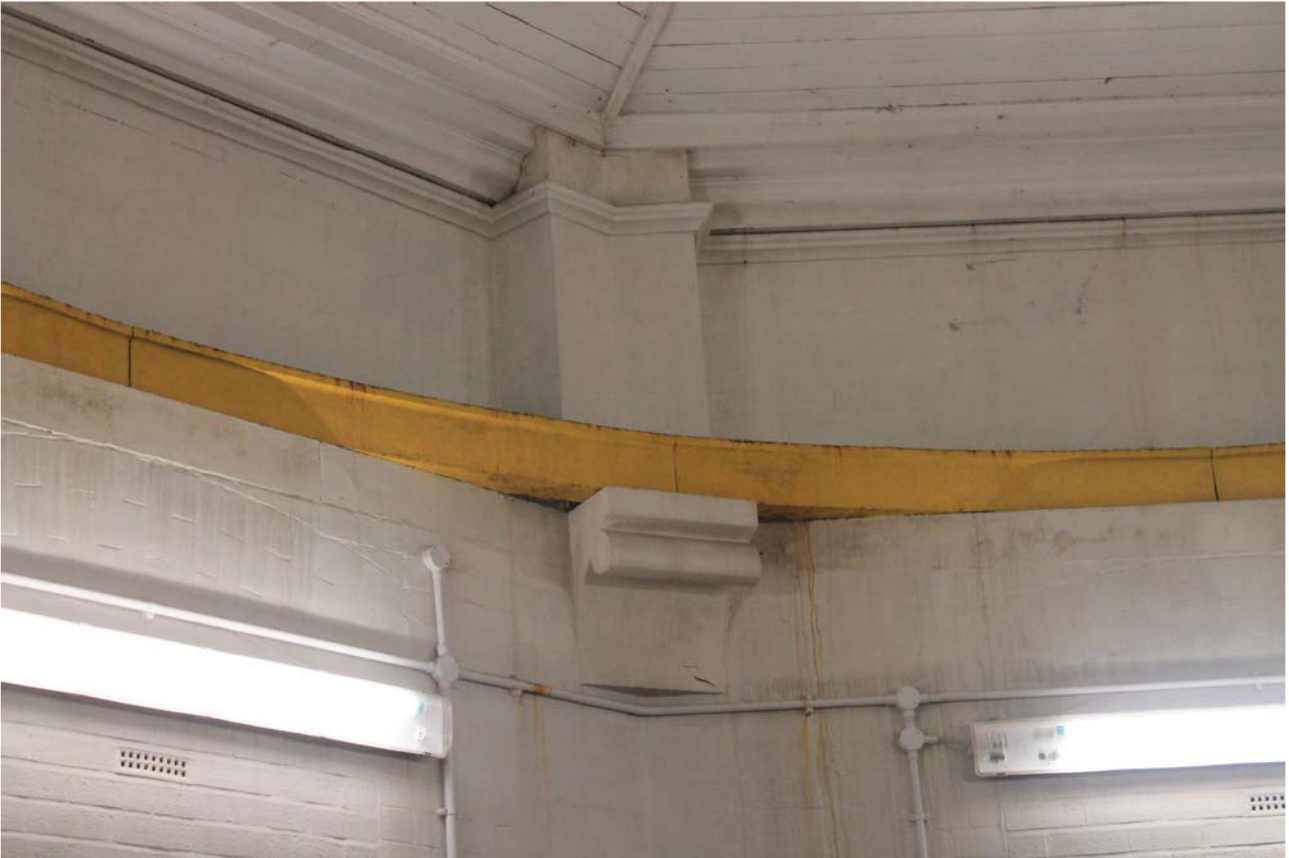
Plate 31: Outlet House 1 Interior, detail of roof support and steel beam from the east

5.3.2 The interior of Outlet House 1 consists of one room with a steel gantry floor with bare white-washed brick walls (Figure 7; Plate 27 to 30). The main outlet pump is in the centre behind a steel rail, which was operational at the time of survey. Each corner of the octagonal space is set back just below roof level with a moulded corbel supporting a large steel beam which circled the entirety of the building to support the machinery (Plates 31 and 32). Above this, and set back slightly, is a small pillar to support the roof, which consists of thin horizontal sarking boards angled with thin timber struts at each junction (Plate 33). Access to the lower part of the building was through a small straight gantry stair to the north-west stair. However, due to health and safety reasons, access was not permitted at the time of the survey.

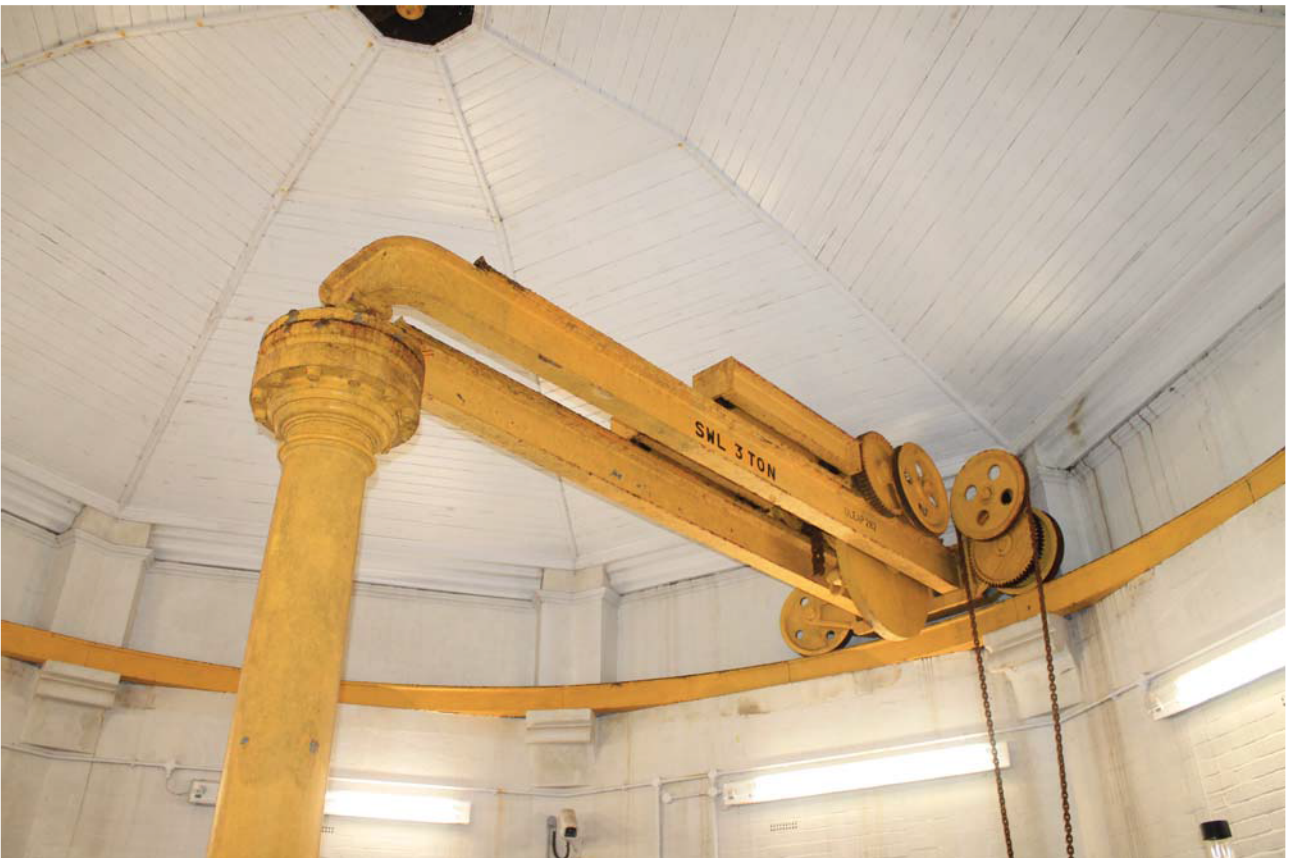
Plate 32: Outlet House 1 Interior, detail of machinery in the roof supporting the main pump from the south

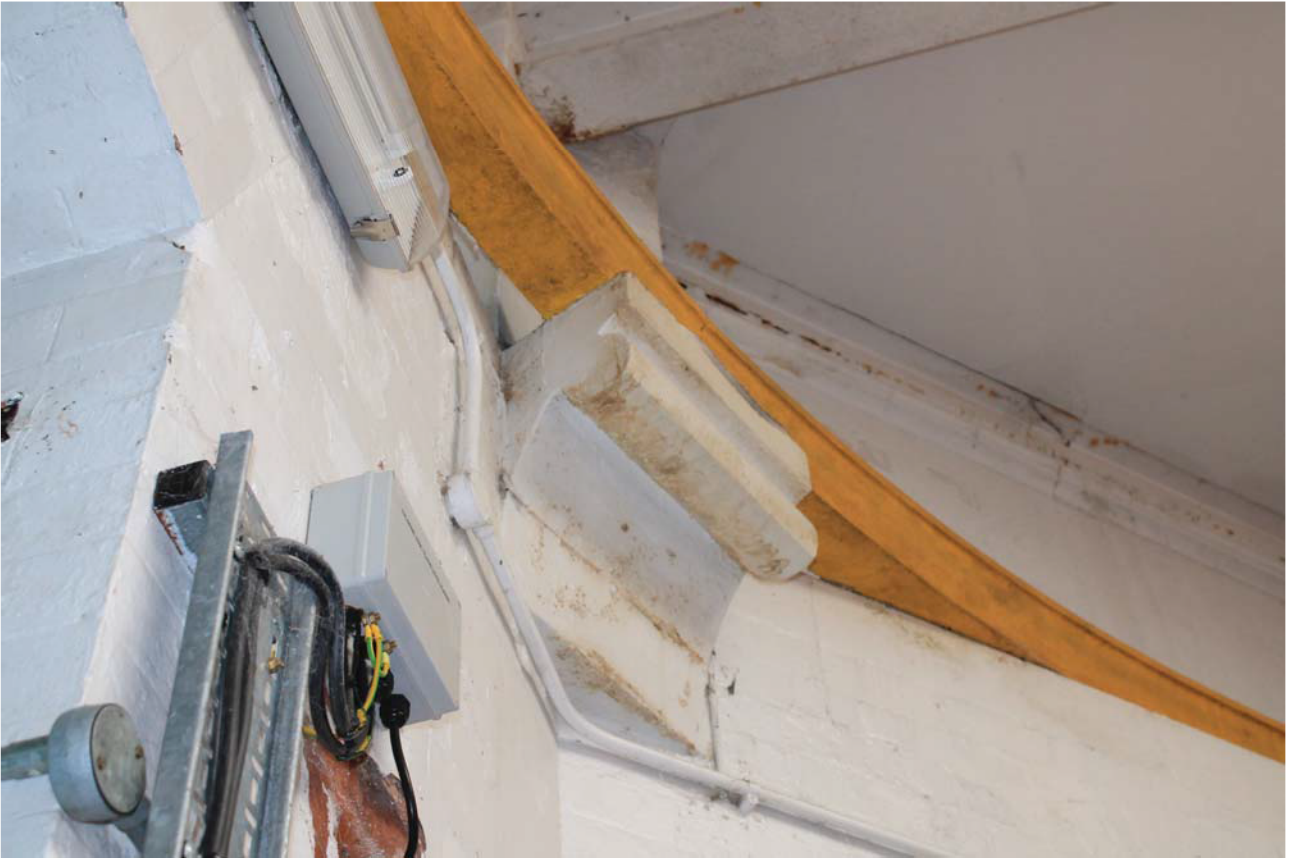
Plate 43: Outlet House 2 Interior, detail of corbel supporting the steel beam from the east

5.4.2 The interior of Outlet House 2 is identical to Outlet House 1, with the white-washed brick walls and steel beam arrangement just below roof level (Figure 8; Plates 41 and 42). The structural arrangement of the roof is also identical to Outlet House 1 with a corbel supporting the steel beam (Plate 43). As mentioned above in Section 5.4.1, the original roof was removed and not replaced, and is now a flat roof with an angled Perspex skylight (Plate 44).

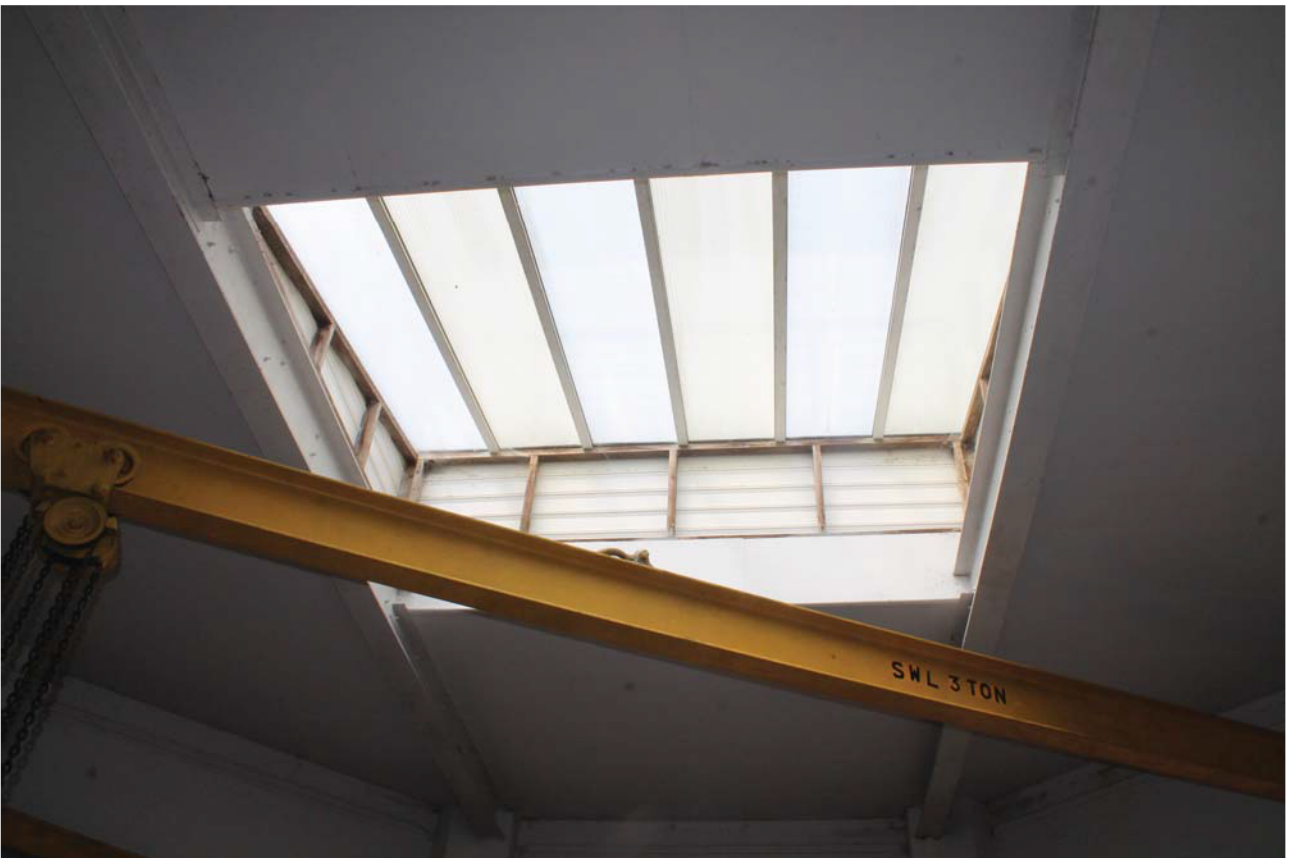
Plate 44: Outlet House 2 Interior, detail of ceiling and skylight, a modern intervention completed in the 1970s from the south-east

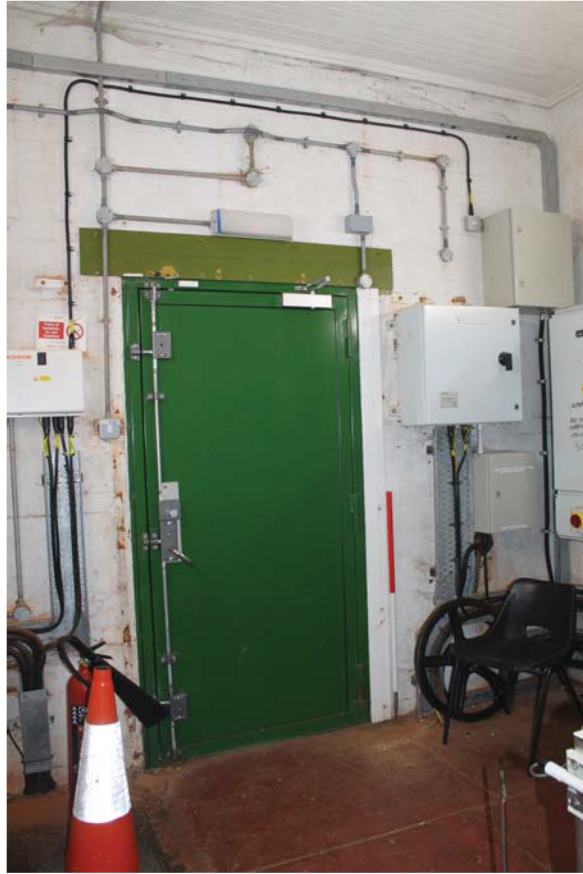
Plate 53: Inlet House Interior, detail of main entrance from the north

5.5.2 Internally, the building is a plain rectangular open space with a stone flagged floor and bare white-washed walls and modern machinery, including modulating inlet valves and flowmeters, to control the flow of water in and out of the Reservoir (Plates 53 and 54). It has a timber planked ceiling above a very plain moulded cornice (Plate 55).

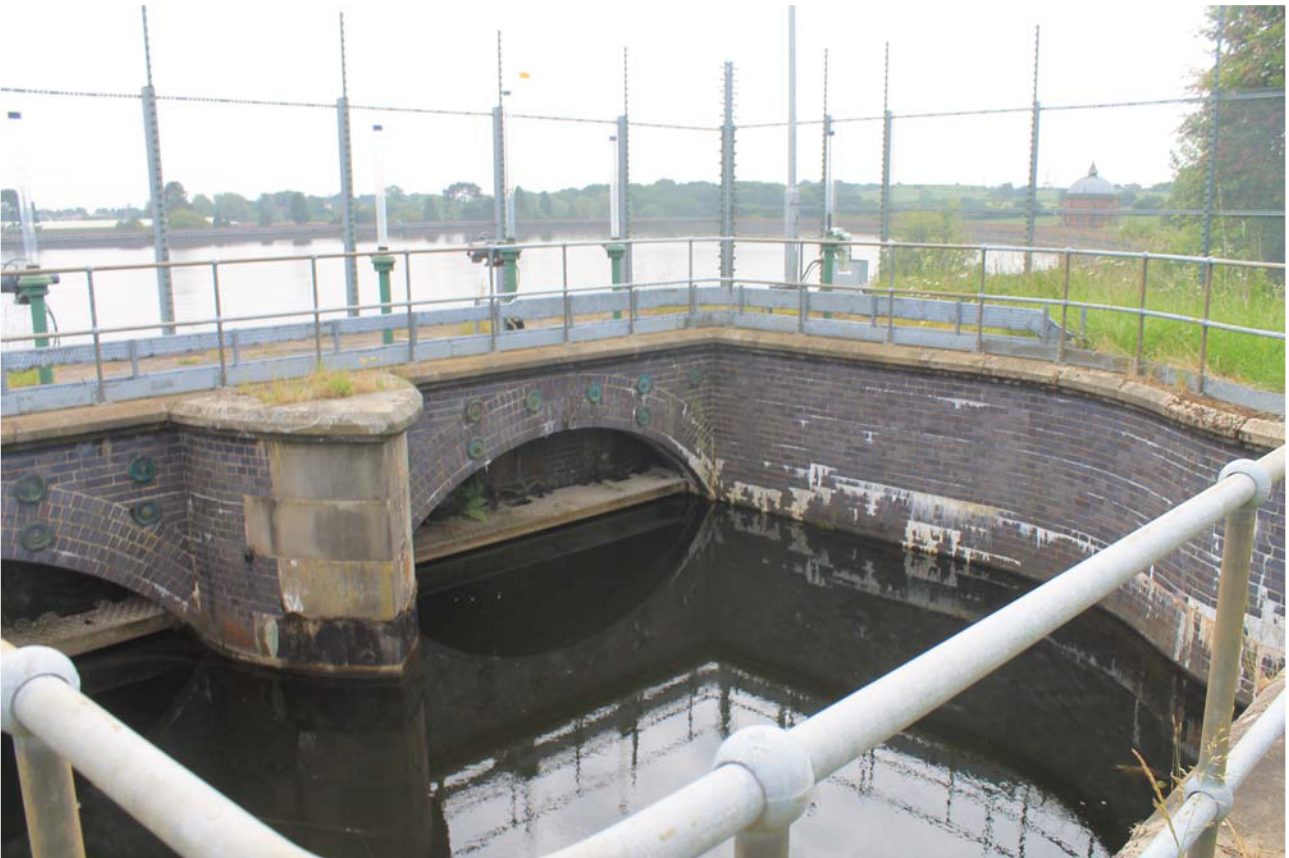
Plate 56: Inlet House, general view of small arches to the inlet basin from the north

5.5.3 Set in front of the inlet house is the inlet basin, consisting of a large dark red brick enclosure. It has two small inlet arches to the north-west side (Plates 56 and 57) and two larger arches to the opposite south-east side with a breakwater between them with sandstone detailing (Plate 58). The modern steel enclosure is set around a much earlier frontage of a brick wall with a set of brick and stone steps to each side to the north-east and south-west. The steps to the north-east side provide the present access to the enclosure, whilst the steps to the south-west are very overgrown with vegetation and are set outside the modern enclosure (Plates 59 to 61).

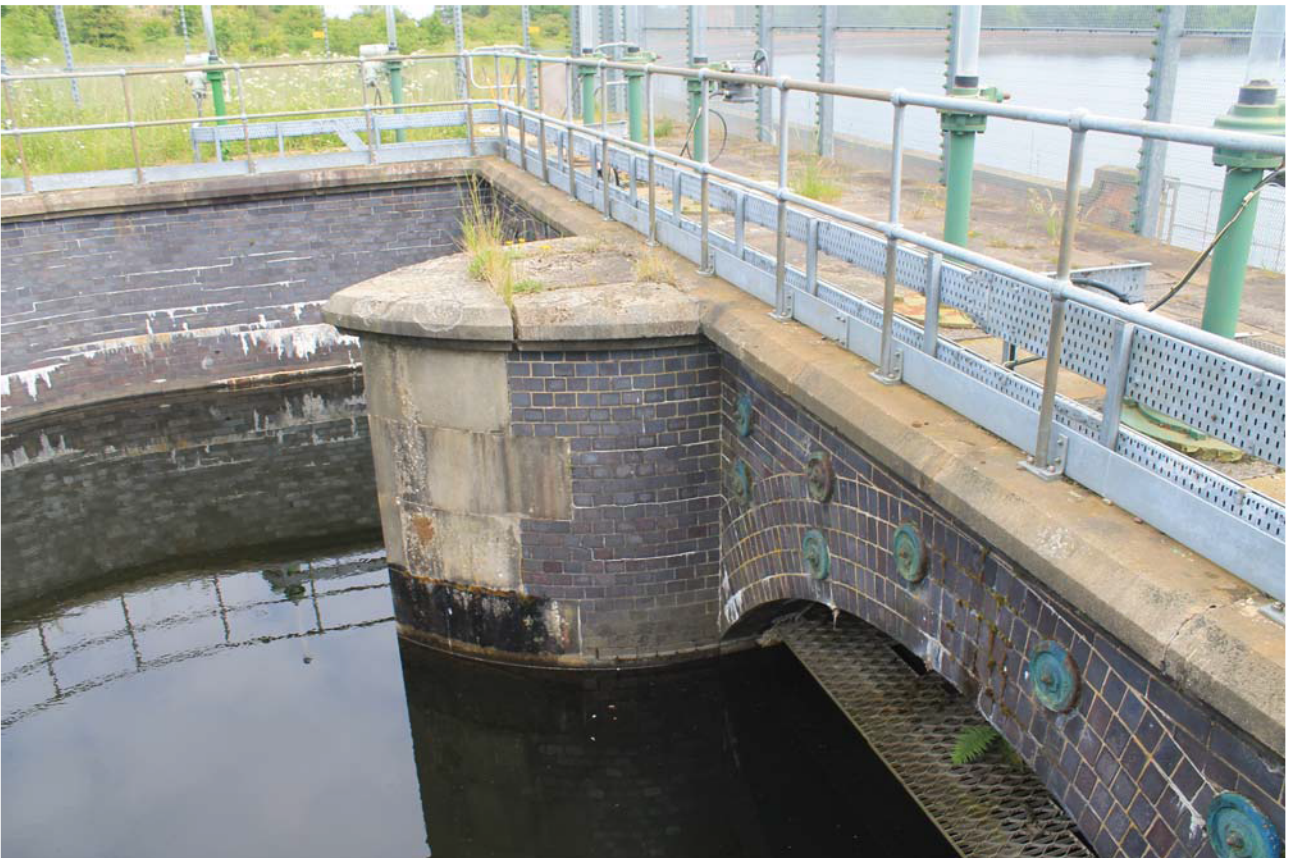
Plate 58: Inlet House, detail of the breakwater to the inlet basin from the west
