Crosshouse Farm, East Kilbride: Archaeological Evaluation Data Structure Report

AOC Project 23525
aocarcha1-1260940
09th August 2016

National Grid Reference (NGR): NS 60862 51504 (Centred)

Planning Application No: EK/16/0001

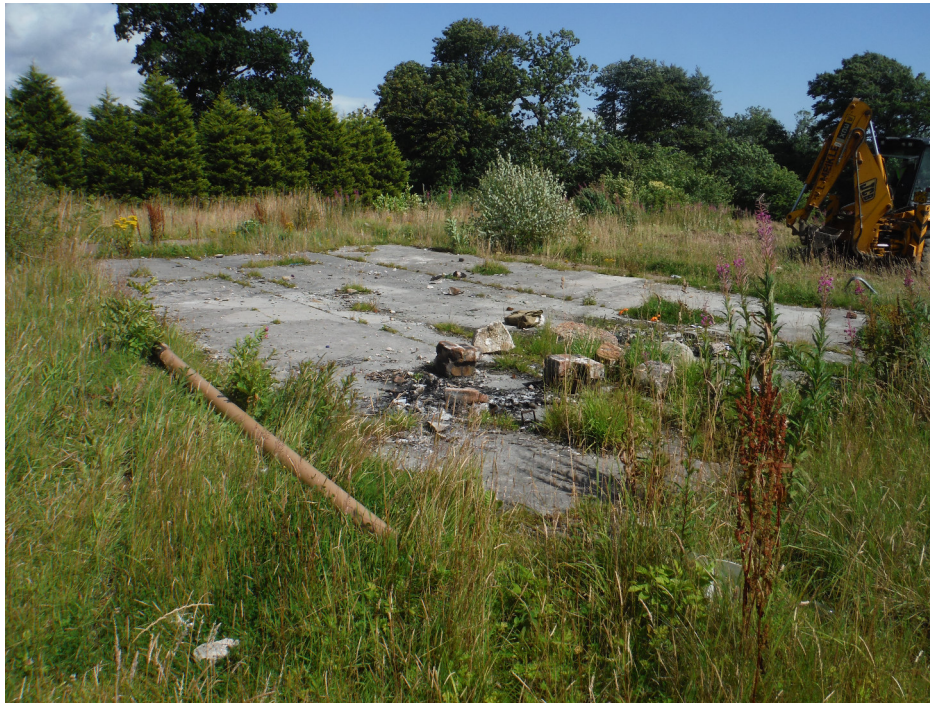
4.2.1 The site currently contains the structural remains of the pre-existing farmhouse buildings which had only been partially removed during demolition. As such numerous features of the residence still existed, including the concrete floor of the main building (Plate 1), various surfaces of concrete and tarmac, and large piles of demolition material including stone, mortar, wood and concrete. A period of neglect following this demolition had allowed for the substantial growth of trees, bushes and shrubs making some areas impassable. Fly tipped refuse was also present across site.

Plate 1: The remains of the existing farmhouse

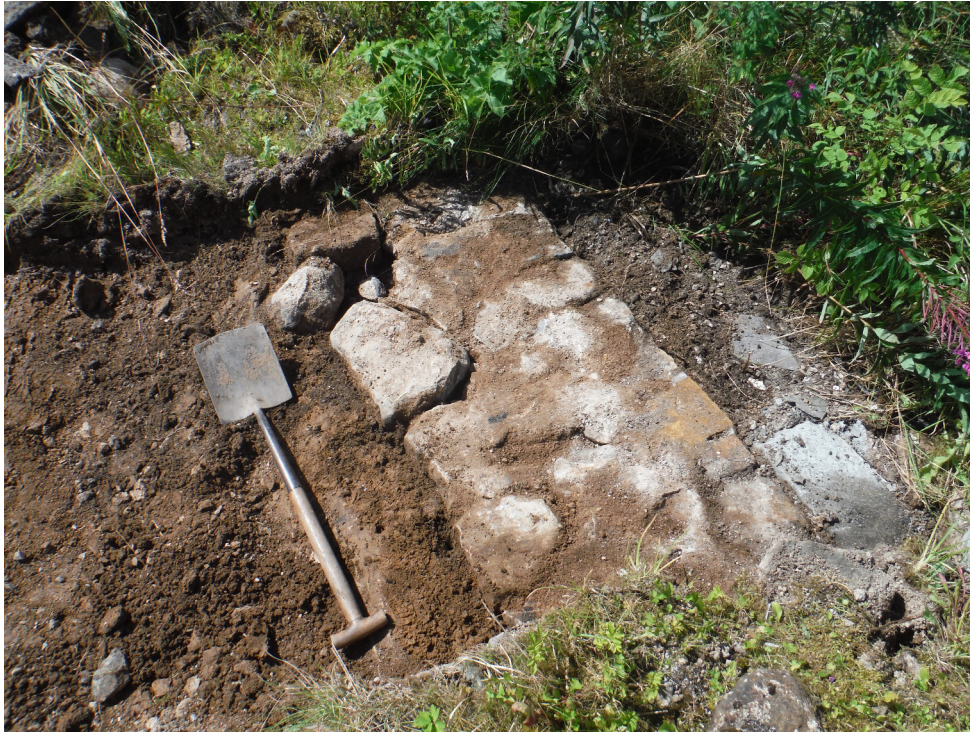
- 4.2.4 The only features discovered within these trenches were the concrete floors uncovered in Trench 2. These floors were continuous with the nearby upstanding farm courtyard. Two foundation walls [301] and [302] were recorded within Trench 3. The walls were 0.75m wide and constructed of un-worked stone and pale brown sandy mortar (Plate 2). It is likely that these walls relate to the north end of the building which is visible on the 1858 Ordinance Survey map (Figure 3). These walls continue to feature on all consecutive maps (Figure 4 and 5) and were likely upstanding until the recent demolition of the site. A slot was excavated against wall [301] revealed that the surviving height of the wall was 0.3m.

Plate 2: Wall [301]

Context No.	Description and Interpretation
301	<p>Sandstone and mortar wall foundations. Orientation N-S. Constructed of a mixture of large to small un-worked stones bonded with pale brown sandy mortar. 0.75m wide, 2m length excavated, surviving height of 0.3m. Cut into and built on top of natural boulder clay.</p> <p>Found directly below shall deposit of demolition material (0.1m thick). May have been upstanding wall in recently demolished farmhouse.</p> <p>No associated internal or external features.</p> <p>Wall foundations</p>
302	<p>Sandstone and mortar wall foundations. Orientation N-S. Constructed of a mixture of large to small un-worked stones bonded with pale brown sandy mortar. 0.75m wide, 2m length excavated, excavated height of 0.1m. Cut into and built on top of natural boulder clay.</p> <p>Found directly below shall deposit of demolition material (0.1m thick). May have been upstanding wall in recently demolished farmhouse.</p> <p>No associated internal or external features.</p> <p>Wall foundations</p>
