Craibstone South (Phase 1), Aberdeen: Archaeological Evaluation Data Structure Report

AOC 23449
24th May 2017

AOC Project No: 23449

Planning Application No: P140470

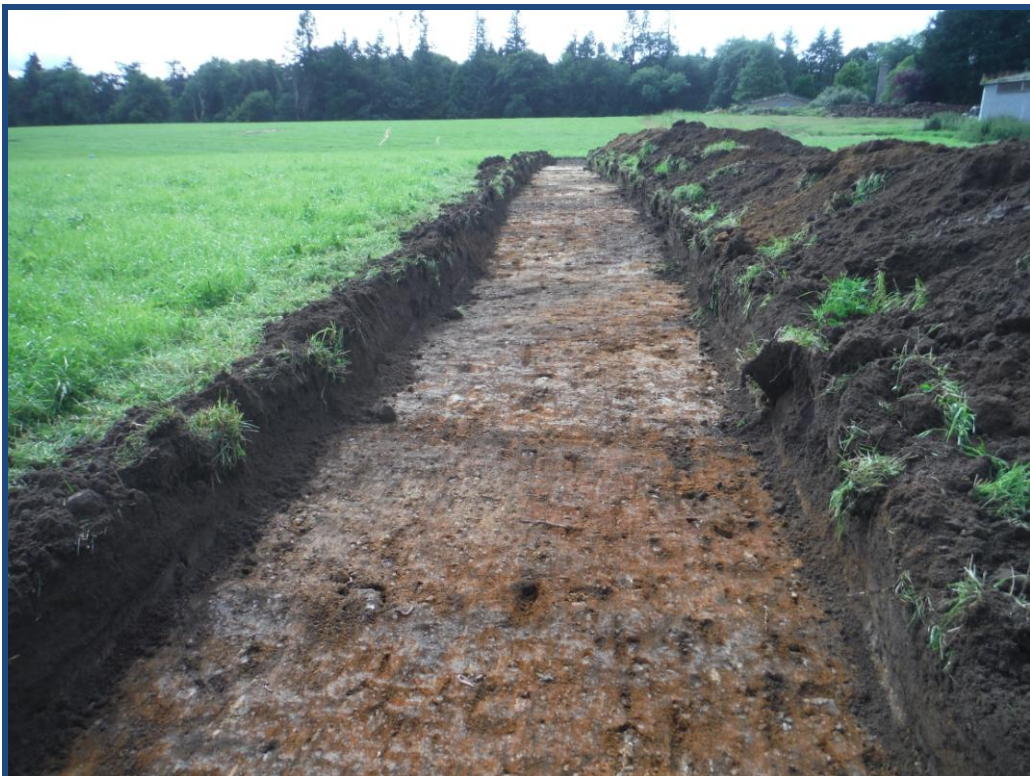
Plate 1 - General view of Trench 1

- 4.2.3 Within Trenches 1 and 2 a series of shallow depressions aligned NE to SW, filled with the overlying dark brown sandy silt topsoil, were found at 5.5 m intervals. These may have been the remains of rig and furrow however due to the nature of the topsoil fill and the high frequency of improvement drains throughout the rest of the site they could be much more recent (within the last 200 years). In Trench 3, three possible post holes were located, however upon excavation these were identified as stone holes as they were filled by the overlying topsoil. Additionally a substantial drain 0.65m in depth was also located in Trench 3, likely from the 19th-20th centuries due to the brown glazed ceramic and pipe bowl found within.

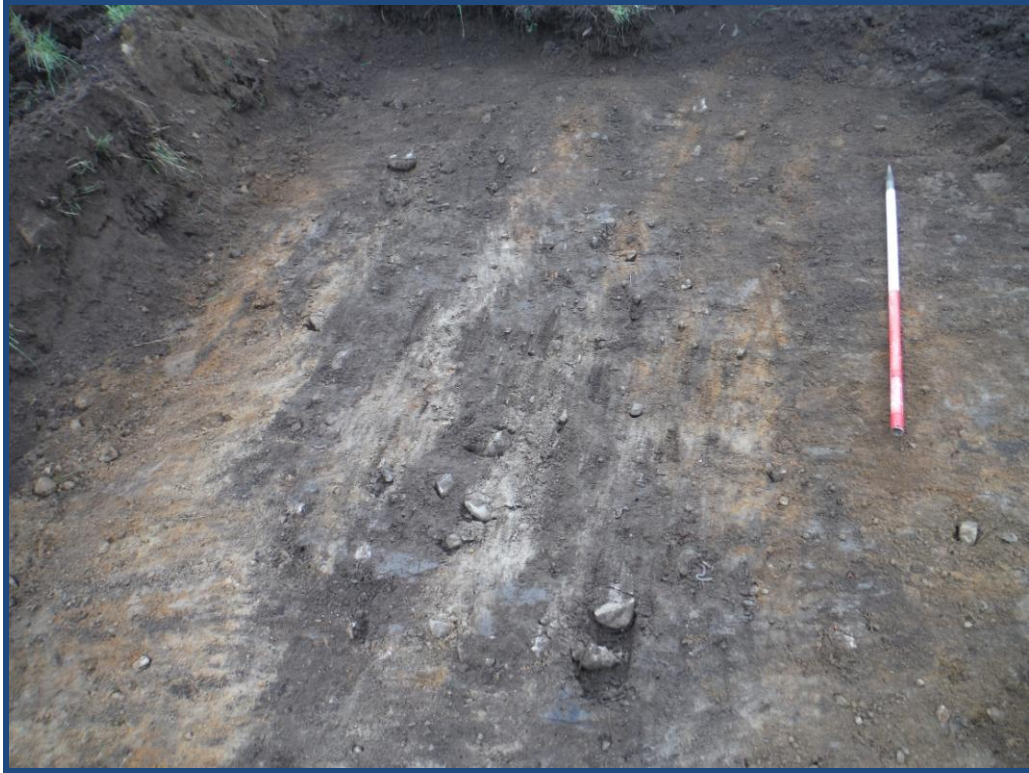
Plate 2 – Plough scars in Trench 3

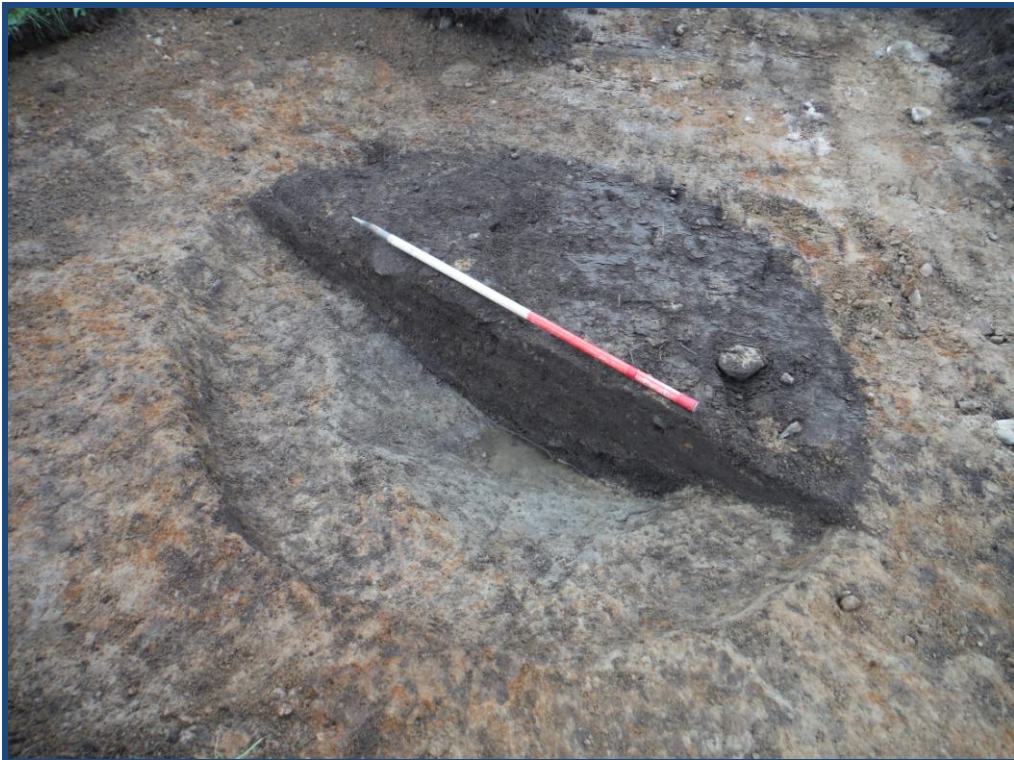
- 4.2.4 The only other feature discovered during the evaluation was a large circular pit 5m from the S end of Trench 15 (Plate 3). The pit measured 1.7m by 2m and 0.4m deep. The circular shape and shelving within the edges before dropping to its full depth in the centre suggests that the pit was likely formed by the removal of a stone, likely contemporaneous with improvement ditches across the site as suggested by the topsoil fill containing fragments of orange field drain and tiny fragments of white glazed ceramic. A 6m² area was opened up on the NE side of the S end of Trench 15 to catch the full extent of the pit and locate any associated features, of which none were found. An additional two 20m linear trenches were opened up on either side of Trench 15 in order to locate any additional features, none were located.

Plate 3 – Pit- half sectioned in Trench 15
