Kirktonbarns Farm, Fife: Archaeological Evaluation Data Structure Report

AOC Project 23562

Planning Ref: 15/00545/FUL

On Behalf of: Selettra Holding Ltd

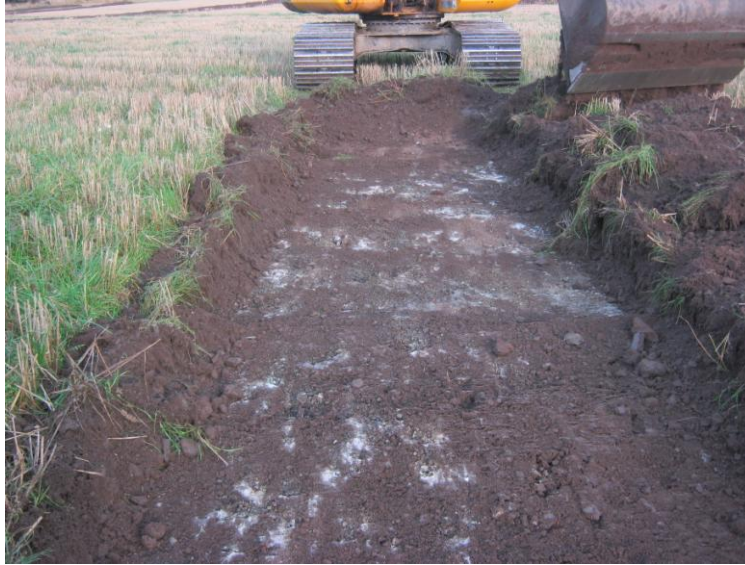
- 4.3 The plough-soil lay directly over natural drift geology of orange-brown boulder clay. Numerous plough scars were present. Numerous areas of shallow, exposed bed-rock were revealed. These occurred in almost all of the trenches.

Plate 1 Excavation showing exposed bedrock

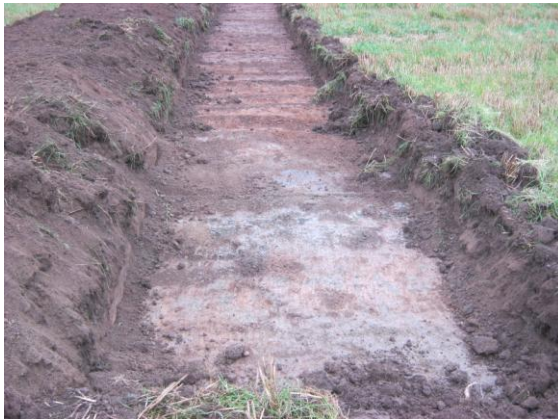
Plate 2 Trench 3 Post-excitation

<i>Dimensions</i>	50 m by 2.0 m
<i>Excavated Orientation</i>	S to N
<i>Plough-soil</i>	0.20 m - 0.30 m in depth
<i>Depth of Excavation</i>	0.22 m – 0.35 m in depth
<i>Significant Features</i>	None
<i>Other Features</i>	None
<i>Natural Subsoil</i>	Glacial till of orange brown boulder clay with plough scars and patches of exposed bed-rock
<i>Finds</i>	Occasional white ceramic

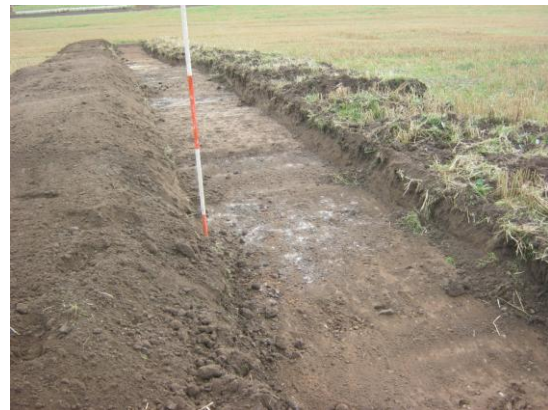
Plate 3 Trench 8 Post-excitation

<i>Dimensions</i>	50 m by 2.0 m
<i>Excavated Orientation</i>	N to S
<i>Plough-soil</i>	0.20 m - 0.40 m in depth
<i>Depth of Excavation</i>	0.22 m – 0.45 m in depth
<i>Significant Features</i>	None
<i>Other Features</i>	None
<i>Natural Subsoil</i>	Glacial till of orange brown boulder clay with plough scars and patches of exposed bed-rock
<i>Finds</i>	None
