# Longstone, Edinburgh: Archaeological Evaluation Data Structure Report

AOC Project 23047

Planning Ref. 15/03075/FUL

# Longstone, Edinburgh: Archaeological Evaluation Report

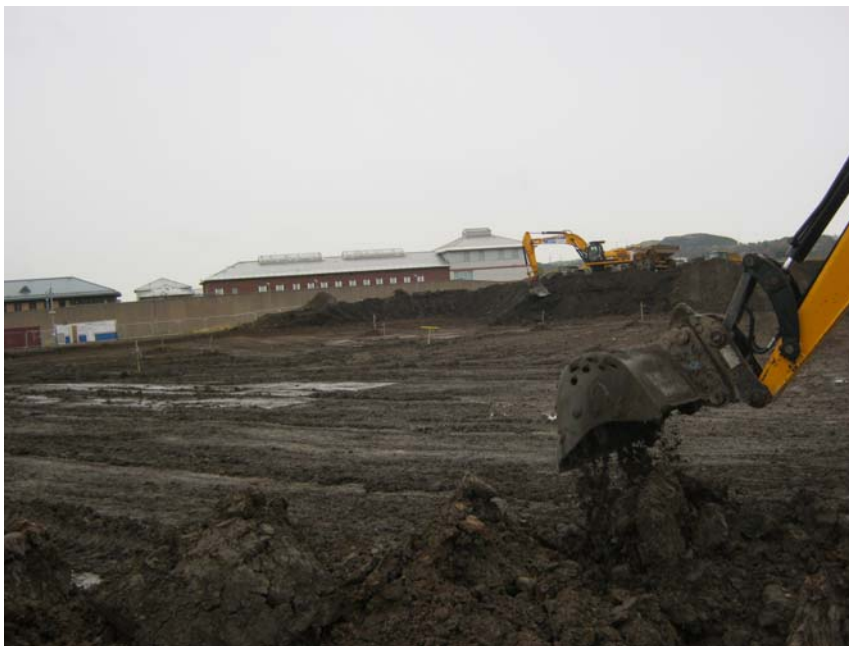
Plate 1 Spoil tip/top-soil under removal from Calder Road

- 4.1.2 The removal of the spoil tip/top-soil dump revealed three metres of deposit overlying the majority of the area. This was removed and deposited within the bund site located to the south of the prison complex. Two thirds of this material had been removed prior to the evaluation. The remainder was removed under archaeological supervision.

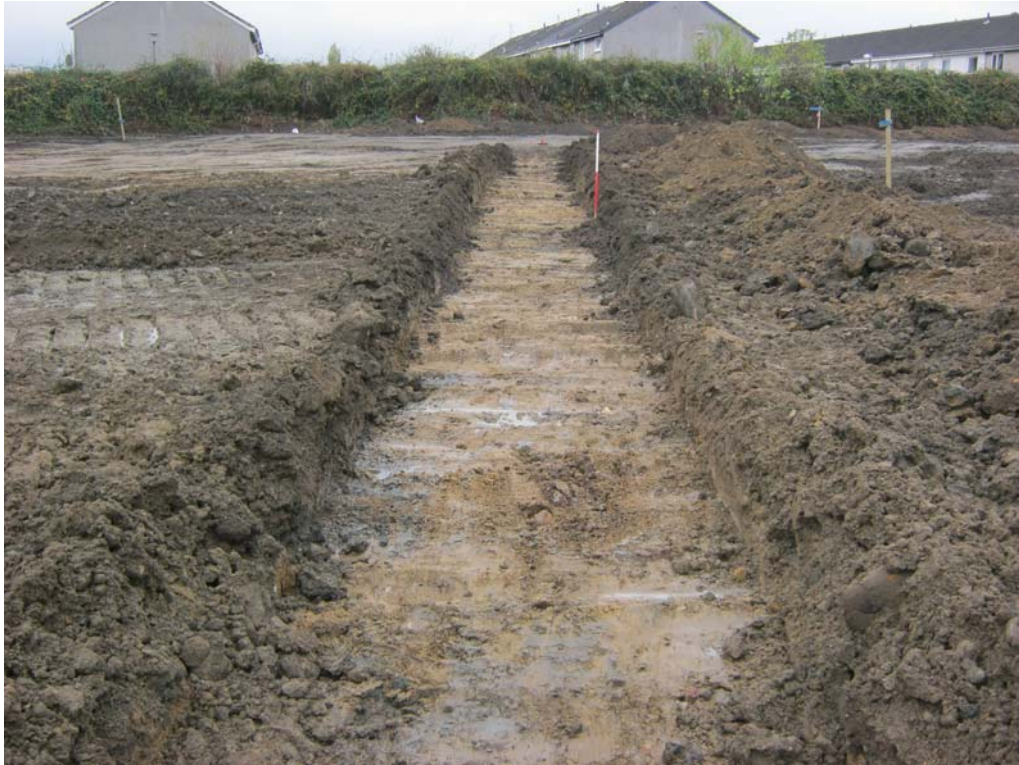
**Plate3 Trench 5 post excavation from north-east**

<i>Dimensions</i>	100m by 2.0m
<i>Orientation</i>	SW-NE
<i>Depth of Topsoil</i>	0.2m
<i>Depth of Excavation</i>	0.4m
<i>Significant Features</i>	N/A
<i>Other Features</i>	N/A
<i>Subsoil</i>	Compact pale orange boulder clay
<i>Finds</i>	None
