# 1-7 Baileyfield Crescent, Portobello, Edinburgh: Archaeological Evaluation Data Structure Report

AOC 23589  
13<sup>th</sup> January 2017

**AOC Project No:** 23589

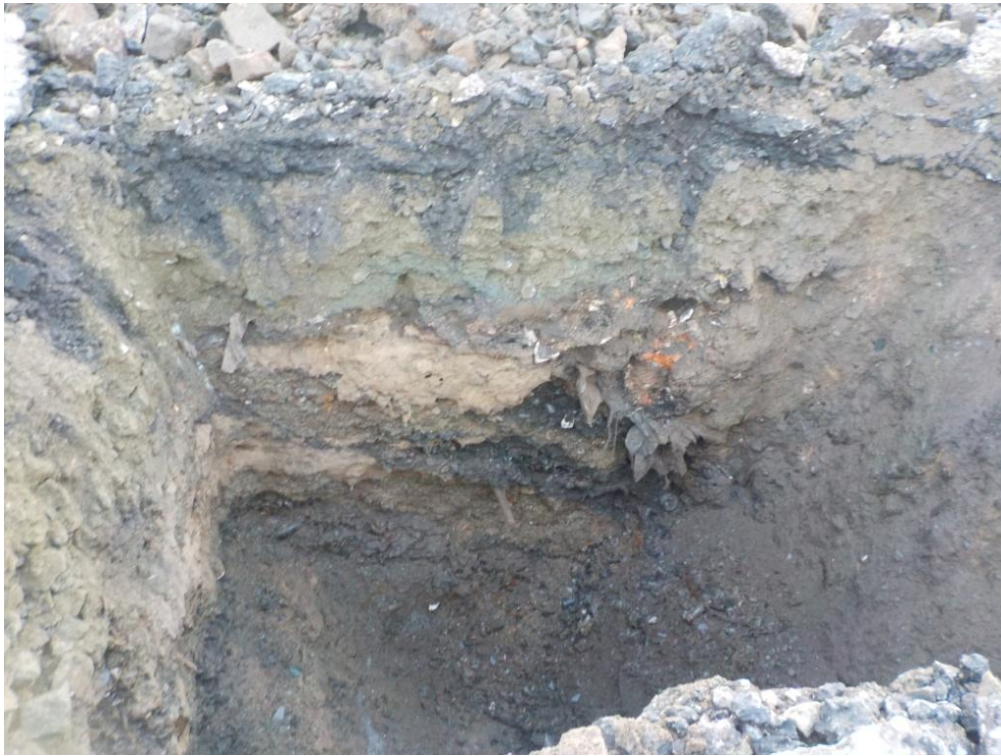
- 4.2 Seven trenches were excavated in total (Figure 4) and in all but Trench 6, they encountered 0.5 m to 1 m of tarmac/concrete covering modern type 1 stone. Under the modern hard standing Trenches 1-3 contained over 4.2 m of dumped sand, ash and clay, some of which contained ceramics and bottles (SF 1-3). Tip lines were visible in the trench section that indicated this area of the quarry was being filled from the N and NE (Plate 1). None of these trenches were able to reach the natural subsoil.

Plate 1: General view of tip lines in Trench 1

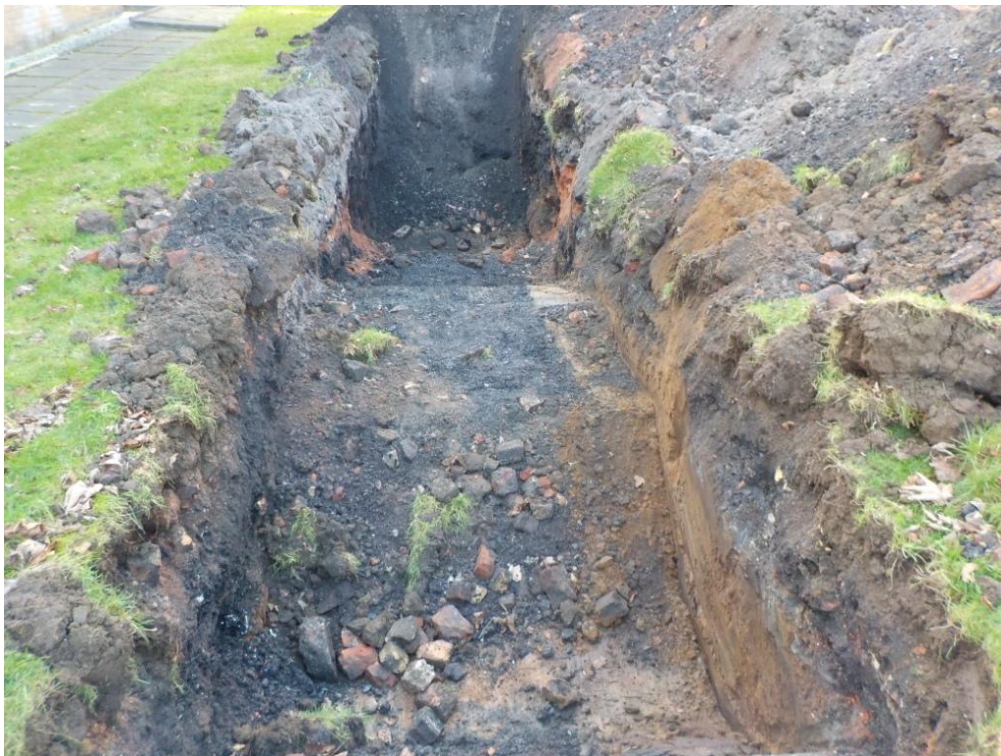
- 4.4 Features related to the 19<sup>th</sup> century use of the site were revealed within Trench 5 and 6. The most northerly trench, Trench 6 revealed the probable edge of the quarry cut [601] with deposit [602] to

the immediate S consisting of ash to depths of 2.1 m (Plate 2). Trench 5 revealed a probable brick floor [501] at a depth of 3.1 m that most likely corresponds to the large 19<sup>th</sup> Century building depicted on the 1896 Ordnance Survey (Figure 3).

Plate 2: General view of cut [601] in Trench 6
