Oldfold Farm Phase 2, North Deeside Road, Milltimber, Aberdeen: Archaeological Evaluation Data Structure Report

> AOC 22800 20th March 2017

Archaeological Evaluation Data Structure Report

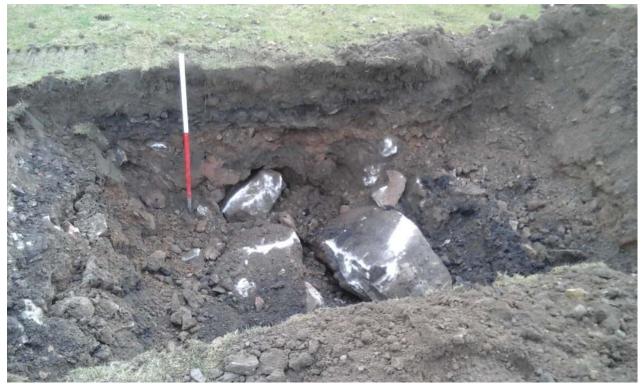
Plate 2: General view of Trench 9 showing made ground

The evaluation consisted of 3130 linear metres of trenching throughout the six paddocks that formed the development area (Fields A-F). An area of modern made ground in field B indicated the former extent of the farm yard, with hard standing created using modern rubble, re-deposited subsoil and modern refuse.

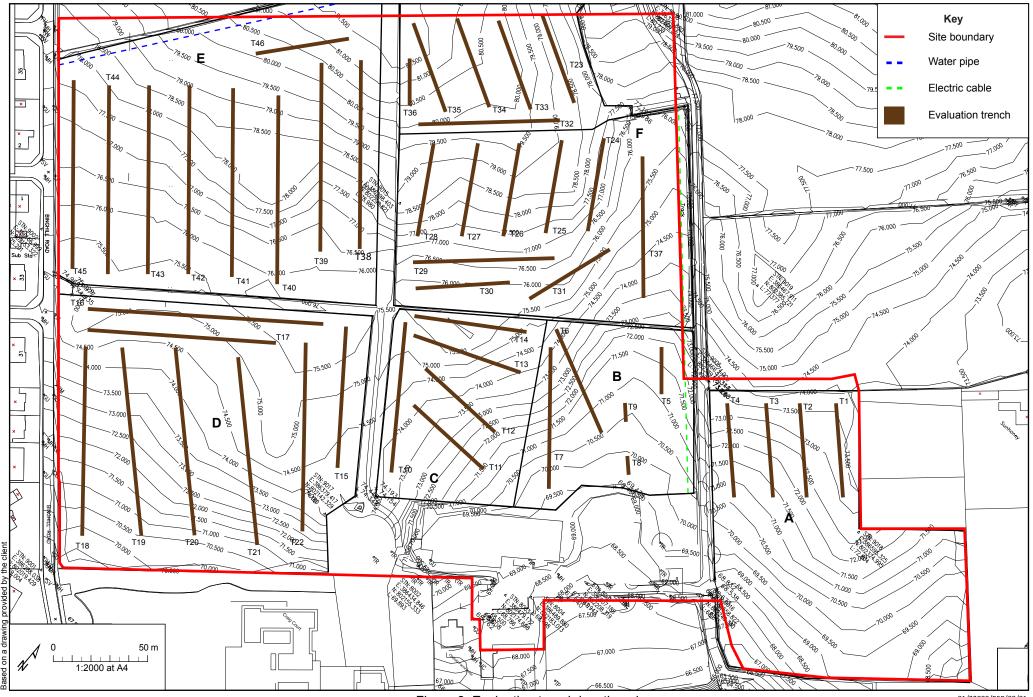
Figure 8: Evaluation trench location plan

- 3.1 The evaluation consisted of 46 trenches of varying length and alignment, equating to 6,260 m² of linear trench (Figure 2). The amount excavated was slightly less than had been stipulated in the WSI (2017). This was due to the presence of a water main at the edge of Field E, a waterlogged area at the south edge of Field D, an in use track way along the boundary of Field E and F, and a previously unknown electric cable along the W edge of Field B.
- 3.2 The trenches were excavated utilising two 13 tonne tracked excavators equipped with bladed ditching buckets, and operating under the constant supervision of an experienced field archaeologist. Each trench was recorded using AOC *pro forma* trench record sheets, photographed, and any potential features investigated further to assess their character and date.
