# Easter Road LIDL, Edinburgh: Archaeological Evaluation Data Structure Report

AOC 23641  
3<sup>rd</sup> April 2017

**AOC Project No:** 23641

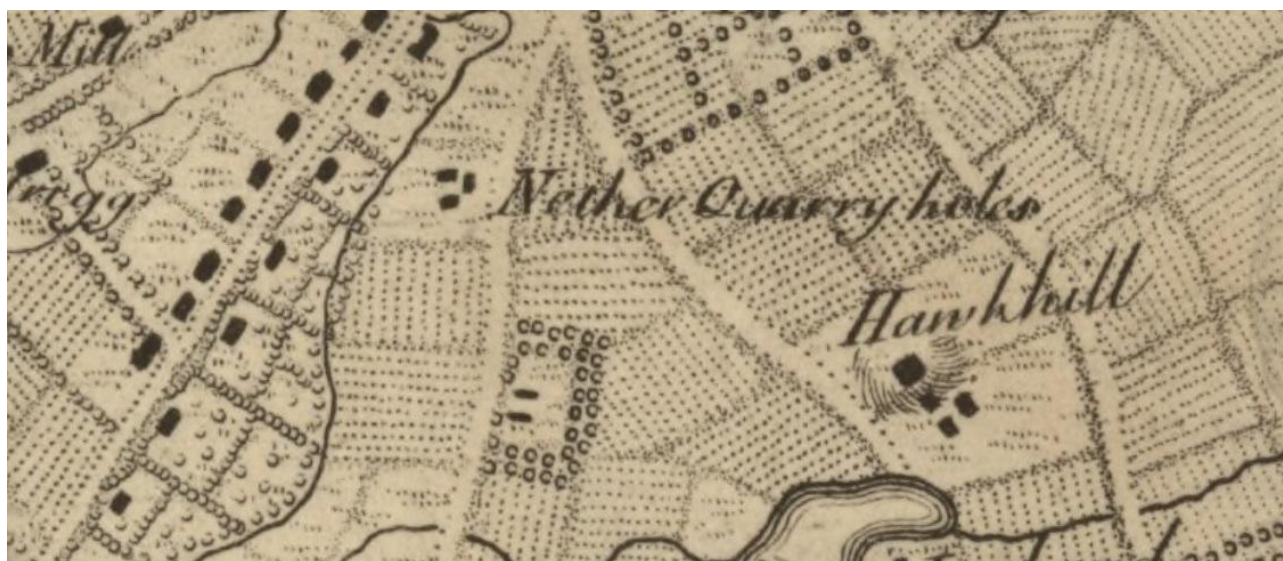
Figure 2: Extract from Laurie's 1766 map

1.3.2 The cartographic sources show that the site was part of a field system in 1766 (Laurie; Figure 2) to the north of a tree lined property, later noted as belonging to J. Sligo Esq (Ainslie 1804). There is no development on the site until 1853 when boundaries and fields related to the Drum House Nursery are placed through the area. There are also two new cottages located to the immediate northwest of the site, labelled as Quarryholes Cottages (Ordnance Survey 1853; Figure 3).

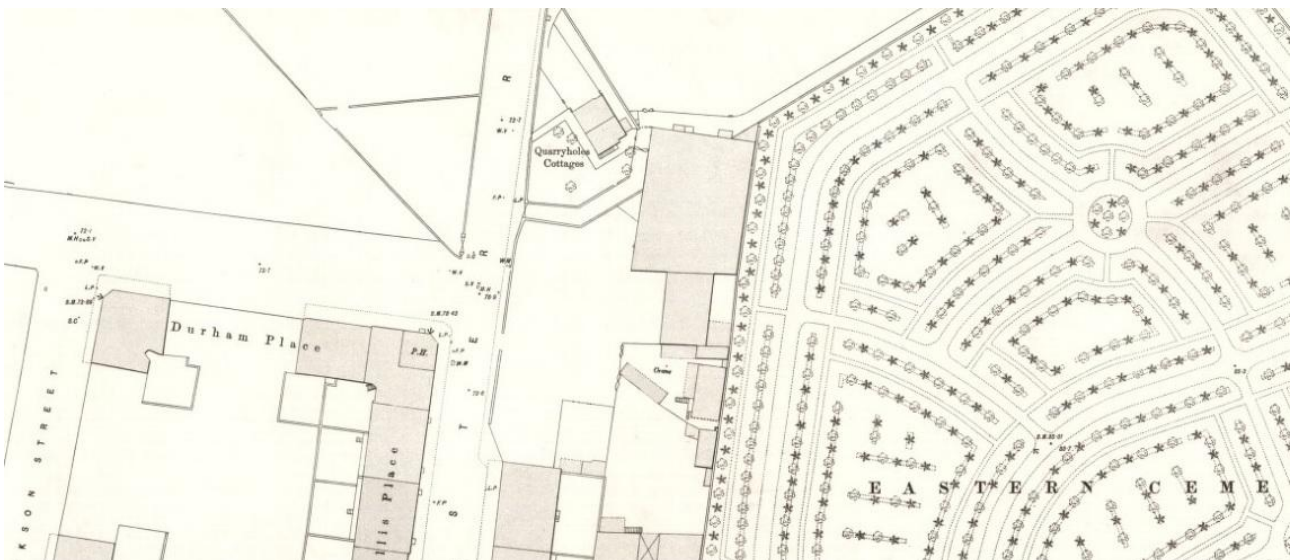
Figure 4: Extract from Ordnance Survey 1894

1.3.3 By 1894 (Ordnance Survey; Figure 4) the nursery has been replaced by the Eastern Cemetery and the street front of Easter Road now contains numerous residential properties. The development site now also contains a large rectangular building to the north, a large open yard area along Easter Road and some smaller buildings along the east edge next to the cemetery. This large rectangular building remains in place into the middle of the 20<sup>th</sup> century with the remainder of the site changing slightly and Edina Copper Works being constructed after 1912 (Ordnance Survey).

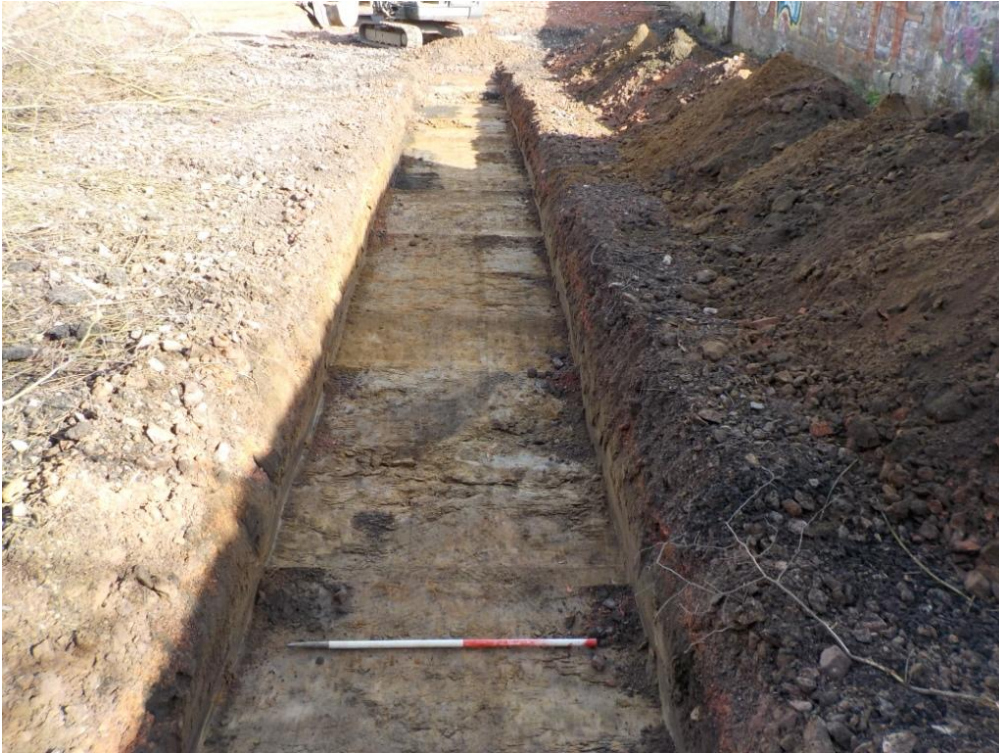
Plate 1: General view of Trench 2

- 4.2 The overburden throughout the majority of the development area consisted of hard core and red blaes overlying a dark greyish brown sandy clay (Plate 1). Trenches located within the former DIY store footprint (Trench 3-5) encountered a number of modern service tracks, and two modern brick walls (Plate 2). Throughout all of the trenches excavated the former soil horizon [613] was seen to have survived the modern developments. This soil was a mid greyish brown sandy clay with frequent coal lumps and flecks and occasional stone.

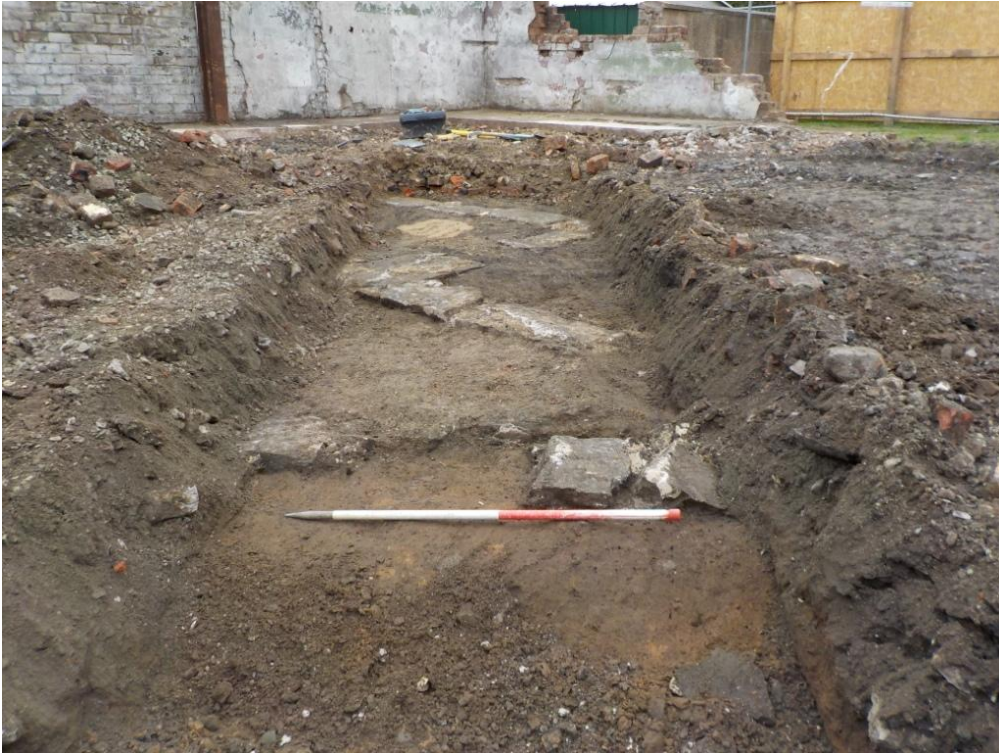
Plate 3: General view of foundations in Trench 6

- 4.3 The only archaeological features revealed in Trenches 1-5 were ceramic tile drains that would typically date to the post medieval period. However, Trench 6 revealed the base foundation course of four sandstone walls [601]-[604], as well as four large rectangular pits [605], [607], [609] and [611]. Walls [601] and [603] were both aligned E-W with N-S wall [602] connecting them both (Figure 6; Plate 3). These three walls all consisted of sandstone slabs, one course wide and one course high measuring 0.45 m to 0.55 m in width. Wall [604] was aligned NE-SW and consisted of sandstone blocks, and was aligned with the remainder of a sandstone wall that serves as part of the current boundary. All of the walls were bonded with sand and lime mortar and were built into the top of soil horizon [613].

- 5.1 The walls found within Trench 6 do not appear to relate to any structures shown on early maps of the site. Due to the shallow depth at which they were present, it is unlikely that they relate to any structures that would predate the mid 18<sup>th</sup> century mapping of the area that shows the site as part of a field system (See Figure 2). Furthermore, they were directly underneath the former floor surface of the later rectangular building so most likely relate to the period just prior to its construction.

- 5.2 The cartographic evidence demonstrates that the period prior to the construction of the large building saw the site used as part of the Drum House Nursery. If the walls relate to this period they could have been boundary walls at the edge of the nursery or for use in dividing some of the different areas shown on the 1853 map (Figure 3). However, it is also possible that they relate to a structure that was built and demolished in the short periods between the Ordnance Survey maps of the area.

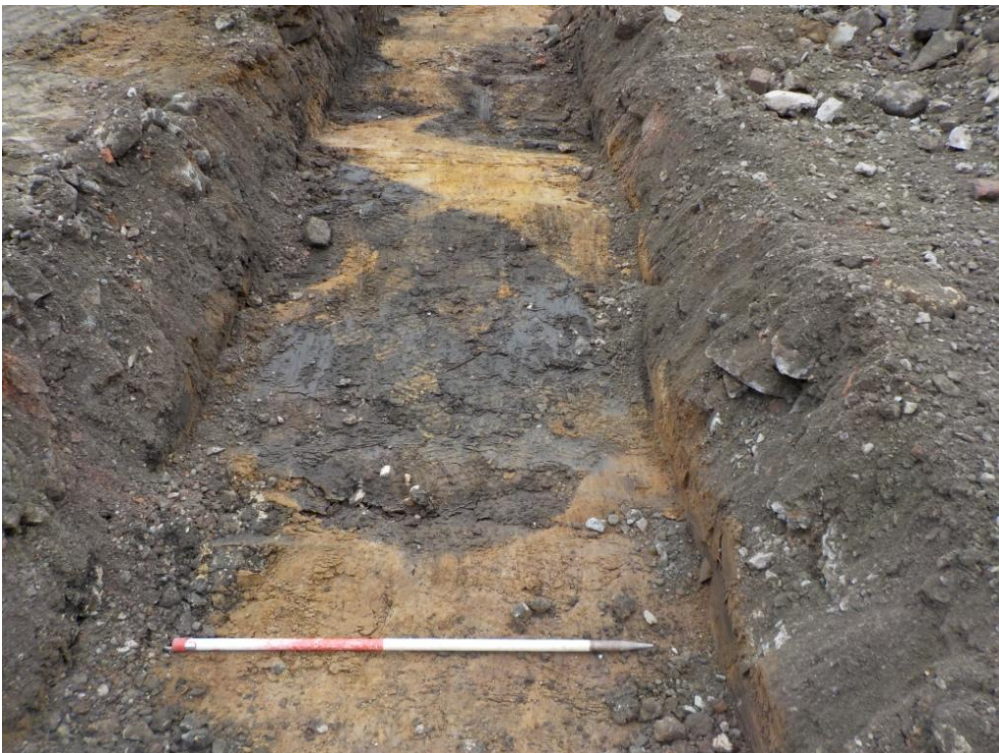
Plate 4: General view of pit [605]

- 4.4 Several pits were located to the southeast of wall [604] and none of them were fully exposed within the trench extents (Plate 4). They were all filled with dark grey sandy clay with occasional stone and coal lump inclusions. Pit [605] was partly excavated revealing steep sides onto a flat base measuring 0.23 m deep. A few sherds of 19<sup>th</sup> century white glazed ceramic were found within the pit fill [606] (not retained).

- 5.3 It is likely that the pits to the east of the walls in Trench 6 relate to the use of the site as part of the Drum House Nursery. The rectangular shape and flat base of the cuts is suggestive of planting beds.
