SGN Gasholder Heritage Review: Sea Street, Herne Bay

Historic Building Recording Report

The gasholder was constructed in 1934 by the Newton Chambers Company. It is a three-lift spiral-guided gasholder in an above ground tank with the capacity of 50,000 feet.

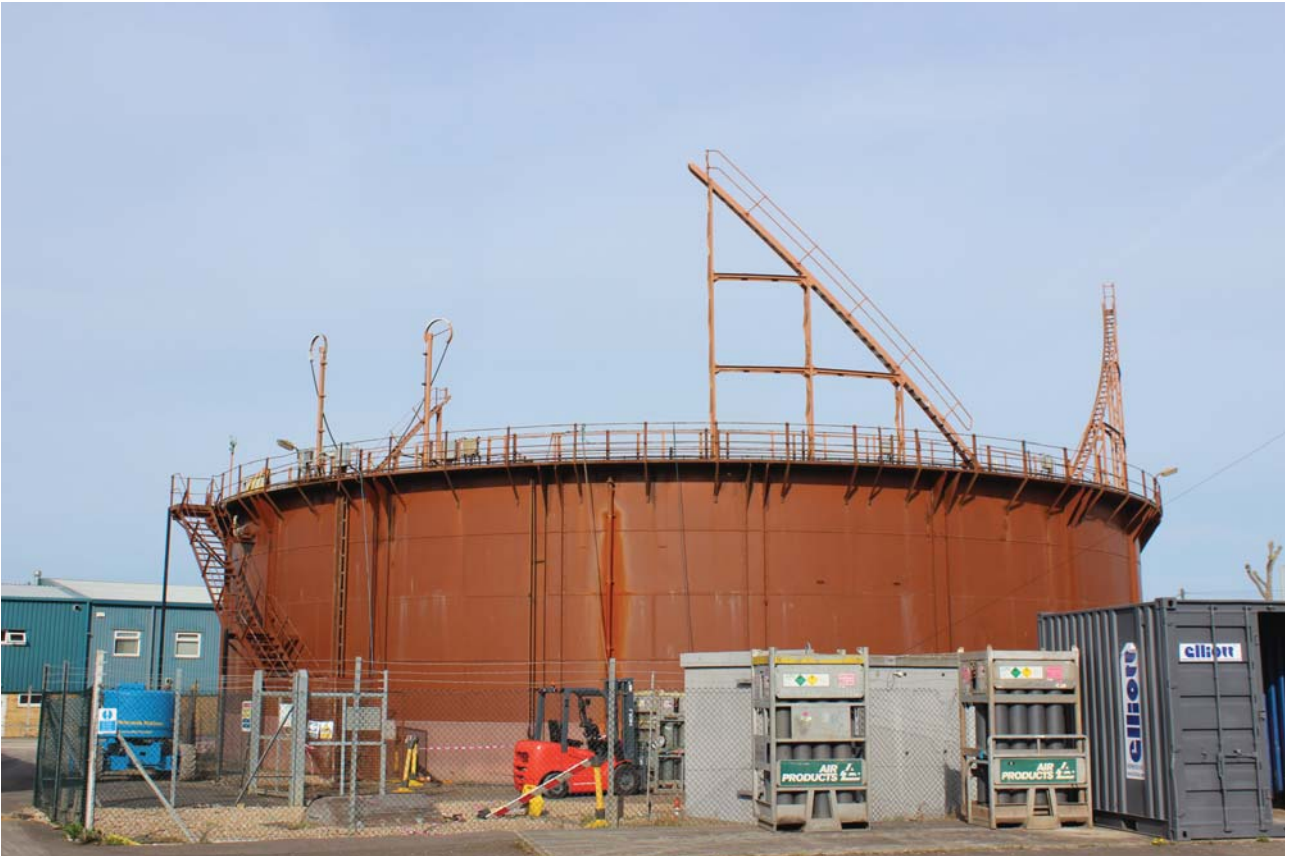
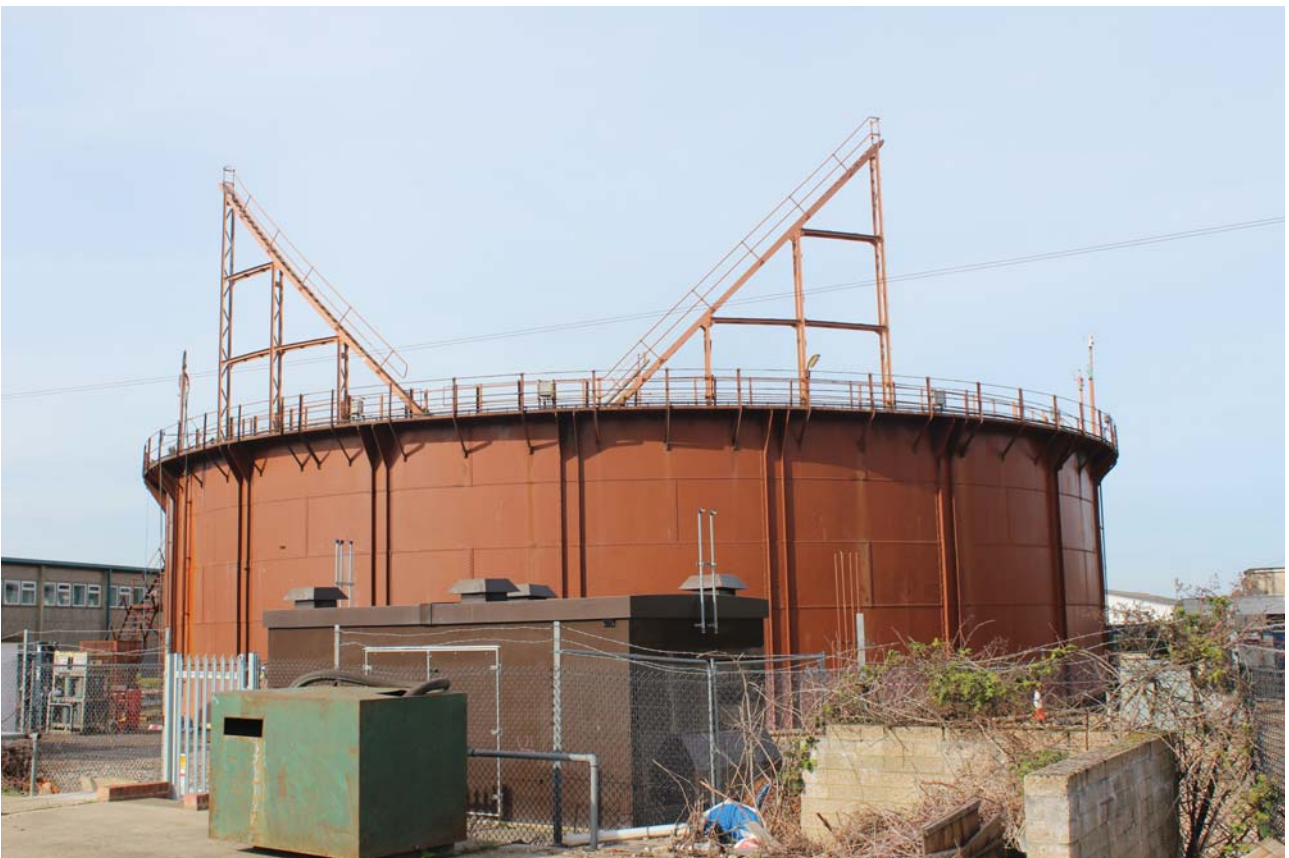
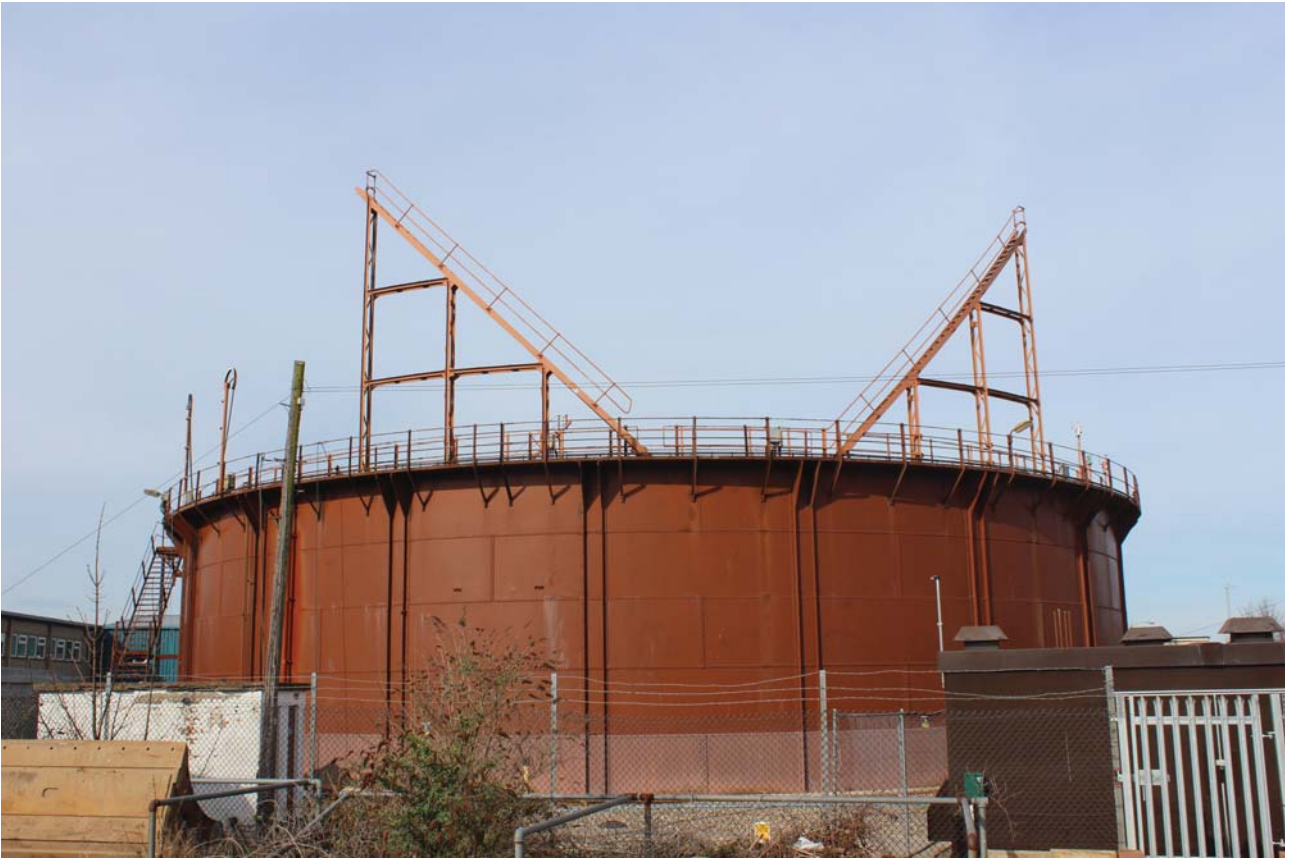
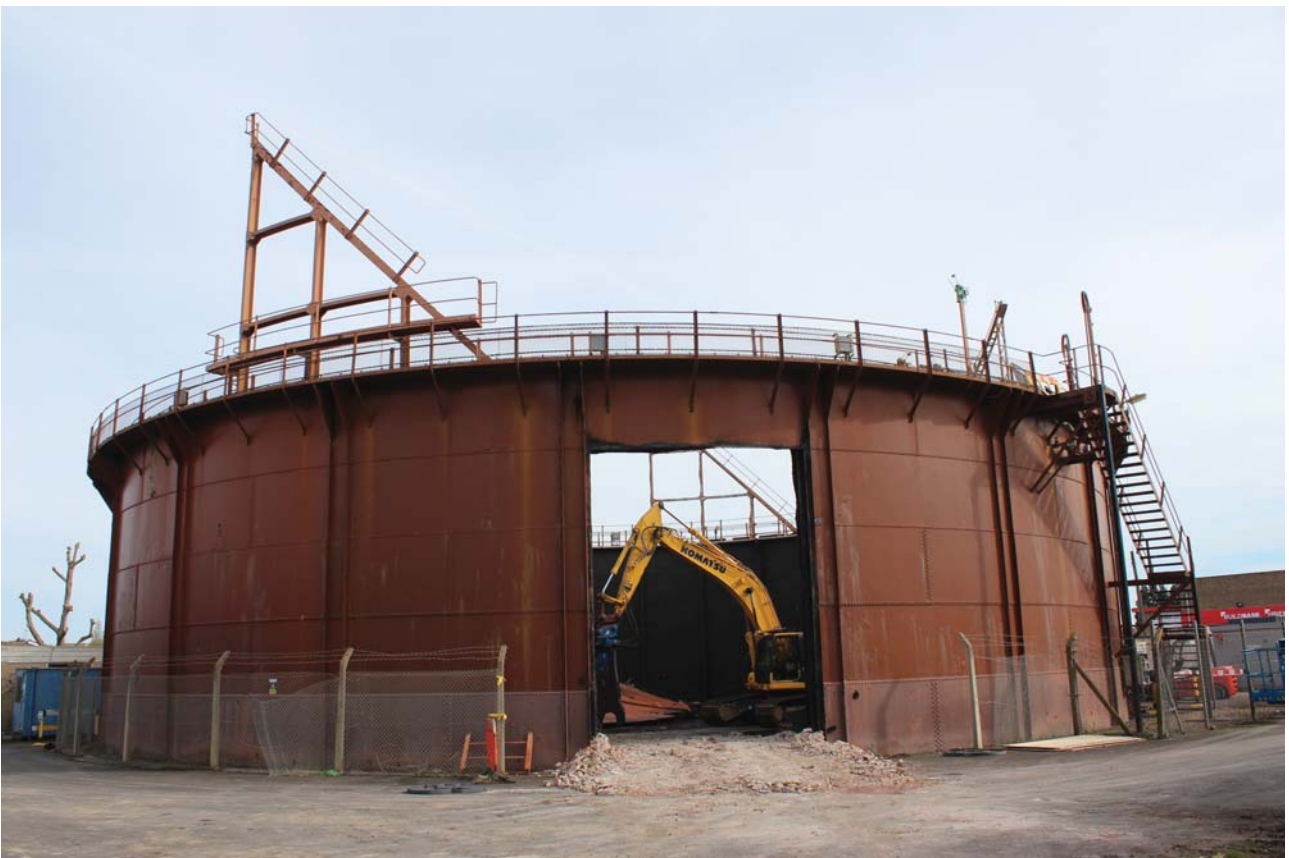
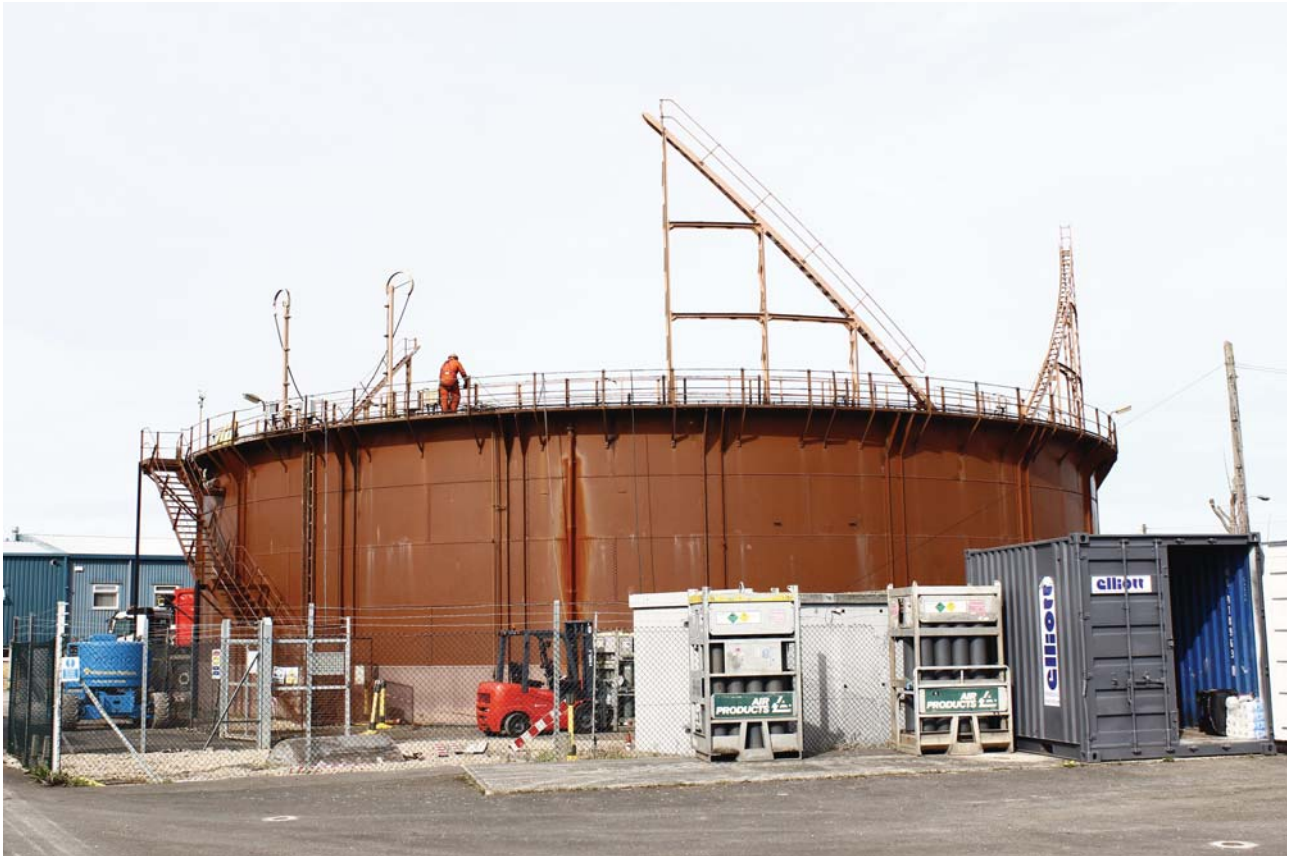
- 4.2.1 This gasholder at Sea Street, Herne Bay is a three-lift spiral gasholder located within a large fenced-off compound and was just at the start of the process of decommissioning at the time of survey. It comprises steel panels riveted together with additional steel plates and brackets throughout (Plates 1 – 9). At the time of survey there was a section cut away on one side of the structure – which was made to enable the decommissioning process – which shows in detail that the holder was constructed from 4 sheets of steel with a large base plate (Plate 10).

Plate 1: Sea Street, Herne Bay, general view of the gasholder from the SEE

Plate 2: Sea Street, Herne Bay, general view of the gasholder from the north-east

Plate 3: Sea Street, Herne Bay, general view of the gasholder from the east

Plate 4: Sea Street, Herne Bay, general view of the gasholder from the south-west

Plate 5: Sea Street, Herne Bay, general view of the gasholder from the south-east

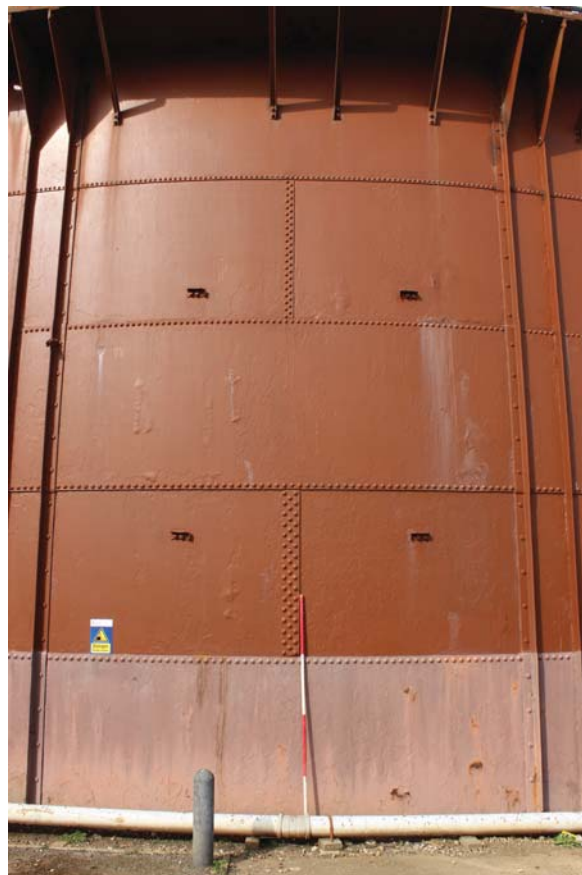
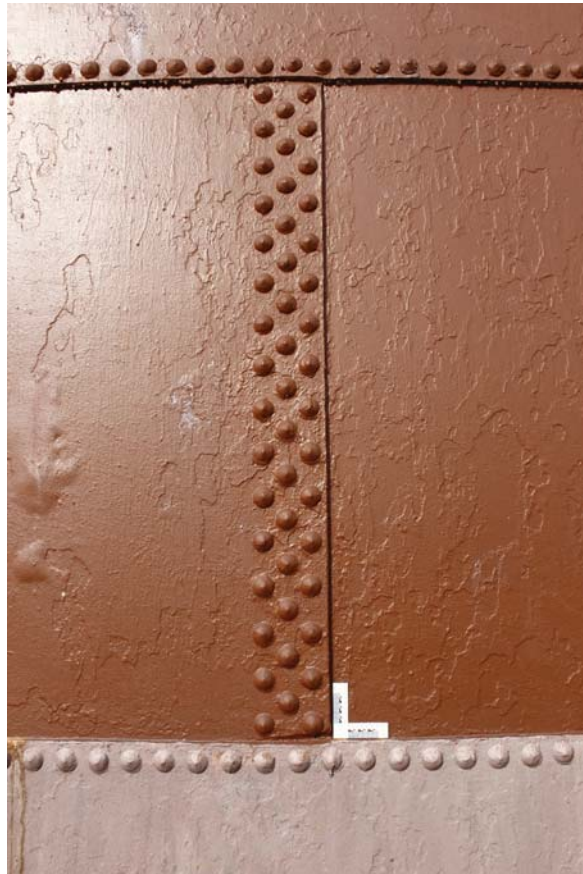
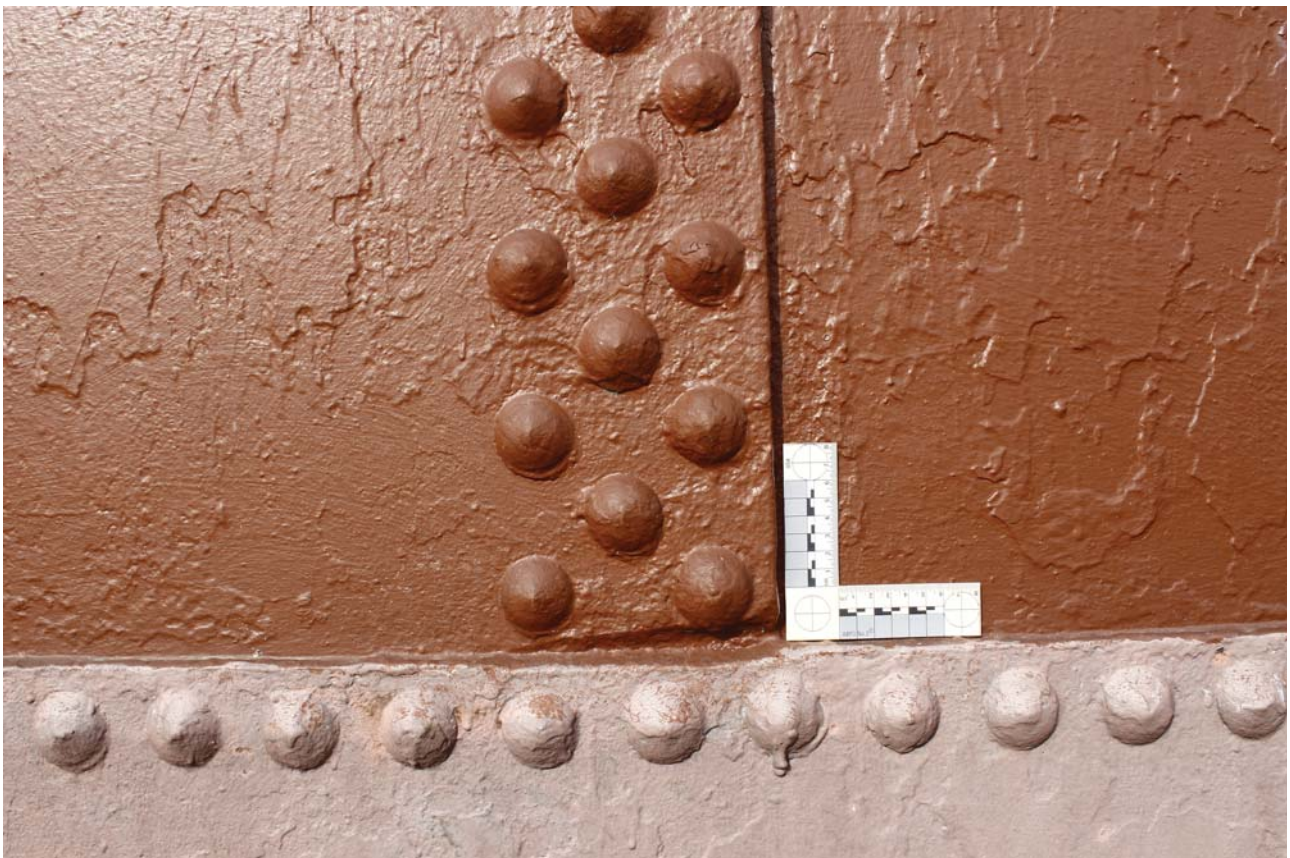
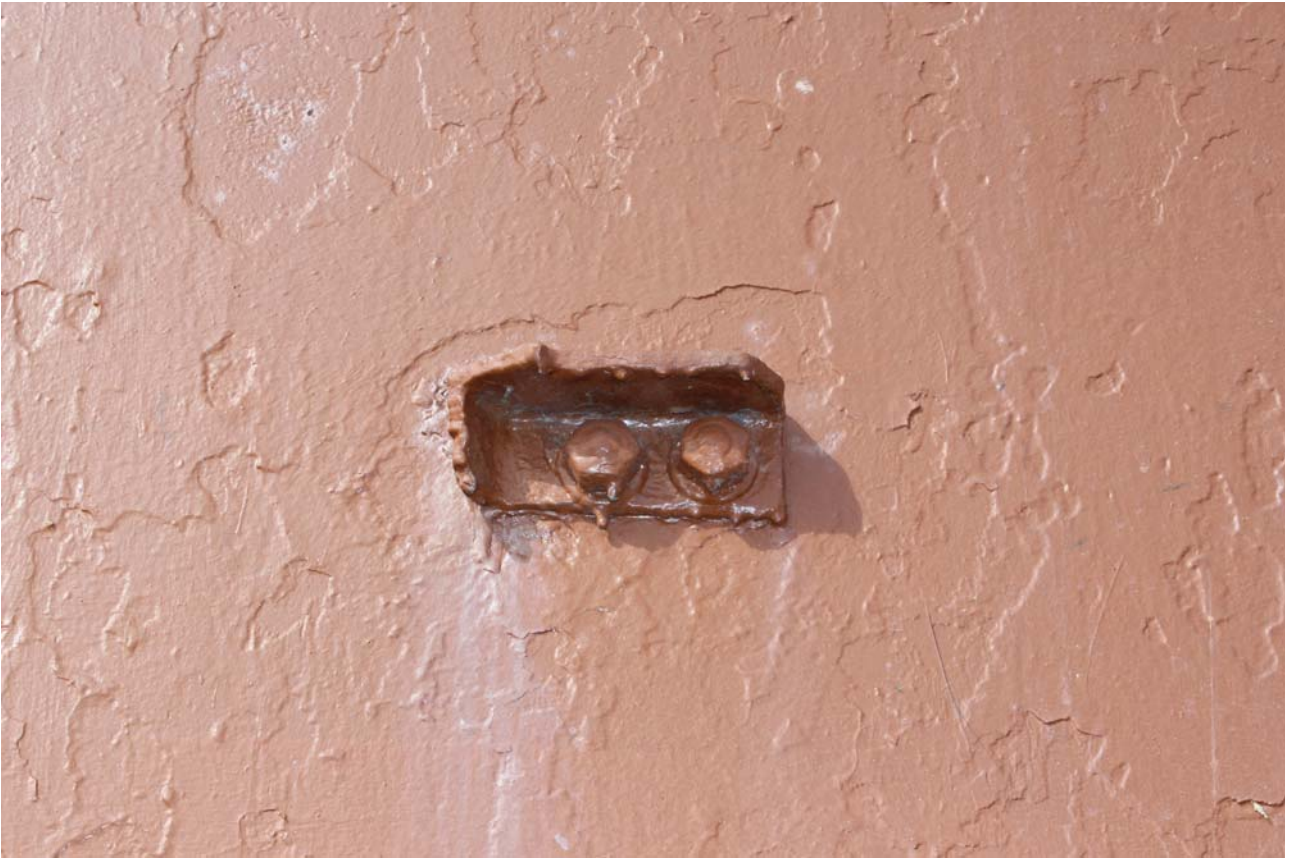
- 4.2.2 The gasholder is currently in a moderate condition with some areas of rusting, particularly to the base of the gasholder and the rivet heads. Vertical stanchions riveted on the outer steel plate support the upper walkway of the gasholder, with addition angled brackets just below the walkway (Plates 11 - 14). This is accessed by a stair on the south side (Plates 15 - 17).

Plate 6: Sea Street, Herne Bay, detail of the gasholder showing the riveted plates, from the SEE

Plate 7: Sea Street, Herne Bay, close detail of the riveted plates from the east

Plate 8: Sea Street, Herne Bay, close detail of the riveted plates from the east

Plate 9: Sea Street, Herne Bay, close detail of the riveted bracket from the east

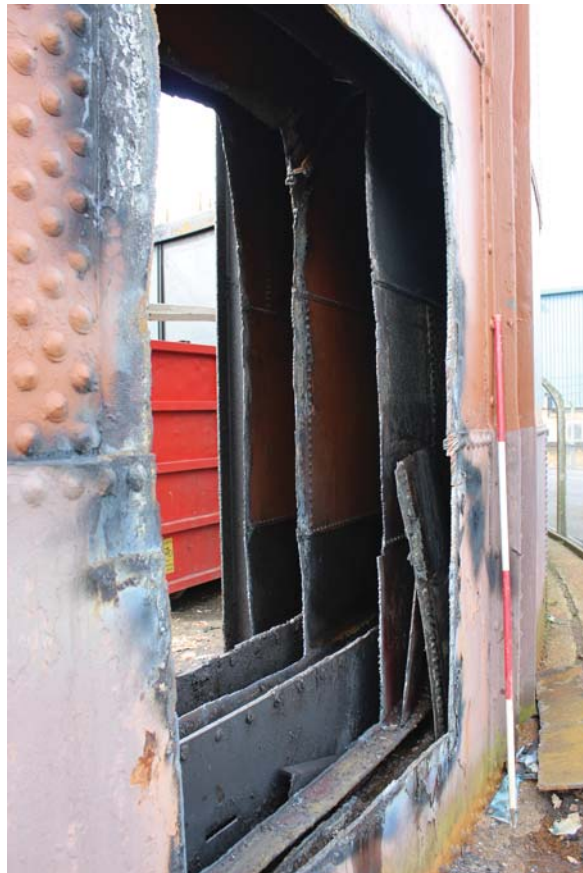
Plate 10: Sea Street, Herne Bay, detail of the section cut through the side of the gasholder from the NNW

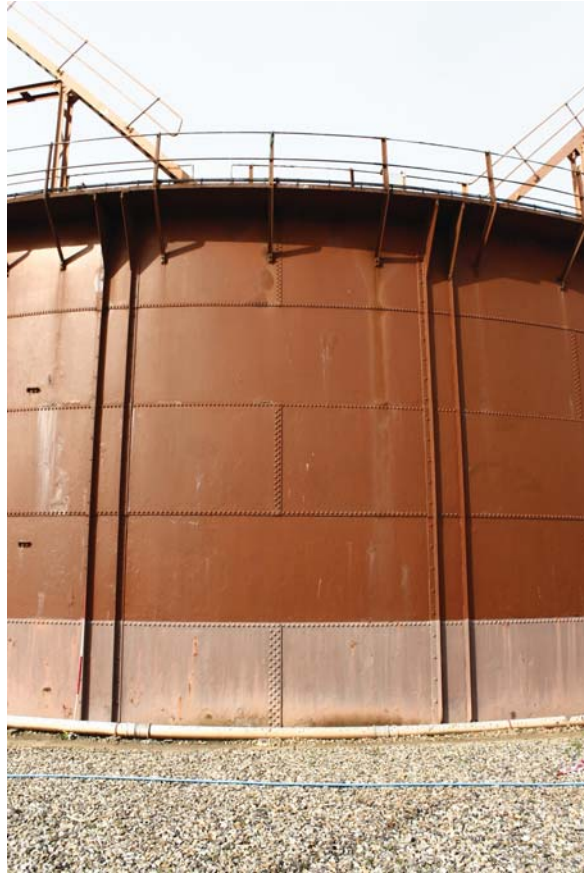
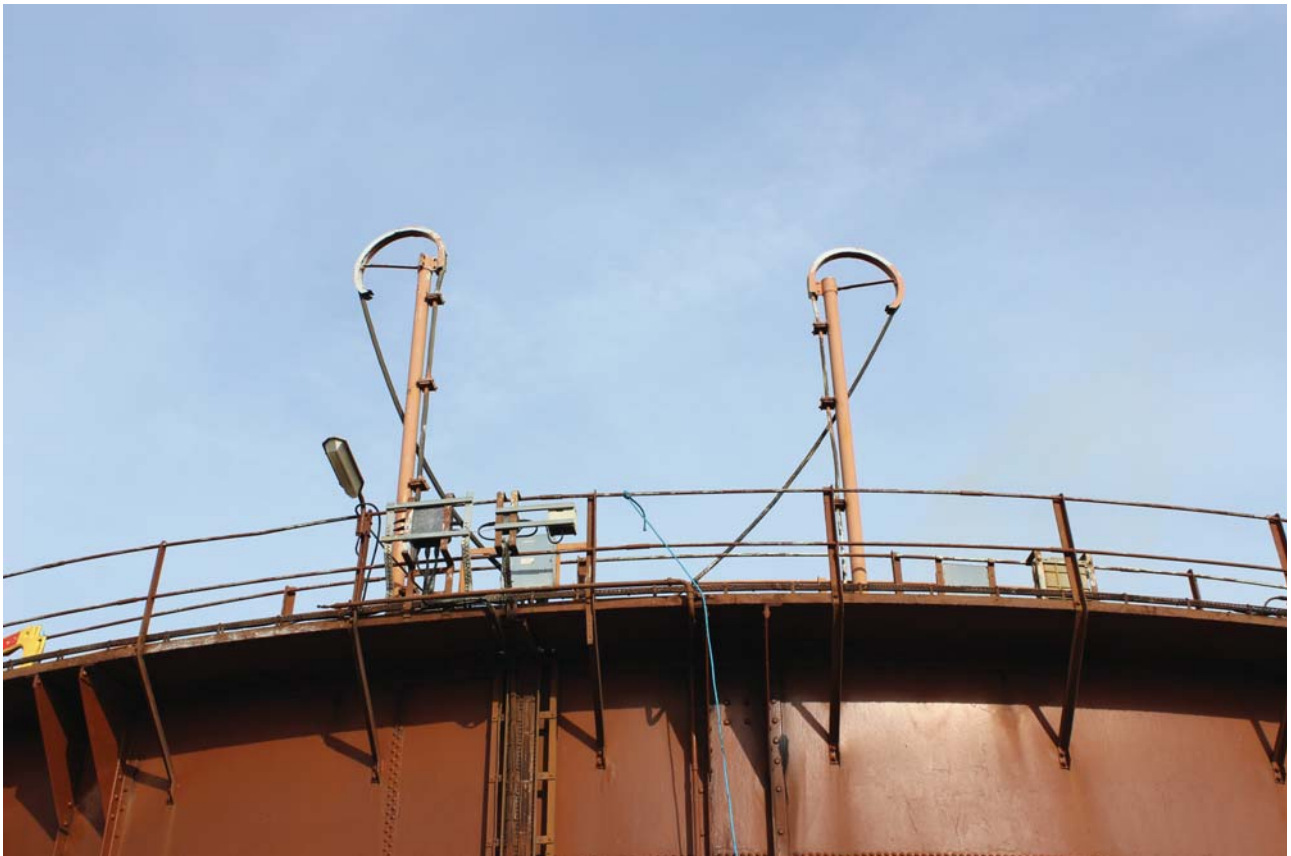
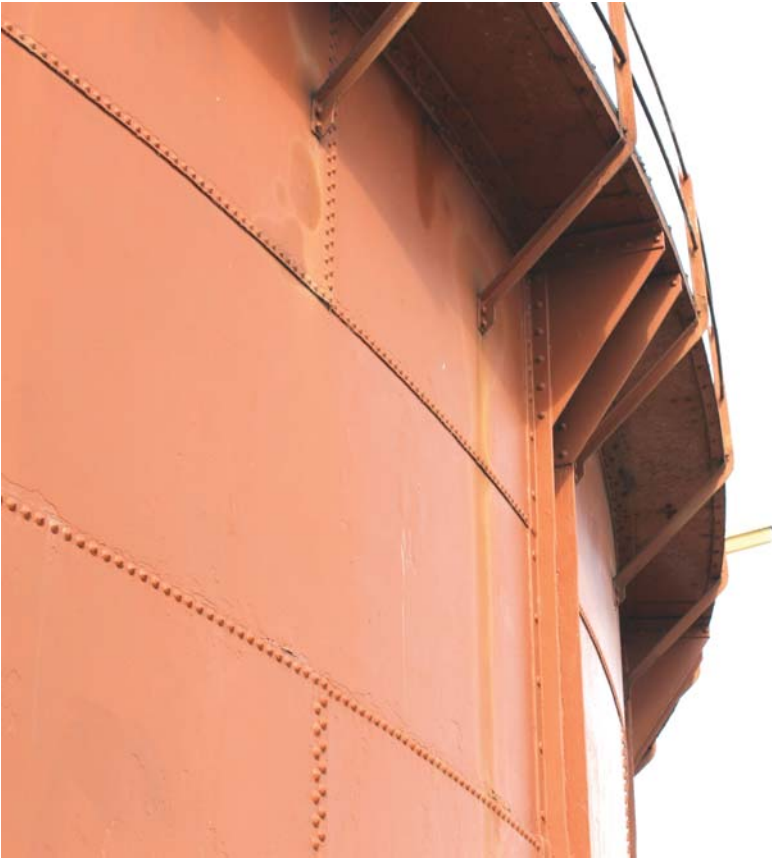
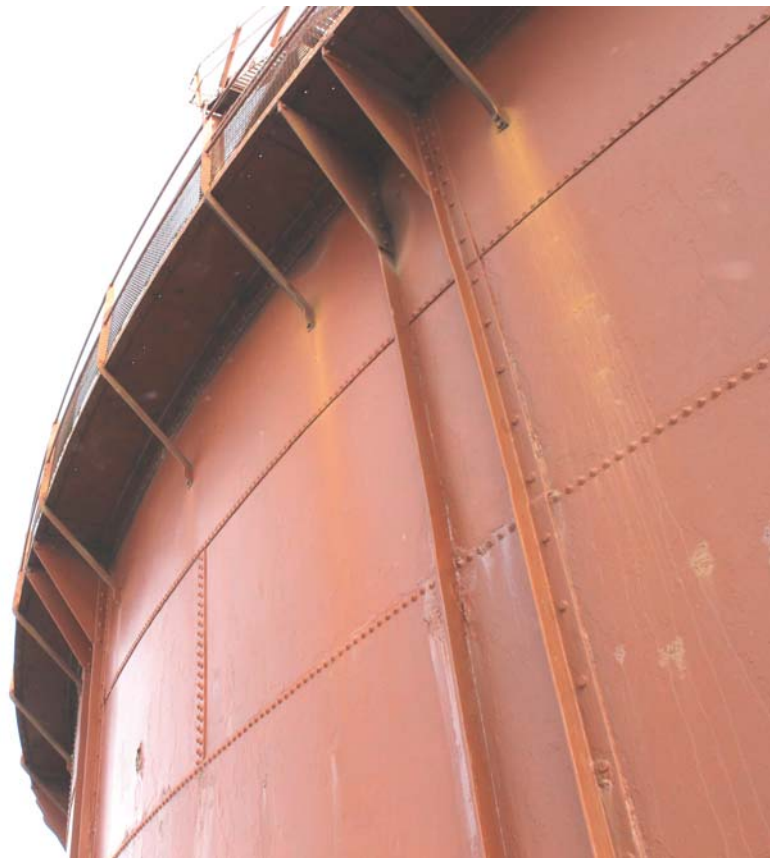
Plate 11: Sea Street, Herne Bay, general view showing the stanchions supporting the upper walkway, from the east

Plate 12: Sea Street, Herne Bay, detail of the upper walkway from the south-east

Plate 13: Sea Street, Herne Bay, detail of the upper walkway from the east

Plate 14: Sea Street, Herne Bay, detail of the upper walkway from the south-west

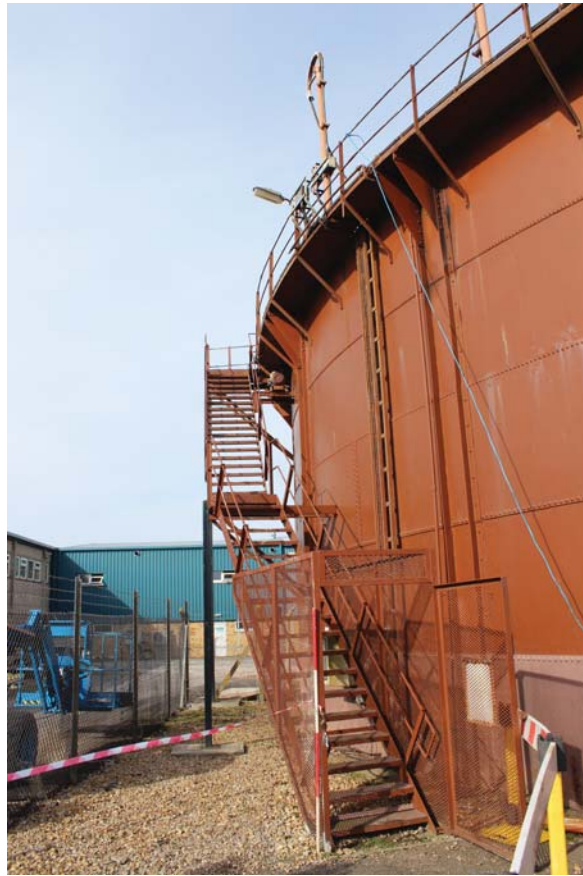
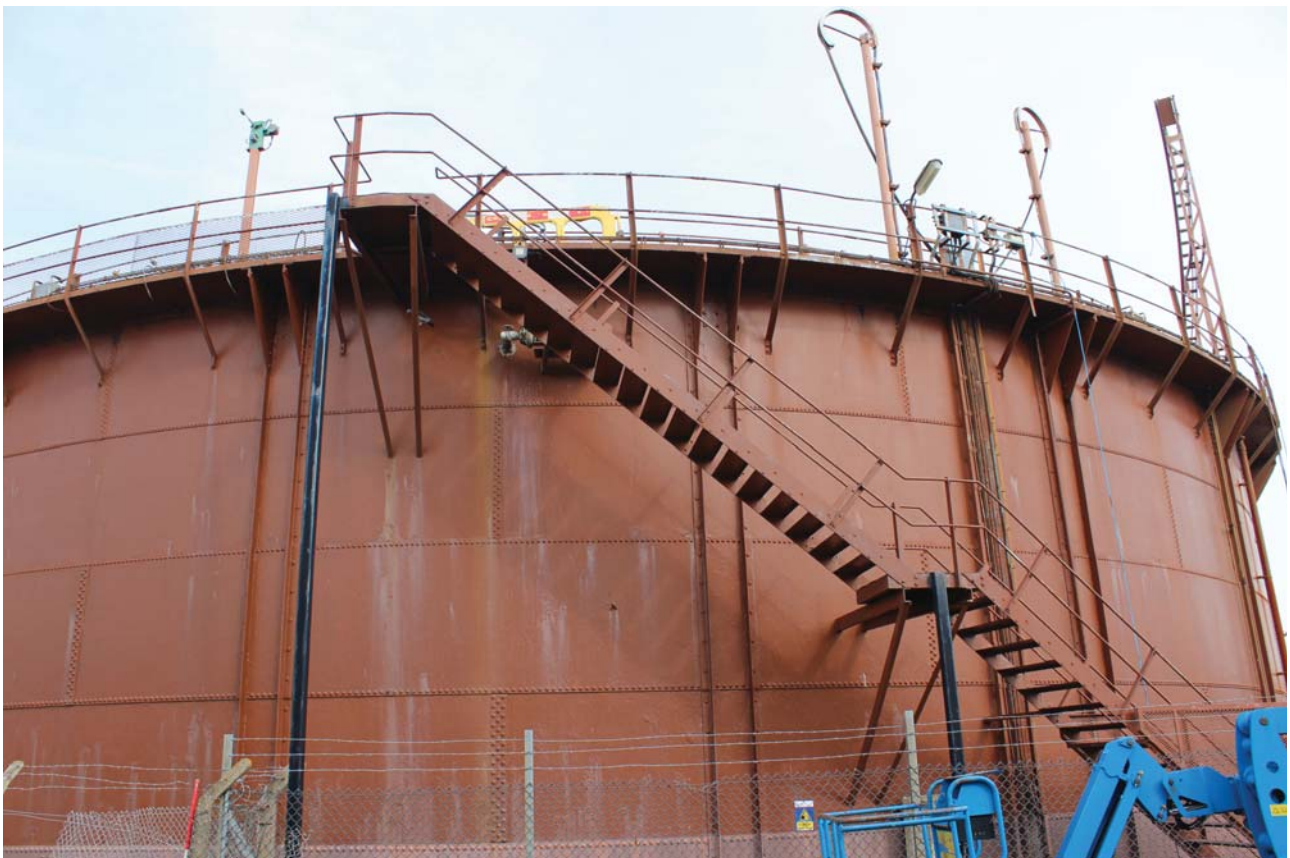
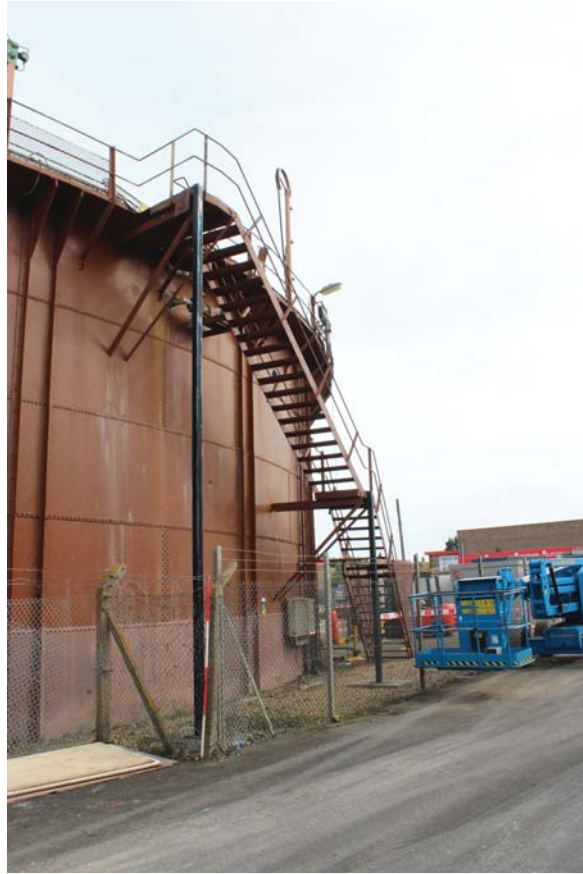
Plate 15: Sea Street, Herne Bay, detail of the stairs from the south-east

Plate 16: Sea Street, Herne Bay, detail of the stairs from the south

Plate 17: Sea Street, Herne Bay, detail of the stairs from the south-west

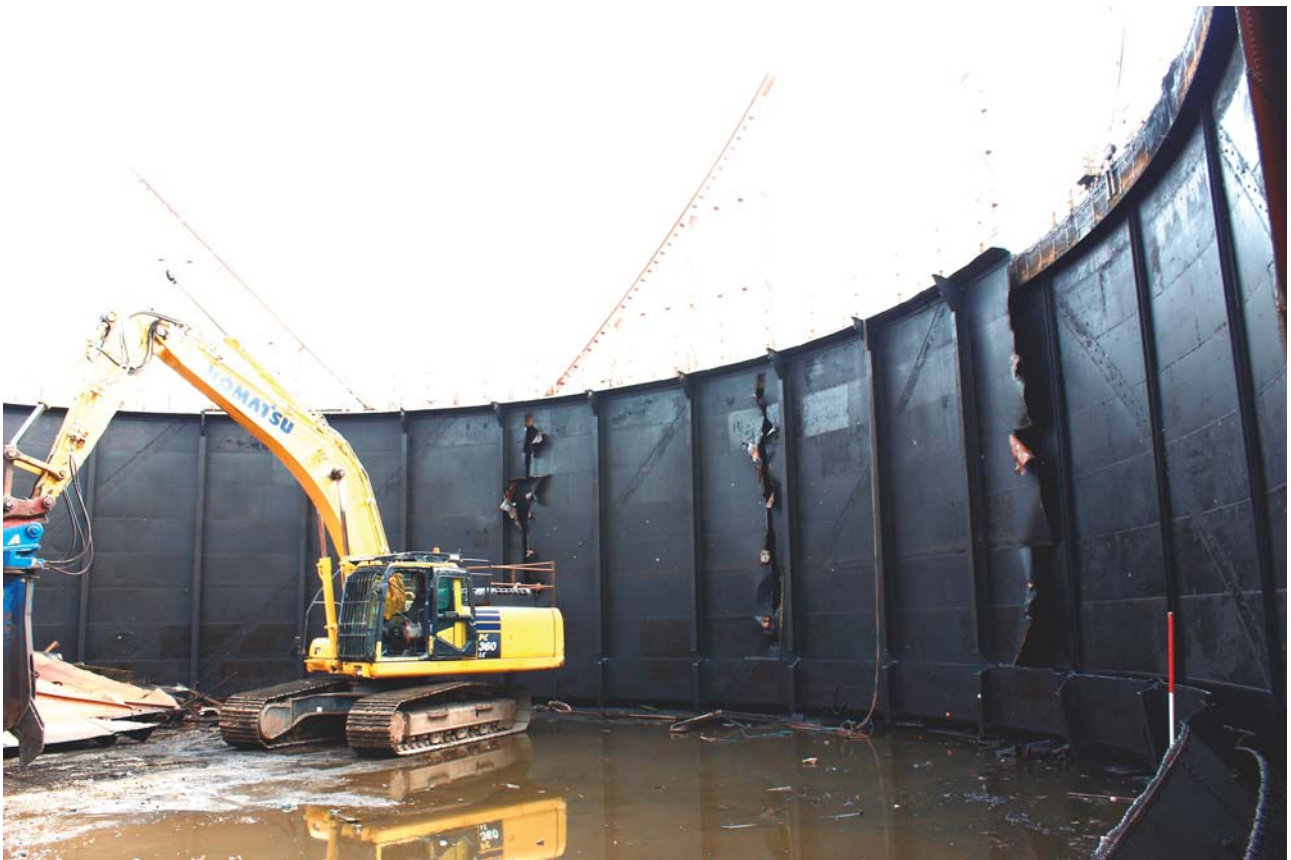
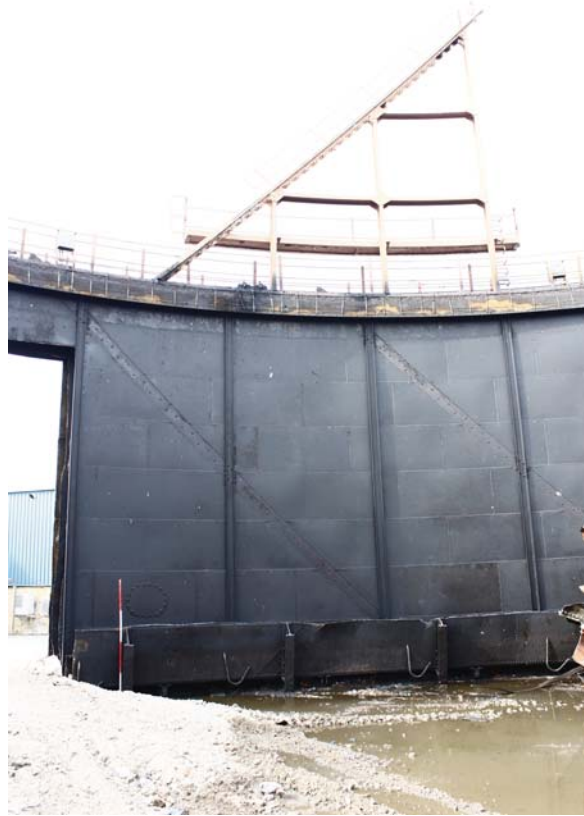
- 4.2.3 The section cut through the side of the gasholder also enabled a record to be made of the interior space, which was painted black and reflected the riveted construction seen to the exterior, and the angled 'lifts' within (Plates 18 & 19).

Plate 18: Sea Street, Herne Bay, general view of the interior of the gasholder from the south

Plate 19: Sea Street, Herne Bay, general view of the interior of the gasholder from the north

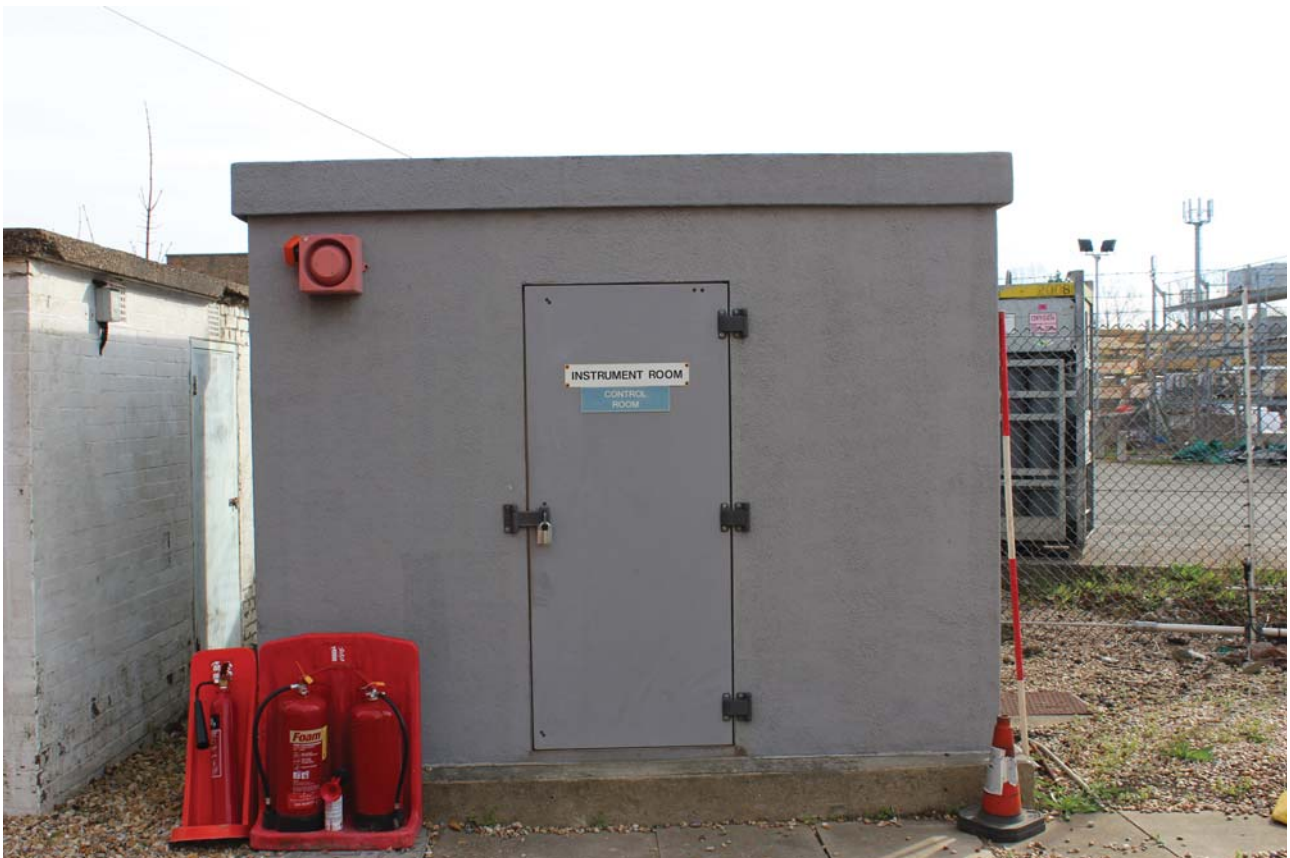
- 4.2.4 There are a number of additional structures associated with the former gasworks immediately prior to the decommissioning. These include:
- Instrument Room/Control Room, a small single-bay flat-roofed building in a roughcast render (Plate 20)

Plate 20: Sea Street, Herne Bay, general view of the Instrument Room/Control Room from the SWW

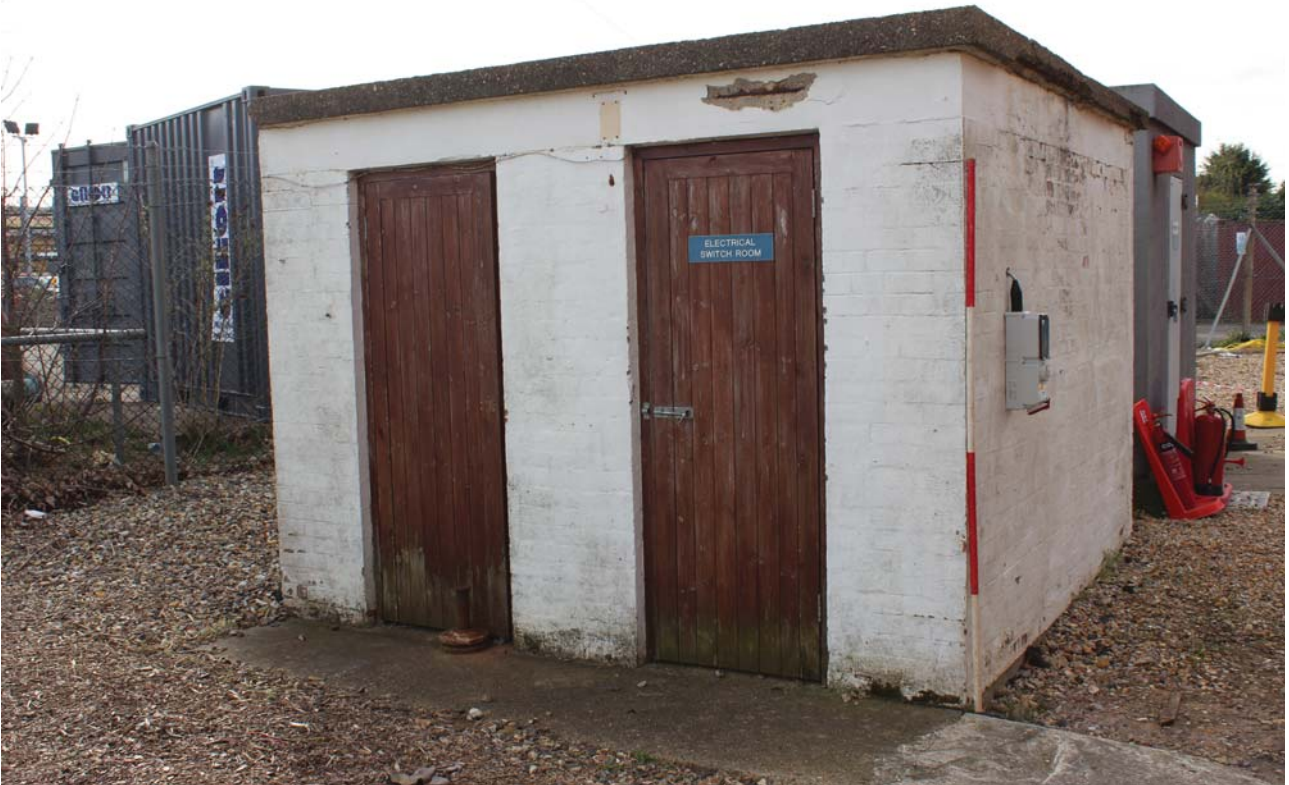
- Electrical Switch Room, a two-bay flat-roofed brick building (Plate 21)
 - Isolator Tank (Plates 22 & 23)
 - Large pipe inlet/outlet set within a half-concrete compound (Plate 24)

Plate 21: Sea Street, Herne Bay, general view of the Electrical Switch Room from the NNW

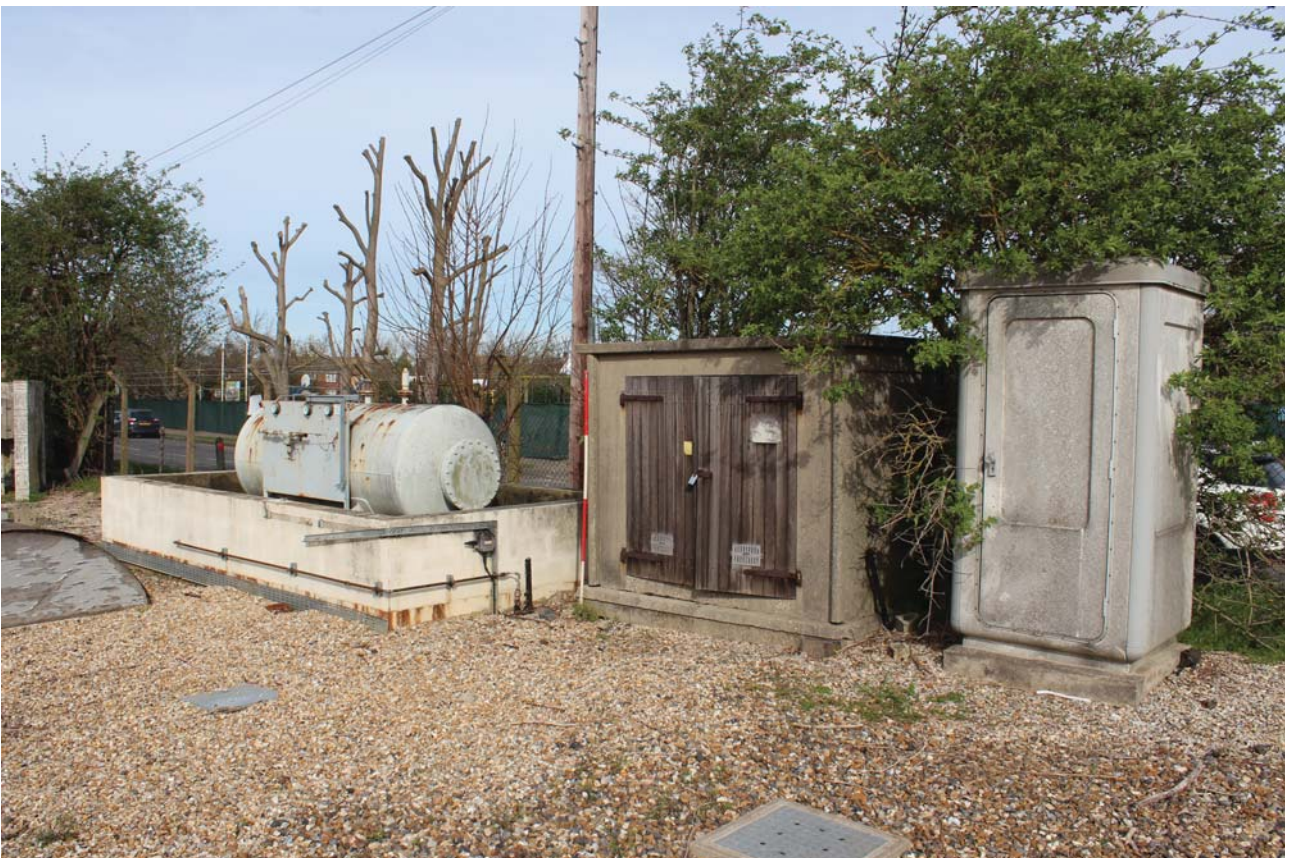
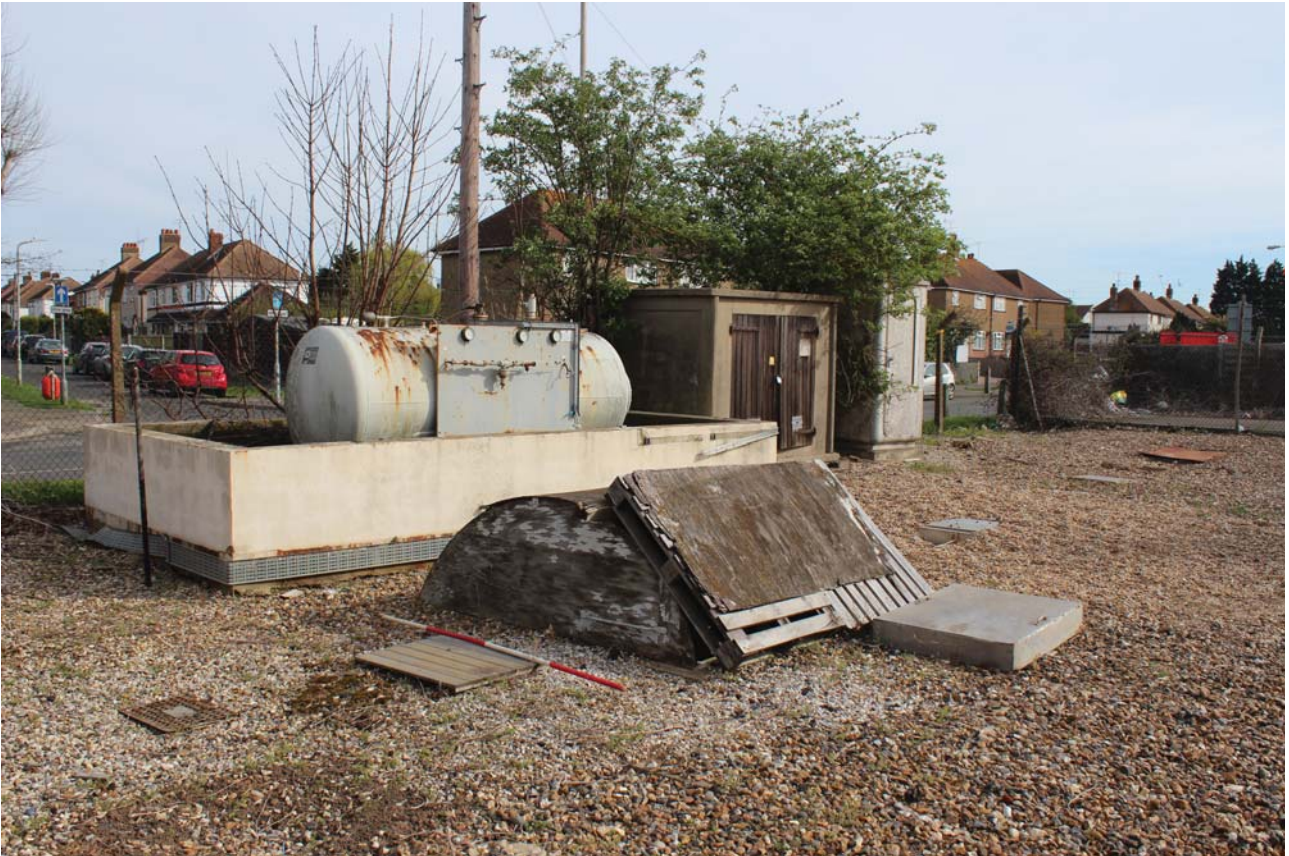
Plate 22: Sea Street, Herne Bay, general view of the isolator tank from the north-east

Plate 23: Sea Street, Herne Bay, general view of the isolator tank from the west

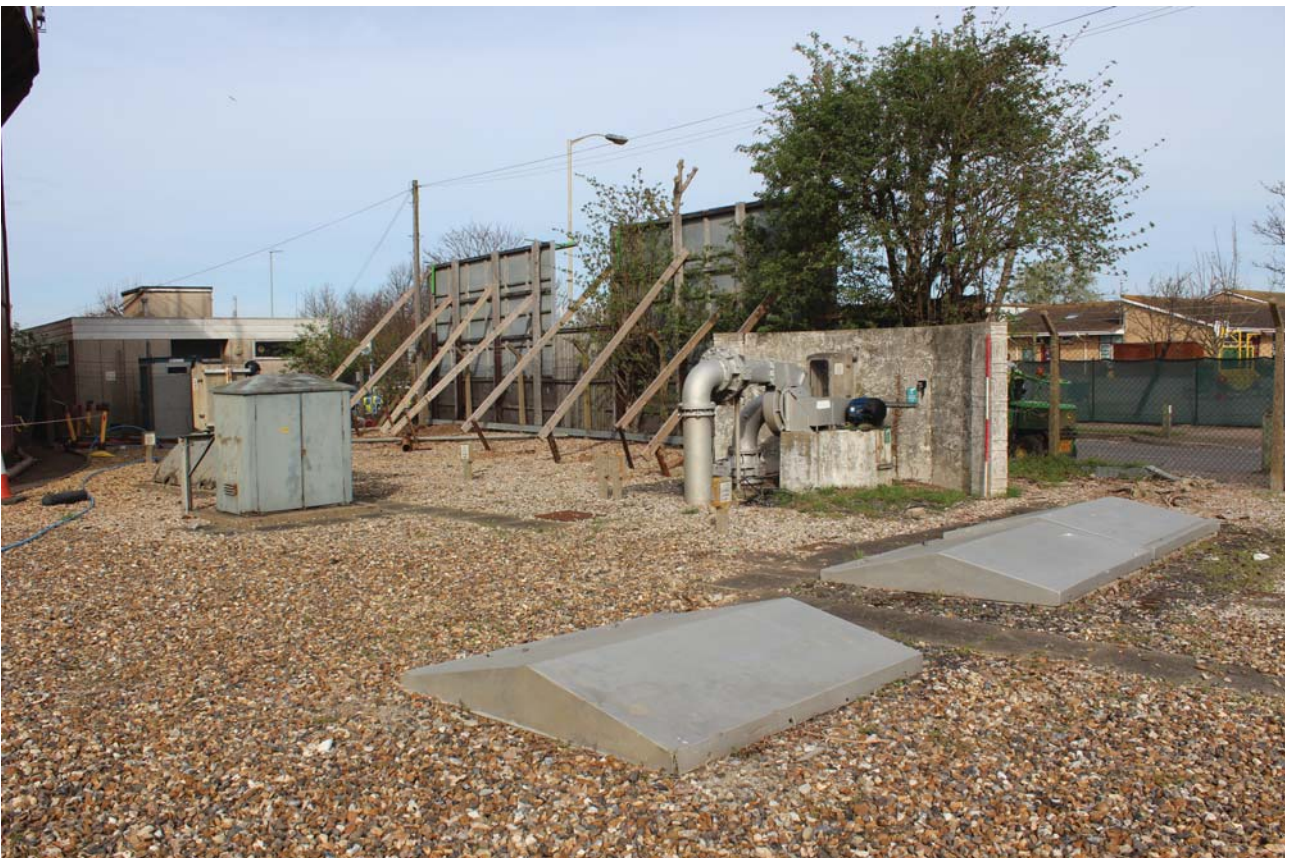
Plate 24: Sea Street, Herne Bay, general view of pipe inlet/outlet from the south
