SGN Gasholder Heritage Review: Sea Street, Herne Bay

Historic Building Recording Report

The gasholder was constructed in 1934 by the Newton Chambers Company. It is a three-lift spiral-guided gasholder in an above ground tank with the capacity of 50,000 feet.

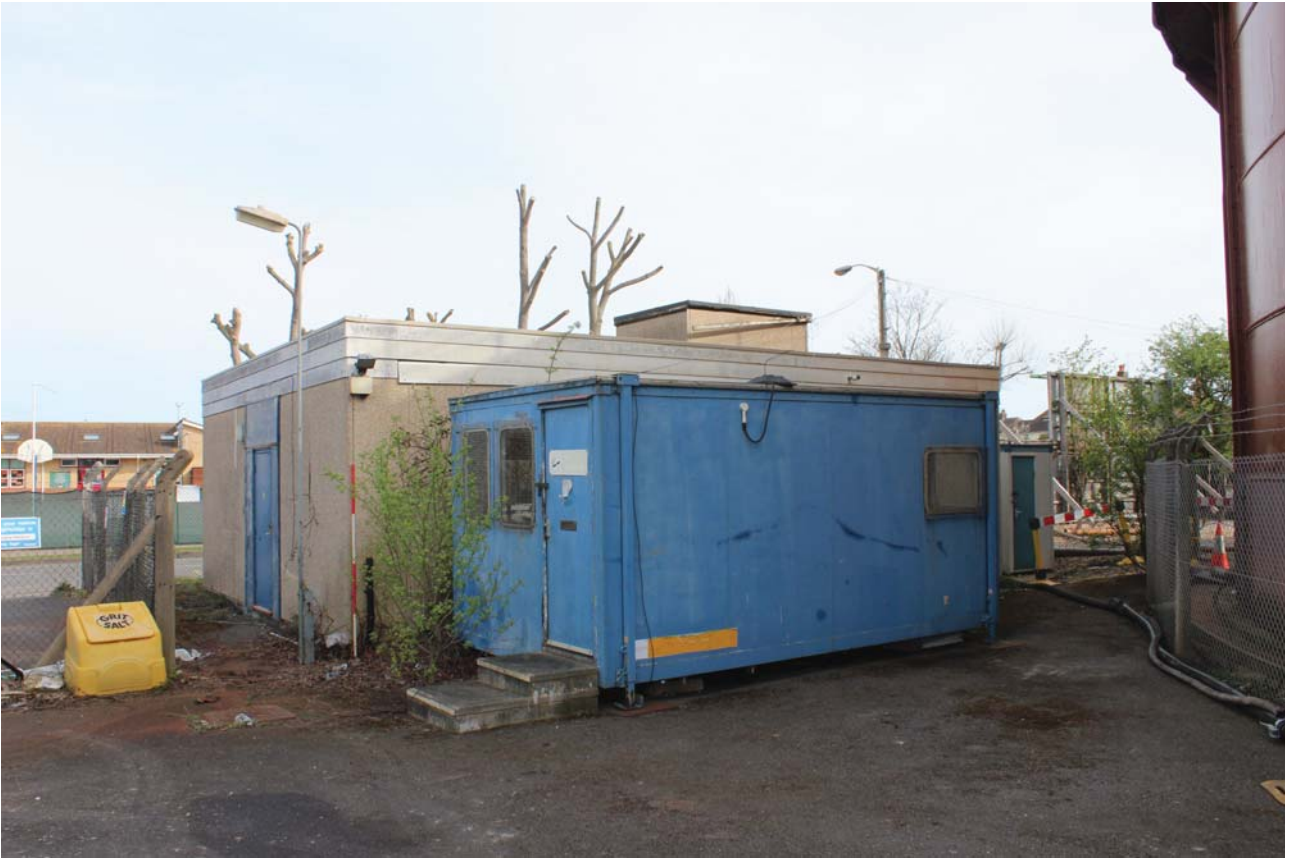
- Large square building in roughcast render and an adjacent temporary building (Plate 25)

Plate 25: Sea Street, Herne Bay, general view of additional ancillary gasworks buildings to the north-west of the gasholder, from the south-west
