SGN Gasholder Heritage Review

Brielle Way, Isle of Sheppey

Historic Building Recording Report

AOC 23686

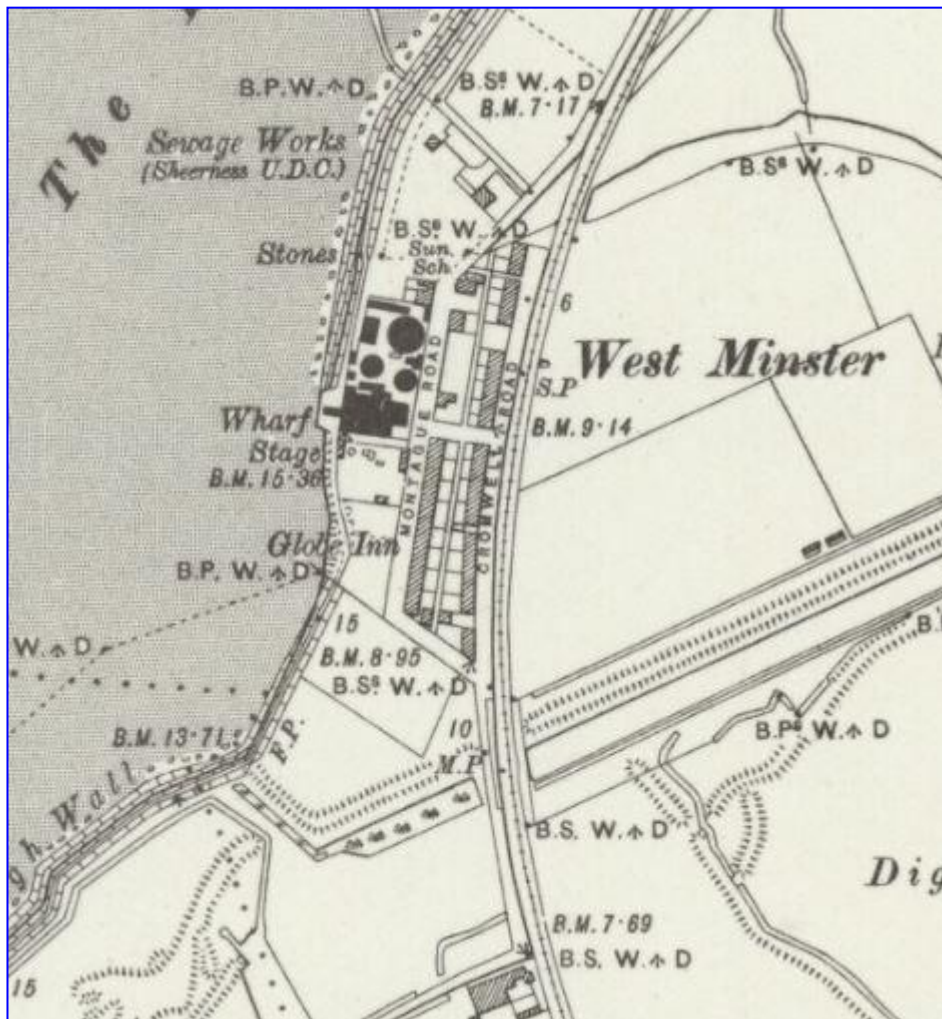
Figure 5: Extract from Ordnance Survey map, 1934
(the presence of Gasholder No 4 has not been updated on this map)

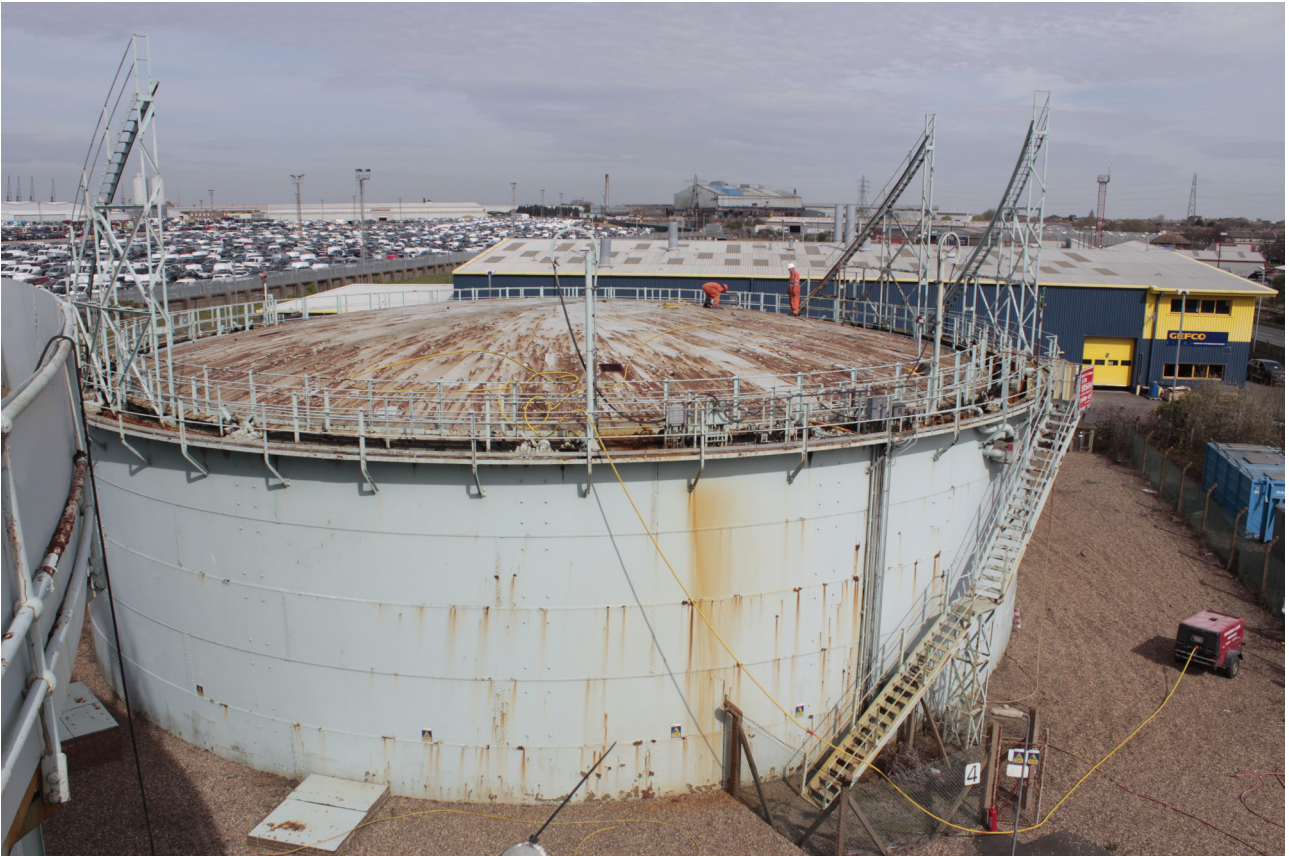
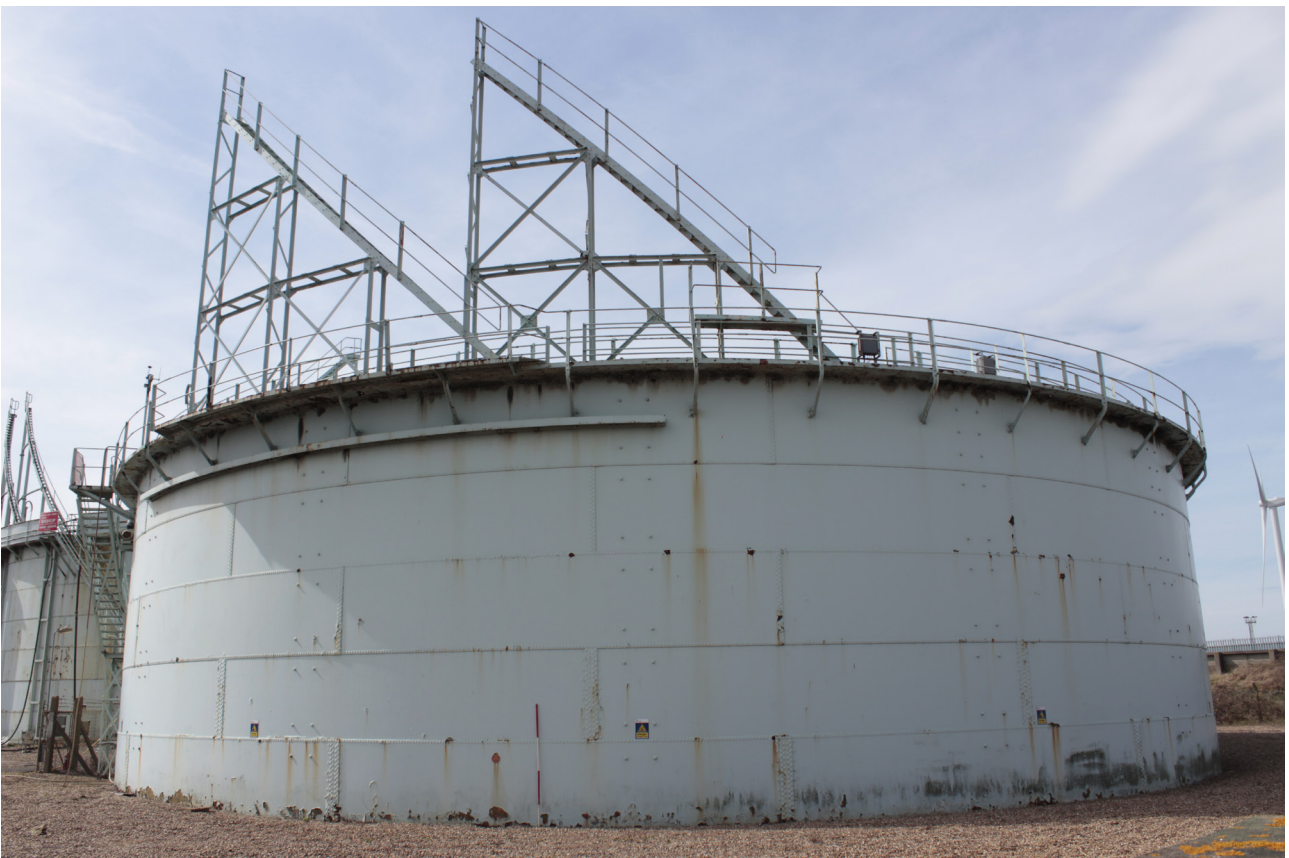
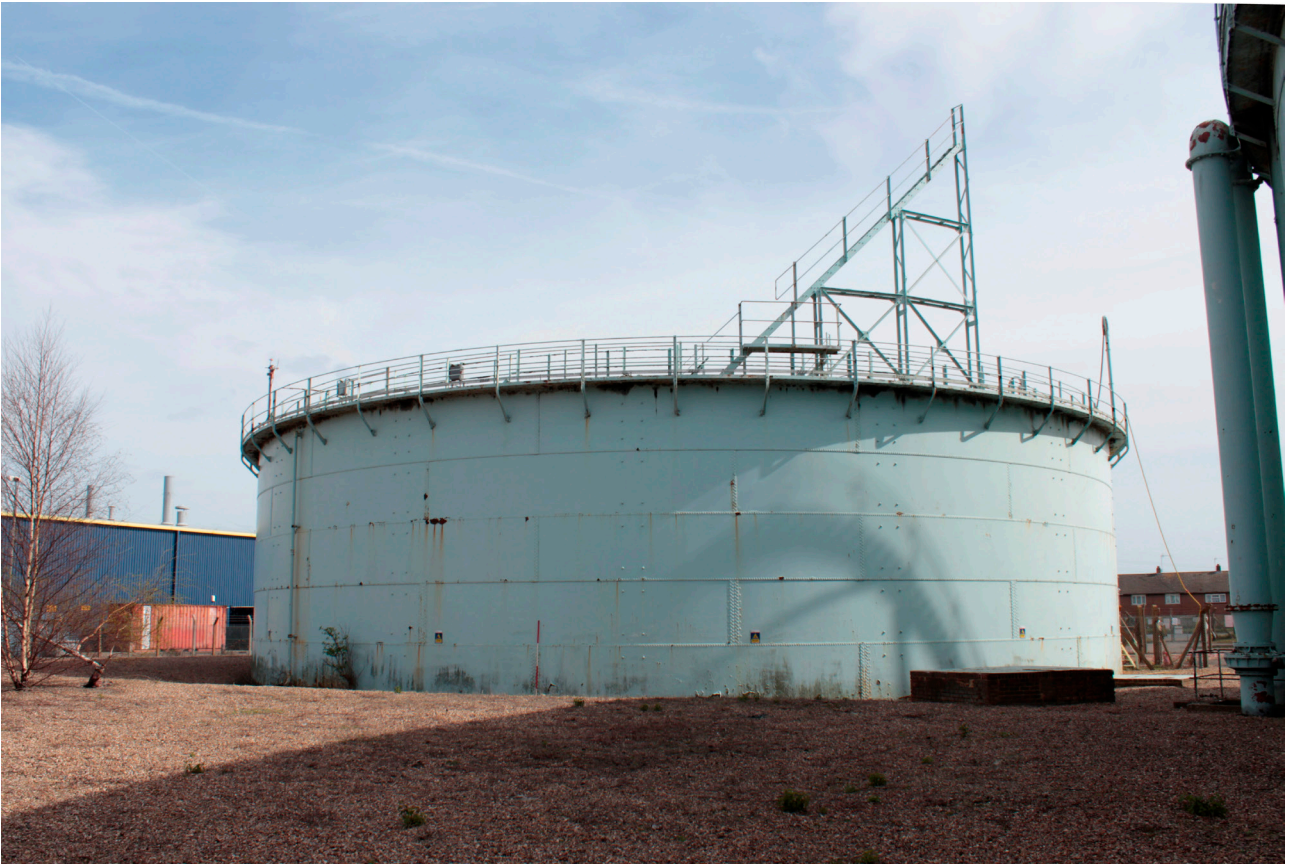
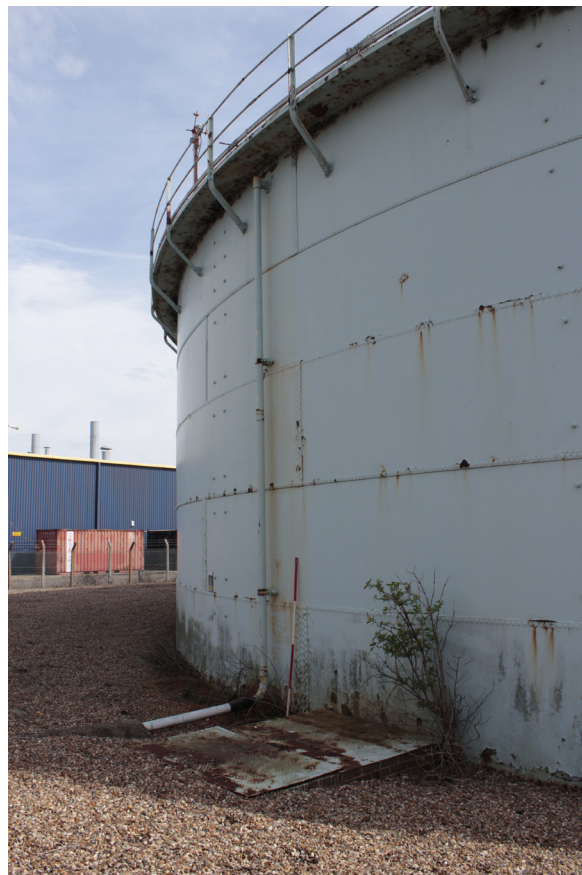
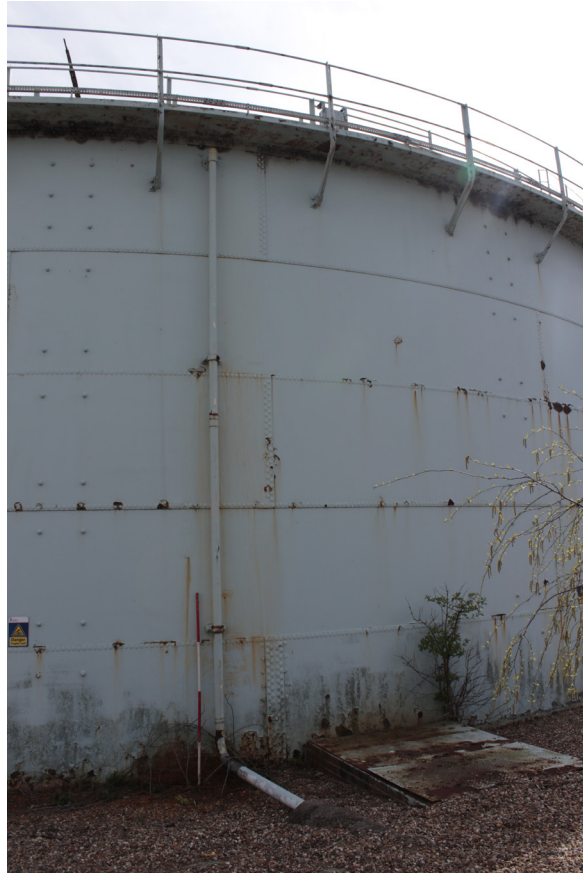
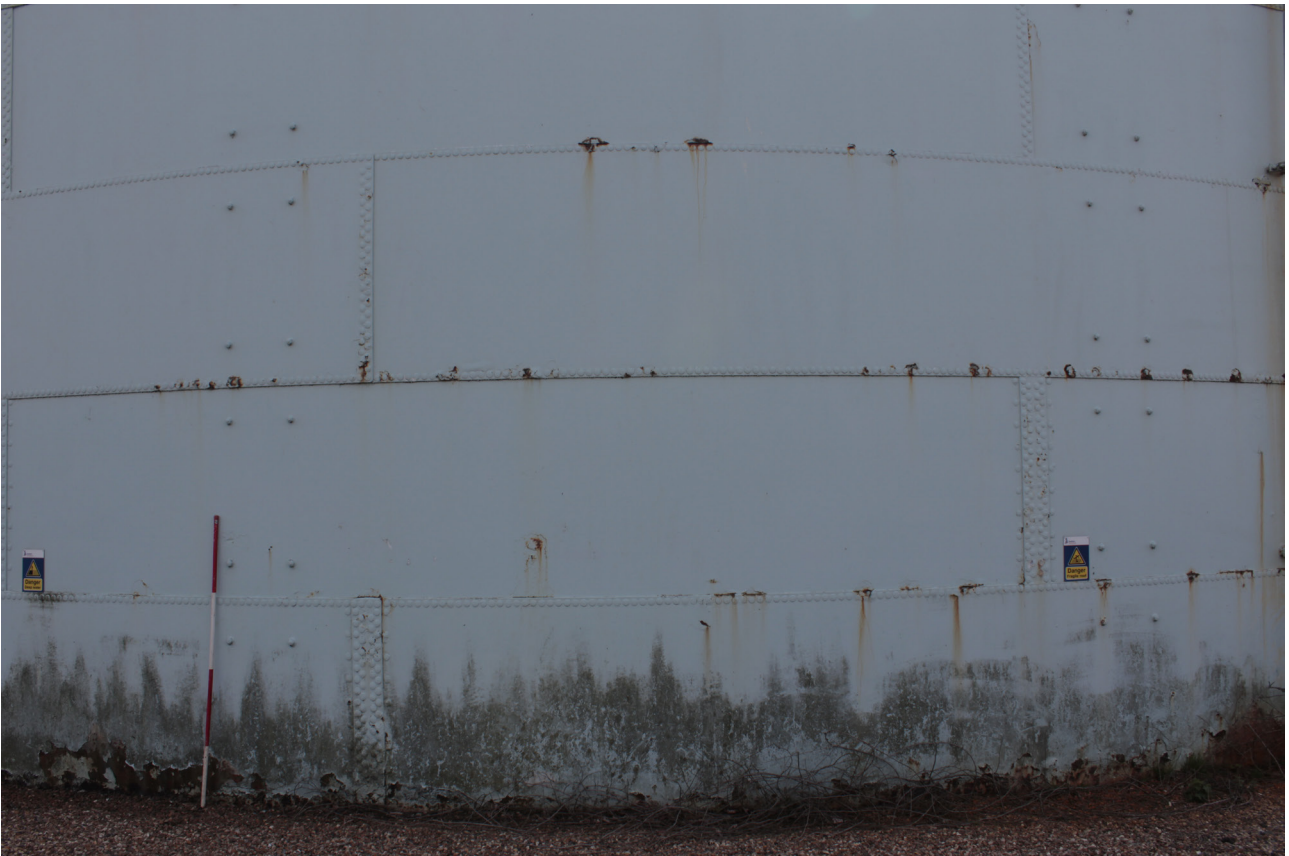
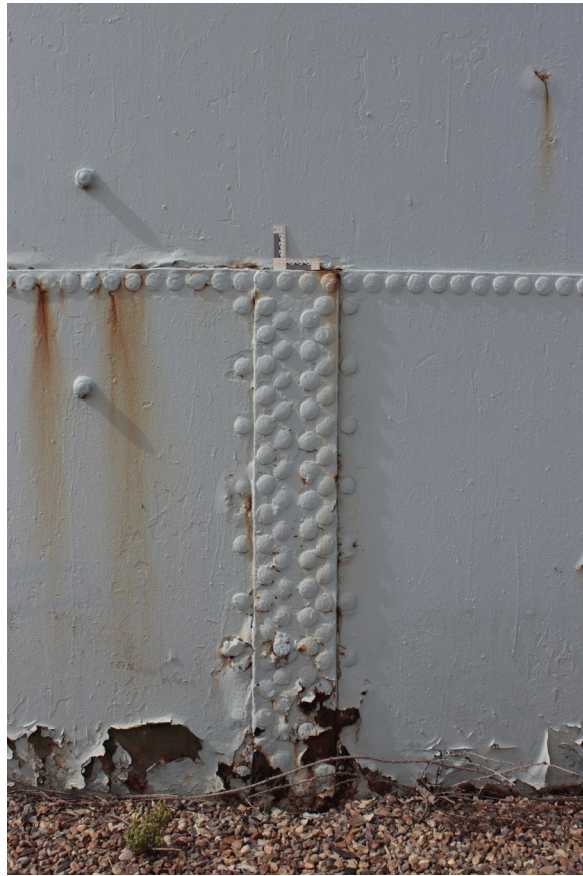
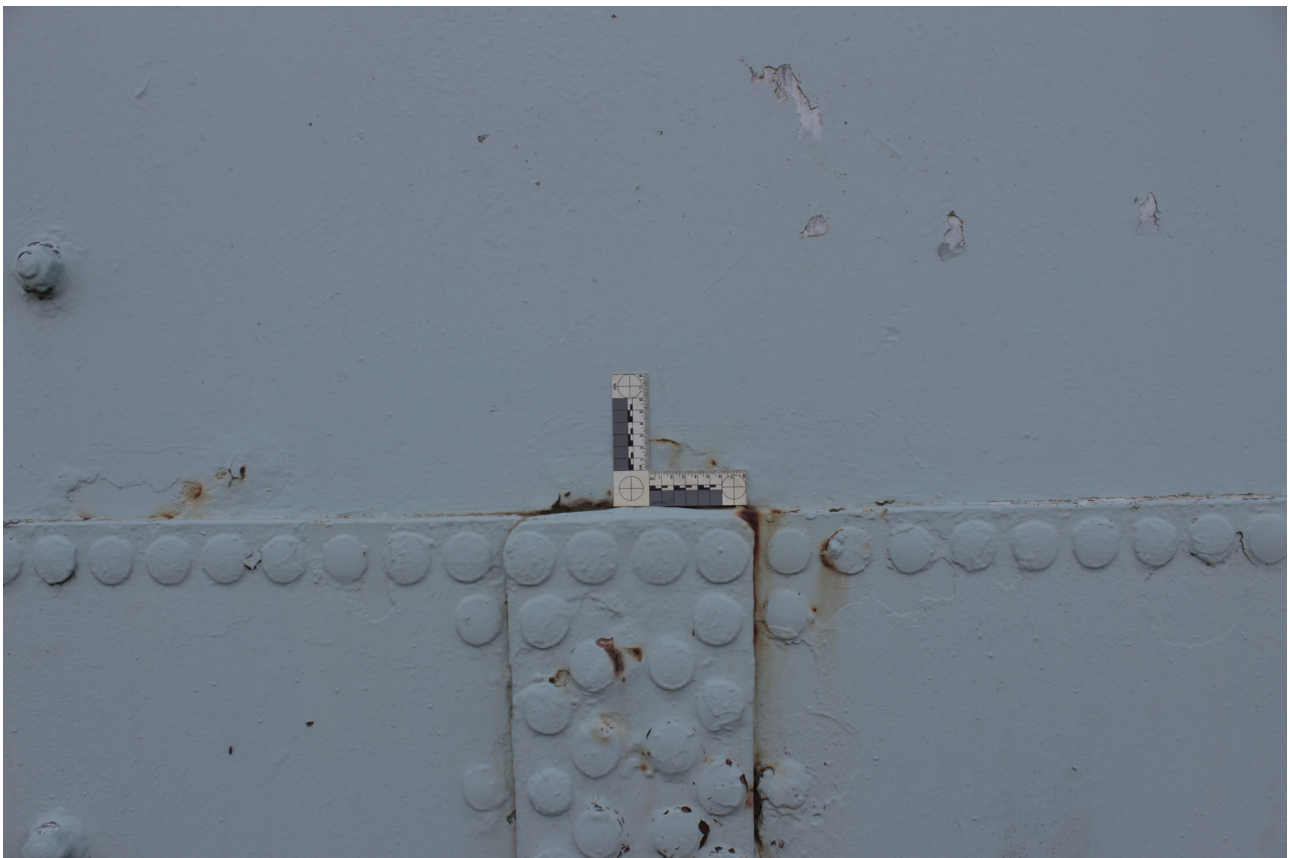
4.2.1 Gasholder No 4 is the smaller of the two gasholders constructed of riveted steel sheets with additional riveted small panels holding the sheets in place (Plates 1 - 8). There is a single vertical gas pipe from the ground on the north-west side. It is a relatively plain construction with the upper walkway supported by plain steel brackets bolted to the top of the gasholder (Plate 9). The upper walkway is accessed via a stair on the south-east side set in two stages with a small landing between (Plates 10 & 11). The base of the stair was enclosed by a small chicken wire and barbed wire compound with concrete posts, although it was possible to access the upper walkway at the time of survey. An electric motor and pump is located at the top of the stair just below the walkway (Plates 12 & 13), which is flanked by a steel safety rail. The lifts were still *in situ* for the gasholder to rise, together with the mechanisms to lock and operate them, including the roller carriage which guides the upwards or downwards movement of the gasholder (Plates 14 - 19).

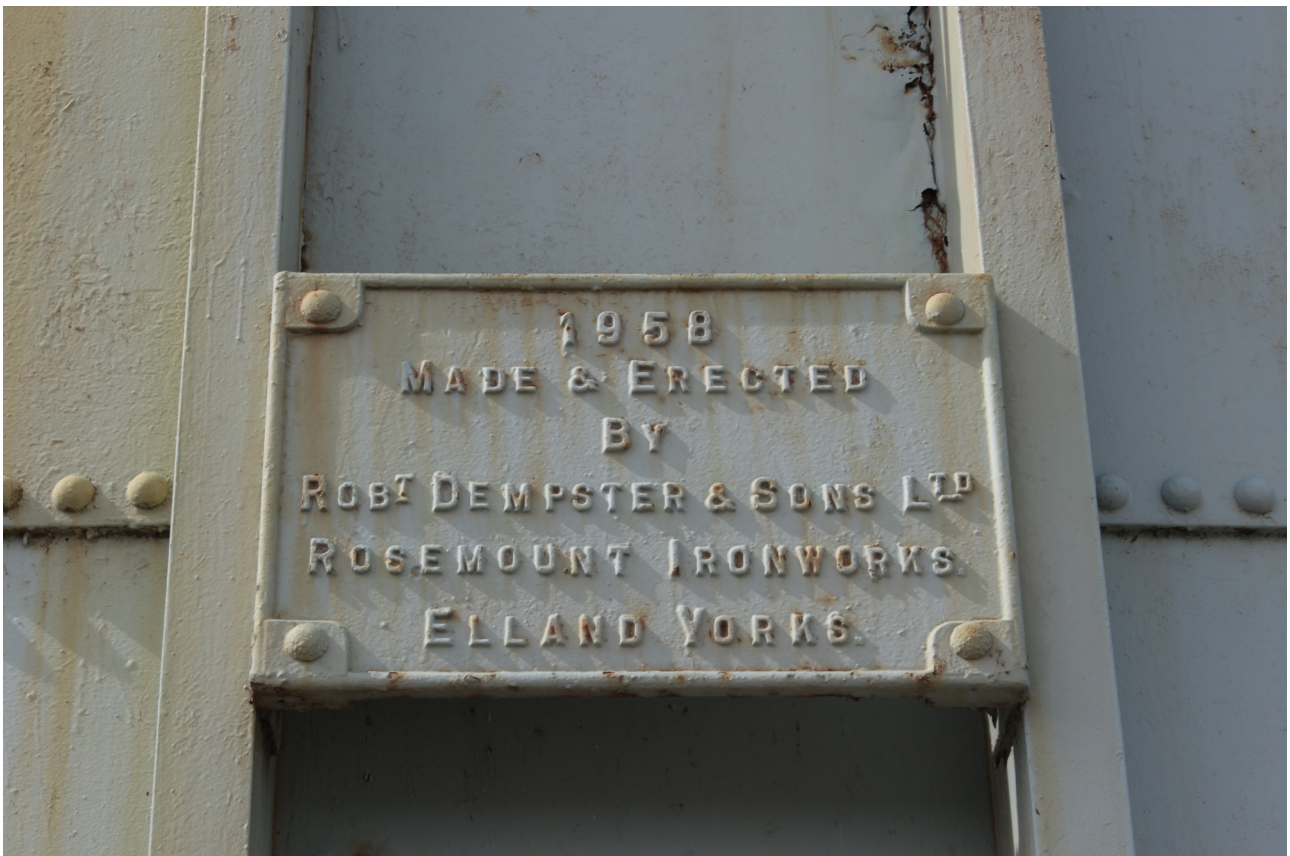
Plate 30: Gasholder No 5, detail of manufacturer's plaque from the east

4.3.1 Gasholder No 5 is a larger gasholder constructed of riveted steel plates with additional rectangular steel riveted plates and vertical stanchions supporting the upper walkway (Plates 20 - 24). There is more pipework associated with this gasholder, with a large double pipe on the north-east side (Plates 25 - 28). The upper walkway is accessed via a stair on the east side, and, as with Gasholder No 4, has a small landing in the centre supported by a steel-framed stanchion (Plate 29). On the west side of the gasholder there is a manufacturer's

plaque identifying the date of construction as 1958 and the company name Robert Dempster & Sons from Ellan in Yorkshire (Plate 30).

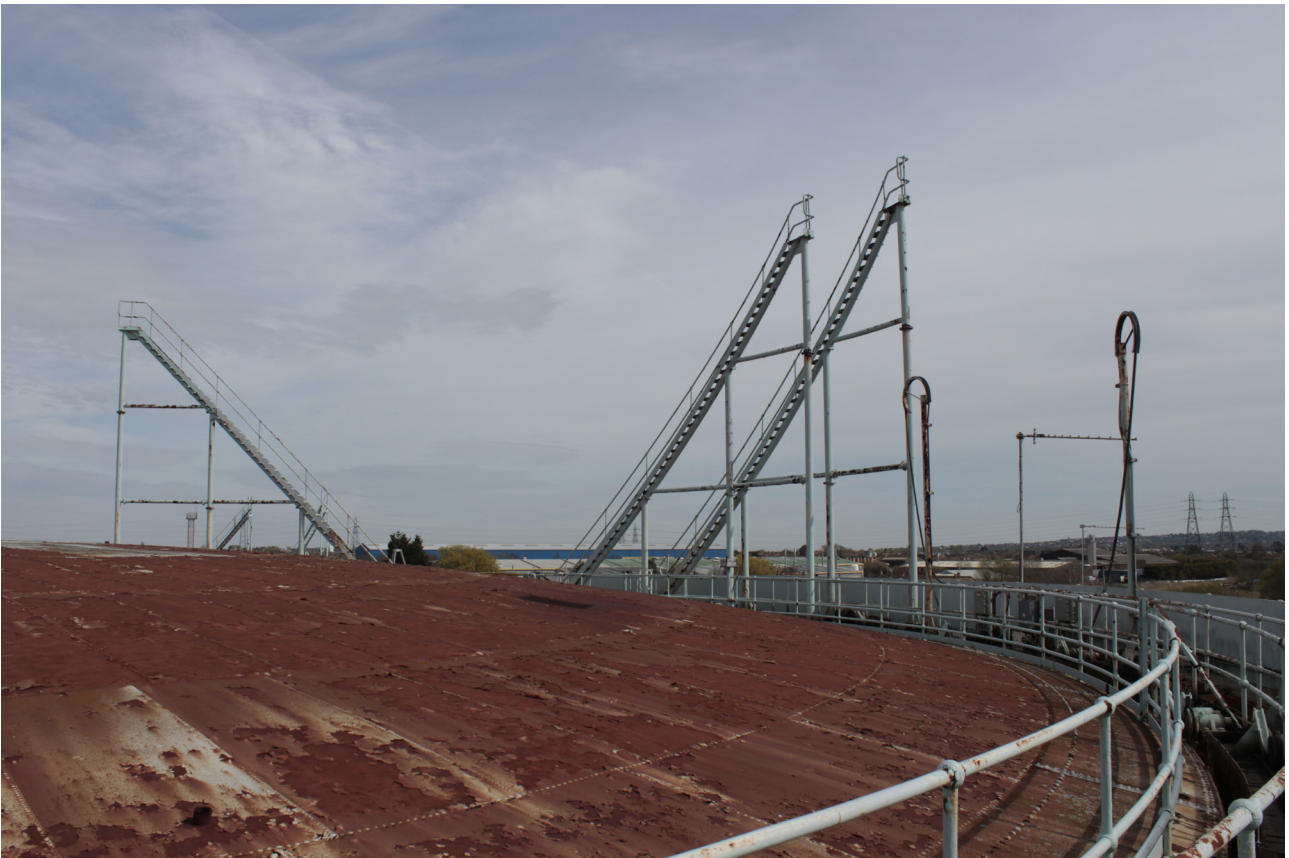
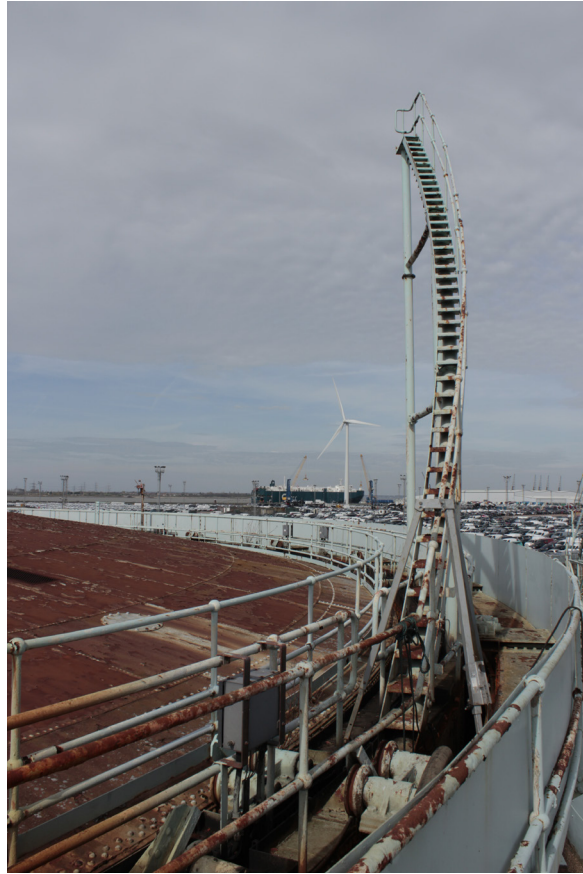
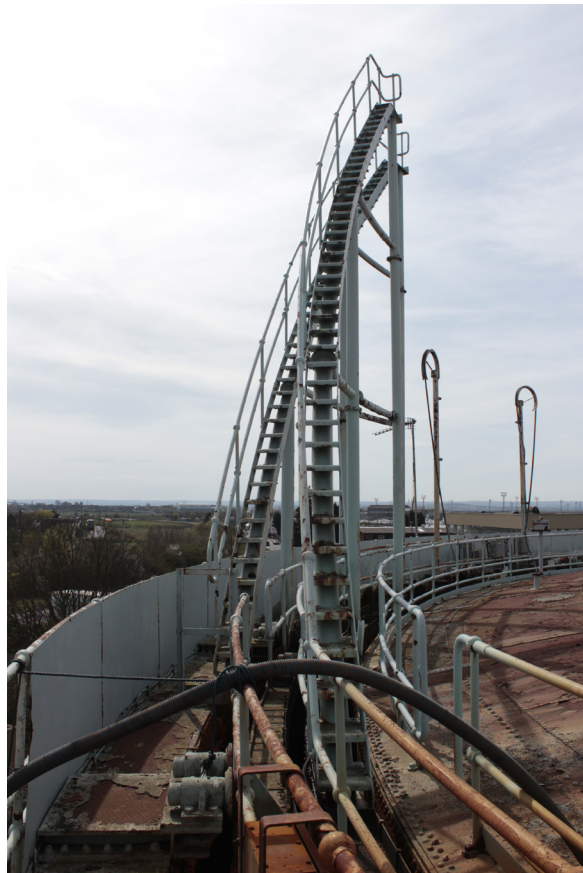
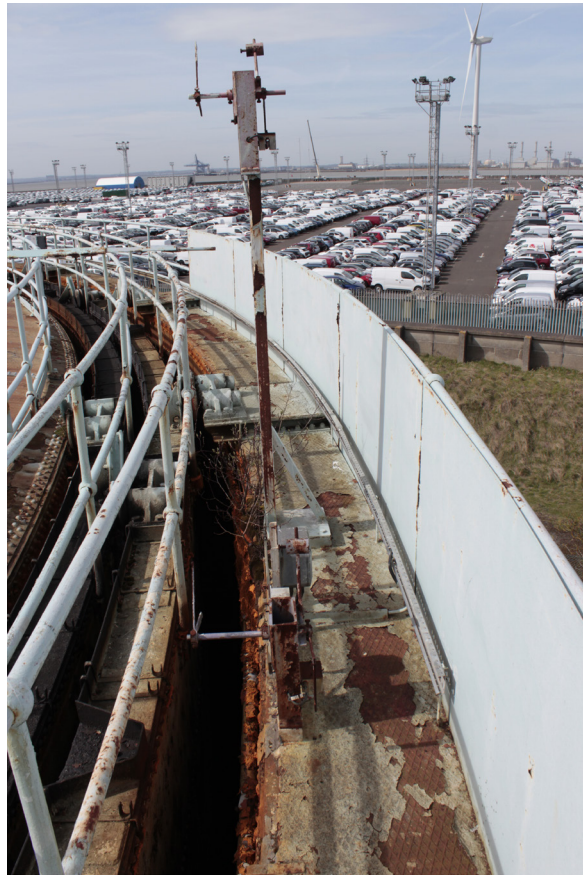
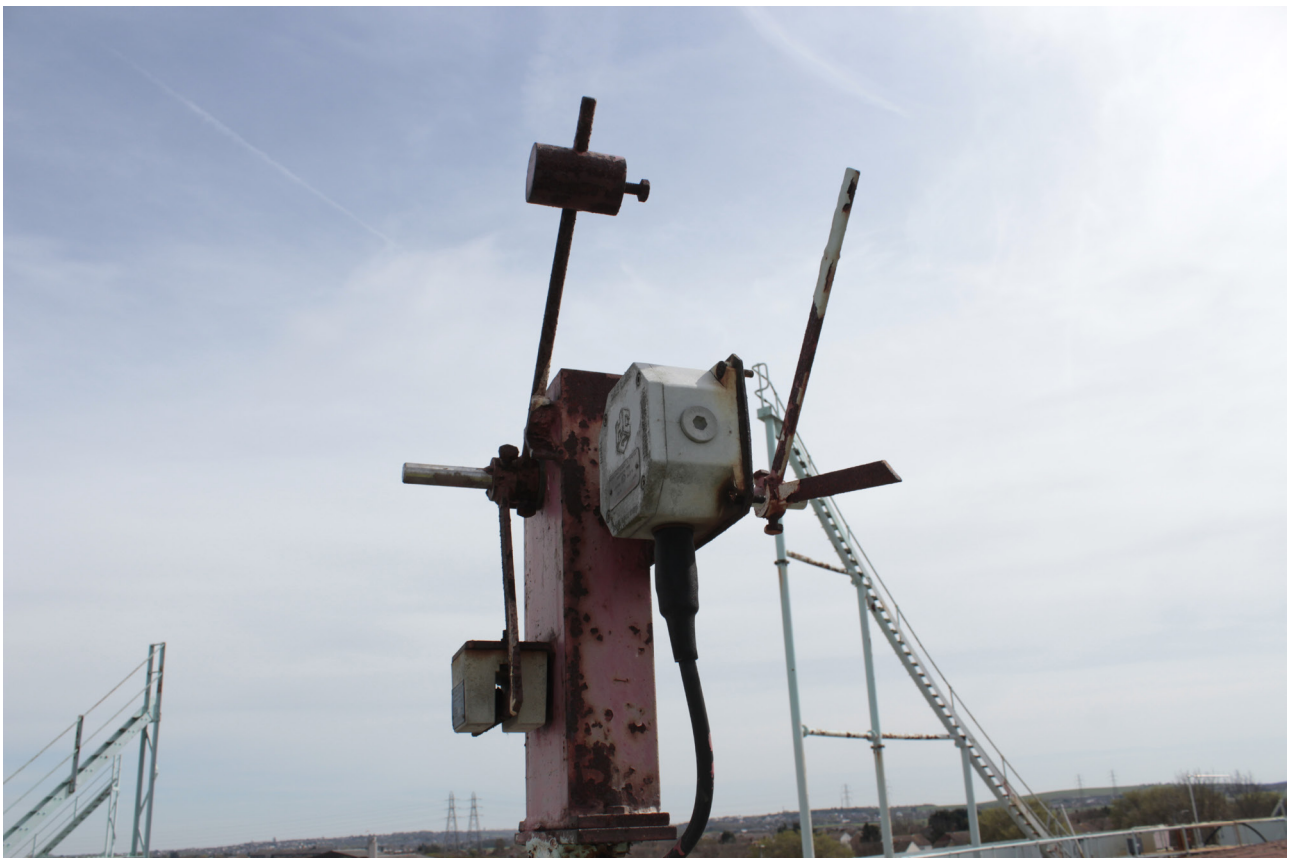
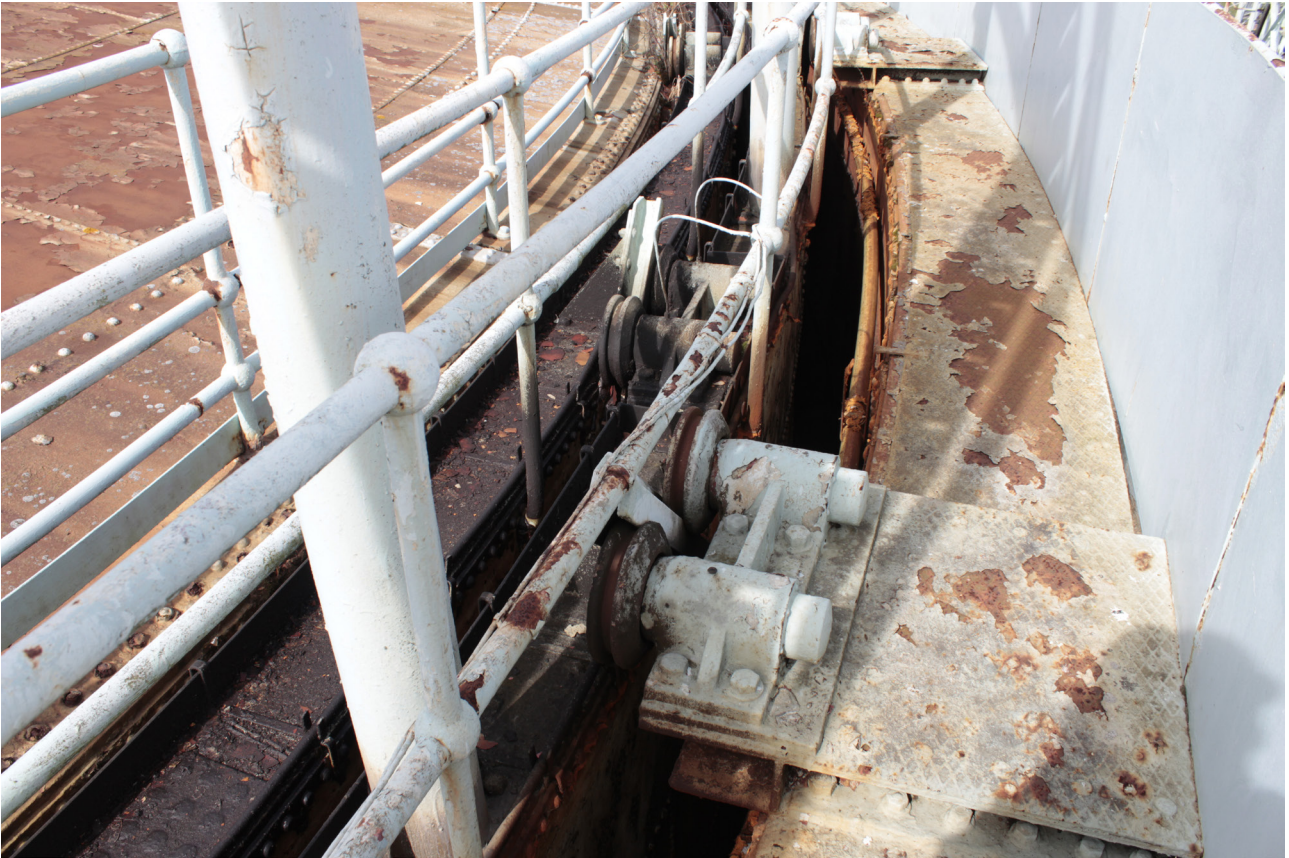
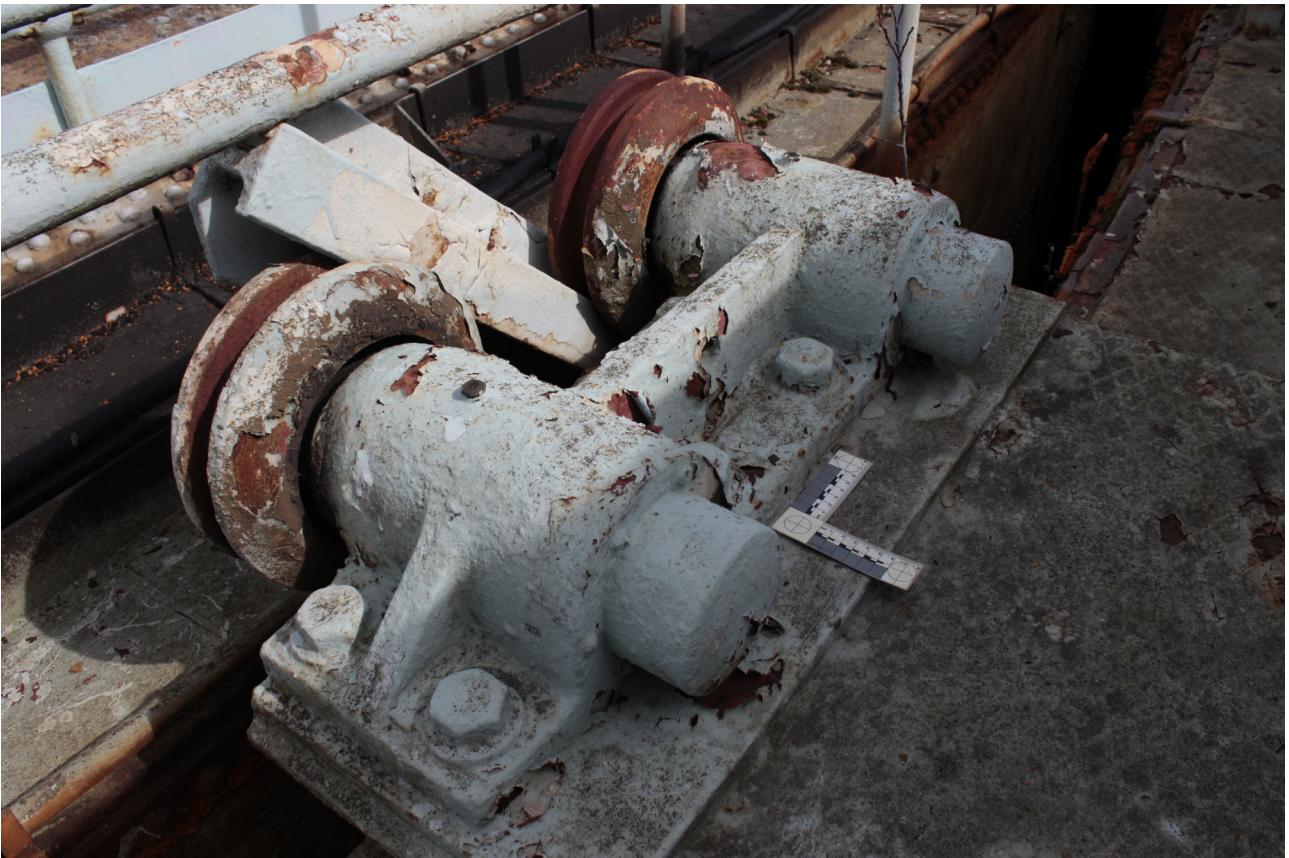
- 4.3.2 The upper walkway to this gasholder was also accessed during the survey providing an opportunity to see the workings of the lift operations. As with Gasholder No 4, the electric pump and motor is located just below the walkway at the top of the stair (Plate 31). The walkway is then framed by steel safety rails with the machinery and features for the operation of the spiral-guided lifts still *in situ*, including (as with Gasholder No 4) the roller carriage which guides the upwards or downwards movement of the gasholder (Plates 32 – 38).

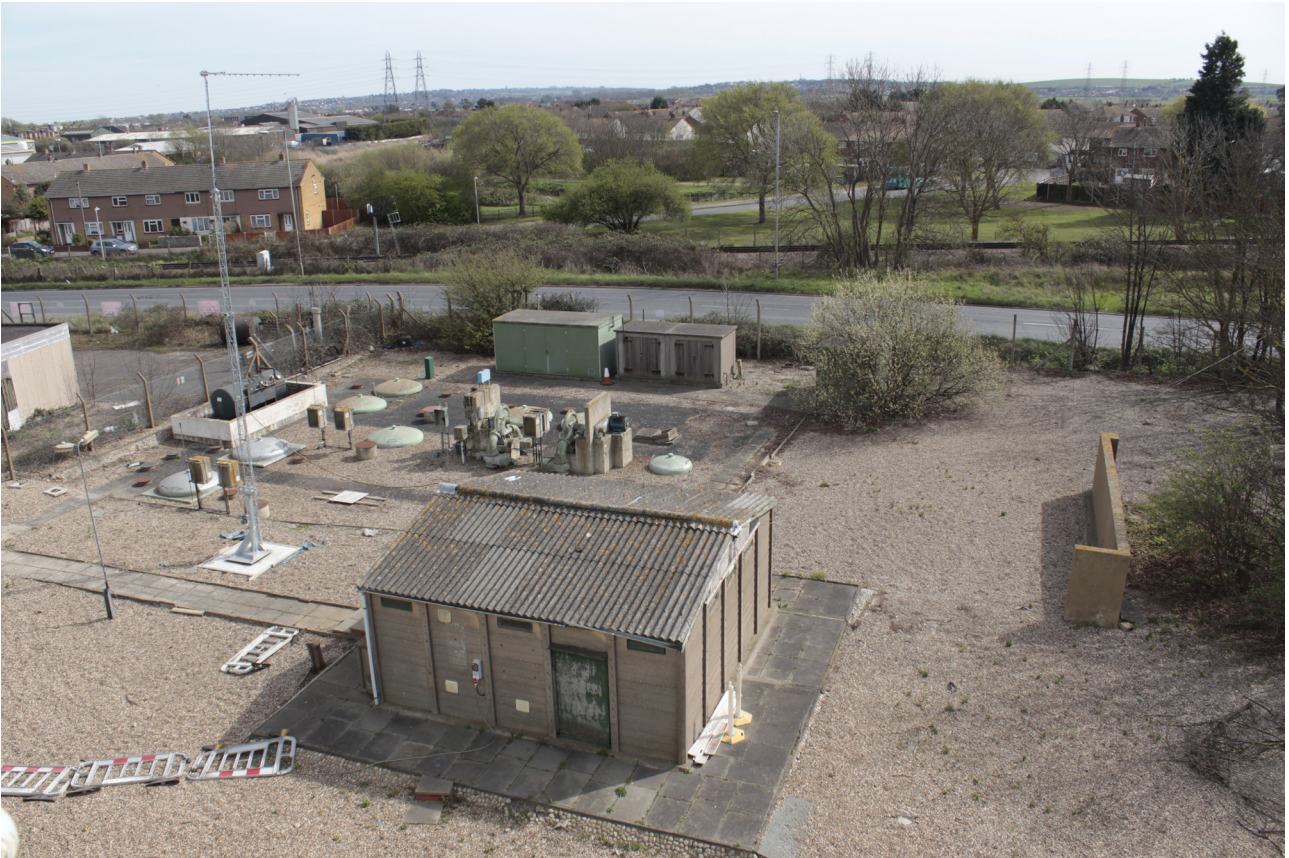
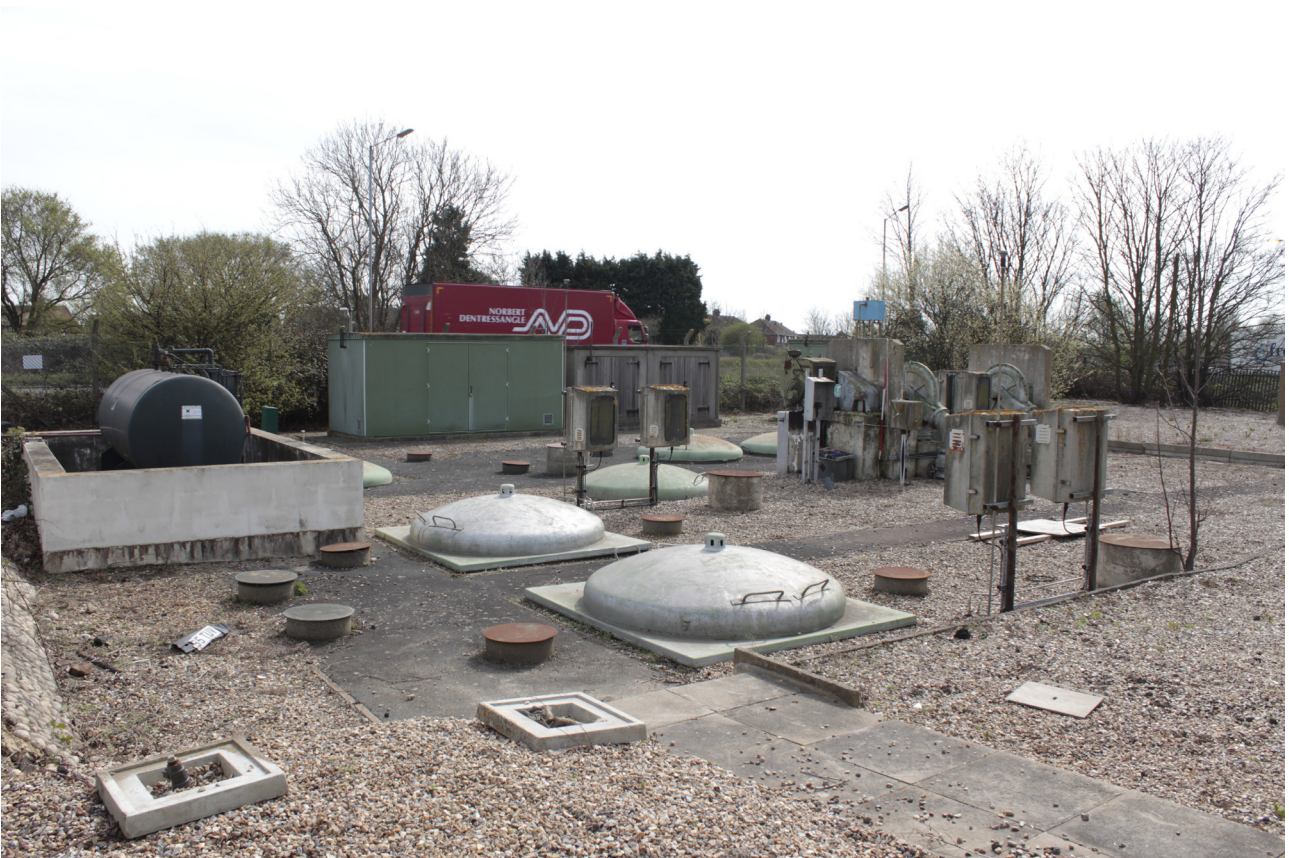
- 4.4.1 All the gasworks buildings were relatively modern in date and consisted of a number of flat roofed concrete and brick structures and a tank set in a concrete compound largely located to the south-east of the site (Plates 39 - 44). The large pipework associated with the input/output of the gas supply is also located to the south-east side (Plates 45 & 46).
