Easter Road LIDL, Edinburgh: Archaeological Excavation Data Structure Report

AOC Project No: 23641

June 2017

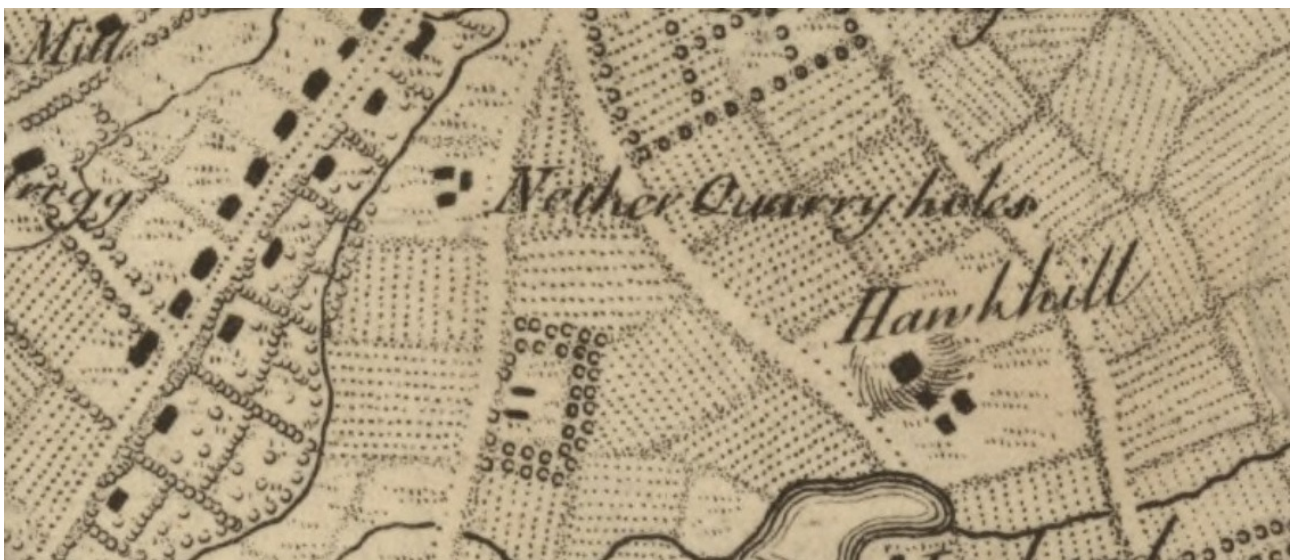
Figure 2: Extract from Laurie's 1766 map

- 1.3.1 The National Monuments Register shows no sites existing within the sites boundaries. The nearest sites noted are the Eastern Cemetery to the immediate east, several listed buildings to the south and west, and 17th century plague burials to the south.
- 1.3.2 The cartographic sources show that the site was part of a field system in 1766 (Laurie; Figure 2) to the north of a tree lined property, later noted as belonging to J. Sligo Esq (Ainslie 1804). There is no development on the site until 1853 when boundaries and fields related to the Drum House Nursery are placed through the area. There are also two new cottages located to the immediate northwest of the site, labelled as Quarryholes Cottages (Ordnance Survey 1853; Figure 3).

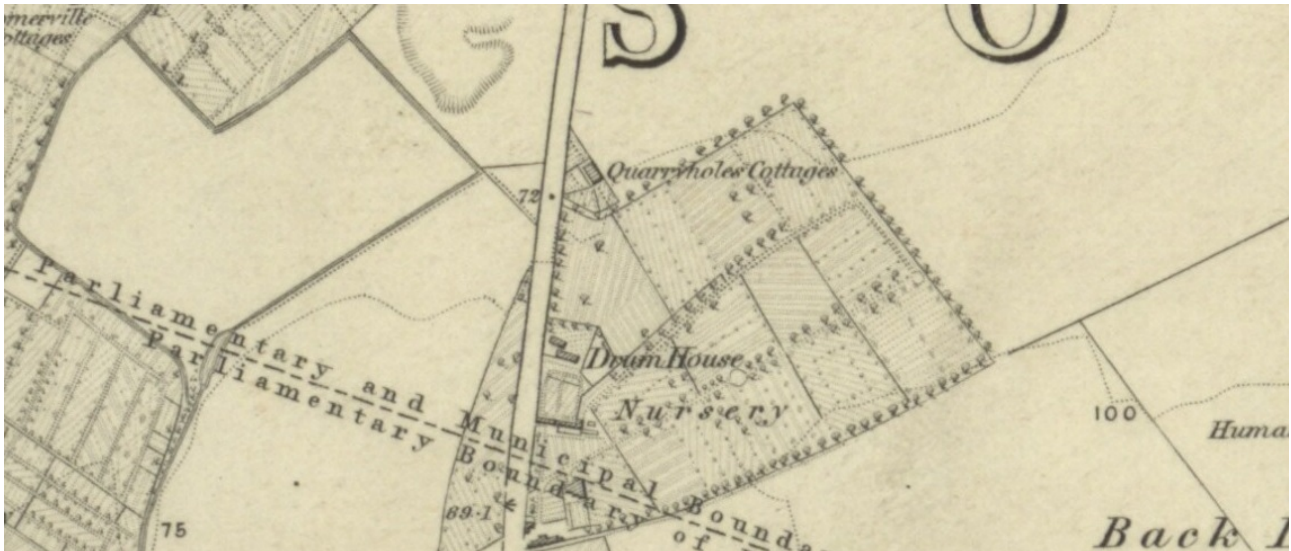
Figure 3: Extract from Ordnance Survey 1853

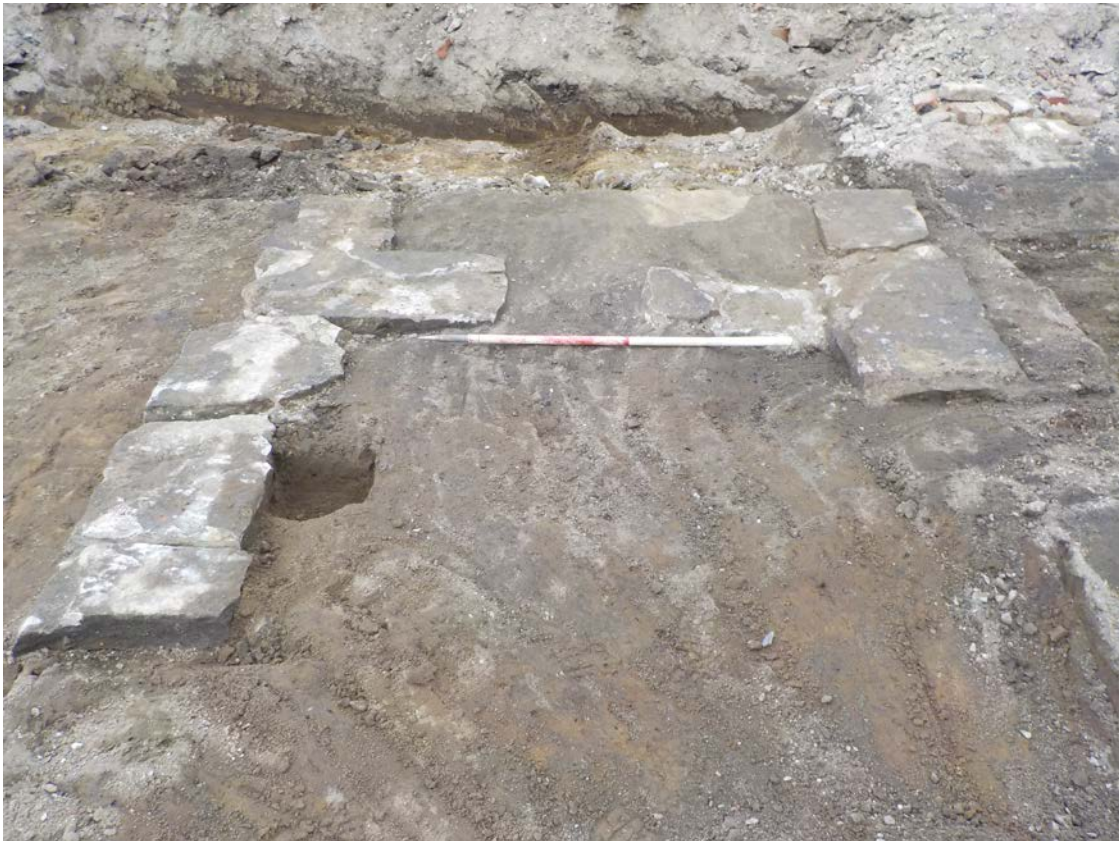
- 5.2.2 Six discrete areas of wall foundation were uncovered during the excavation (Figure 5). Three of these were to the west of the excavation area, wall [002] & [003], wall [004] & [005] and wall [006]. One was to the north wall [007] & [013] and one towards the eastern boundary wall [008] & [009], as well as a small area of irregular shaped sandstone flagstones to the southern most edge, [014]. All walls were of a rough hewn sandstone block construction with lime and sand bonding. The foundations were a single course, with individual sandstone blocks varying in dimensions (0.5 - 0.7 m x 0.35 - 0.41 m x 0.12-0.40 m). All the walls were set into [028] with no visible cut and had been severely truncated by later building works associated with the site.

Plate 1 View of Greenhouse foundation [002-005], Structure 1

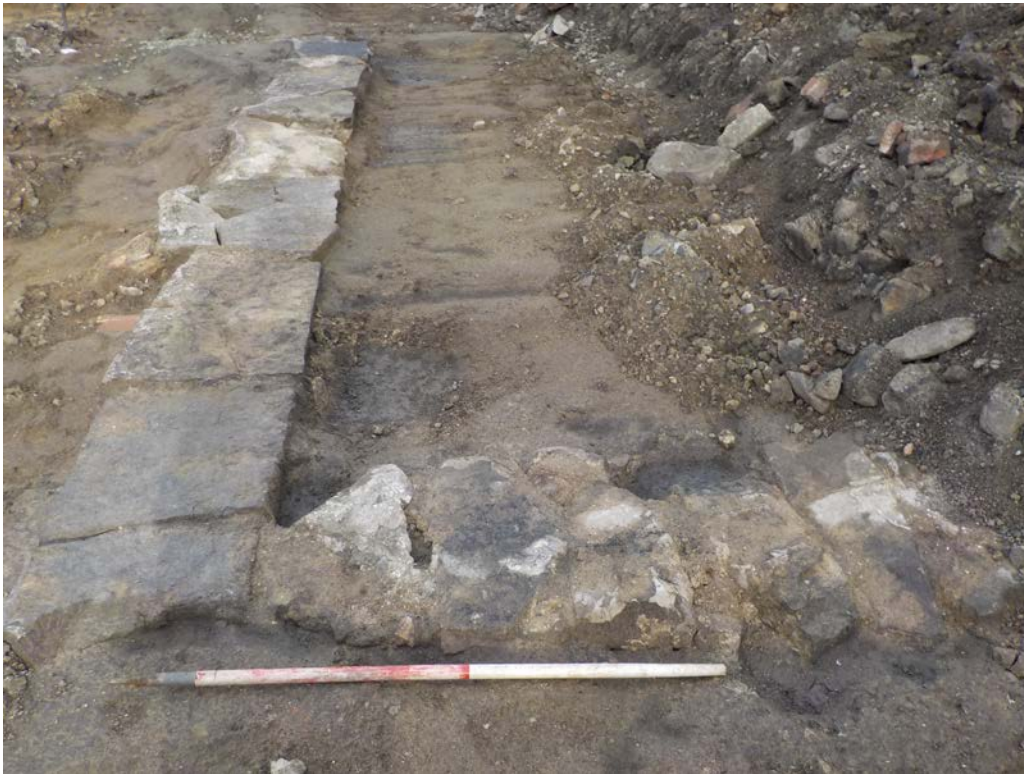
- 6.1 The archaeological excavation completed at the new LIDL site on Easter Road has shown partial remains of structures not previously detailed on the cartographic evidence. The majority had been previously truncated by later building works.
- 6.2 The sandstone block foundations likely relate to relatively temporary structures associated with the 19th C Drum House Nursery. These potentially acted as the foundations bases for Victorian greenhouses. The remains form the bases of five distinct structures (Figure 5), however they have largely been truncated. Some fragments of 19th C pottery was found in amongst the stones, thus further suggesting their Victorian origin.

Plate 2 View of foundations [007] and [013], Structure 3

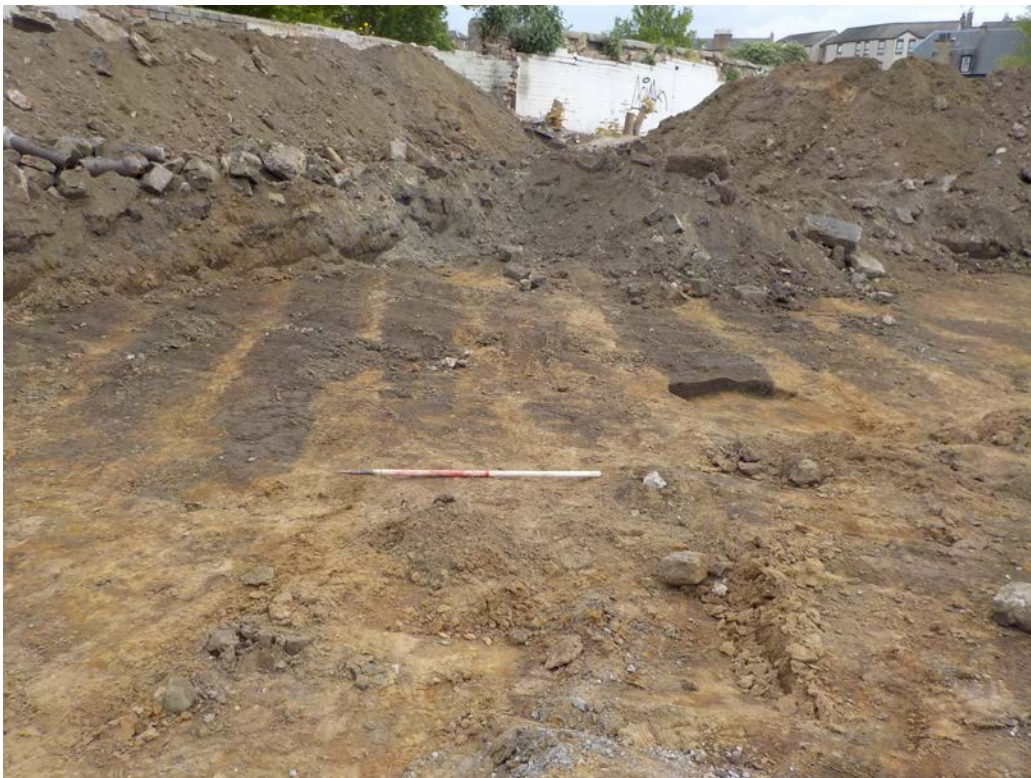
- 6.3 The pit features contained several post-medieval to modern white earthenware pottery fragments. Thus they are also likely related to these 'greenhouses' in some manner. They are at least likely to be associated with the Drum House Nursery in some incarnation, perhaps acting as planting beds. The fills and forms of the large pits were not dissimilar to the furrows and are potentially contemporaneous. The furrows are therefore likely to be part of the planting beds as seen in the 1854 Ordnance Survey map.

Plate 3 View of furrows [011]
