Aberlady, East Lothian: Archaeological Evaluation Data Structure Report

AOC Project No: 23882

Planning Application No: 16/00552/PM

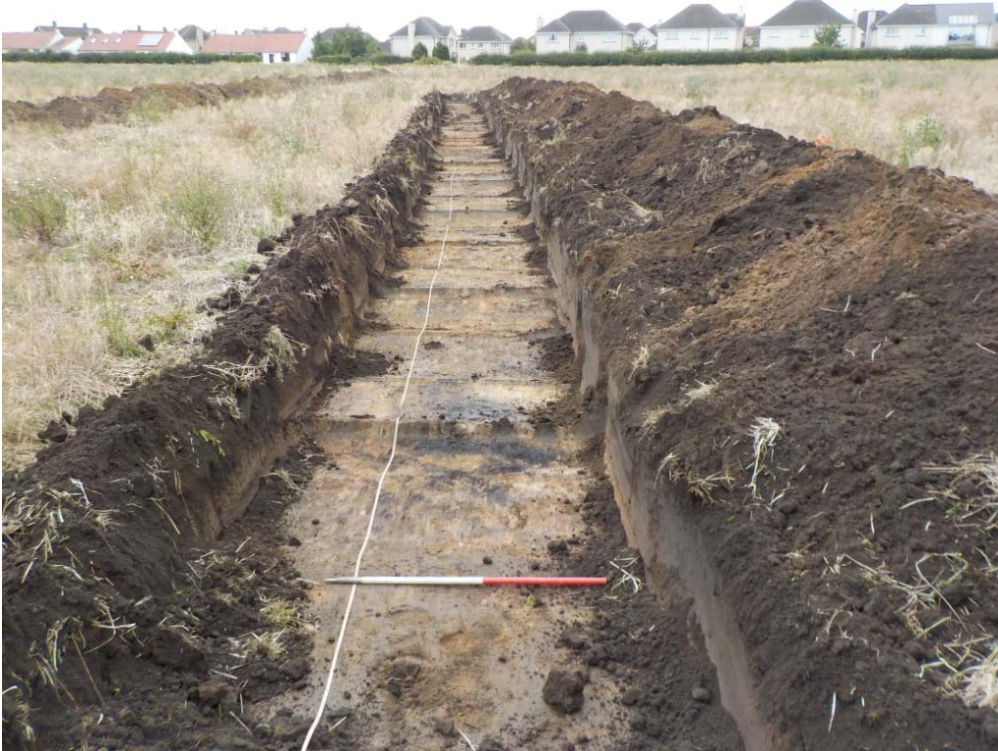
Plate 1: General view of Trench 9

Dimensions 50 m by 2 m
 Excavated Area 100 m²
 Excavated Orientation E to W
 Soil make-up Topsoil – Dark grey sandy loam – 0.6 m
 Natural Subsoil Mottled orange, brown and pink slightly clayey sand
 Significant Features None
 Other Features Ceramic tile drains at 1 m and 40 m aligned NNE-SSW.
 Rubble drain at 7.4 m to 17.9 m aligned WNW-ESE

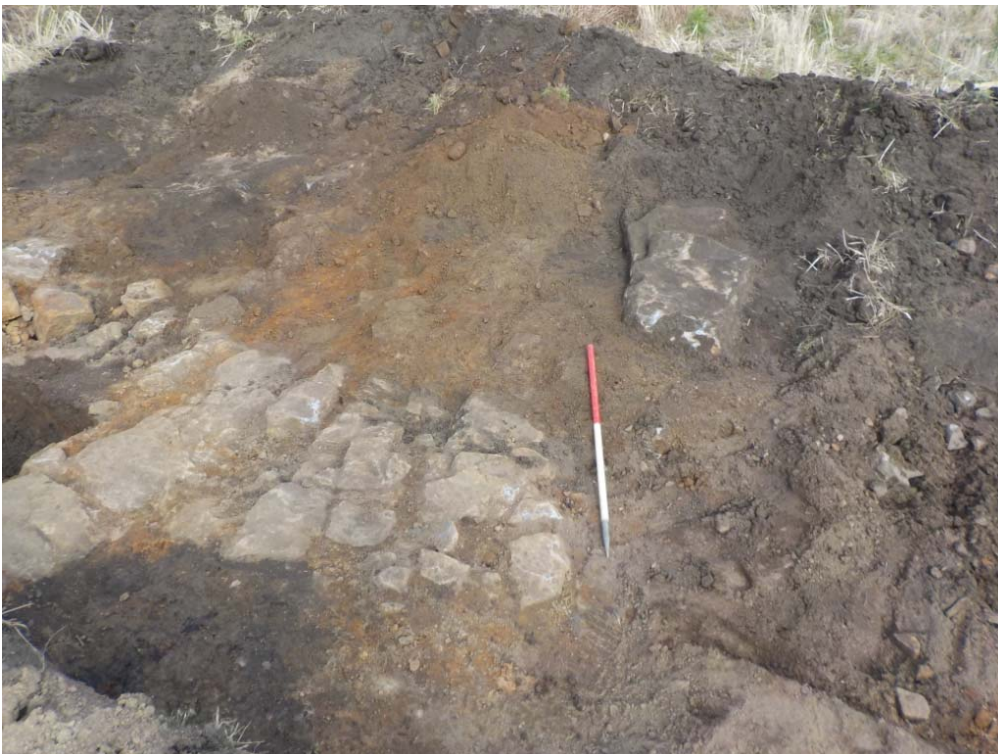
Plate 2: General view of bedrock in Trench 1

A large area of bedrock was revealed within Trench 1 & Trench 8, with two areas where the rock had been cut out, most likely to enable easier ploughing of the field. Four modern iron objects were found within these stone hole pits, including a large nail or bolt and a thick piece of metal sheeting.

<i>Dimensions</i>	100 m by 2 m
<i>Excavated Area</i>	200 m ²
<i>Excavated Orientation</i>	E to W
<i>Soil make-up</i>	Topsoil – Dark grey sandy loam – 0.6 m
<i>Natural Subsoil</i>	Mottled orange, brown and pink slightly clayey sand
<i>Significant Features</i>	None
<i>Other Features</i>	[101] – bedrock; [102]/[103] – large quarry pit; [104] – bedrock; [105]/[106] – large quarry pit; [107] – bedrock; [108] – bedrock; [109] – bedrock. Ceramic tile drain at 4.6 m and 20.5 m aligned NE-SW. Also at 56 m and 67 m aligned E-W.
<i>Finds</i>	None

[107]	T1	Large area of truncated stone that is under subsoil to the N of T1. Bedrock protrusion
[108]	T1	Fragments of stone aligned NW-SE and measuring 2 m long by 0.5 m wide. Fragmented by ploughing and machine excavation. Bedrock protrusion
[109]	T1	Line of truncated bedrock measuring 2 m long by 0.7 m wide, aligned NW-SE. Bedrock protrusion
