Edmondstone Estate, Walled Garden & 8 Acre Field Edinburgh; Archaeological Monitored Top-soil Strip & Excavation Data Structure Report

OASIS No:1-291723

AOC 23911

14th July 2017

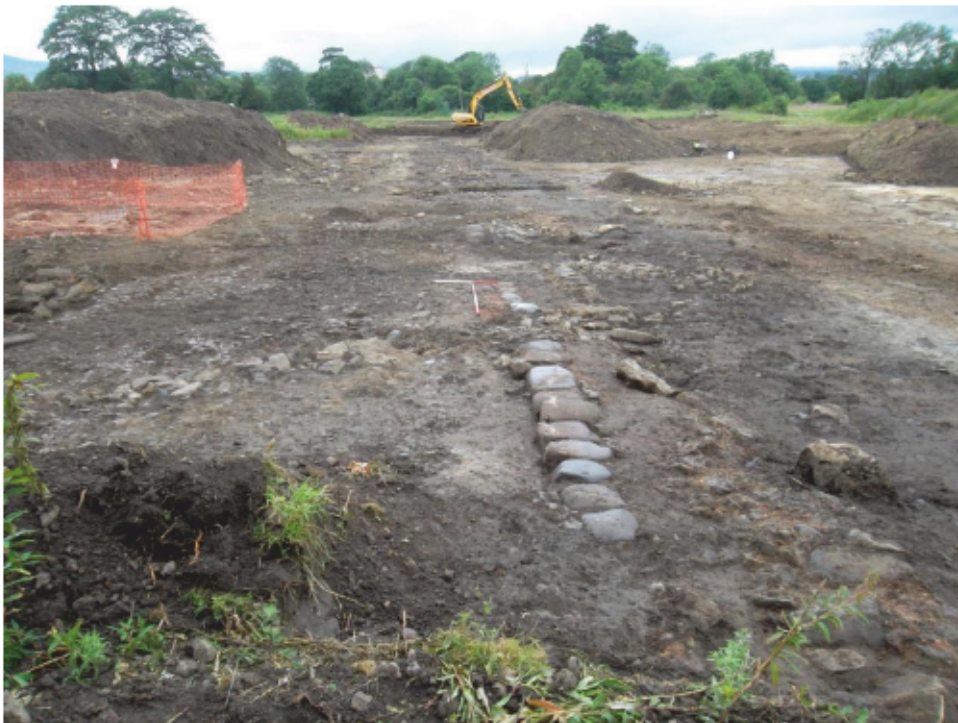
- 4.2.1 The fragmentary remains of a cobbled road [023] aligned east-west, was uncovered to the east of the Eight Acre Field. The road was partially lined with large rounded kerb stones [015] which measured on average 0.46 m by 0.62 m in size.

- 4.2.2 The base of the road [016] consisted of a highly compacted mix of small angular and sub angular stones embedded in the clay subsoil. This deposit measured 4.2 m wide and continued for approximately 12 m before fading out (Plate 1).

- 4.2.3 The remains of the original road surface were present in the form of patches of compact, flat rounded stones raised 0.22 - 0.23m above (016).
- 4.2.4 Small finds were restricted to a small assemblage of 19th century ceramics retrieved from the base layer of the road. However the road has undergone significant truncation and later material from the overlying top-soil is likely to have become mixed in with the road matrix. The form and location of the road coupled with its appearance on the Roy map of 1747-55 suggest an earlier date for the road. It most probably has its origins in with the early 16th century development of the estate. Given its east-west alignment and metalled surface there is also the possibility of an even earlier Roman date for the structure as an extension of Dere Street.

Plate 1: Overview of road (016)

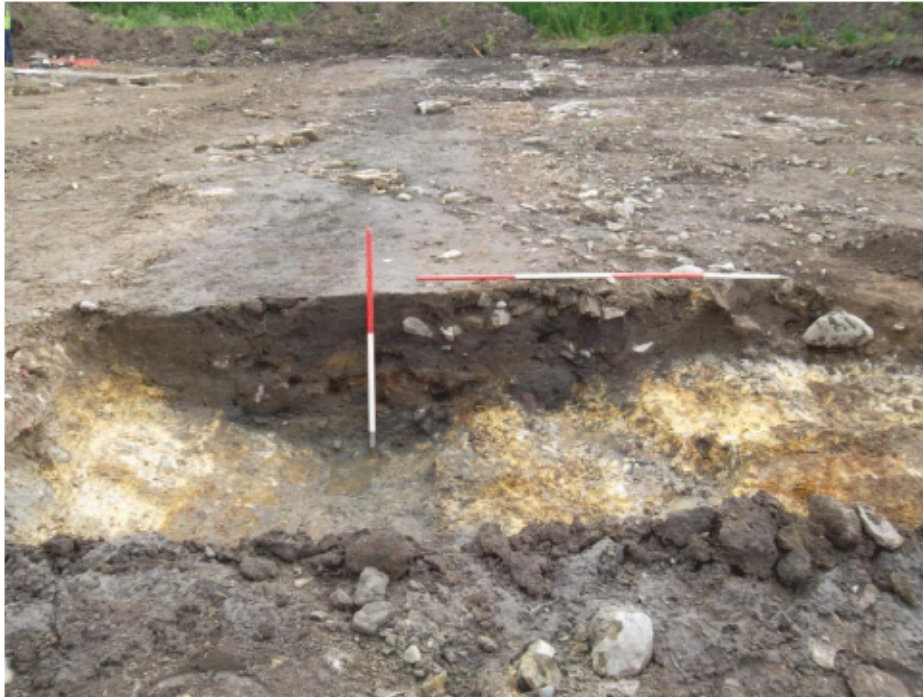
- 4.3.1 A linear feature (009) was observed running parallel to the road throughout its recorded extent.
- 4.3.1.1 The ditch measured 4.32 m in width with a depth of 0.84 m. the ditch had steeply sloping sides and a broad, u-shaped base. The upper fill of the ditch (014) ran through the entirety of the ditch and consisted of moderately compacted sandy clay. This overlay a very compacted basal deposit (029) of sandy silt/grey clay which ranged from 0.06 m to 0.22 m in depth (Plate 2). In slot 2 a deposit of yellow, mixed clay was found lying between contexts (014) and (029). This measured 0.11 m. This deposit was not encountered in any of the other slots.

Plate 2: Slot 1 through ditch [009]

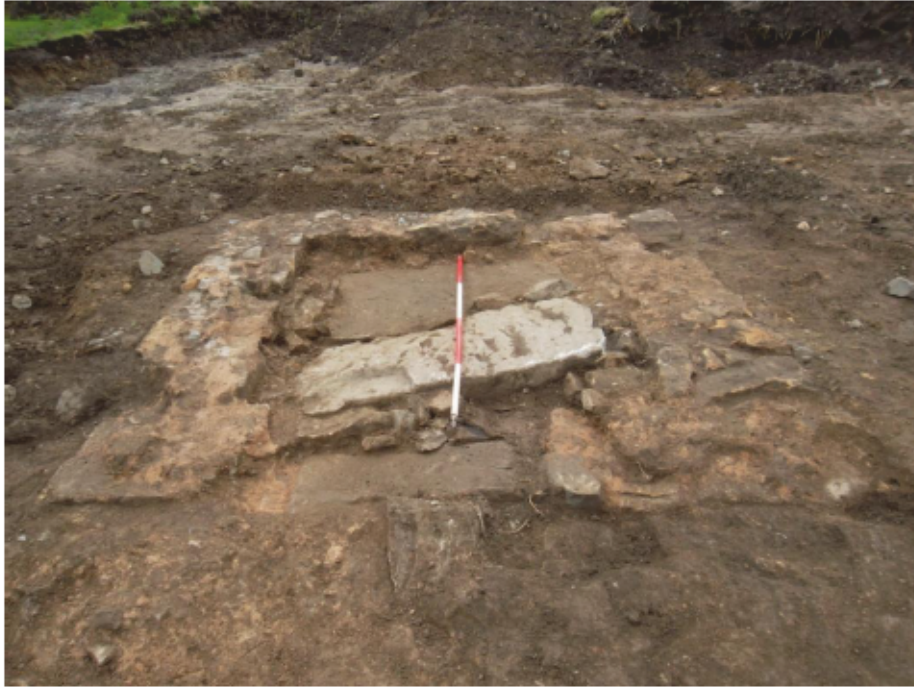
- 4.4.1 A probable large square sandstone cistern of indeterminate date was discovered to the immediate south of the road. The cistern was constructed from large rectangular sandstone blocks bonded with concrete. The opening had been sealed using two large rectangular cover stones. These were cracked and therefore the decision to continue with further investigatory works was dismissed due to potential health and safety concerns (Plate 3). Though the capstones were kept in place, water could be seen through cracks in the capping stones revealing a water filled interior.

Plate 3: Cistern/well [007]

- 4.4.2 Two rubble drains were seen running into the cistern including drain [018] running into the feature from the east and a second drain entering it from the west. Two nails were recovered from the top-soil directly overlying the feature.

- 4.4.3 No direct dating evidence was retrieved from the feature and it is also difficult to date regarding form. There remains the possibility that the feature is of an earlier date given its close proximity to the road which is likely to be of Medieval or even Roman date. However, considering the designs of the drains feeding into the feature it is likely the cistern relates to water management associated with the post medieval development of the Edmondstone Estate.

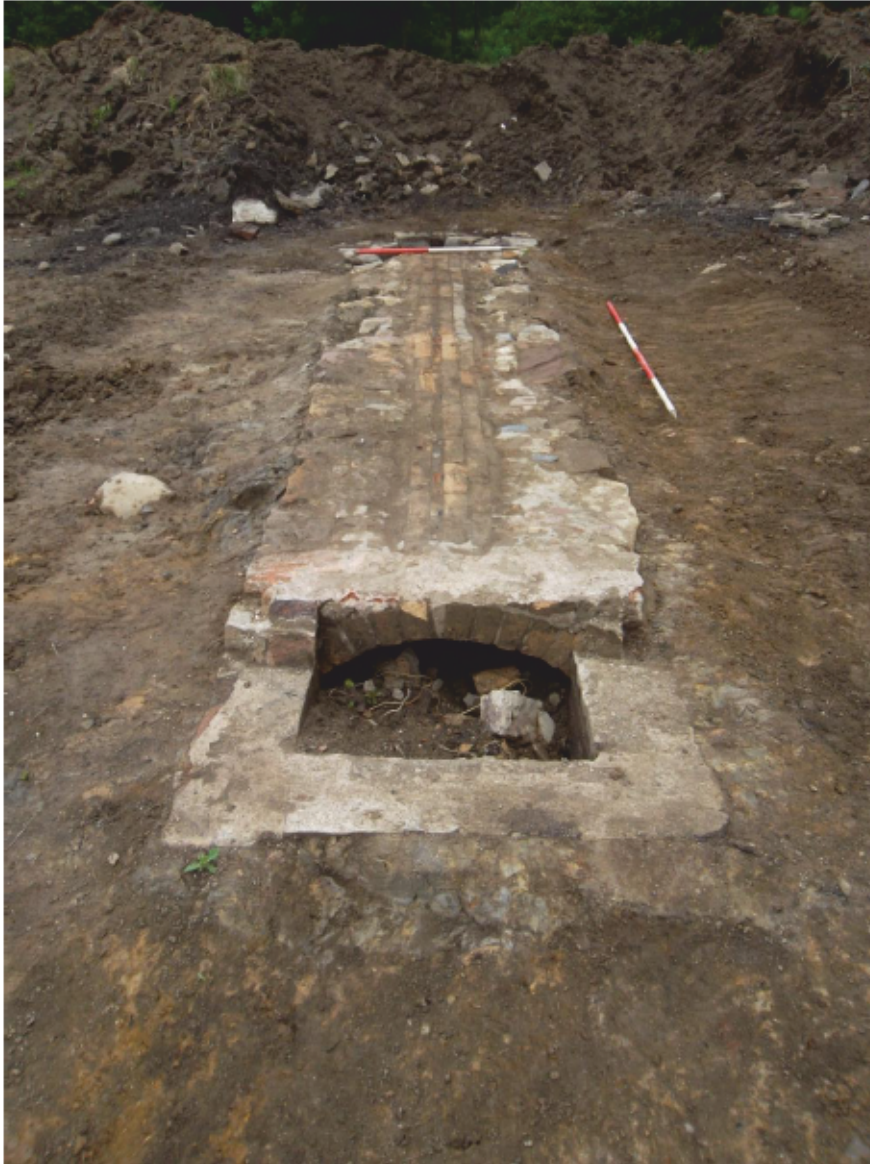
- 4.5 *Brick and Sandstone Cistern [004] and associated Well [005]*
- 4.5.1 A brick covered sandstone cistern [004] and associated well [005] were located to the north of the road. The cistern was covered by an over arching roof of concrete bonded red frogged bricks (Plate 4). A square opening at the southern extent of the feature was filled with a mixture of brick and demolition material and extended to a depth of 0.25 m before water was encountered. Various dumped materials were recovered including branded ceramic bottles and various rusted pieces of metal. The north end demonstrated a degree of damage making it impossible to determine how the well and cistern may have interacted. The structure measured 1.22 m wide by 5.58 m long.

Plate 4: Flue [004]

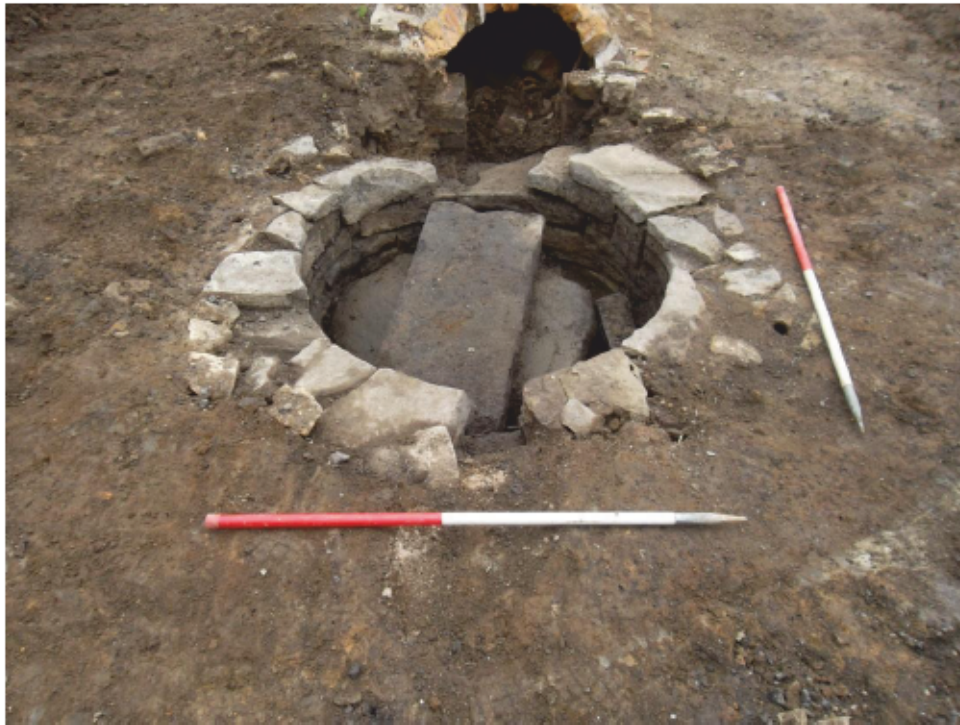
- 4.5.2 The well [005] lay to the immediate north of the cistern and was constructed using large sub rectangular blocks of unbonded sandstone. The structure was 1.10 m wide and 1.20 m in length. The depth of the well remained unknown as the existing water level prevented further excavation at a depth of 0.52m [Plate 5]. Two large sandstone capstones [028] were found within the well after cleaning which most likely collapsed in sometime after the well was covered over. The well was back filled by loosely compacted black ash. During its removal sherds of white ceramic and branded glass bottles were recovered.

Plate 5: Well [005]

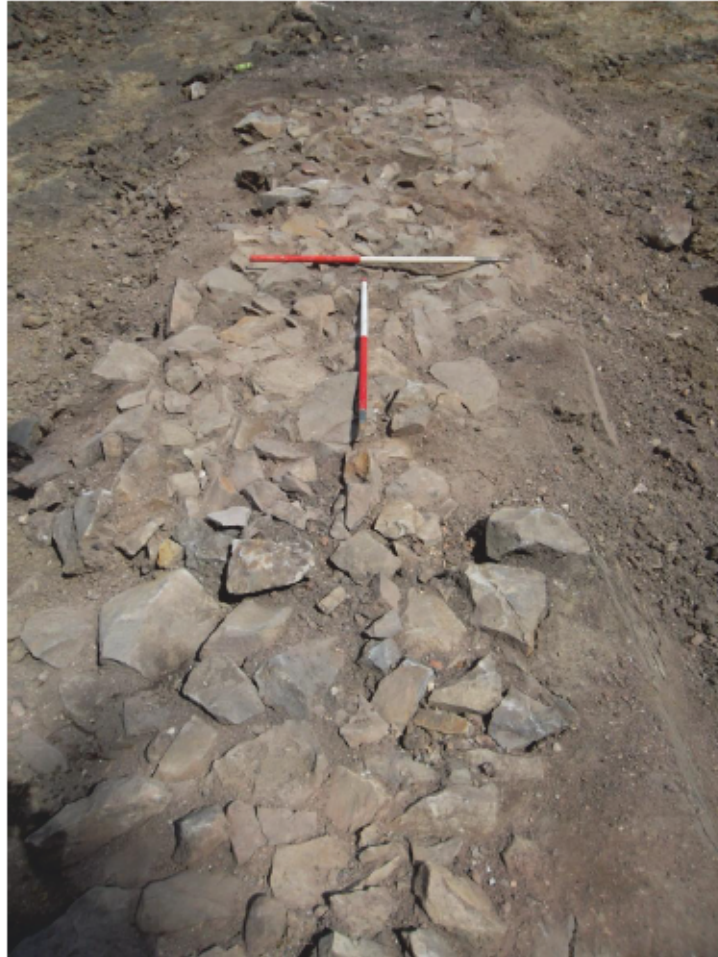
- 4.9.1 Despite extensive excavation works within the walled garden the only feature revealed was the stone track way [003] previously discovered in the GUARD evaluation in 2014 (Spence 2014). The composition of this track way consisted of small angular stones overlain by a red gritty ash (024). The path measured between 0.65 m to 0.71 m in width and up to 0.20 m in depth. The trackway extended throughout the walled garden and ran between two bricked up entrances.

Plate 6: Stone Track [003] within the Walled Garden
