New houses west of Reid Terrace, Portgordon, Moray

Archaeological Evaluation Data Structure Report

28th July 2017

AOC Project Number: 70167

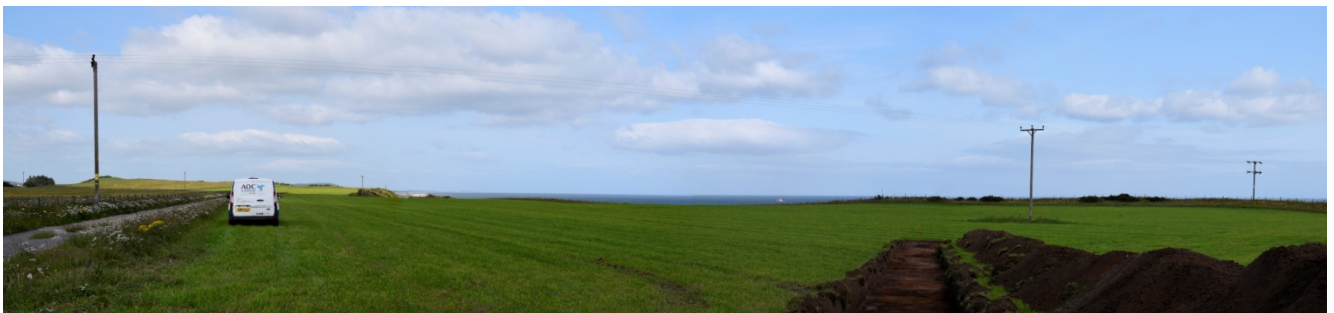
Plate 1: Panorama shot looking northwest over the north field of the development area

- 5.2 The site comprised pastoral farmland (**Plate 1**) and the plough soil averaged between 0.3 – 0.4m deep, with deeper areas along the roadside and towards the east and west extents of the development area. The land itself was relatively flat with some small hilly areas towards the west. The underlying subsoil (002) consisted of mixed sands with areas of extensive iron panning present, particularly in the eastern half of the site (**Plate 3**). A trial pit was excavated at the southeast end of Trench 13 to examine the stratigraphy of the natural. An earlier strata of natural sand – (003) (**Plate 2**) – contained some clay, and if this prevented the drainage of water from the layer above it may account for the interesting iron pan formation across the site.

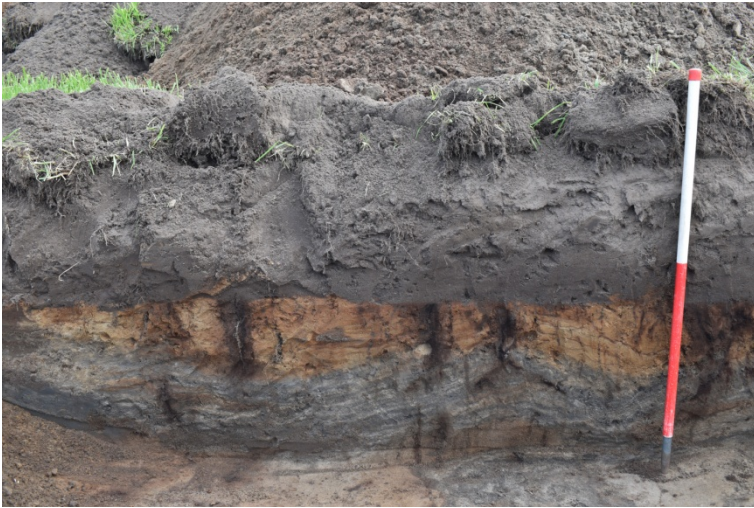
Plate 2: Record shot of natural stratigraphy, southwest facing section of Trench13, note the first pale yellow sand horizon (002) and the grey clay-rich sand horizon (003) underlying

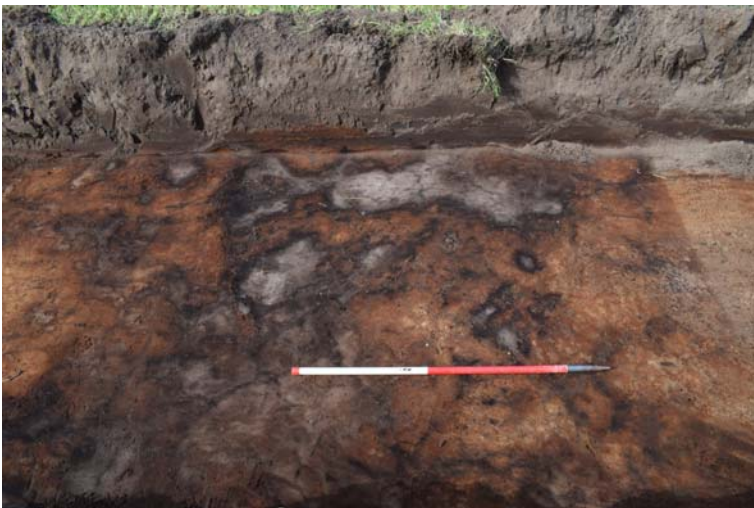
Plate 3: Record shot of iron pan in the natural sandy subsoil

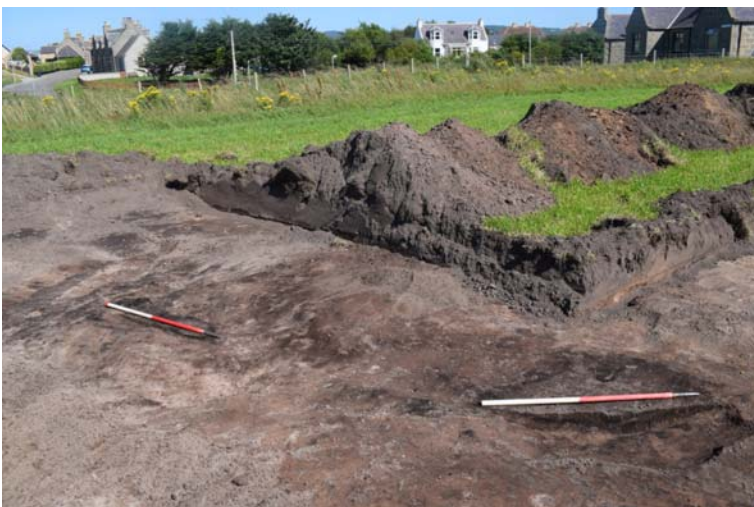
- 5.3 Trench 12 contained the remains of three possible pits – [1201], [1203] and [1205] (**Plate 4**), the last of which had been truncated by a plough mark [1207] that contained a fragment of C19 pottery – SF01. The amorphous and sometimes indistinct cuts and nondescript fills of these features indicate that they may be of natural and not of archaeological provenance. Trench 15 contained two pits, [1501] and [1503], the former of which had been partially overlain by the trench edge. There were no hand-retrieved artefacts/ecofacts from the pits, which are of unknown age and function (**Plate 5**).

Plate 4: Mid-excavation image of pits [1203] (right) and [1205] (left)

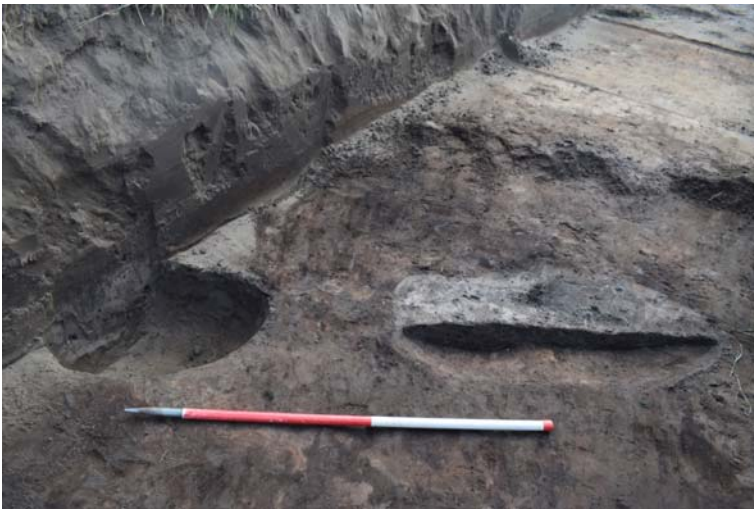
Plate 5: Mid-excitation image of pits [1501] (left) and [1503] (right)

- 6.1 The archaeological evaluation at the development site identified five small pits, three of which may be natural features – [1501], [1503] and [1505]. The two pits identified south of the road, [1501] and [1503] are of archaeological significance. The remaining two features, a possible field boundary and drainage ditch, are likely relatively recent features.
- 6.2 While there were no other indications of archaeology present over the remainder of the site, it seems most likely that the area around the location of [1501] and [1503] has the most archaeological potential. The landscape conditions are also promising for containing archaeological potential. Due to the access constraints in this south field limiting the evaluation, an archaeological watching brief in this area is recommended to ensure that any surviving archaeology is recorded during development.

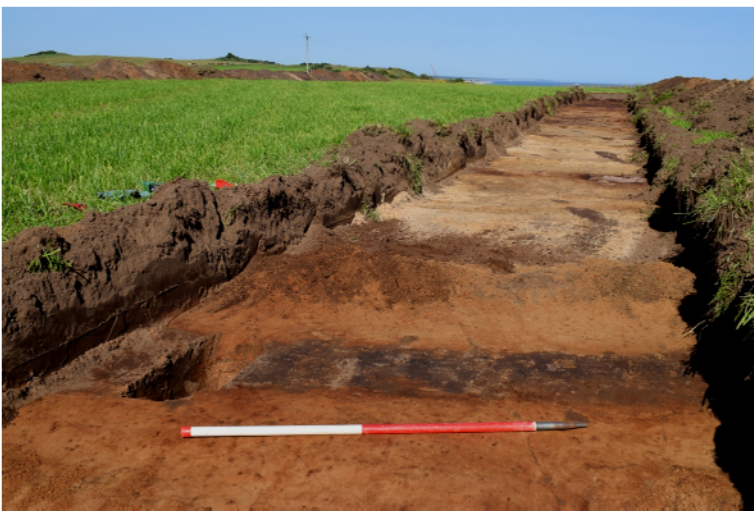
- 5.4 A shallow linear slot that appeared in Trenches 4, 5 and 17 was interpreted tentatively as the remains of an early 20th century field boundary (**Plate 6**), first identified on the 1902 2nd edition Ordnance Survey map (NLS 2017; **Figure 4**). Although there was no datable information recovered to confirm this interpretation, it does appear in the same location as the boundary shown in the map.

Plate 6: Looking west over possible field boundary [401]

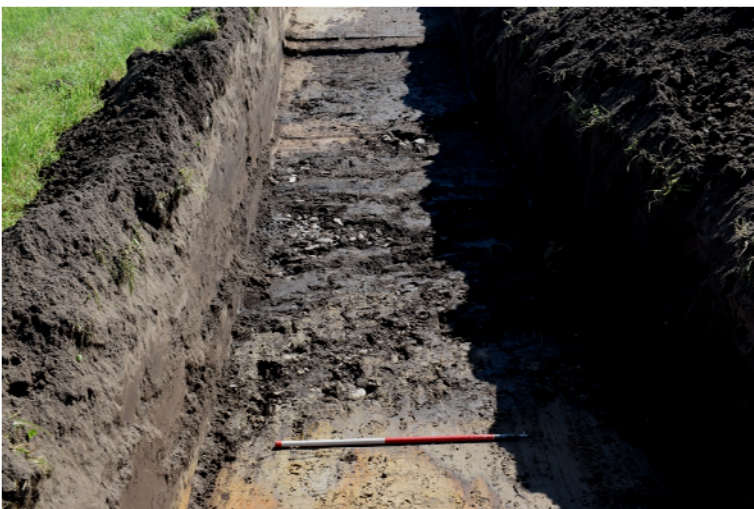
- 5.5 A large clay and stone filled ditch present in Trench 1 and 3, following the base contour of a small hillock towards the cliff edge, was interpreted as a drainage ditch (**Plate 7**). The landowner recalls augmenting this in the past.

Plate 7: Looking southeast over drainage ditch [101/301]
