# Lion's House, Berwick-upon-Tweed

## Archaeological Watching Brief:

### Data Structure Report

*AOC Project No: 23900*

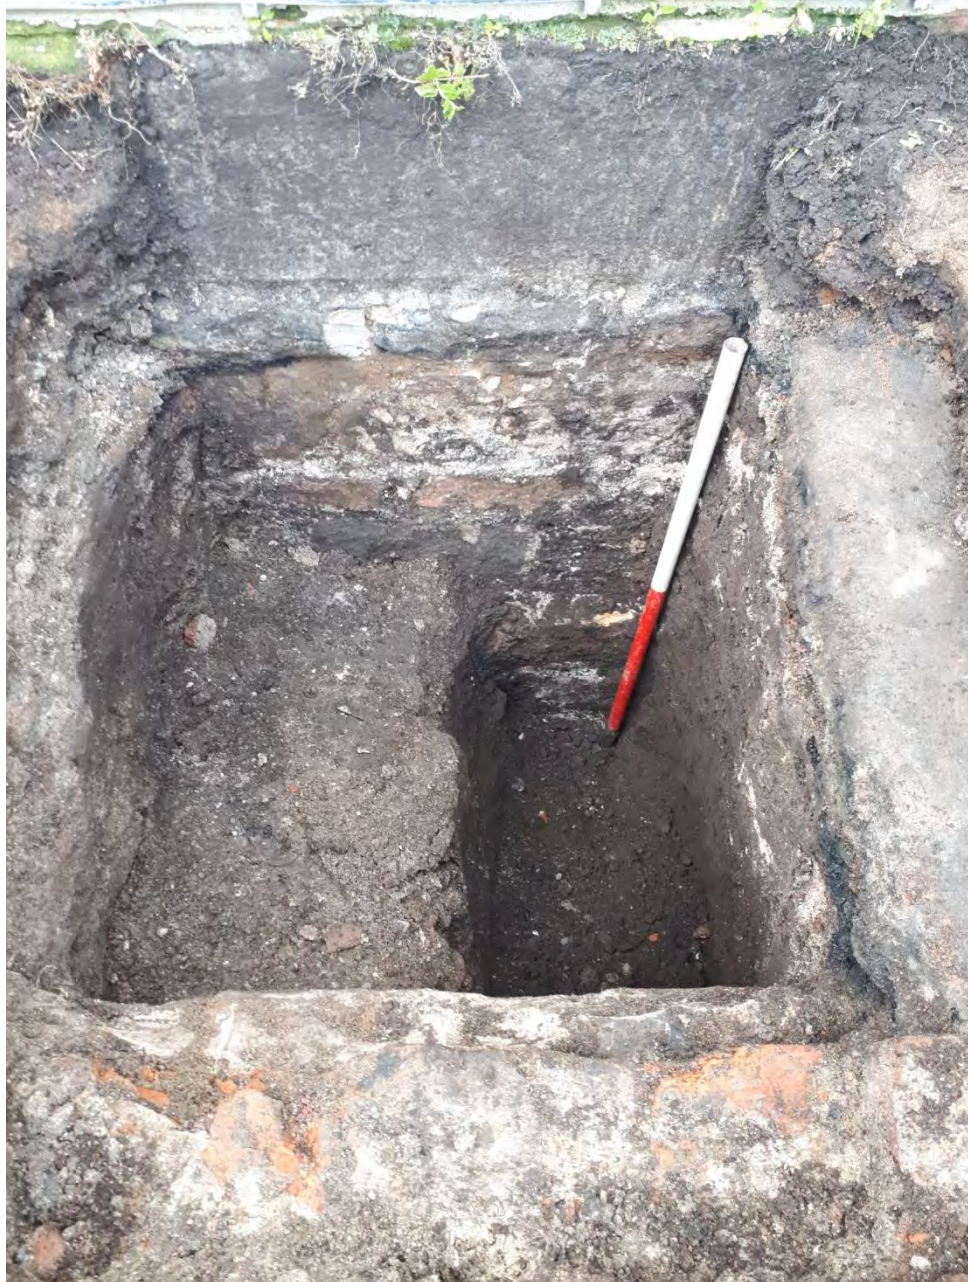
- 4.3 Within Test Pit 1, it was found that the foundations [002] for the western wall of Lion's House measured 1.40 m deep to excavated depth however the full extent is unknown. It was comprised of a single large worked sandstone block at the top measuring 0.80 m long x 0.25 m deep, then smaller works sandstone blocks underneath. These were bonded with a lime mortar.

- 4.4 Also within Test Pit 1 was another wall or possible foundation [003]. This ran parallel to foundations [002] on N-S alignment and measured (as exposed) 0.90 m x 0.70 m x 0.15 m, though its full extent

is unknown. This was comprised of small worked sandstone blocks for 0.60 m and then had a layer of red brick on top measuring 0.10 m deep.

Plate 1 Post excavation shot of Test Pit 1 showing [002], [003] and [004] from West

- 4.5 A possible surface [004] was also uncovered on E-W alignment measuring, as exposed, 0.70 m long x 0.10 m wide x 0.05 m deep.
- 4.6 Within Test Pit 2 there was evidence of a brick structure within the N-facing section and a sandstone slab [007] on an N-S alignment measuring 0.90 m x 0.250 m x 0.20 m. It was wholly exposed but it is unknown if it is a singular slab or part of a surface.

- 5.1 The foundations [002] within Test Pit 1 are uncommonly deep for the height of the original building but it is unclear whether it is the foundations for the house or perhaps include foundations of an earlier structure. These foundations do not extend to the west so are therefore not at risk from any excavations required as part of the redevelopment works.

- 5.2 From their position and form the wall foundations [003] appear to belong to a porch structure dating to the late 19<sup>th</sup> century which was demolished in 1976 and for which there is existing photographs. The surface [004] is believed to be associated with this porch and of late 19<sup>th</sup> century date.

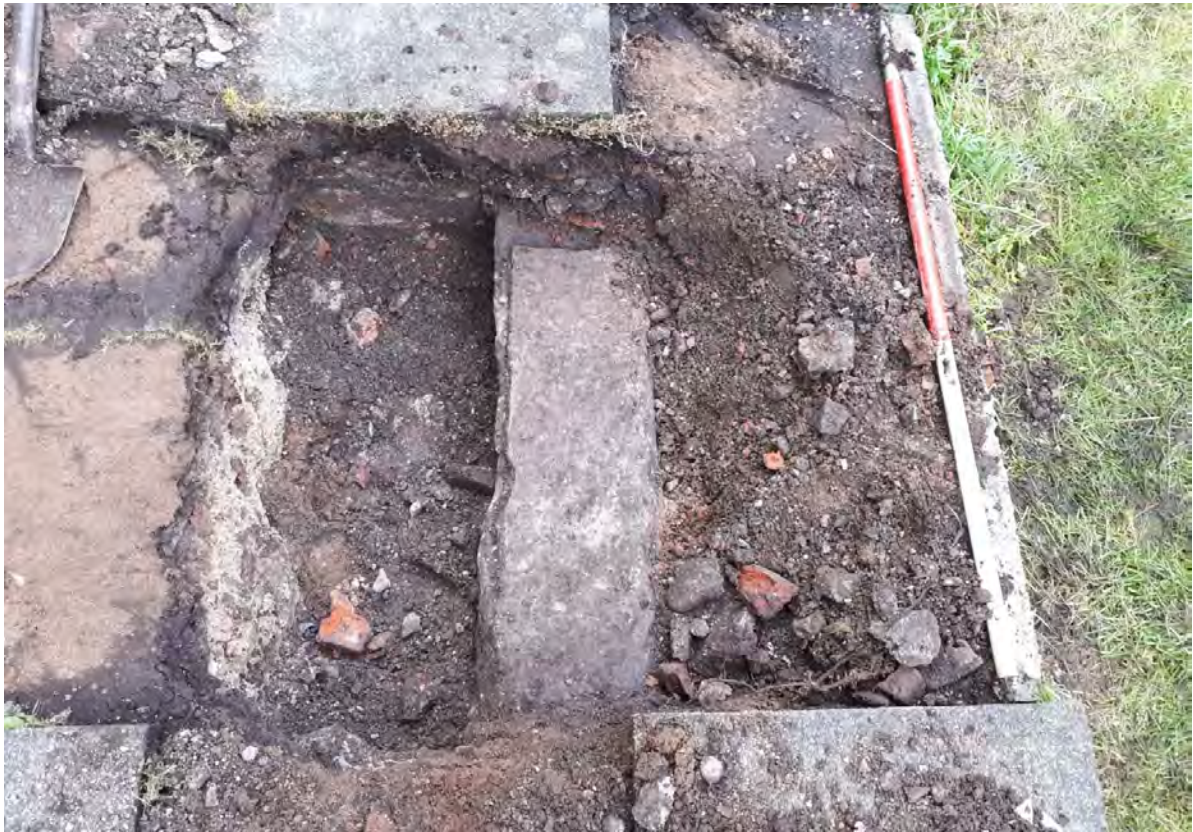
Plate 2 Post Excavation shot of Test Pit 2 showing [007] from North

- 5.3 The sandstone block [007] within Test Pit 7 may also be related to the possible surface [004] but this is unknown. It may also have been used as a step onto a surface which was later completely replaced by the concrete slabs [001].
