9-11 Horne Terrace, Edinburgh: Archaeological Works Data Structure Report

AOC 23617
26th September 2017

On Behalf of: AMA (Majestic) Ltd.
15 Coates Crescent
Edinburgh
EH3 7AF

Planning Reference: 16/02688/FUL

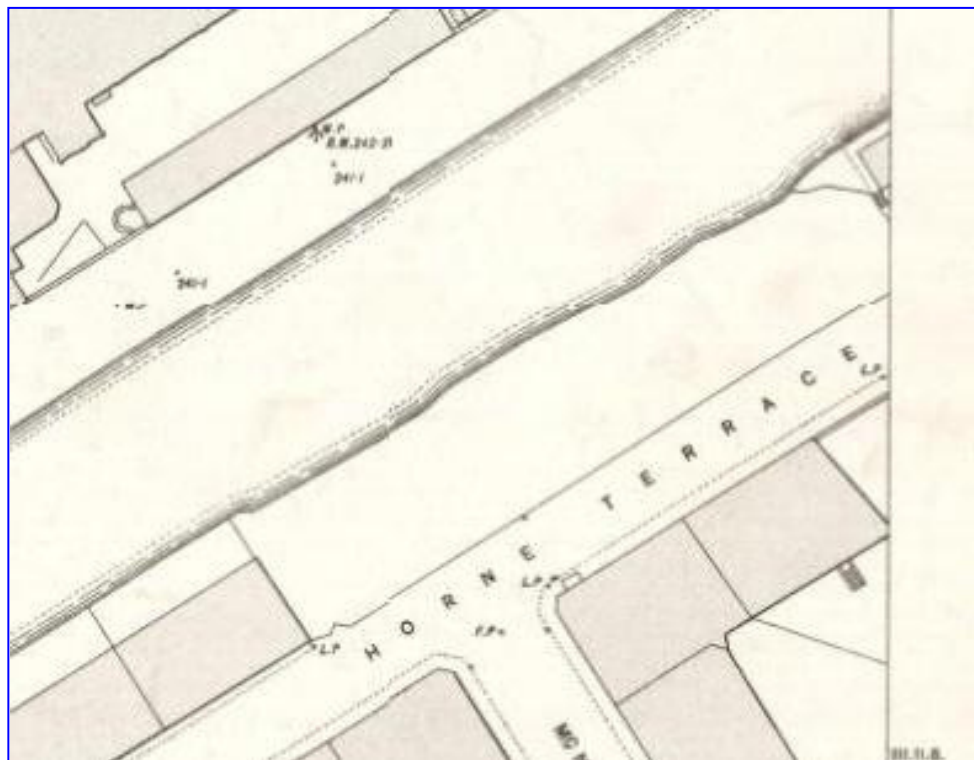
Figure 4: Extract from Ordnance Survey map, 1877, Edinburgh Sheet 38

1.3.2 By 1877, a lot of development had taken place as shown on the 1877 Ordnance Survey map (Figure 3). St Peter's Place tenements have been built to the south of Horne Terrace and west of Viewforth. To the north of the Terrace, are a number of small industrial buildings. The 1894 Ordnance Survey map shows that the slip is still present on the site and that the buildings to the east may have fallen within the site boundary. By 1909 the site is occupied by a long range of industrial buildings (Figures 4 & 5). By the 1949, these same buildings are annotated as numbers 9, 10 and 11 with drive, possibly an entrance to the canal side shown between numbers 9 and 10 (Figure 6).

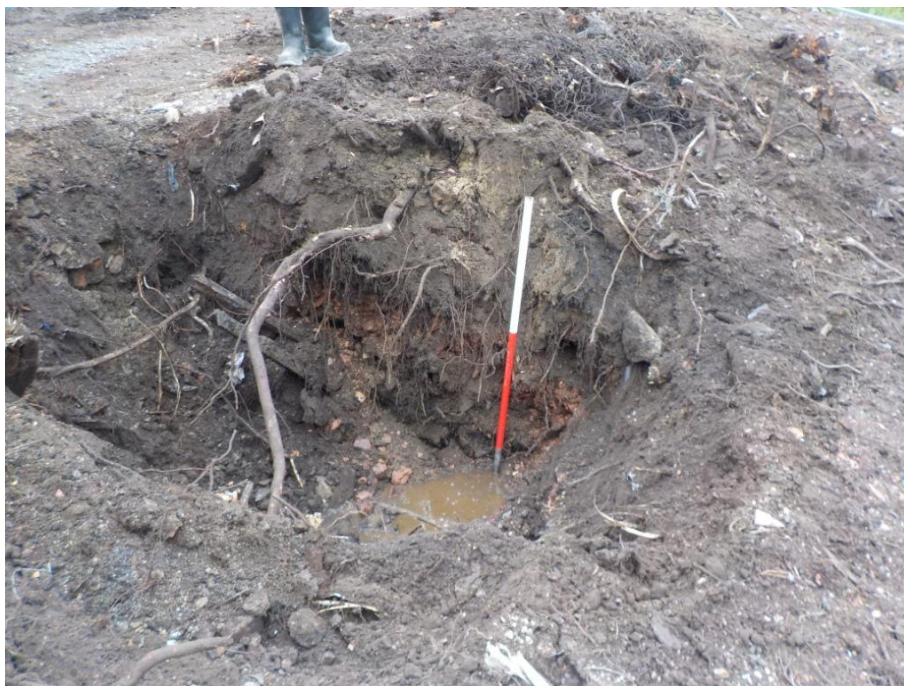
Plate 1: E-facing section of Test-pit 1

- 4.2.1 The evaluation was conducted on the 24th May 2017 and comprised two test pits within the scheduled area and two trenches out with the scheduled area (Figure 2). The two test pits were positioned on the canal bank and encountered heavily rooted topsoil overlying deposits of ash and rubble until a depth of 1.5 m (Plate 1). At this point the trenches had to be abandoned due to water entering the trench from below.

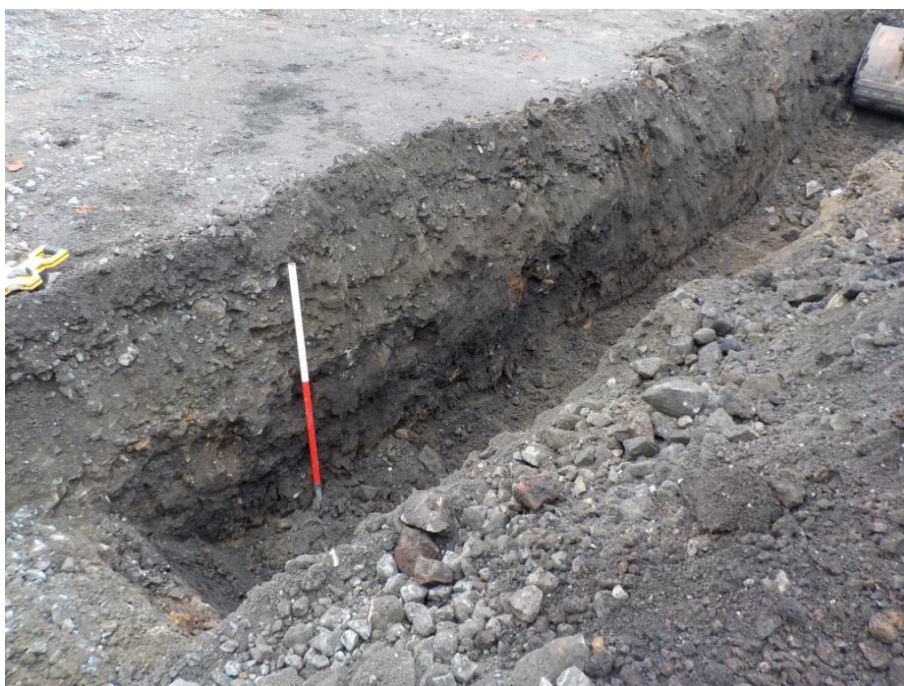
Plate 2: General view along S-facing section of Trench 4

- 4.2.2 The trenches out with the scheduled area encountered modern and historical made ground consisting of sandstone and brick rubble overlying a black ash and silt deposit measuring between 0.15 m and 0.4 m thick (Plate 2). This contained some dumped timber fragments in places but no significant artefacts. The underlying subsoil was a pale grey and green sandy clay encountered at 0.9 m to 1.7 m below the present ground surface (73.006 m OD).

- 5.1 The evaluation revealed that the development of the canal has impacted upon the deposits overlying the natural subsoil throughout the area. The black ash and silt found to overlie the clay subsoil is indicative of canal water ingress into the development site in the past, suggesting that previous soil horizons had been removed.

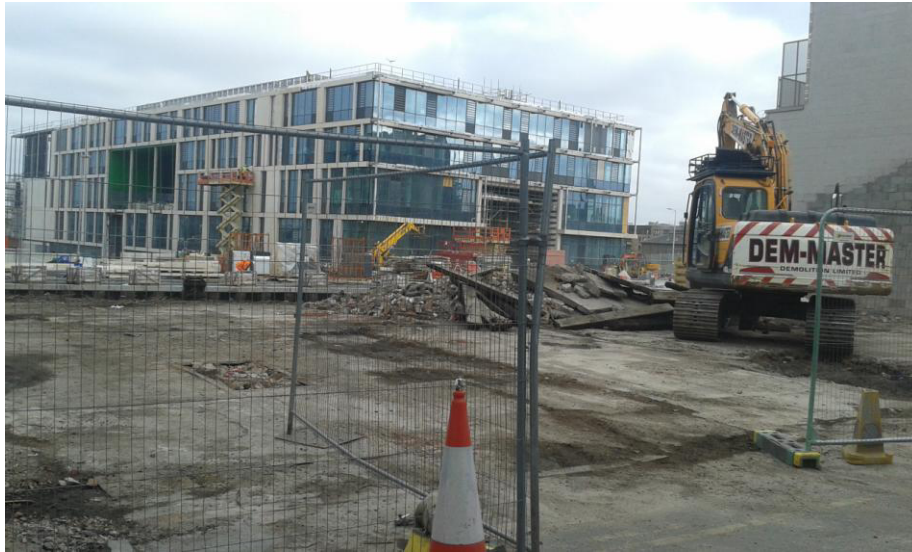
Plate 3 – General view of the Development area showing floor slab of former industrial building

- 4.3.1 Monitoring of the removal of the former industrial building floor slabs revealed a made ground of bricks, concrete and wooden planks throughout the development area. A cobbled surface (002) was exposed within the NE corner foundation of the former building, about 2 m from the bank and 1.80m from the wall of the property to the east. The cobbles (002) were of varying sizes but on average 0.20m x 0.15m x 0.09m and were set in a circular pattern with a gap to the west. The central part was covered by a circular metal plate (003) measuring 1.75m wide and 0.02m thick with a hollow centre measuring 0.45m. The circular metal plate (003) covered a concrete bowl

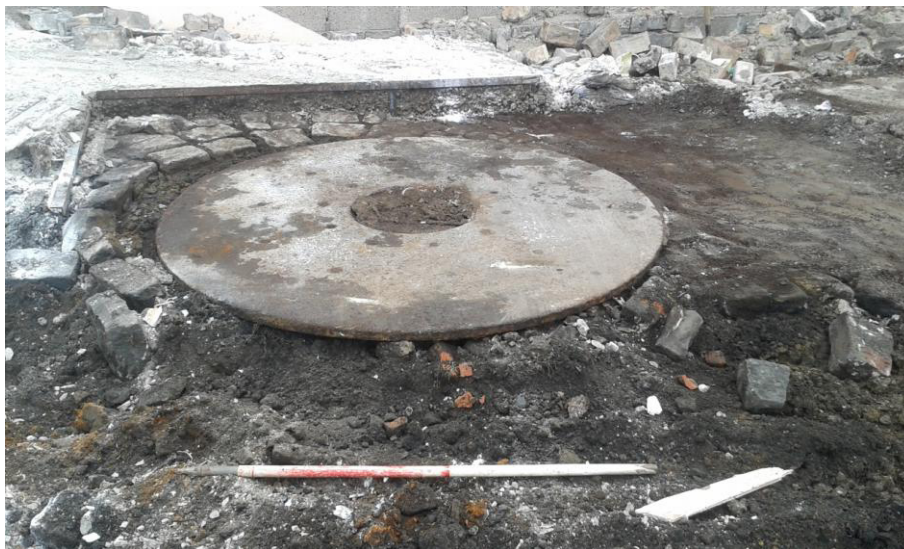
Plate 4 – General view of cobble surface (002) and metal cap (003)

(004) with dimensions 0.50m in the centre of the cobble set (002), directly below the gap in the metal plate. There was no indication of heating within the stone bowl, although slag fragments and clinker (005) were exposed to the west side of the concrete bowl (004).

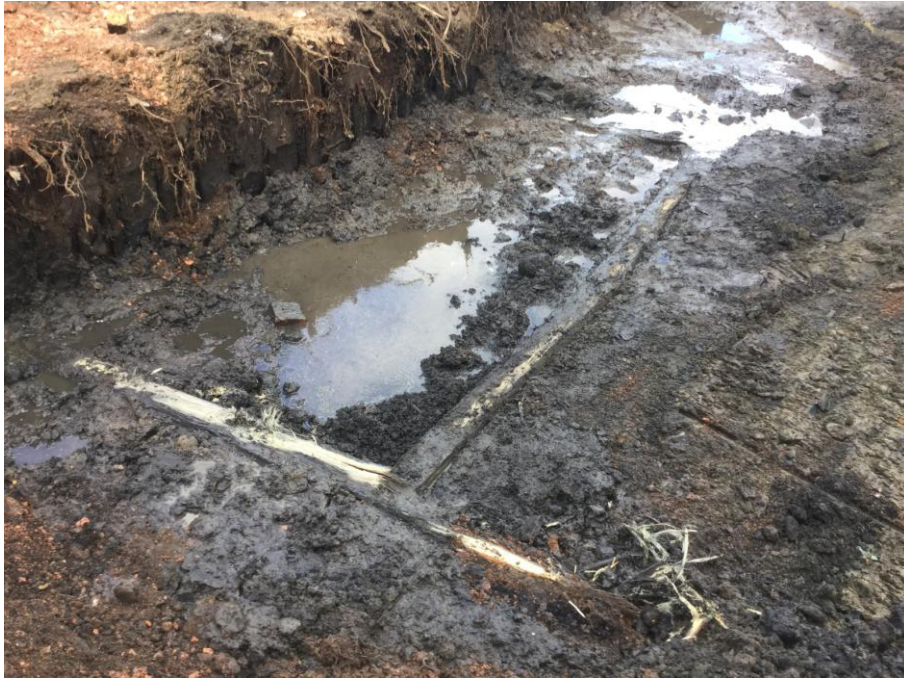
Plate 5 - Slipway planks (010), (011) and (012) with canal lining (007)

4.3.2 Monitoring of the area along the south bank of the canal revealed the original wooden canal lining (007) in a SW-NE orientation. A possible cut for the canal (006) was exposed 5m SE of the original wooden canal lining (007). Some of the excavated areas were affected by flooding making it difficult to monitor, however stones were observed to the NE which could indicate paving for the canal floor. The remains of an old slipway was uncovered to the west, consisting of 3 wooden

planks, one NE-SW orientated (010) measuring 4.7m and 2 NW-SE orientated (011) and (012) measuring 2m and 3.5m. Nail holes were visible in (010), with nails surviving in (012).

007	Original canal lining constructed of sleepers 5m to north of cut [006]. 38m length observable, 0.9m wide. Individual timbers 1 x 0.3 x 0.09m. These were also staked at the bottom to drive into the ground. Original wooden canal lining, contemporary with slipway (010), (011) and (012), 1818-1820s
