Saughton Hall, Edinburgh: Archaeological Monitored Topsoil Strip & Excavation Data Structure Report

Saughton Hall, Edinburgh: Archaeological Recording of Site Investigation Trenches

Data Structure Report

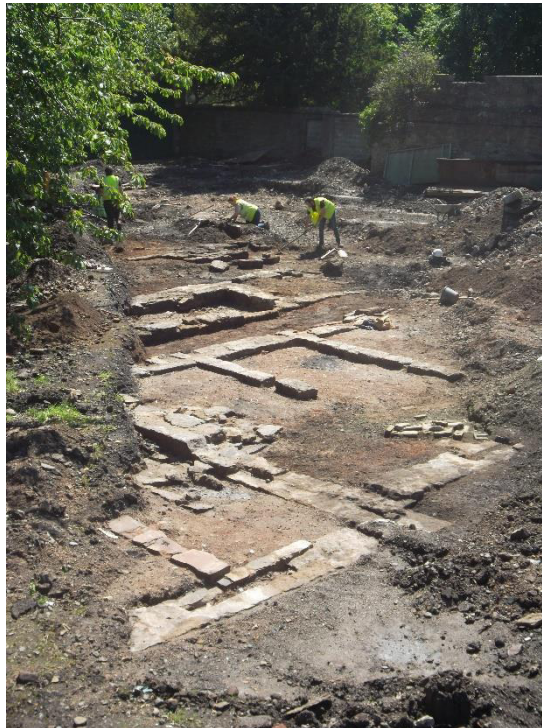
Plate 1: Post excavation shot of 1st area of excavation

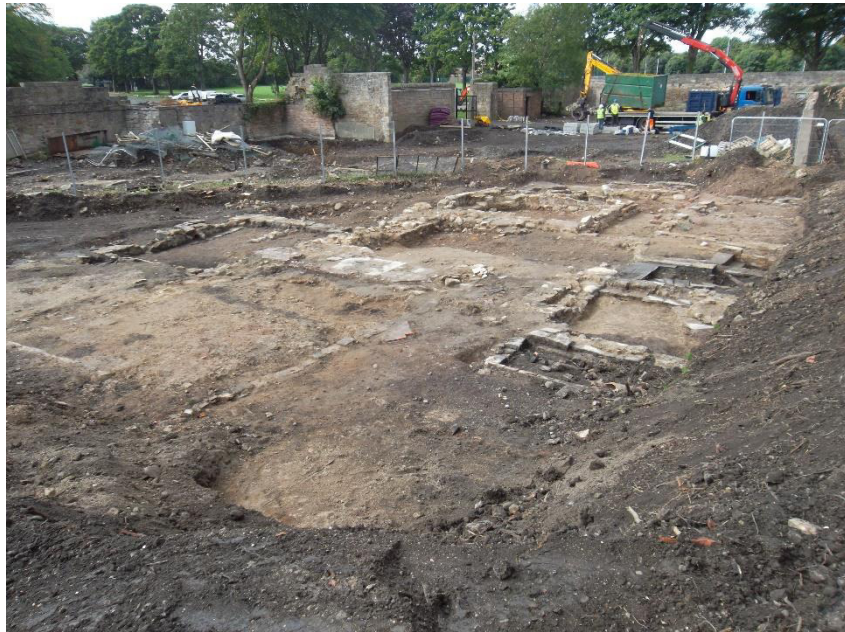
Plate 2: Post excavations shot of 2nd area of excavation

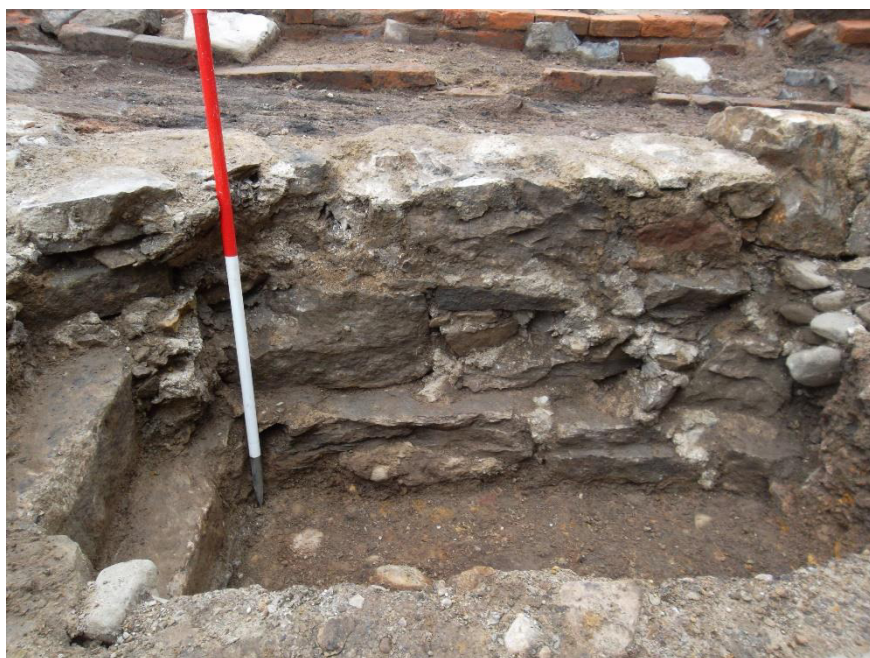
Plate 3: Victorian walls within 1st area of excavation

4.2.1 The excavations in the North-West area of site were completed first due to an issue with access for the rest of the site. These works revealed foundations that were predominantly later in design, likely 19th Century, possibly related to the private asylum that was in 1824. At least five rooms were identified once the site had been cleaned. The majority of these rooms were constructed using large rectangular sandstone blocks measuring 0.70 m x 0.30 m x 0.30 m bonded with mortar. The foundations were found to continue on for up to 0.5 m in places. The rooms varied in size ranging from 1.70 m x 3.10 m to 3.5 m x 2.5 m. The walls for the most part ran perpendicular to North therefore running North-east to South-west and North-west to South-east (Plate 3)

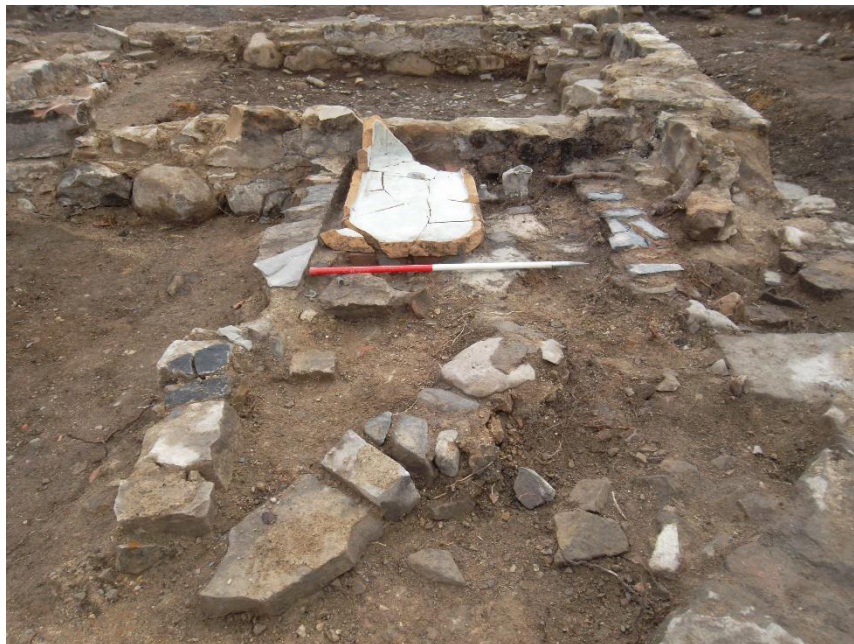
Plate 4: Shower base within 2nd area of excavation

- 4.3.1 This area of the excavation focused on the site for the original 17th Century house. Extensive foundations were found to the North-west of this area. Initially a continuation of the 19th Century walls were observed including the red brick lined linear [026] which was found to continue on a North-east trajectory before turning to the South-east and terminating at the main corridor.
- 4.3.2 The remains of a shower room were discovered within this area, obviously a later addition it remains remarkably well preserved with the original lead pipe still running to it. This likely formed part of the last phase of developments for the house. It is surrounded by medium sized angular sandstones with n o obvious binding material, probably forming the foundation for a small dividing wall (Plate 4).

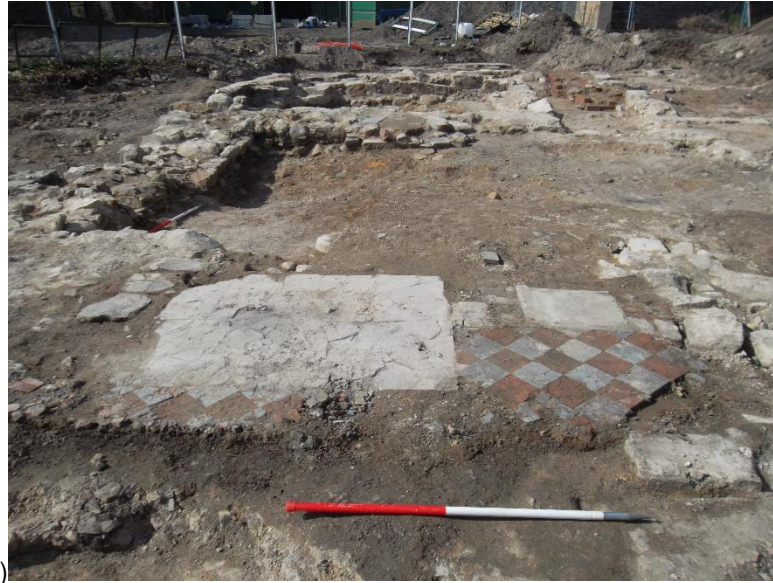
Plate 5: Tiled flooring of possible kitchen area

- 4.3.3 A significant tiled floor [049] was discovered lining a large concrete rectangular area. This likely formed part of a kitchen area with the concrete slab possibly supporting a large range or other cooking equipment. The tiles are mortar bonded measuring 0.10 m x 0.10 m x 0.05 m aligned

approximately North-east to South-West. Further examples of this can be seen in the corridor running through the centre of the house and at the frontage of the building in the 3rd excavation area. (Plate 5)

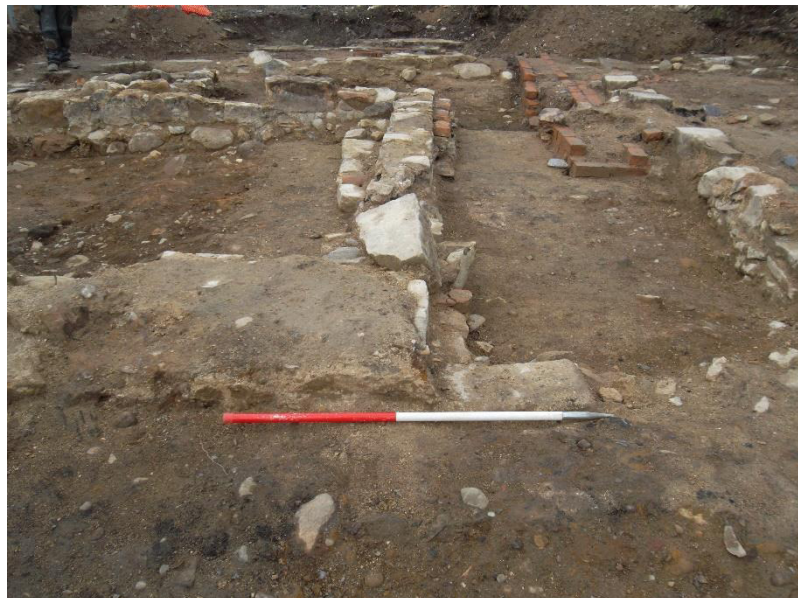
Plate 6: Central Corridor

4.3.4 The corridor runs NW-SE through the centre of the house. It consists of a mortar flooring material with it being line with large rectangular mortar bonded sandstone blocks. Later additions show these being replaced with concrete bound red hand fired bricks. The corridor is approximately 1.20 m wide and is present throughout the entirety of the building though is notably better preserved in at the North-western extent. (Plate 6)

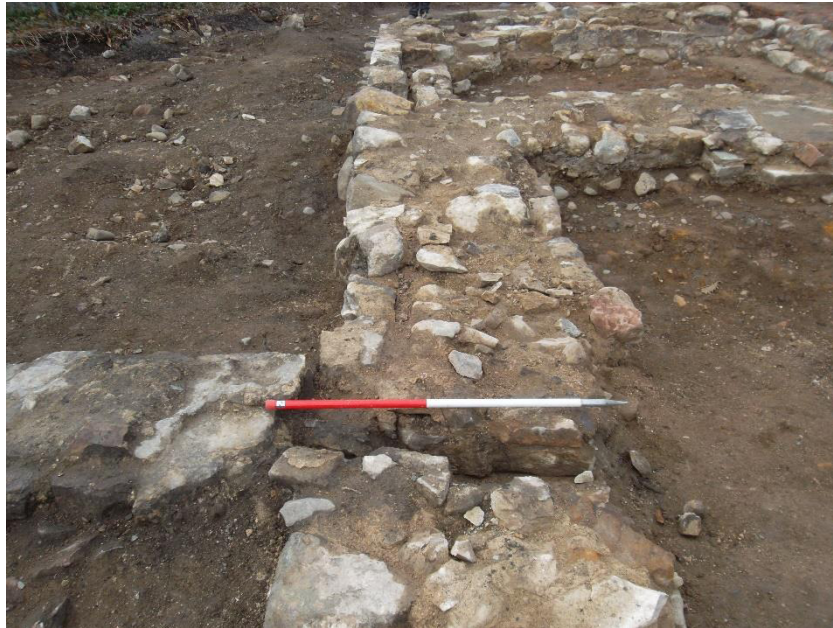
Plate 7: Possible original 17th Century foundations

4.3.5 Potential 17th century building foundations can be seen within the excavation of this area. These foundations [063] consisted primarily of rubble filled sandstone walls bound with a lime mortar mix. The external components of the wall consisted of rectangular roughly hewn sandstone blocks measuring 0.52 m x 0.21 m. It is considered possible that the wall foundation [063] may

have formed part of the external of the original 17th Century structure based on its location and overall size. (Plate 7)

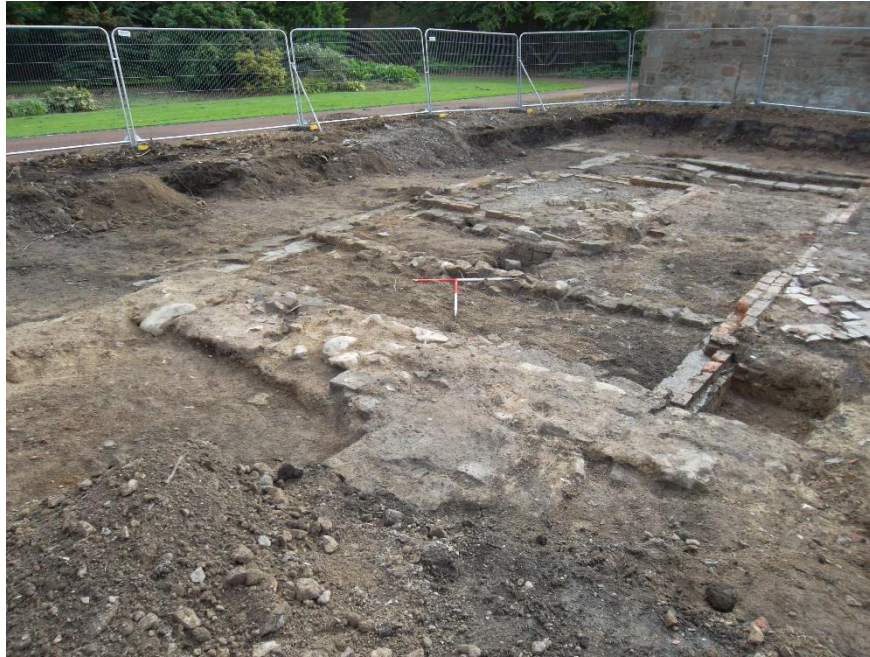
Plate 8: Post excavation shot of 3rd area of excavation

4.4.1 This area of excavation focused almost entirely on the frontage of the building. As with the previous area a mixture of 19th Century and possible 17th Century foundations were discovered during the works. The later 19th Century foundations consist of the majority of the building forming the frontage of the building. Walls were constructed using large rectangular blocks bonded with mortar running almost entirely North-west to South-east and North-east to South-west.
