Inner Forth Landscape Initiative: Evaluation Excavations at Valleyfield Stables Data Structure Report

AOC 60079

September 2017

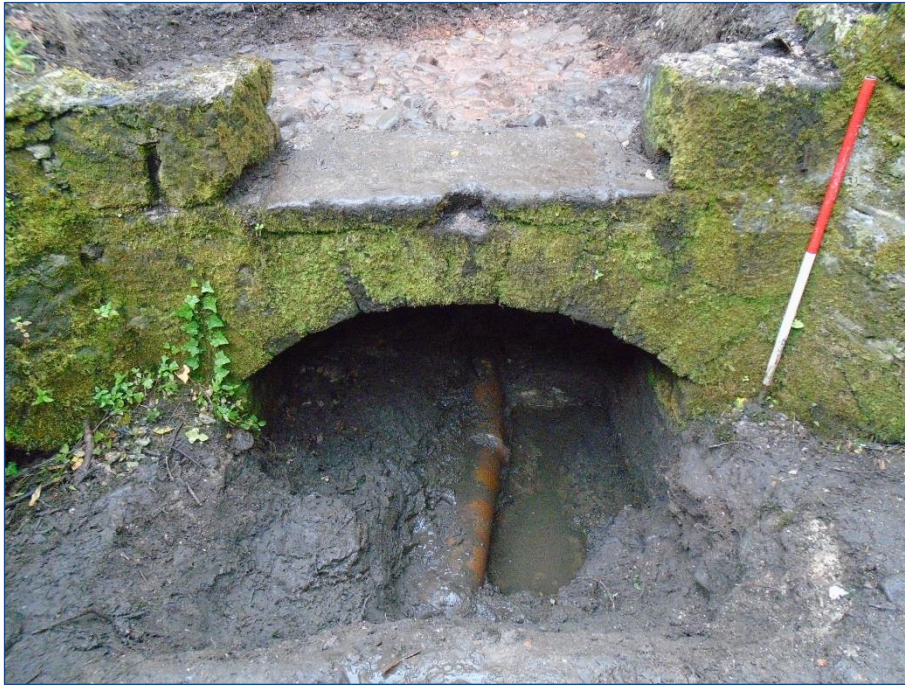
Plate 6: Trench 2 within centre of structure showing drain pipe [210] set in silting deposit (211) with dumped cobbles (208) above, from NW.

Within the centre of the stone structure a trench was excavated against and within one of the arches of the structure. Removal of demolition rubble (209) exposed a deposit of cobblestones (208) seemingly dumped into the centre of the structure. Underlying the cobbles was a waterlogged deposit of sandy silt (211) that appears to be an infilling of the structure. This deposit was not fully excavated. Set within silting deposit (211) was a ceramic drain pipe [210] that had been inserted through the outer wall of the structure. This drain pipe appears to have been a later addition to the structure.

Trench 2 excavated over the central stone feature and courtyard interior revealed the cobbled surface of the courtyard as well as investigating the nature of the central feature within the courtyard. Previous descriptions of this structure have described it as a doocot, however no evidence for this was recovered during the excavations. The excavation into the interior of the structure has demonstrated that a deep structure has been constructed, this later filled in with a silting deposit and was used for drainage before being sealed with a dump of stone. This leads to the suggestion that this central feature is a well or font rather than a doocot.

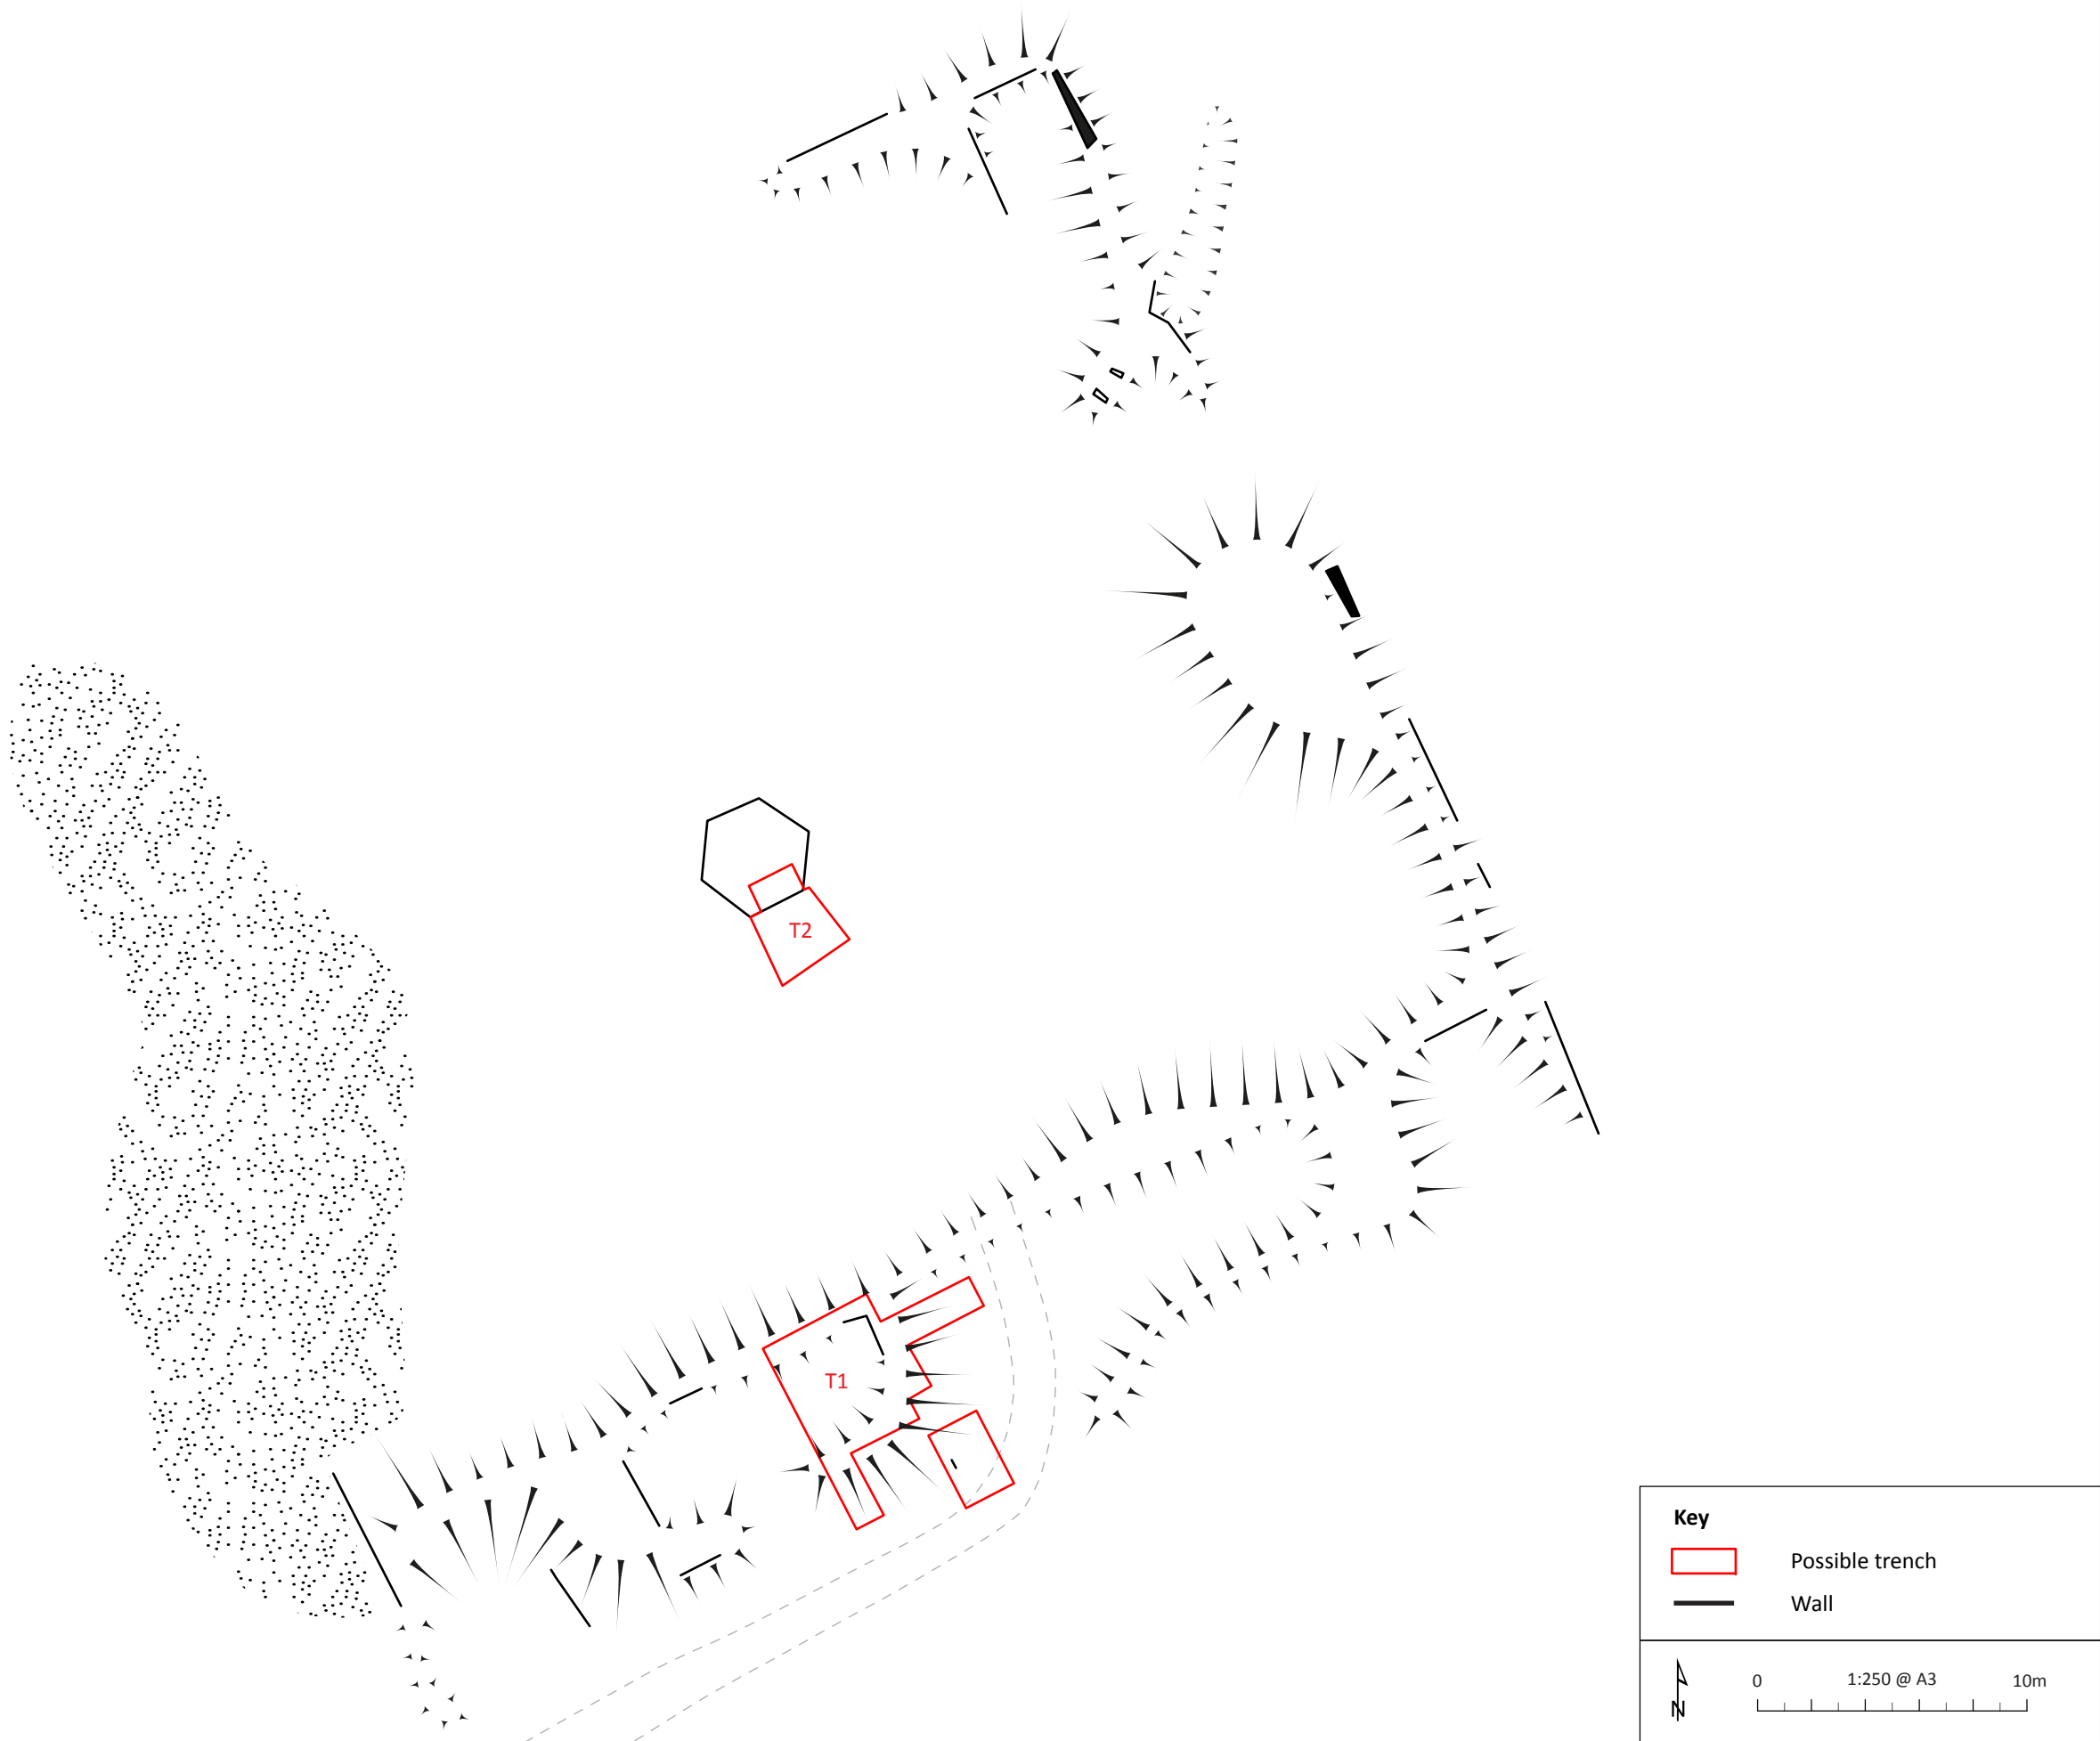
Figure 2: Topographic Survey

The topographic survey (Figure 2) recorded the upstanding remains of the stable courtyard and associated remains. For the most part the demolished buildings are covered by deep deposits of demolition rubble masking the layout of the building; thick overgrowth has further masked the remains of the stable block. The remains of the stables were clearest on the southeast and northeast sides and the survey focussed on these areas. The stable block forms a rectangular structure 48m by 46m in overall size. While for the large part details of the structure could not be made out above ground there were in places sections of upstanding wall projecting above ground.
