165 Castlebank Street, Partick, Glasgow: Archaeological Evaluation Data Structure Report

On Behalf of: Nixon
Clydeport Building
16 Robertson Street
Glasgow
G2 8DS

AOC Project No: 23761

Planning Application No: 15/01920/DC

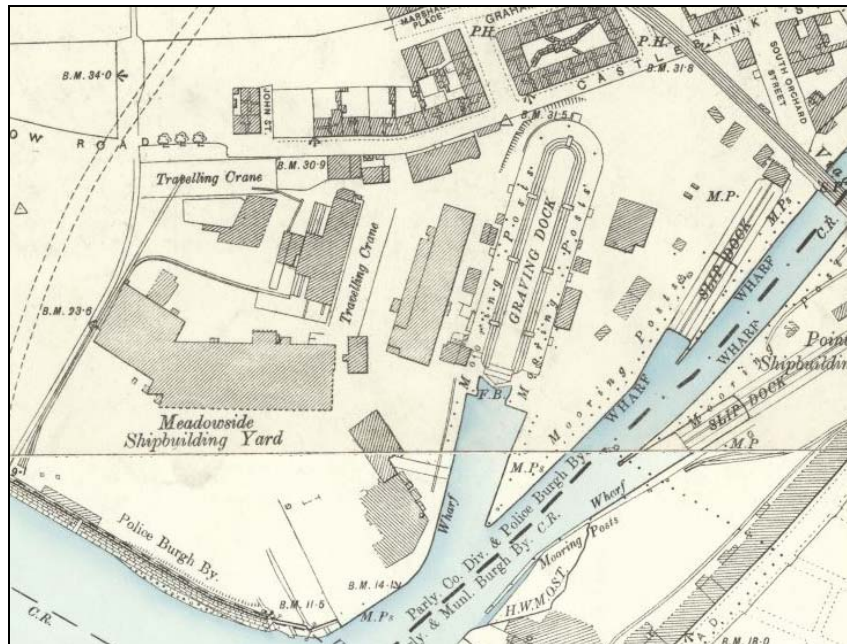
Figure 5: Ordnance Survey, 1896. Lanarkshire 006.05. Surveyed 1893 to 1894, Published 1896

1.3.6 A “Dry Dock” was completed and opened in 1858, measuring 474 feet in length, 61 feet in width and 18 feet in depth. This was the first dry dock on the upper Clyde and the northern portion of the dock lies within the development site. The dock is also annotated “Graving Dock”.

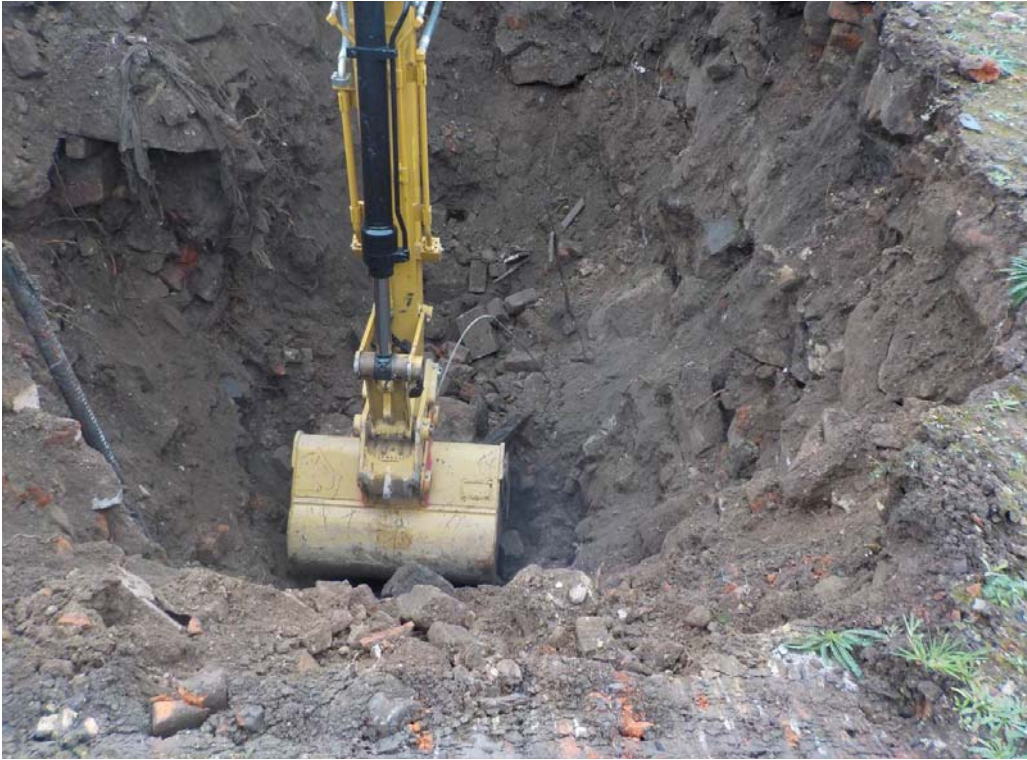
Plate 1: General view of Trench 4 excavations to 4m

- 4.2 The overburden throughout the development area consisted of made ground deposits containing modern dumped materials such as ash, brick, sandstone, concrete and modern plastic. Around the dock, this overlay layers of ashy clay containing former ceramic and cast-iron pipes related to the use of the area as a dock. Trenches within the dock area encountered of 3m to 4m of made ground, with at least 8m of made ground thought to be present within the centre of the dock (Plate 1).

- 5.2 As for the condition of the remains, it is not possible to establish if more detailed features of the dock will have survived due to the limitations of the evaluation, given the depths of rubble overlying the area. It is likley that parts of the dock will have been truncated and possibly removed, as evidenced by the concrete pile in Trench 4.

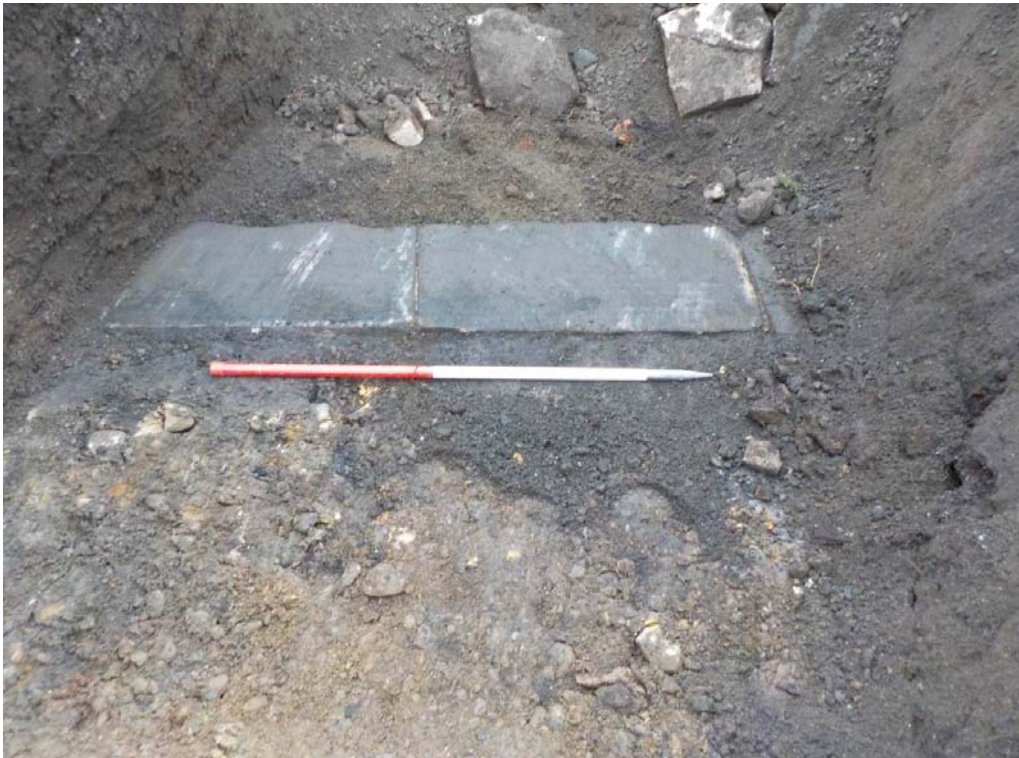
Plate 2: General view of dock wall [601]

- 4.3 The surface of the area immediately surrounding the dock [101] and [201] was present at depths of 3.5m and 3.1m respectively and appeared to consist of either sandstone or concrete. At higher levels, the top of the retaining wall for the dock, [601] and [1003] were also present, measuring 0.5m thick and consisting of large, smooth, sandstone coping stones (Plate 2). Both walls were within the cut for the dock [402], noted in trenches 4, 5, 6, & 10, showing it had a width of approximately 45m.

601	T6	Sandstone wall consisting of smoothed sandstone blocks with rounded corners measuring 0.88 m by 0.48 m. Length of wall revealed measures 2 m wide by 0.48 m. Aligned NNE-SSW. Dock wall (east)
901	T9	Concrete surface with wooden beam insert measuring 1.8 m wide. Truncated to the east. Concrete surface
902	T9	Concrete slab remnant measuring 2.4 m wide. At higher level and of different construction to concrete [901]. Concrete surface
1001	T10	Square shaped brick wall consisting of two courses of brick in width. Recorded from height. Measured 1.1 m wide. Probable manhole
1002	T10	Brick wall aligned N-S to immediate E of cast iron pipe. Measures 0.5 m wide (2 courses). Probable brick wall
1003	T10	Sandstone wall consisting of single course of large sandstone blocks. Aligned NNE-SSW and truncated by modern activity to the SSW. Possible dock wall

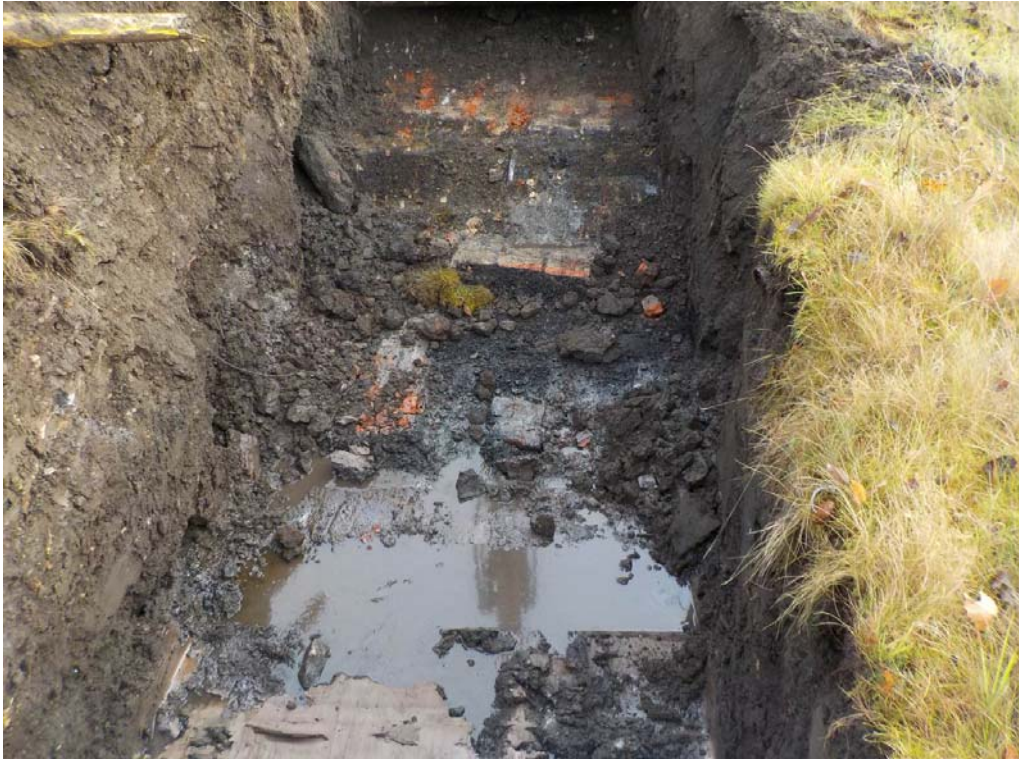
Plate 3: General view of Trench 10 showing manhole [1001], and wall [1002]

<i>Dimensions</i>	25 m by 2 m
<i>Excavated Area</i>	50 m ²
<i>Excavated Orientation</i>	W to E
<i>Soil make-up</i>	Made ground (1) – Dark grey sandy clay and occasional concrete, tarmac, brick and stone inclusions – 2.4 m
<i>Natural Subsoil</i>	Purplish grey clay
<i>Significant Features</i>	[1001] – Brick manhole at 3 m to 4.1 m [1002] – Brick wall at 5.5 m [402] – Cut for clay at 15 m [1003] – Possible wall of dock at 18.2 m
<i>Other Features</i>	Cast iron pipe at 4.8 m; 8.1 m; 8.5 m; 20.3 m aligned NNE-SSW. Depths vary from 1.2 m to 2.4 m (W to E). Ceramic drain at 12.2 m aligned N-S at depth of 2.1 m.
<i>Finds</i>	None

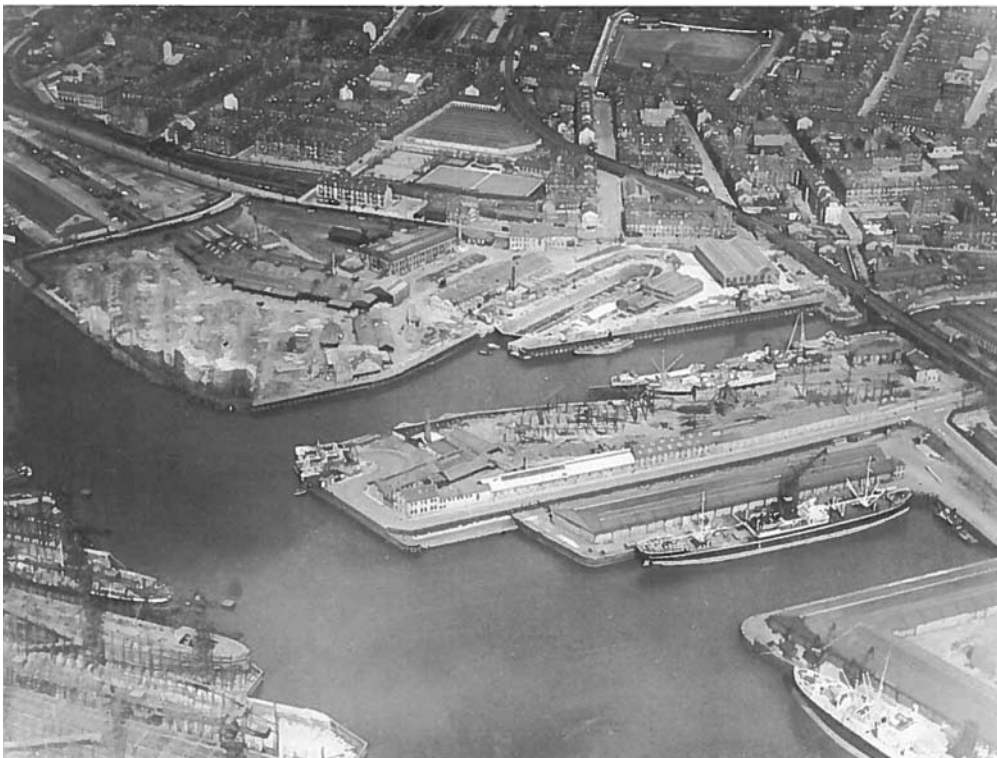
Plate 4: Aerial view showing dock

- 5.1 The main focus of the evaluation was to identify what had survived of the dock and the surrounding buildings since their abandonment and demolition in the recent past, and to assess their condition.. Photographs of the dock indicate that the base of the dry dock was contained by a stepped wall with a stone or concrete surface surrounding it (Plate 4). From the evaluation works, and from the earlier survey conducted by Ogilvie Construction, it has been possible to note that this dock yard area and the top of the dock wall were in-situ at a depth of 3.1 m to 3.5 m. This lower level would then have been contained by a further retaining wall, that was seen to have survived on the north eastern side as wall [601]. To the north-west, this retaining wall may have been truncated, and in the area of wall [1003], the dock yard and ground level are at comparable heights suggesting there was less need for a similar wall.
