Crooks Scooped Settlement, Langholm, Dumfries & Galloway: Archaeological Watching Brief Data Structure Report

AOC Project 24140 4th December 2017

An archaeological watching brief was required by Connicks on behalf of their client SPIE during the refurbishment of an 11kv overhead powerline that passes through an area north of Langholm, Dumfries & Galloway.

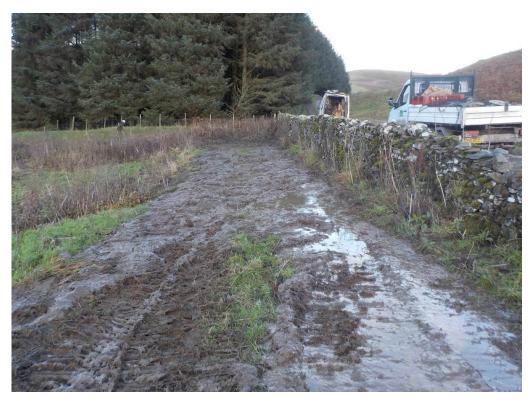
Plate 1: Post excavation view of access

- 3.1 Due to the steepness of the settlement bank on the west edge, the proposed access for the excavator was changed. Access was obtained from the southern edge of the monument, along the side of the boundary wall (Figure 2). Due to heavy rain from the previous two days the ground conditions were very soft, and the central area of the monument was filled with water. The interior was avoided as much as possible and due care was taken to tidy the track marks made by the excavator upon leaving the site (Plate 2).

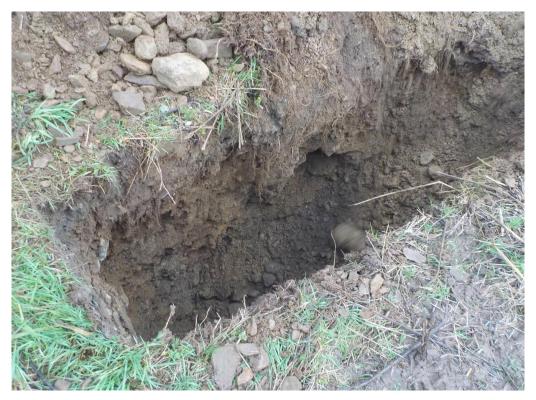
- 4.1 The archaeological watching brief was undertaken on 23rd November 2017. Weather conditions were fair allowing for good archaeological visibility throughout.
- 4.2 The removal of the pole did not disturb the ground surface around the pole location, and inspection of the hole showed no indications of archaeological features within. The excavation for the replacement pole measured 2.1m (NW-SE) by 0.7m, and was 2m deep. The topsoil [001] consisted of 0.25m of dark greyish brown sandy loam with abundant gravel inclusions. This overlay 1.75m of re-deposited gravel [002] with occasional large angular stones (Plate 2). The natural subsoil was not encountered during the excavations.
- 4.3 No archaeological features or artefacts were found during the archaeological works.

Plate 2: SW-facing section of excavated trench

5.1 The archaeological works showed that the bank surrounding the settlement platform consists of re-deposited gravel, most likely obtained from the excavations of the platform in the prehistoric period. No archaeological features or artefacts were encountered within the excavation area and as a result no further archaeological works are recommended. These recommendations will require approval from Historic Environment Scotland.

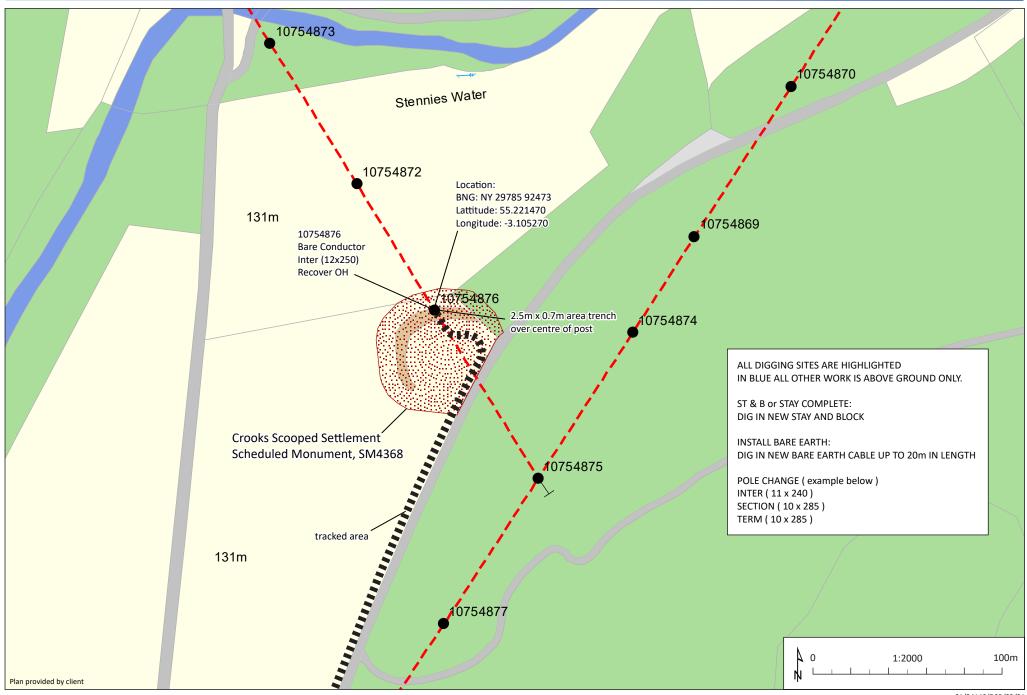
01/24140/DSR/02/01

Figure 2: Trench and access location
