Generator Installation and Access Upgrade, Nerabus, Islay

Desk-based Assessment and Archaeological Watching Brief Data Structure Report

On Behalf of:	Scottish Water
Argyll and Bute Council Planning Reference:	16/03217/PP
National Grid Reference (NGR)	NR 22560 55296 (centred)
WCAS Report No:	72/NER/18
OASIS No:	westcoas1-311199
Prepared by:	Y. Robertson
Date	22/02/2018

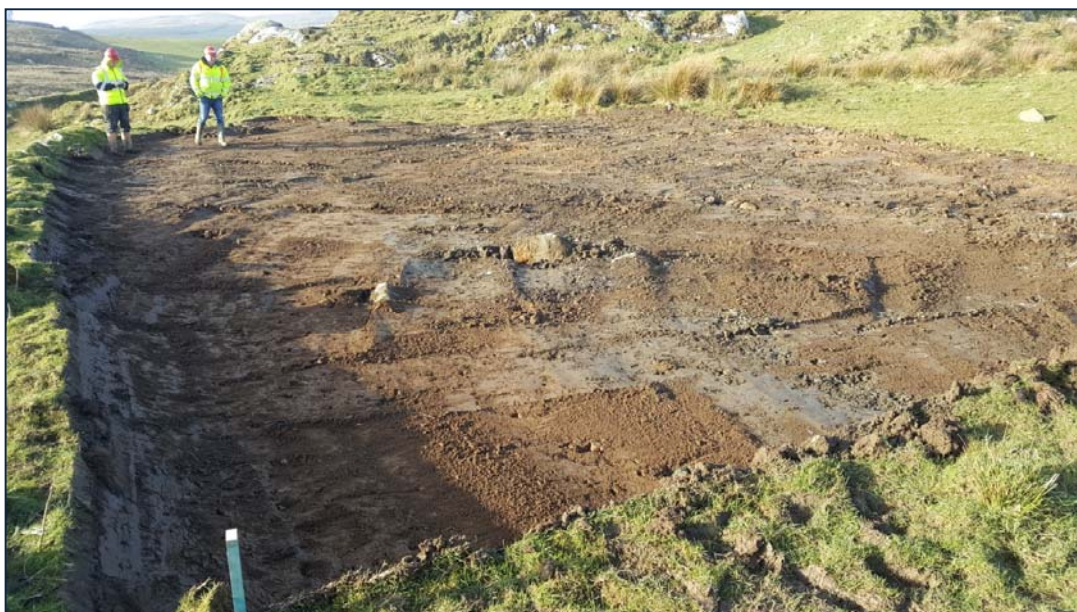
Plate 2: Post-excavation photo of the site compound looking N

- 5.2.2 No archaeological features were observed during the groundbreaking works. At the top of the hill where the compound area is located, topsoil was slightly deeper overlying the compact medium grey brown silty clay and natural subsoil. (**Plate 2**). Several small fragments of 19th or 20th century ceramics were scattered within the topsoil. No features

were identified in association with these artefacts suggesting that they have been deposited on the surface and have become buried over the years.
