SGN Gasholder Heritage Review

Blackwall Lane, Greenwich,

Historic Building Recording Phase I & II Final Report

AOC 23686_L
31st October, 2019

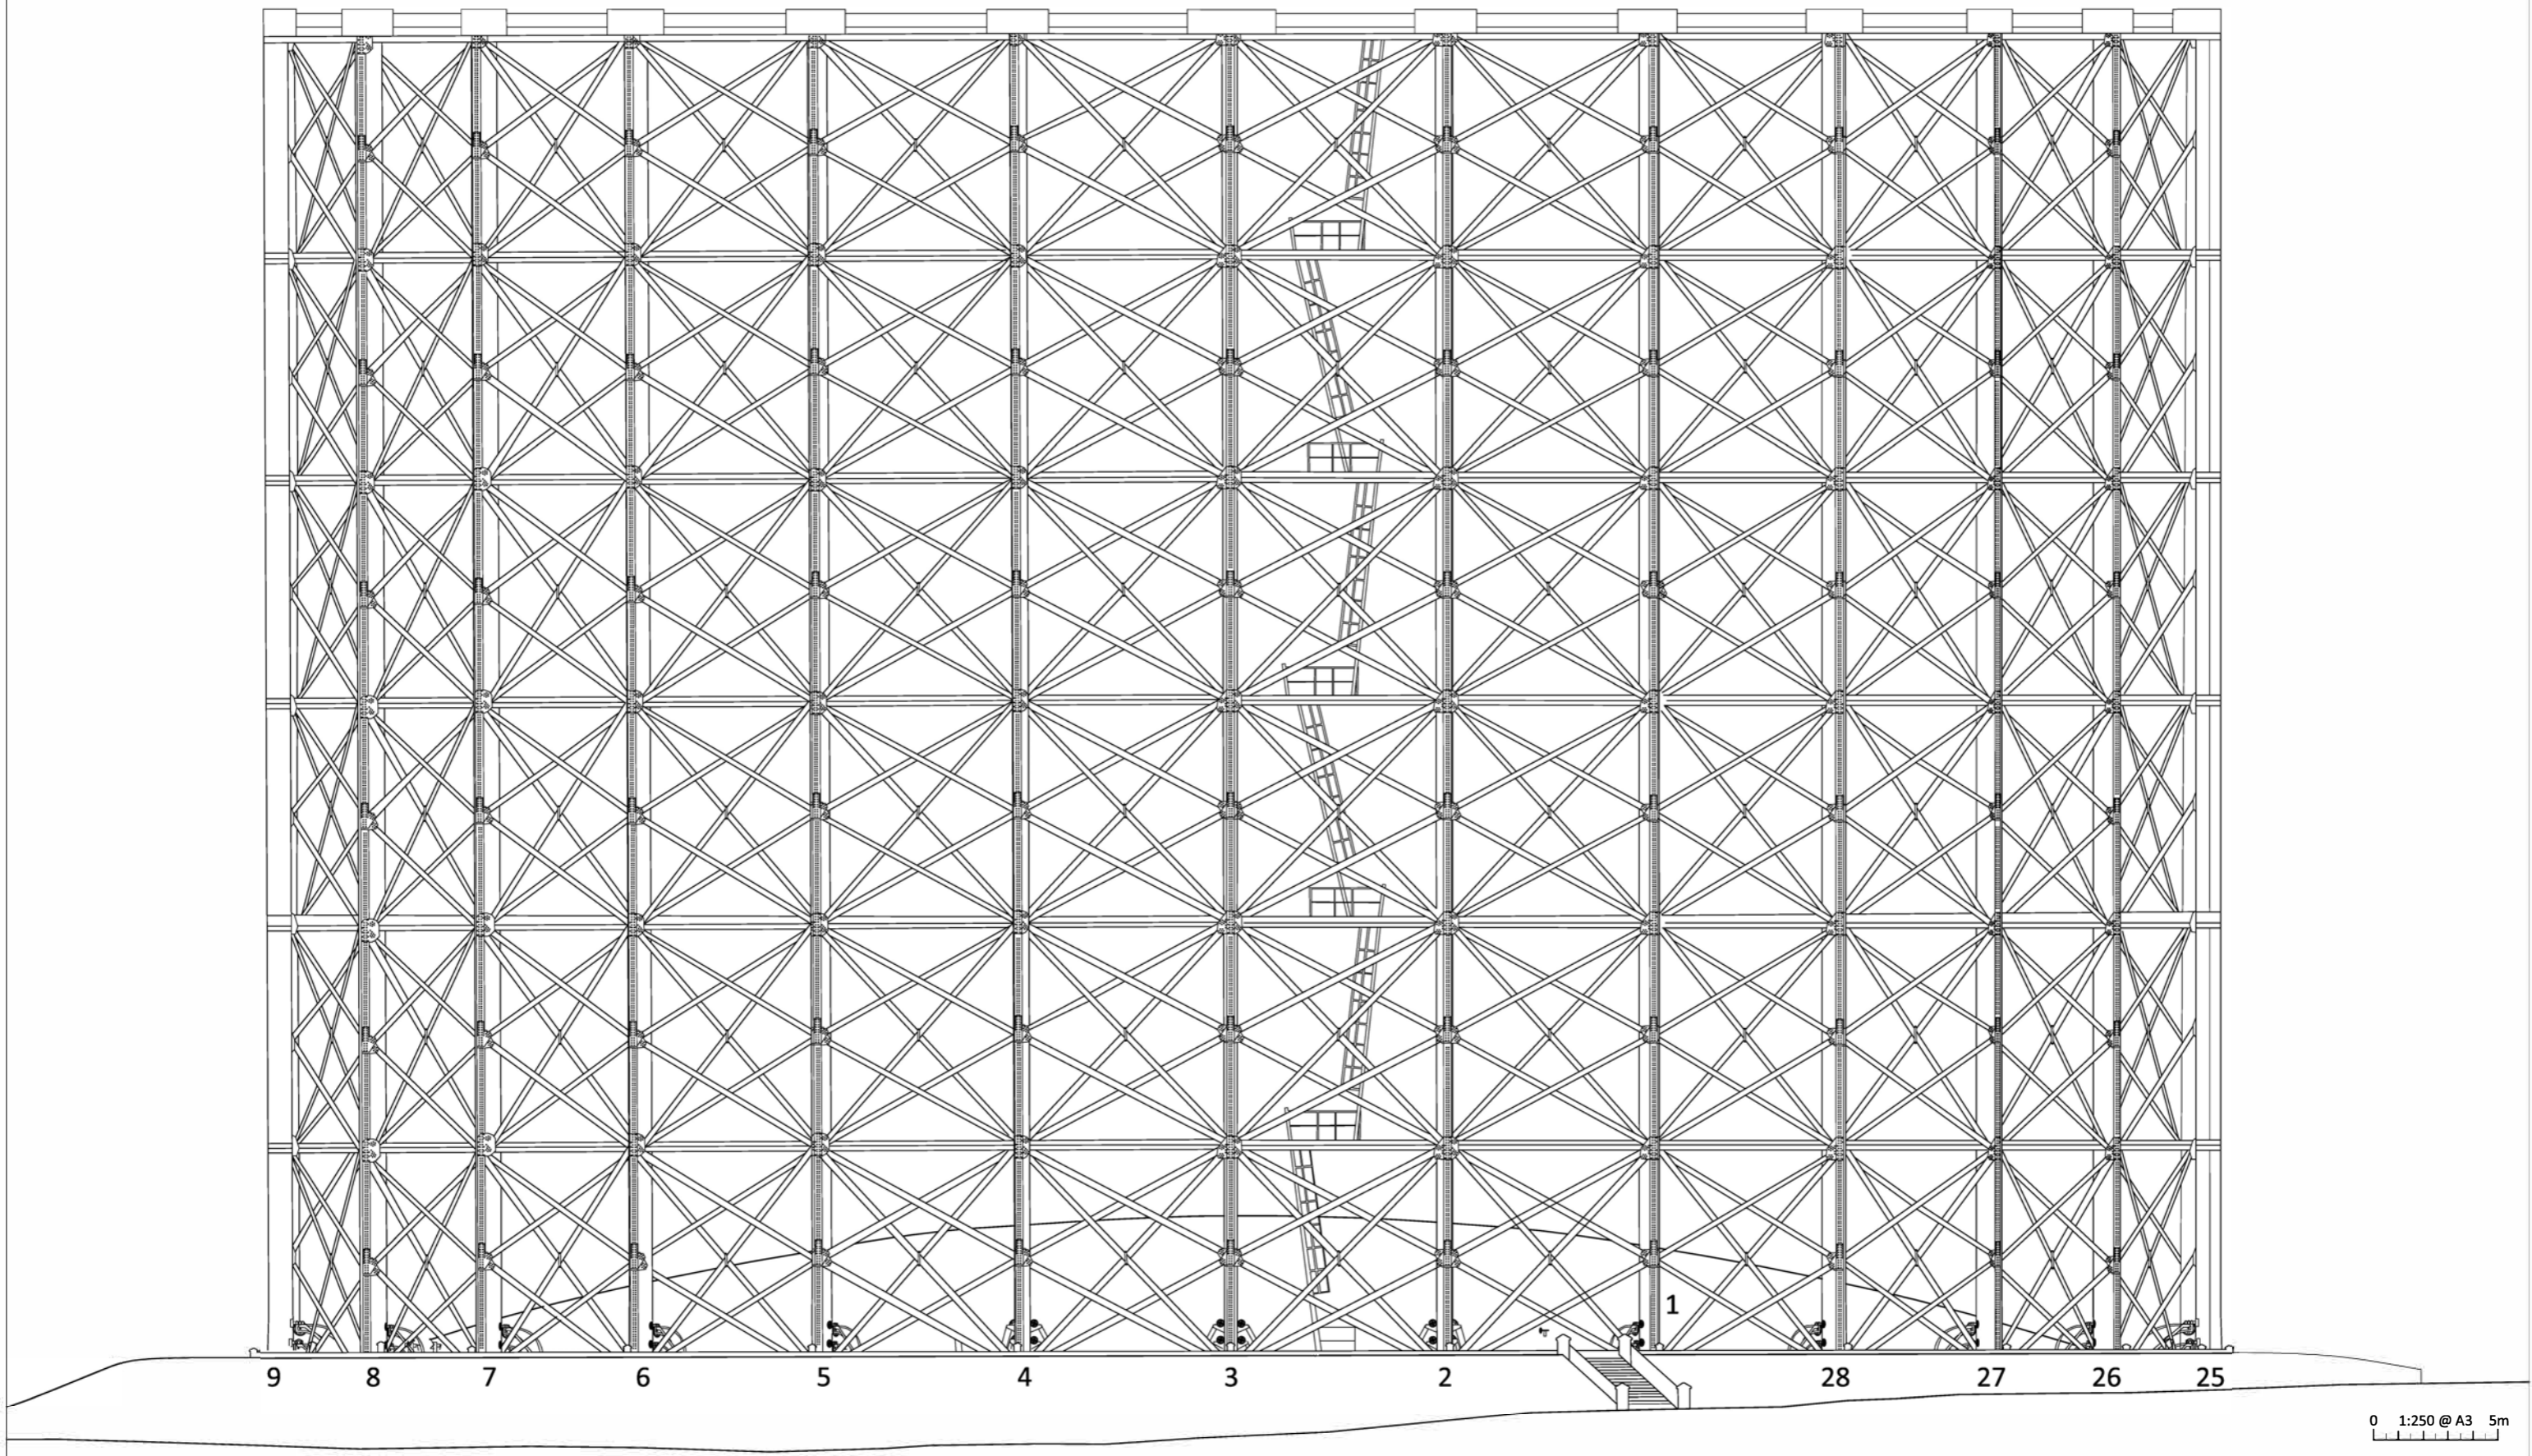
Figure 25: Blackwall Lane, Greenwich, Gasholder No 1, north-facing elevation

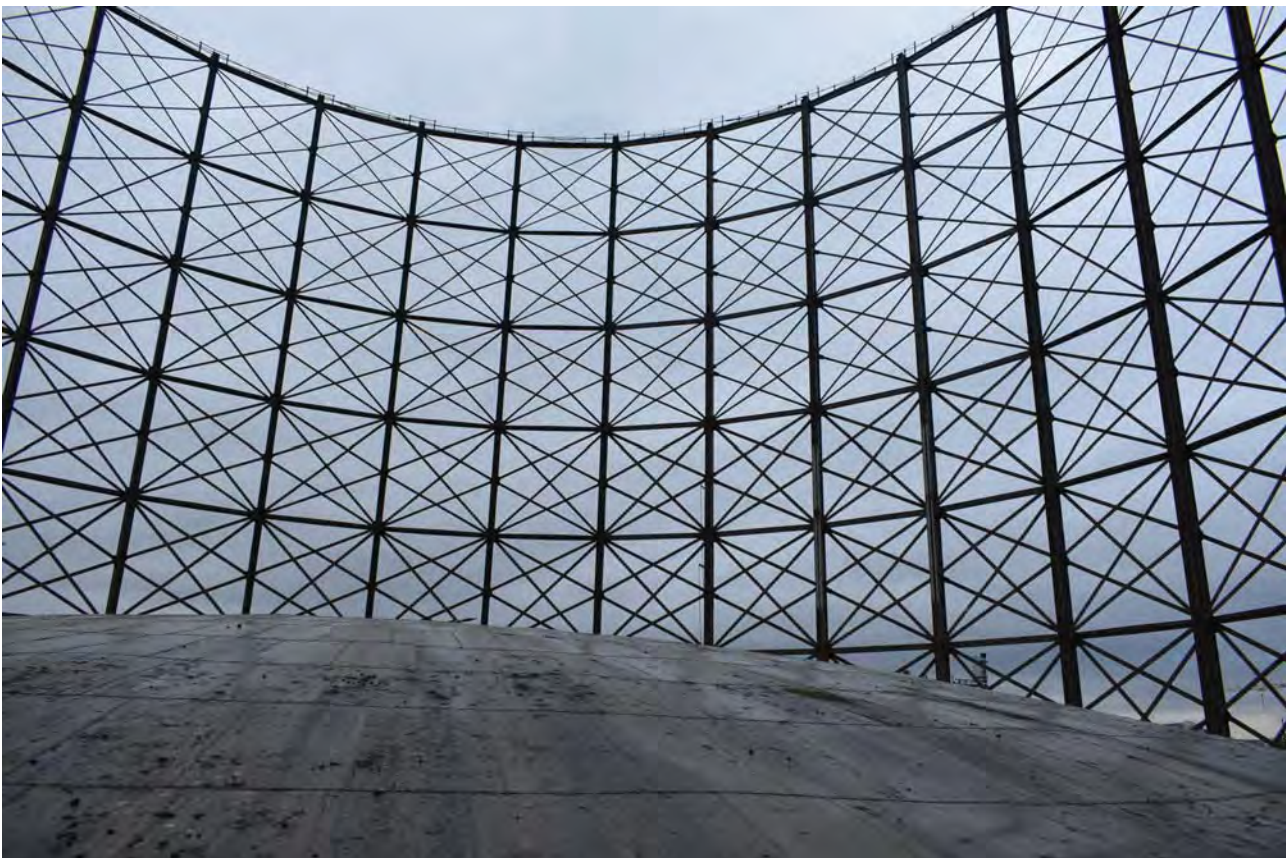
Plate 4: Gasholder No 1, detail of the frame from the NNE

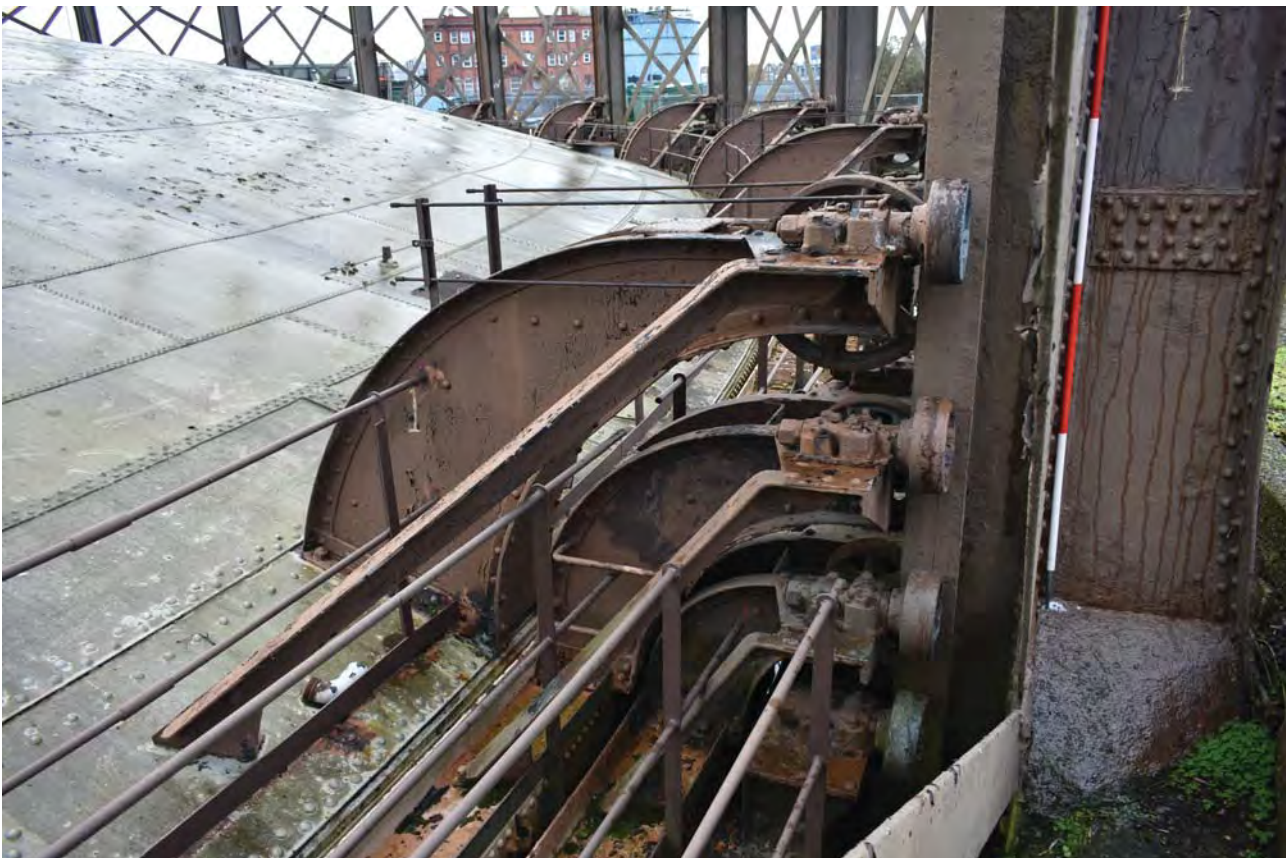
Plate 14: Gasholder No 1, detail of the guided rollers behind No 1 standard from the ENE

- 5.4 The guided rollers are located behind each standard, and consist of three sets of flanged radial rollers (Plates 14 - 16).
- 5.5 Other additional features noted during the works include two sets of knock-off switches, Q & R, which are located between No 7 and No 8 standards and S & T, which are located between No 19 and No 20 standards (Figure 24; Plates 17 - 19). The gas main (U) is located to the WSW of the gasholder (Plates 20 - 22).

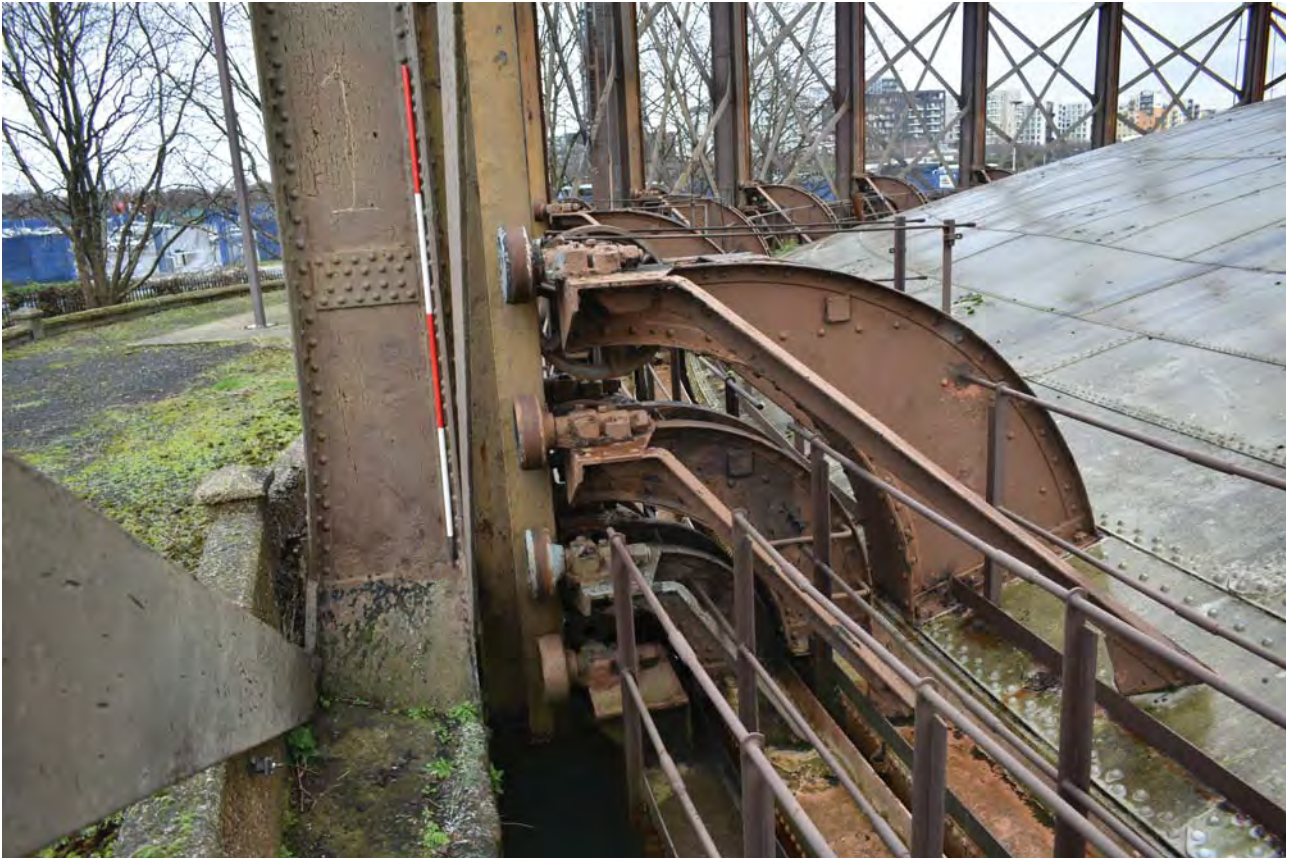
Plate 15: Gasholder No 1, detail of the guided rollers behind No 1 standard, from the WNW

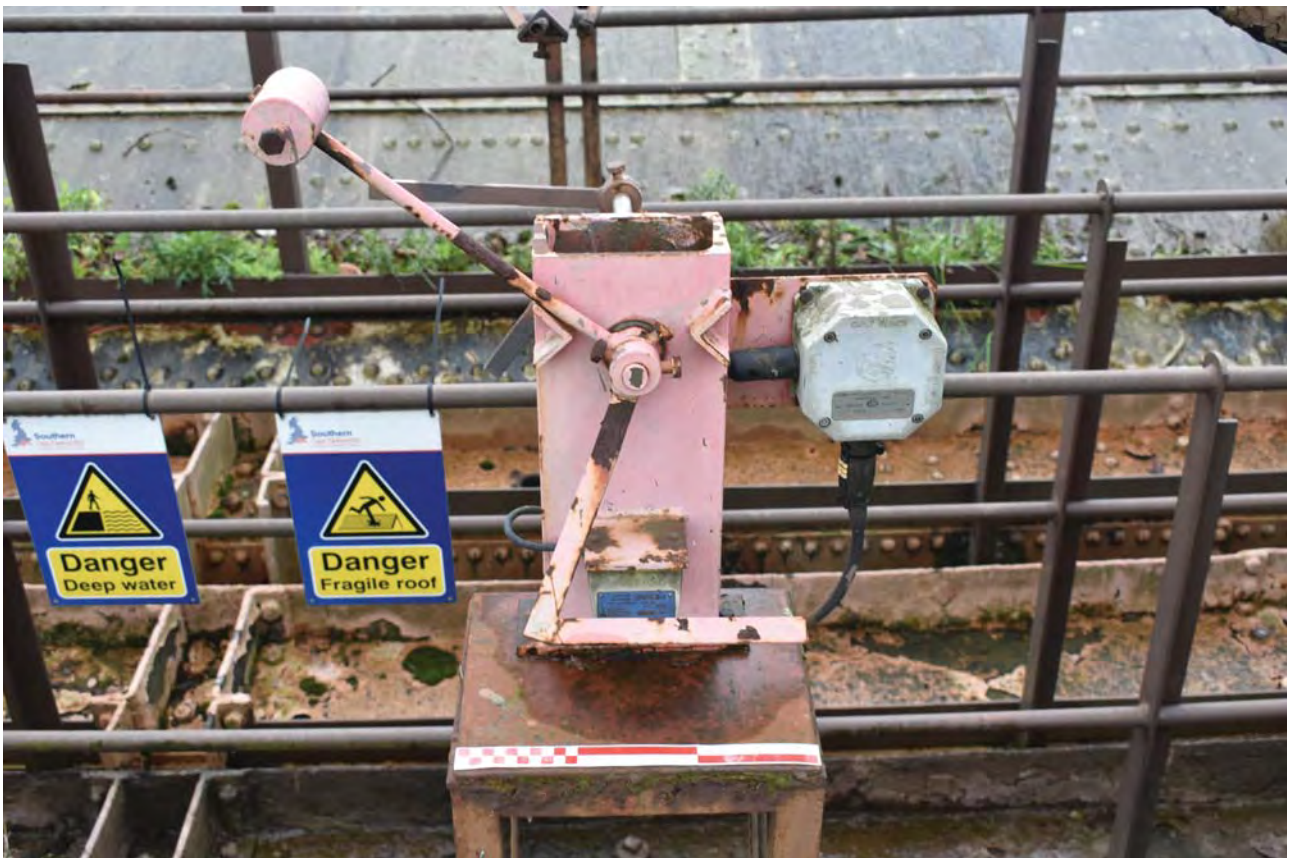
Plate 18: Gasholder No 1, detail of the northernmost knock-off switch (Q) between No 7 and No 8 standards from the north-east

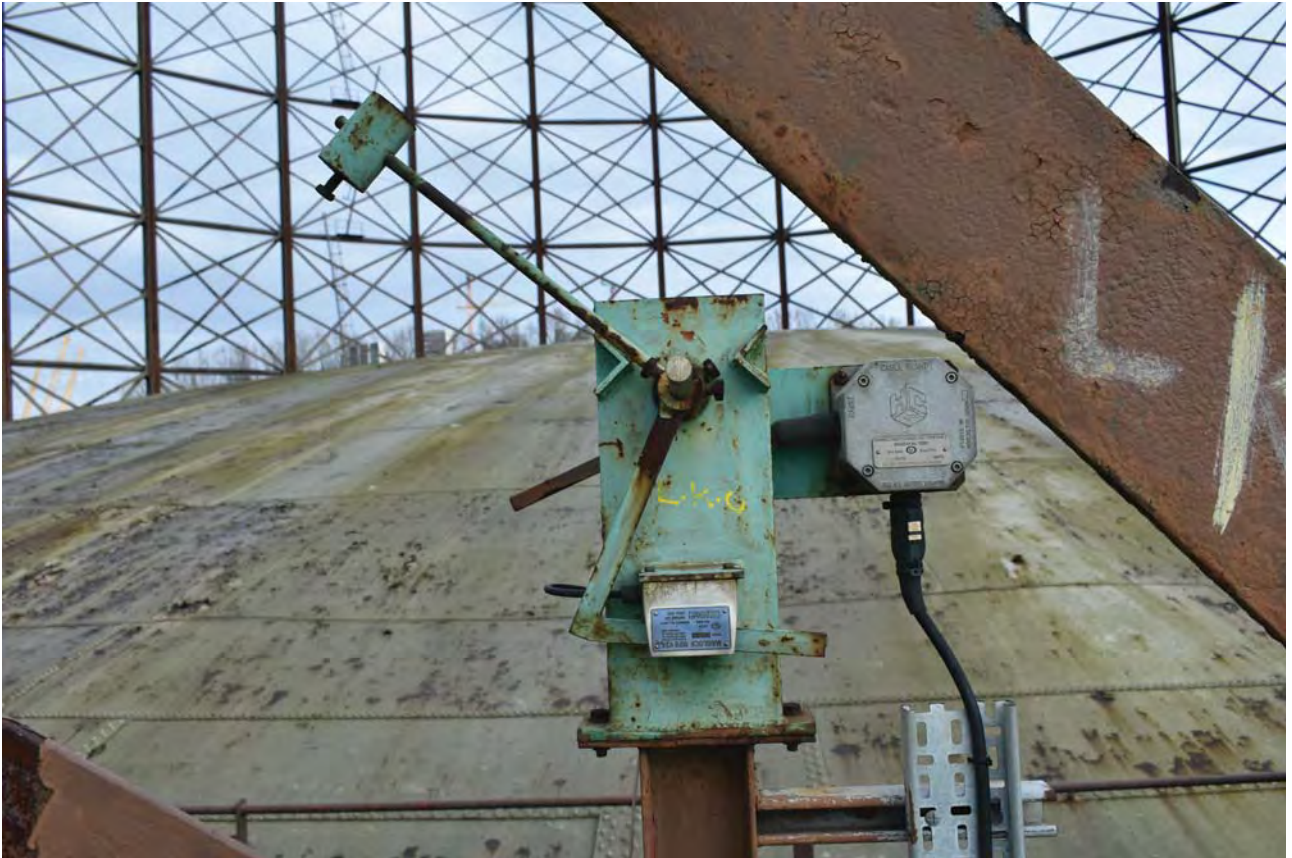
Plate 19: Gasholder No 1, detail of the knock-off switch (S) between No 19 and No 20 standards from the SSW

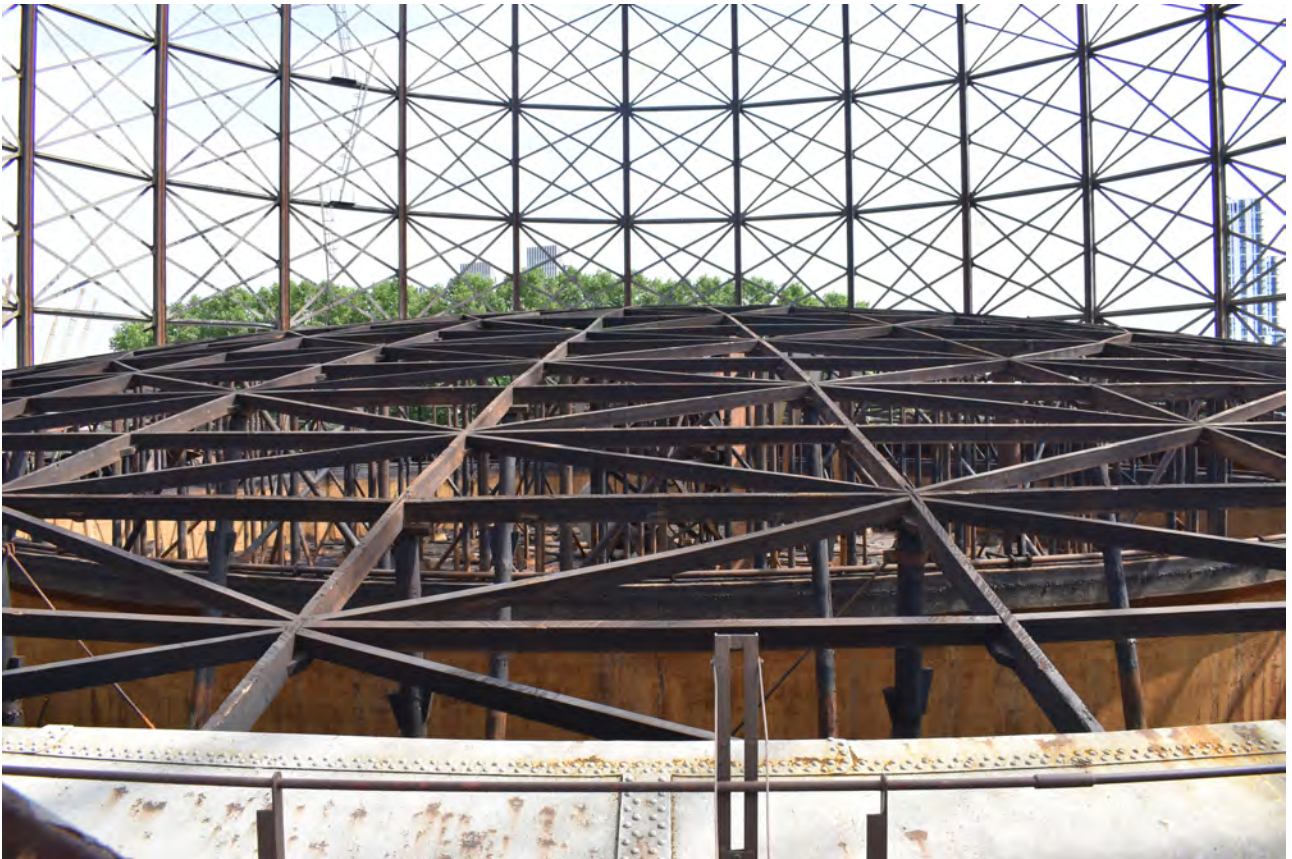
Plate 23: Gasholder No 1, general view of the timber support frame visible due to the crown removal, from the south-west

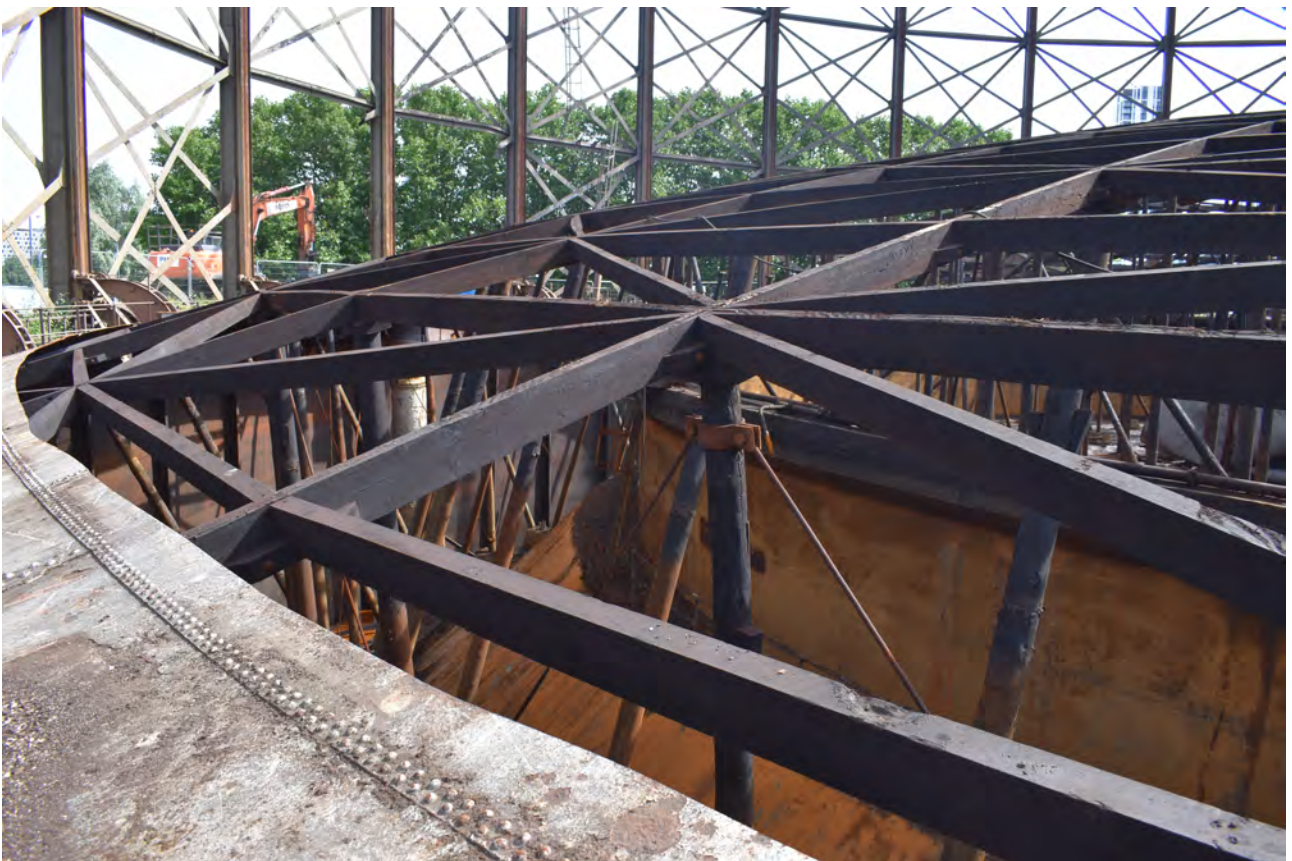
Plate 24: Gasholder No 1, general view of the timber support frame comprised of many short lengths of timber, from the WSW

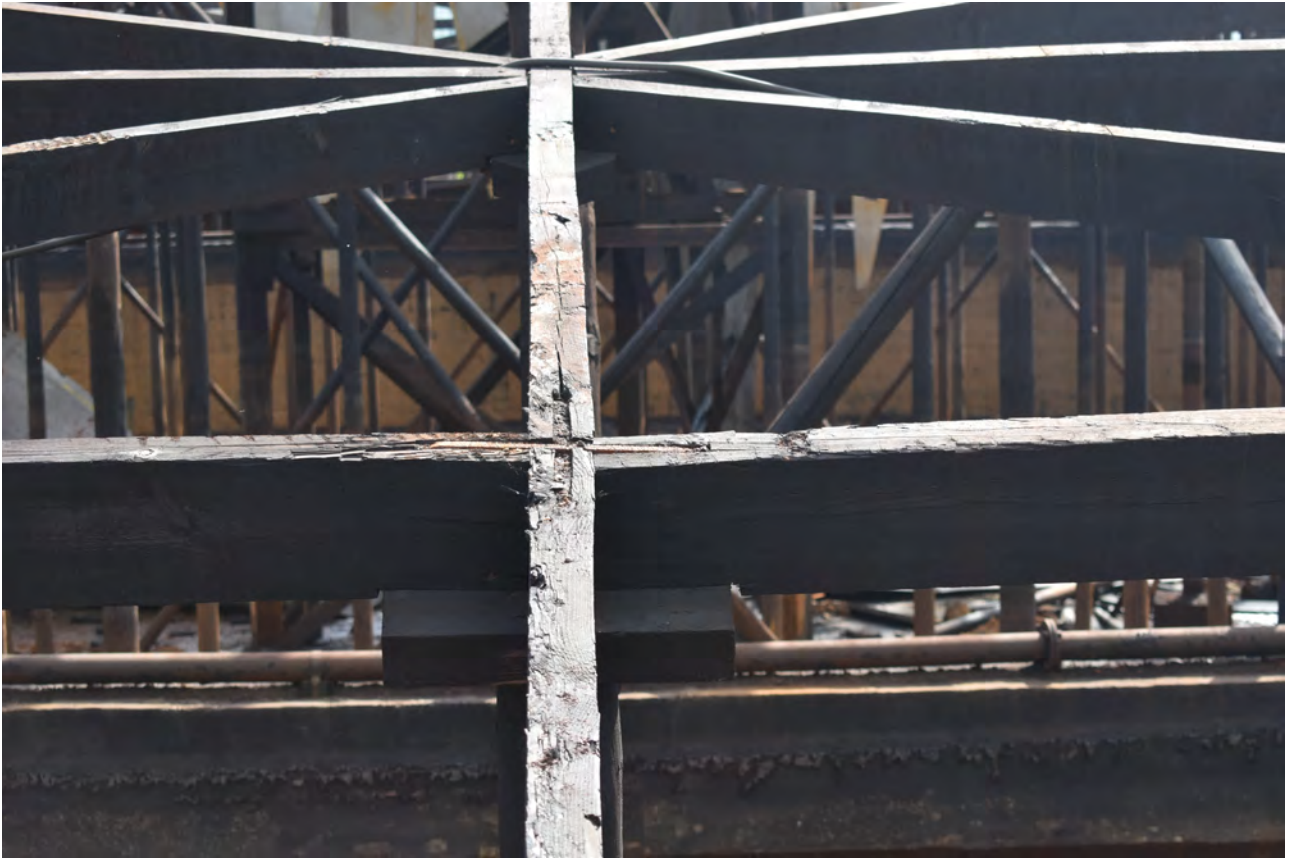
Plate 25: Gasholder No 1, detail of metal joint between spoke and ring timbers, from the WSW

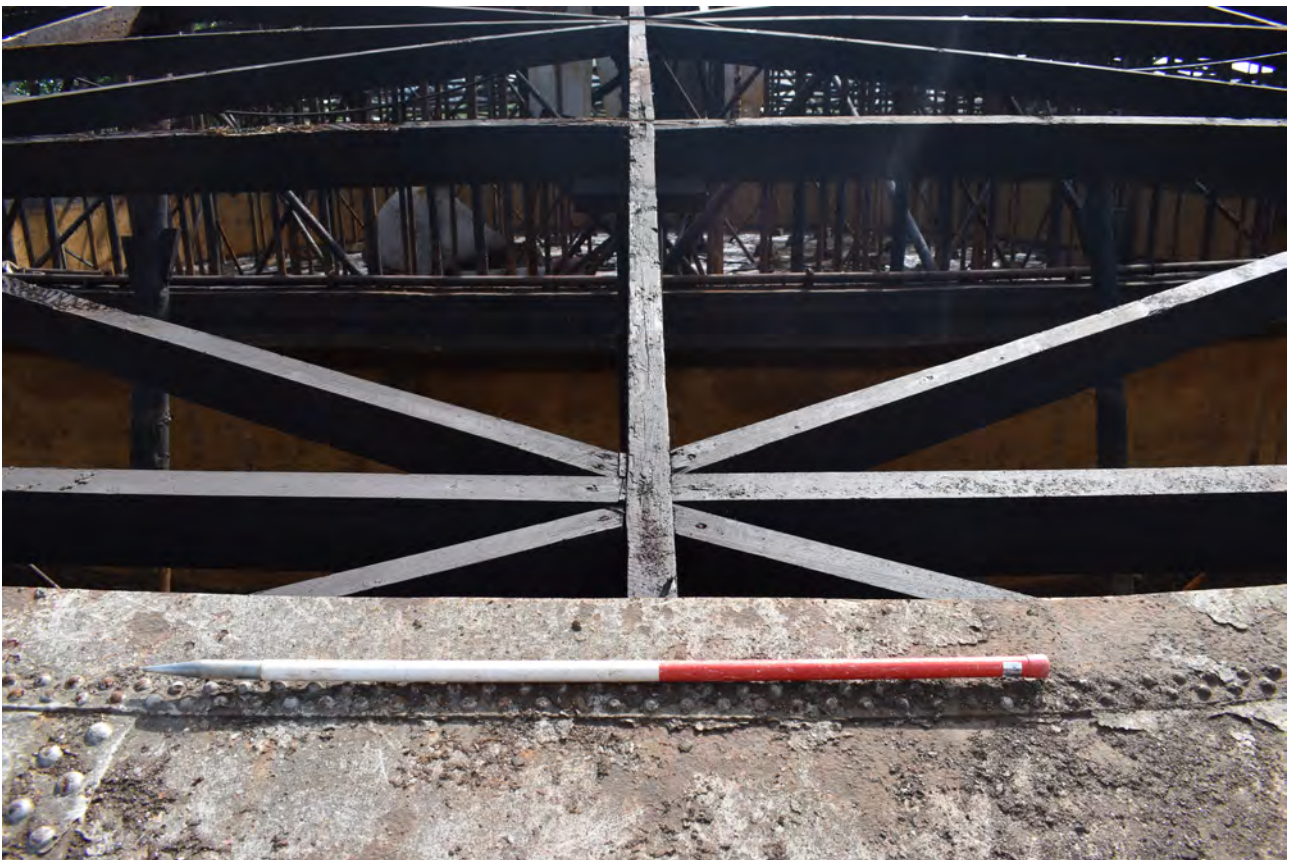
Plate 26: Gasholder No 1, detail of nailed joint, from the WSW

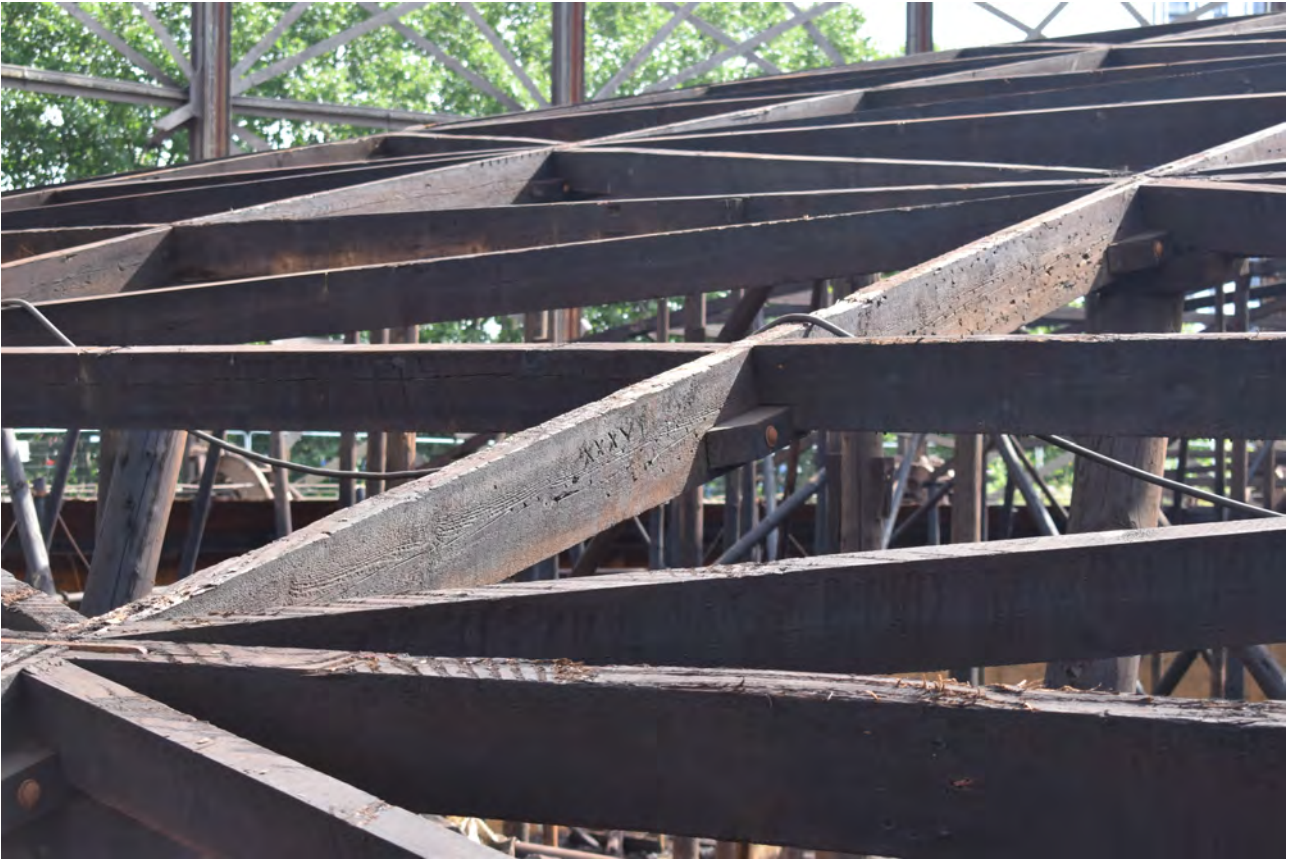
Plate 27: Gasholder No 1, detail of blocks nailed at the joints to increase stability, from the WSW

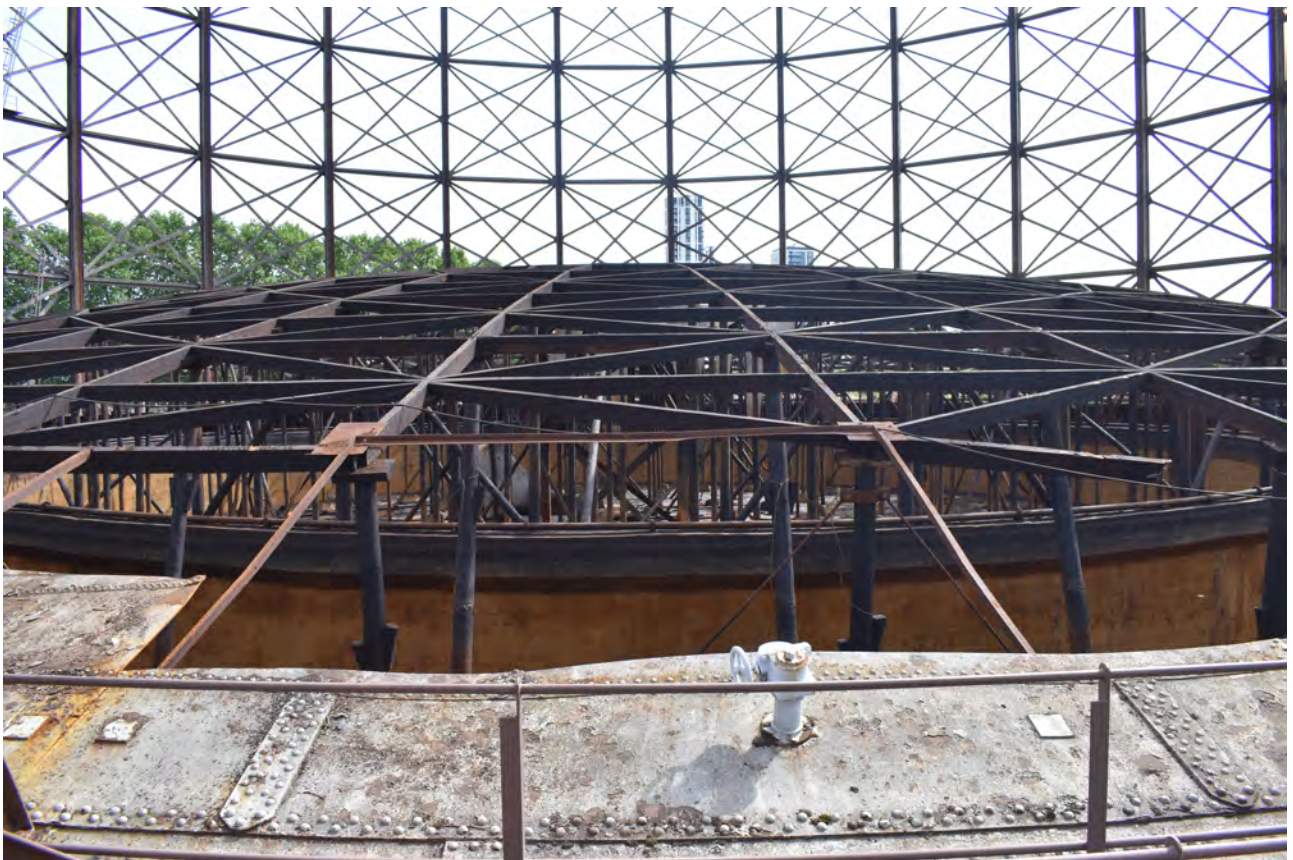
Plate 28: Gasholder No 1, detail of metal repair to the crown support frame between standards 21 and 22, from the south-west

- 6.2.5 Finally, there have been some repairs to the holder in the 20th century after damage in 1917, which caused refurbishments in the 1920s, and repair after damage from the IRA bombing in 1979 (HE 2017b). Whilst the first repairs appear to be minimal, three standards, the bracing between them, the lifts between them and sections of the crown rest frame, were replaced to the west side of the holder after the 1979 attack. This consisted '*... largely [of] steel I-beams welded at the joints, which do not closely replicate the original design.*' (*ibid*, 3). The sheeting over the bell was also repaired at the same time. The most recent alterations to the structure include the replacement of the hand rails at the top of the holder (*ibid*).

GRE_408	View of repair to crown support structure after 1979 fire damage, between standards 21 and 22	SW	08/07/2019
GRE_409	Detail of steel angle bar used to repair to crown support structure after 1979 fire damage, between standards 21 and 22	SW	08/07/2019
GRE_410	Detail of steel angle bar used to repair to crown support structure after 1979 fire damage, between standards 21 and 22	W	08/07/2019
GRE_411	General view of crown support structure from standard 20	S	08/07/2019
GRE_412	Detail of tank below valve on top of crown near to gas main	SE	08/07/2019
GRE_413	Detail of tank below valve on top of crown near to gas main	SE	08/07/2019
GRE_414	General view of crown support structure, between standards 19 and 20	SW	08/07/2019
GRE_415	General view of crown support structure from standard 18	S	08/07/2019
GRE_416	General view of crown support structure, between standards 17 and 18	S	08/07/2019
GRE_417	General view of crown support structure from standard 17	SE	08/07/2019

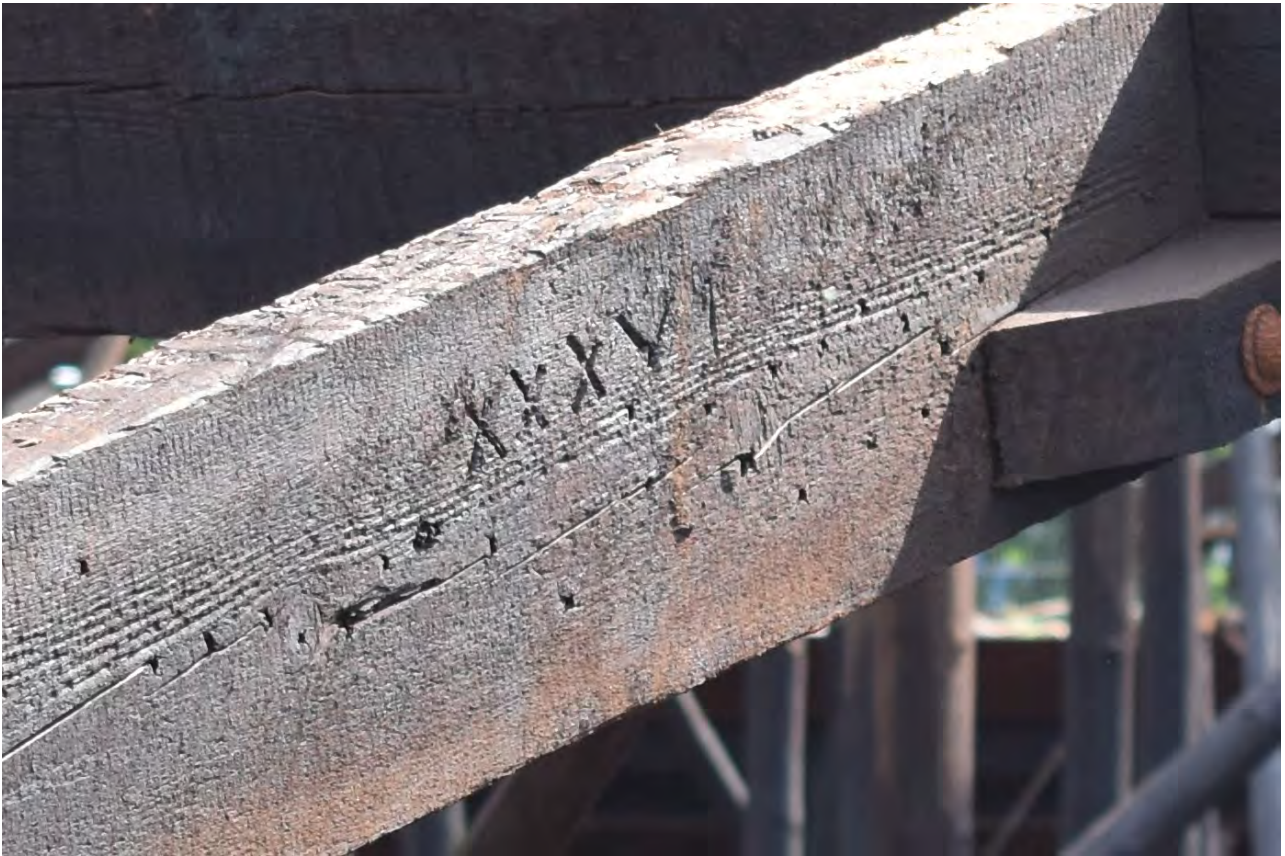
Plate 29: Gasholder No 1, detail of carved roman numeral (XXXVI) on spoke timber suggesting a numbering system was used during construction, from the WSW

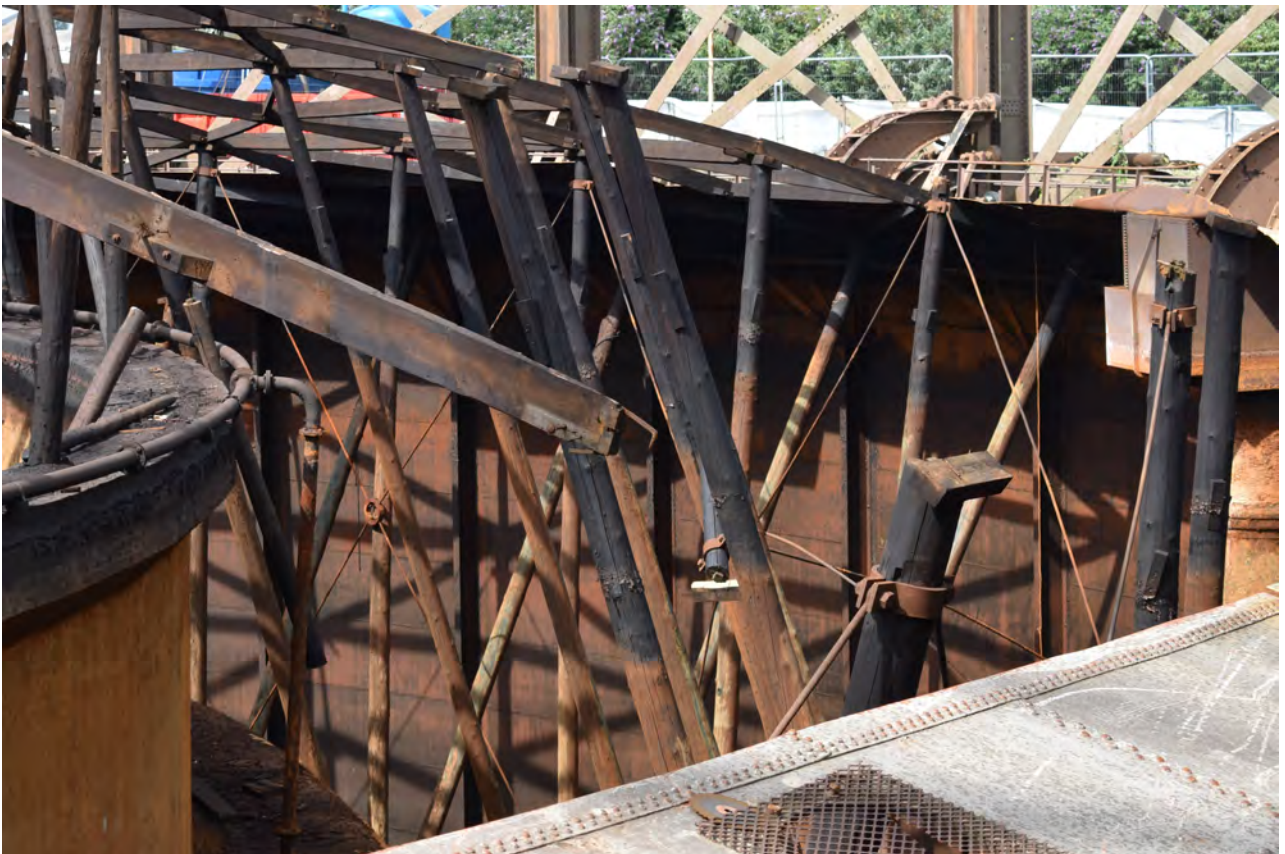
Plate 30: Gasholder No 1, general view of diagonal tie-bars secured with tension rings between the timber uprights of the outermost support ring, from the east

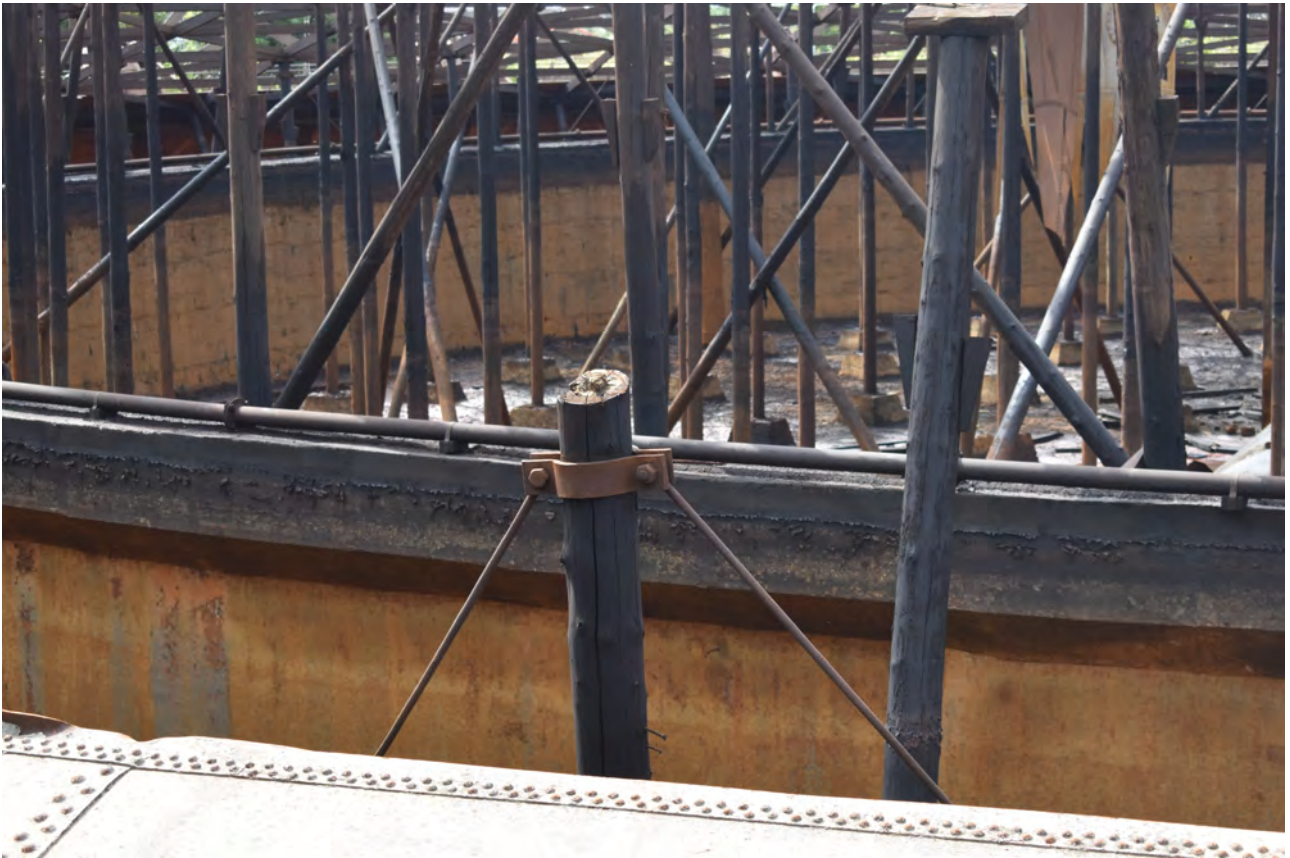
Plate 31: Gasholder No 1, general view of concrete block bases for uprights, from the north-east

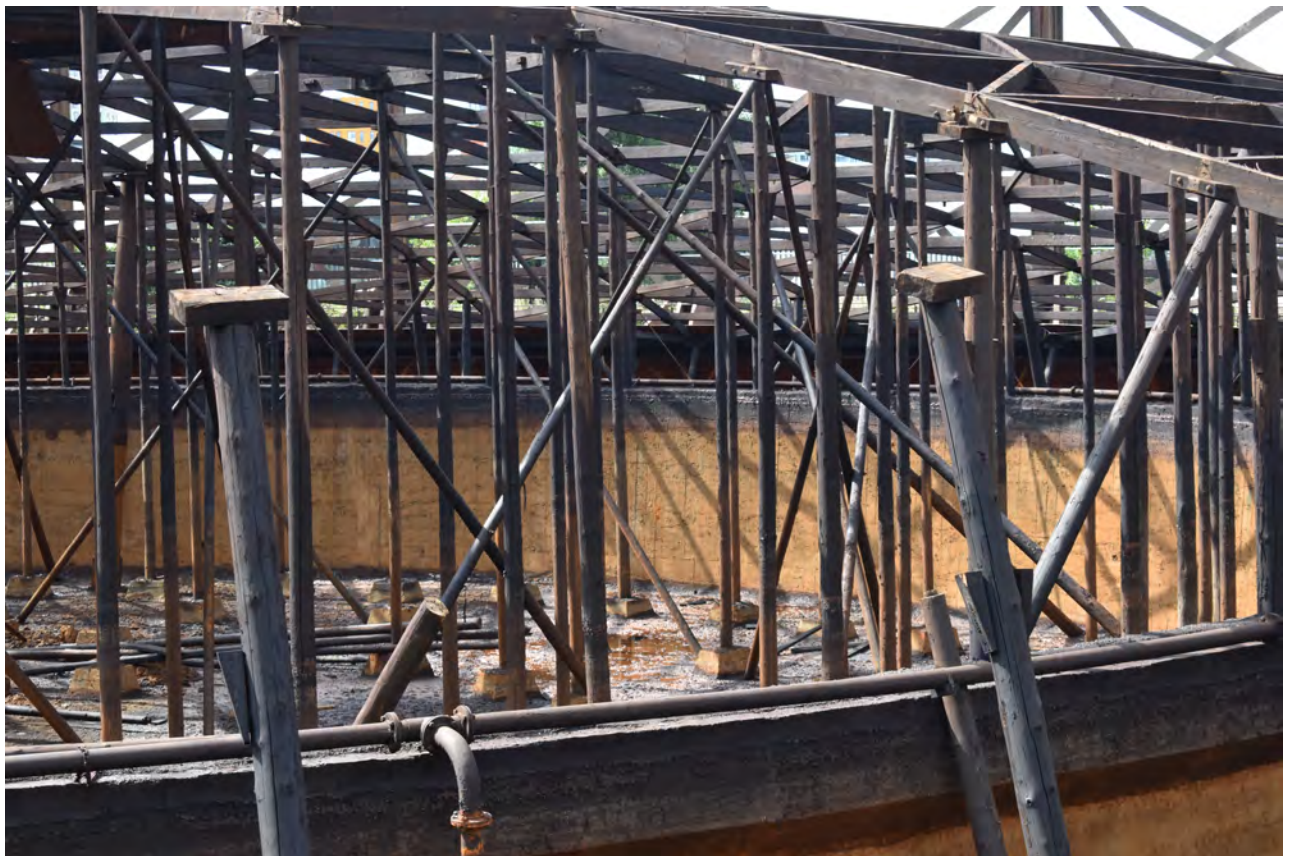
Plate 32: Gasholder No 1, general view of concrete block bases for uprights, from the north-east

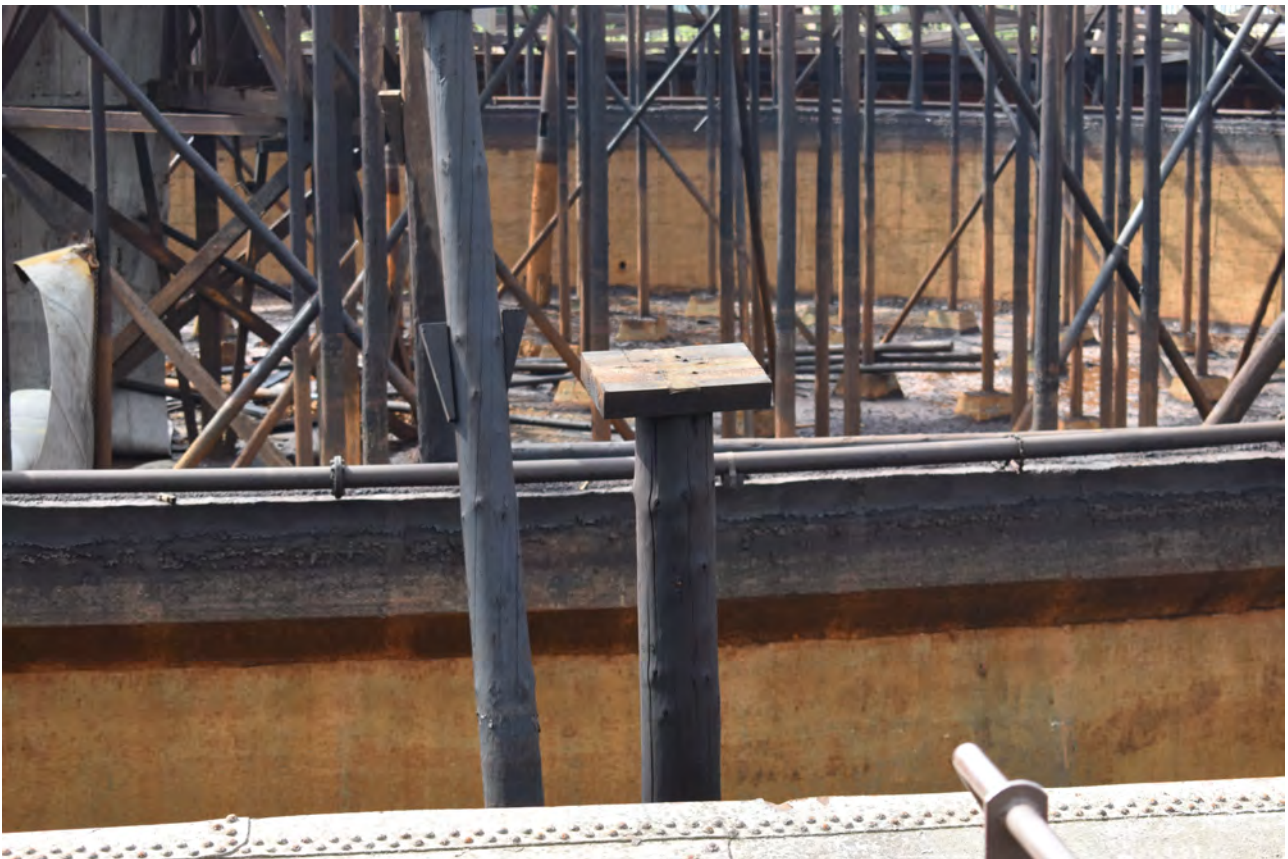
Plate 34: Gasholder No 1, detail view of a square block set on top of each upright to support the timber joint above, and blocks nailed to the side of the uprights for standing on during constructions, from the north
