SGN Gasholder Heritage Review

Blackwall Lane, Greenwich,

Historic Building Recording Phase I & II Final Report

AOC 23686_L
31st October, 2019

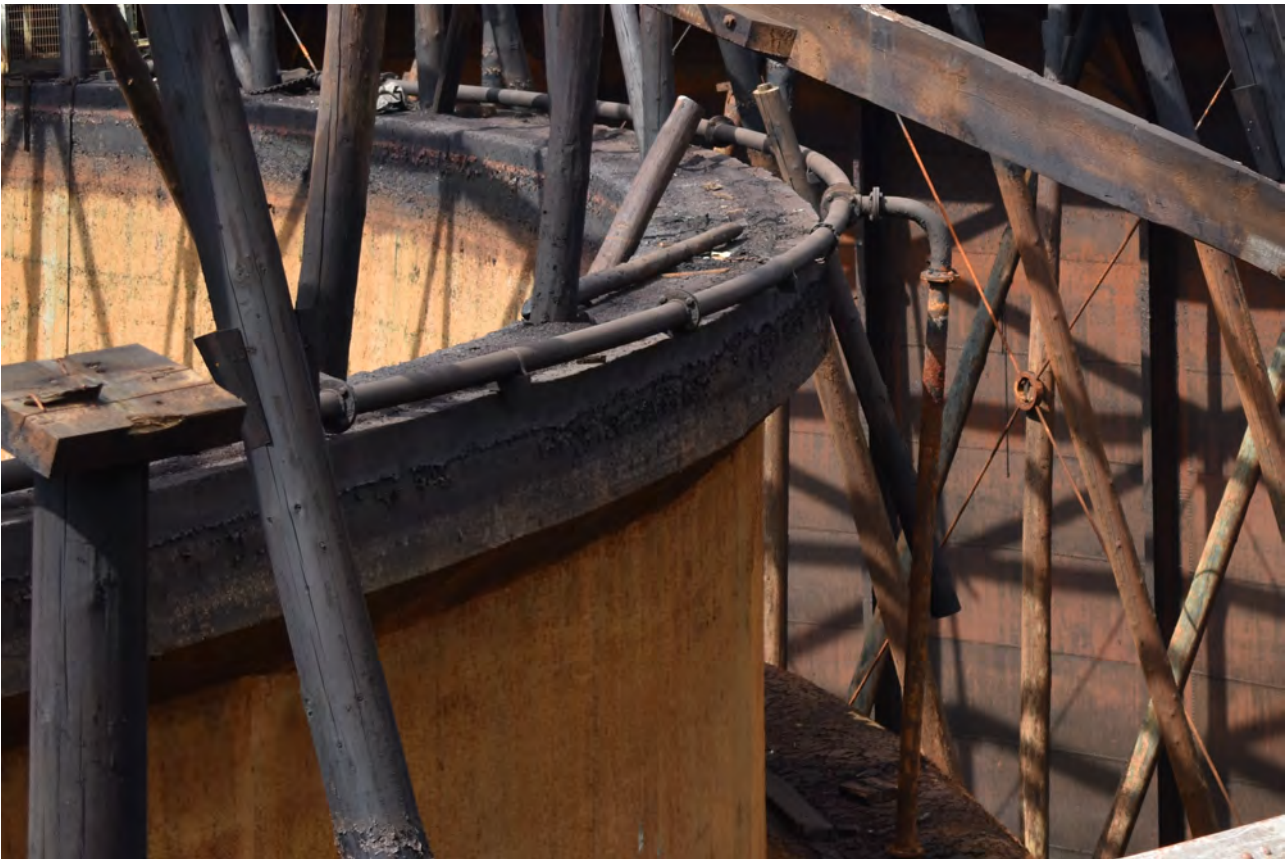
Plate 38: Gasholder No 1, general view of a pipe entering the tank from the north and running up and around the top of the wall in the tank, from the ENE

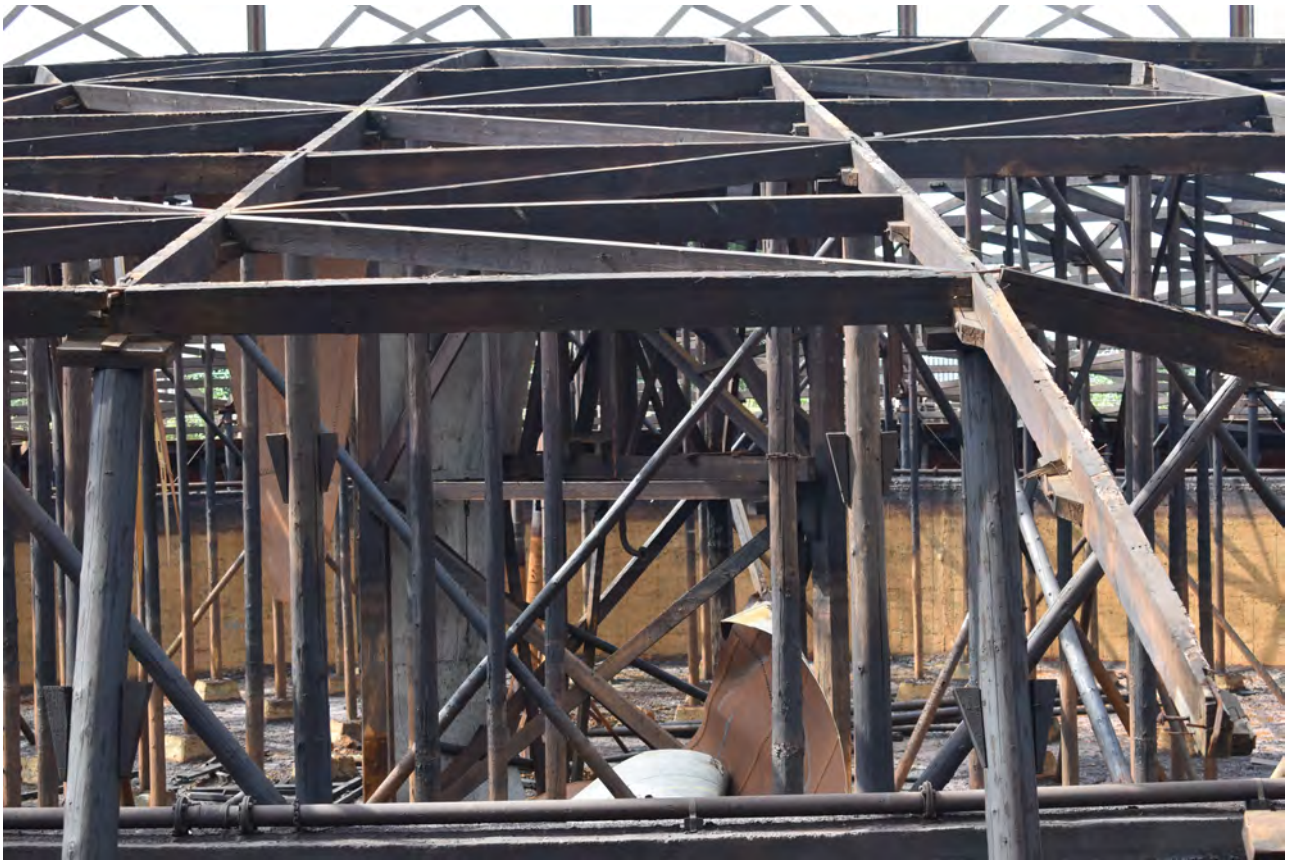
Plate 39: Gasholder No 1, detail of central triangular support framework, from the NNE

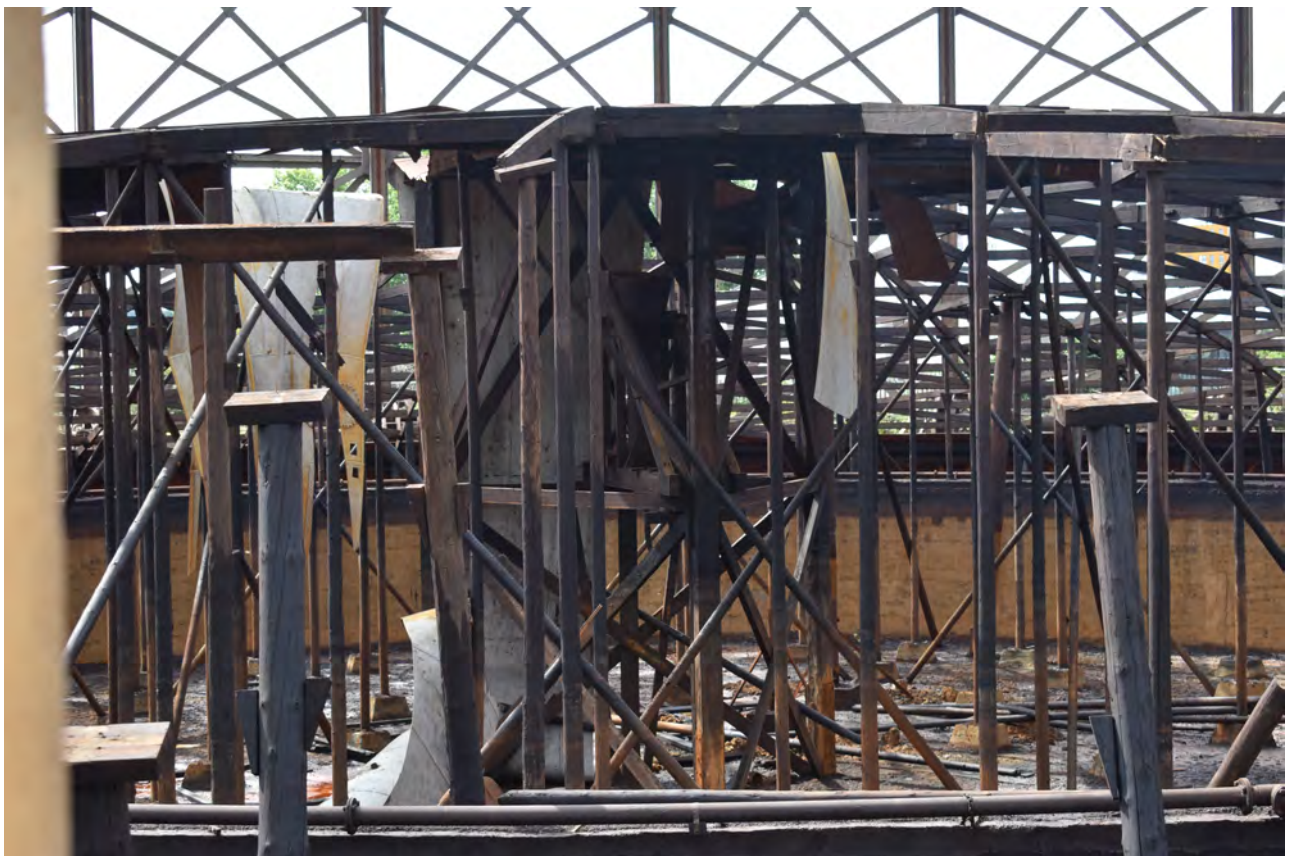
Plate 40: Gasholder No 1, detail of central triangular support framework, from the north

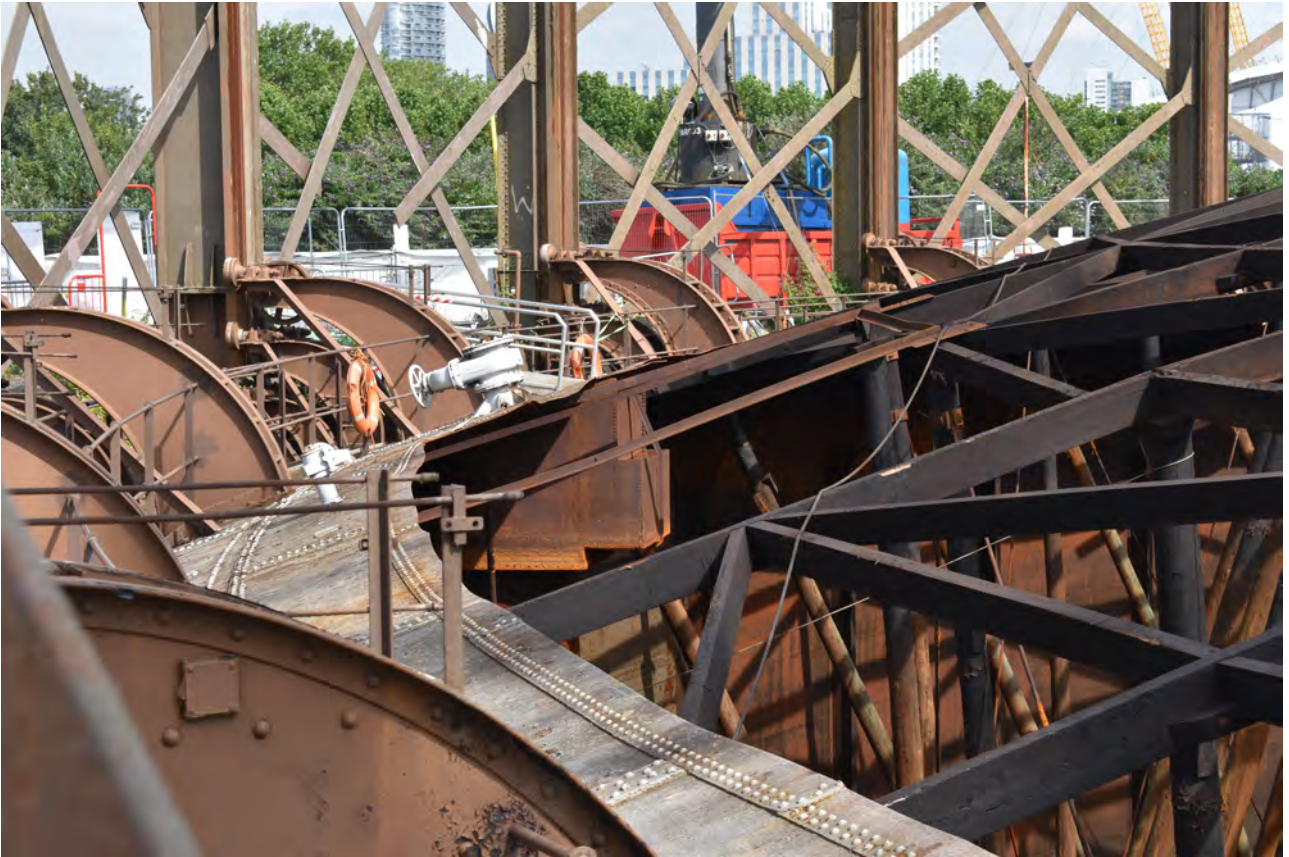
Plate 41: Gasholder No 1, general view of the outlet pipe with Livesey man-lid on the WSW of the gasholder, from the SSW

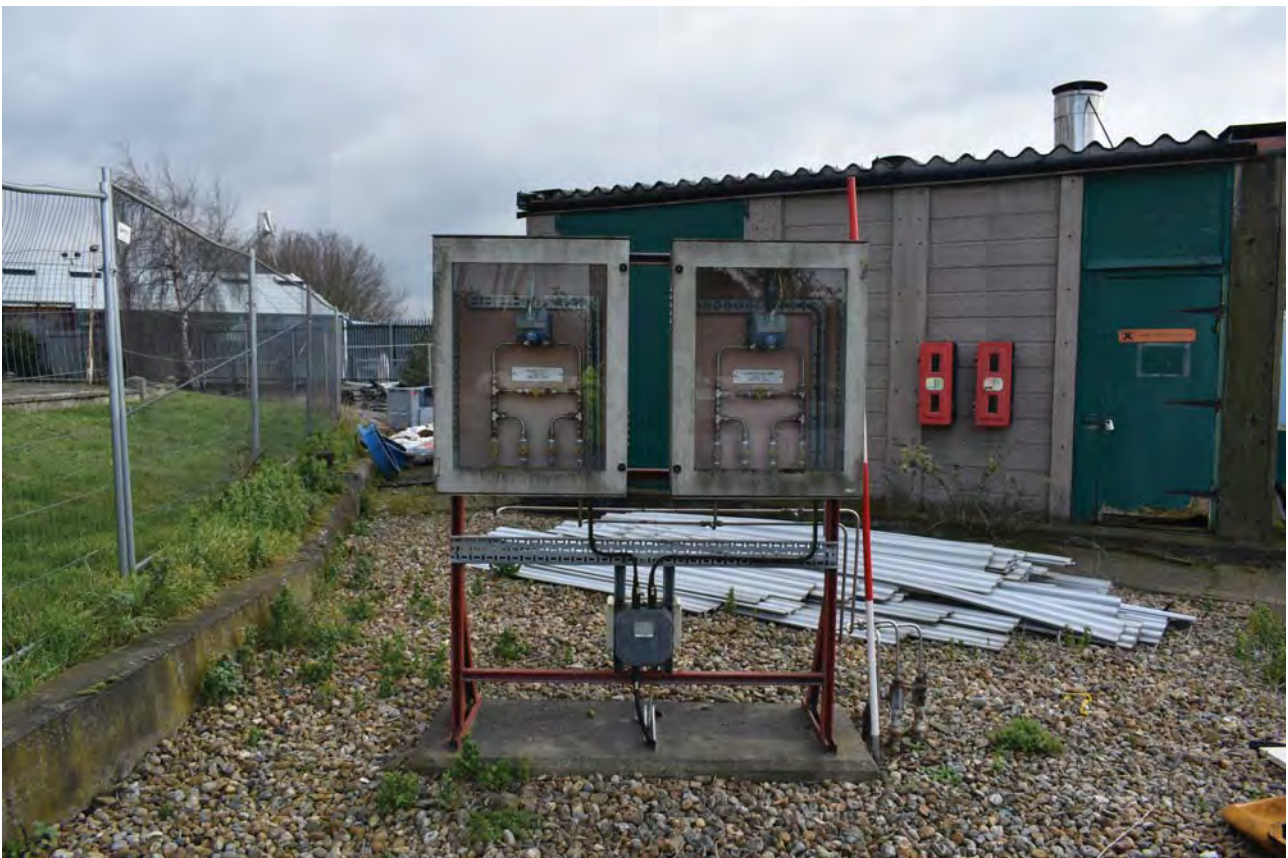
Plate 48: Hi (Holder Outlet Valve) and Hii (Volumetric Governor Overflow), general view from the NNW

- F: Jet Booster valve and associated pipework (Plate 46)
 - G: Modern shed (Plate 47)
 - Hi: Holder outlet valve (Plate 48)

- Hii: Volumetric Governor Overflow valve (Plate 48)
- I: Unknown valve to the immediate north-east of valves Hi & ii
- J: Unknown valve to the west of the gasholder
- K: Steel tank and pipework in a concrete compound (Plate 49)
- L: Cover for underground pipework (Plate 49)
- M: Small concrete enclosure with pipe fitting (Plate 49)
- N: Unknown valve
- O: Small steel shed to the north-west side of the gasholder opposite L & M (Plate 50)
- P: Large section of pipework (Plate 51)
