Travel Route, Little France Drive to The Wisp, Edinburgh

Archaeological Watching Brief & Metal Detecting Survey: Data Structure Report

AOC Project 24290
19th April 2018

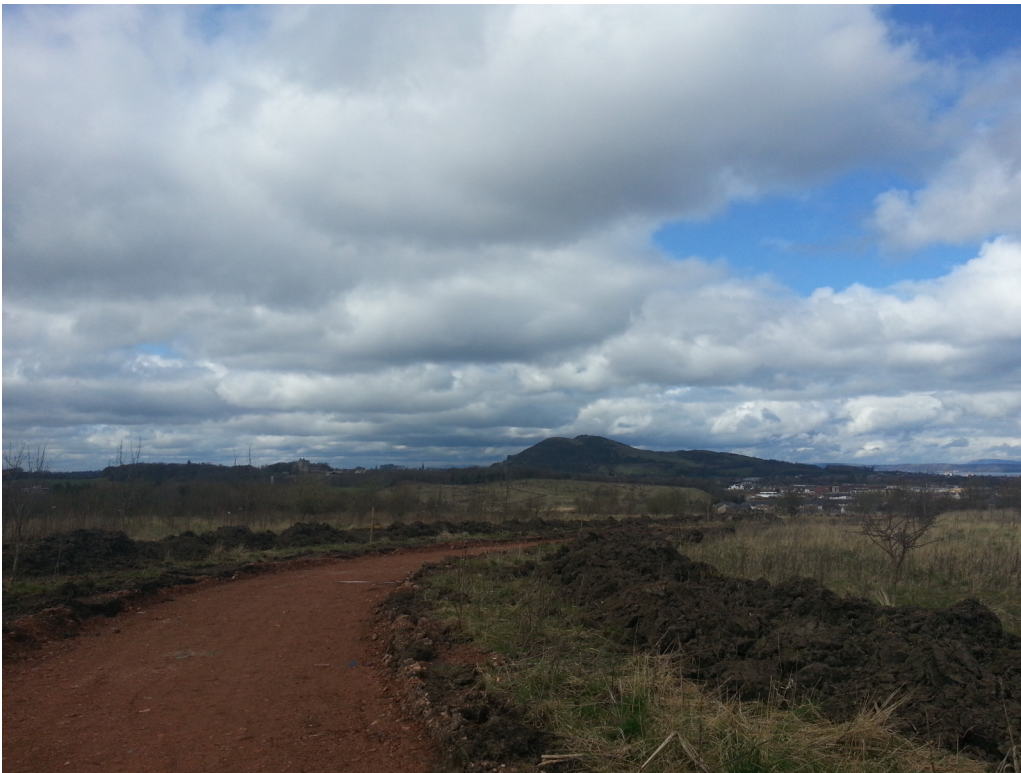
Plate 1: View of the route from the west.

4.1 The watching brief and metal detector survey were conducted concurrently between the 3rd and the 12th of June 2018. An archaeologist detected all stretches of path prior to the machine(s) excavating. [Plate 1] provides a general view of the route.

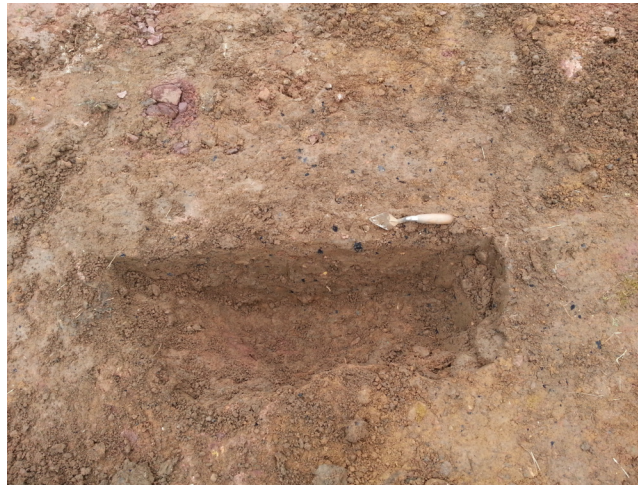
Plate 2: 18th/19thC Pit [007].

4.3.1 An oval pit feature [007] measuring 0.7m by 0.5m by 0.3m was recorded close to the earthen embankment [005]. The pit a grey brown silty clay with flecks of coal [Plate 2], the fill contained a single hand-made brick, likely of 18th-19th century date.

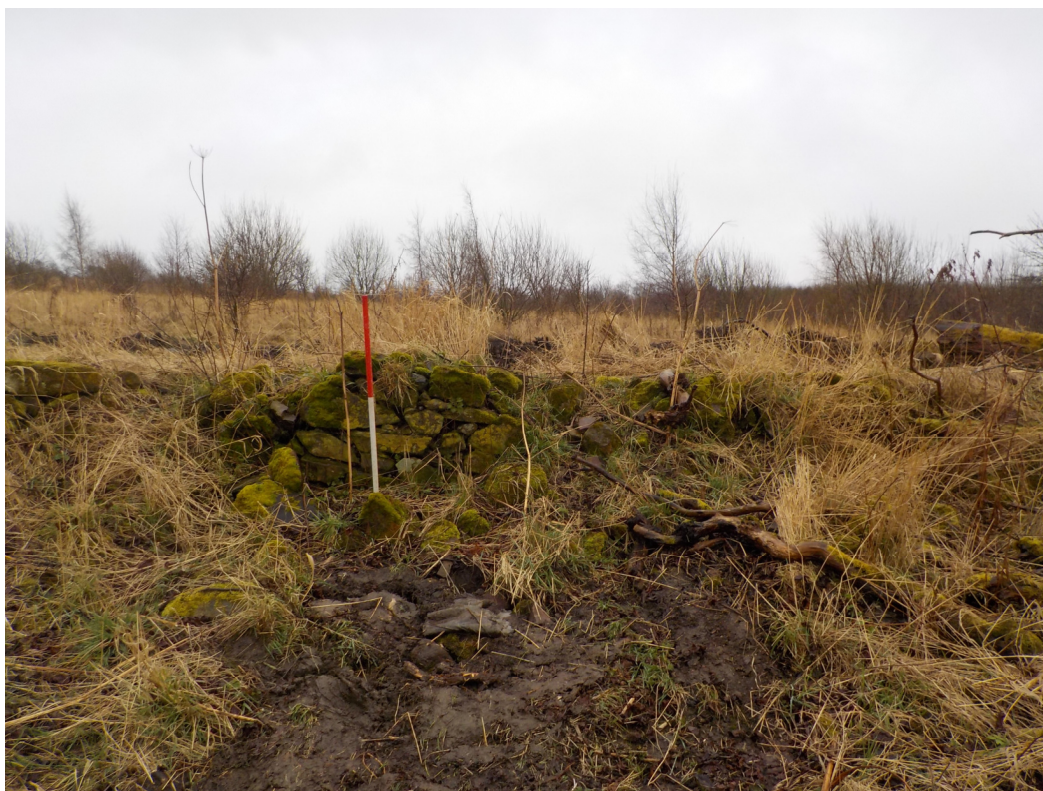
Plate 6: Historical wall [003] from west

The drystone boundary wall [003] was aligned NE-SW and survives to a height of 0.7m [Plate 6]. The wall is a single course in width (0.40m) and is a maximum of five courses in height. Numerous dislodged stones were visible around the base of the wall and it is likely that it was formerly more substantial. To incorporate the new path a 6.5m long stretch was removed under archaeological supervision. The machined section of the wall was recorded and photographed after drawing and photographing.
