***AN ARCHAEOLOGICAL INVESTIGATION OF
DRAKE'S LEAT,
ENDSLEIGH PLACE,
PLYMOUTH***

JANUARY 2007

Site Code: AR 2006 500

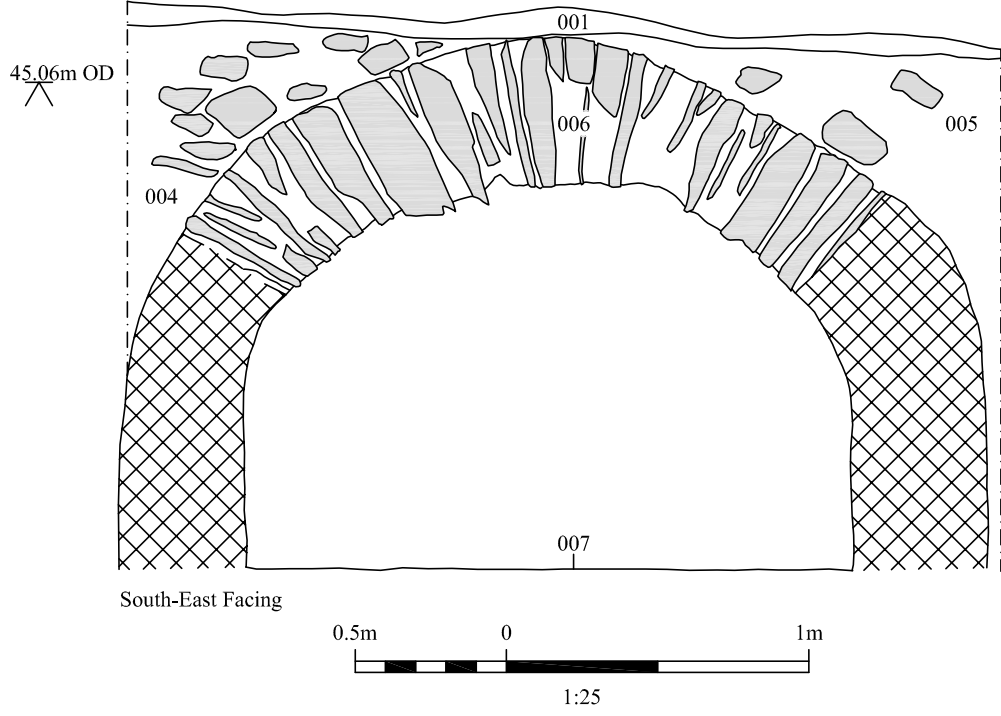
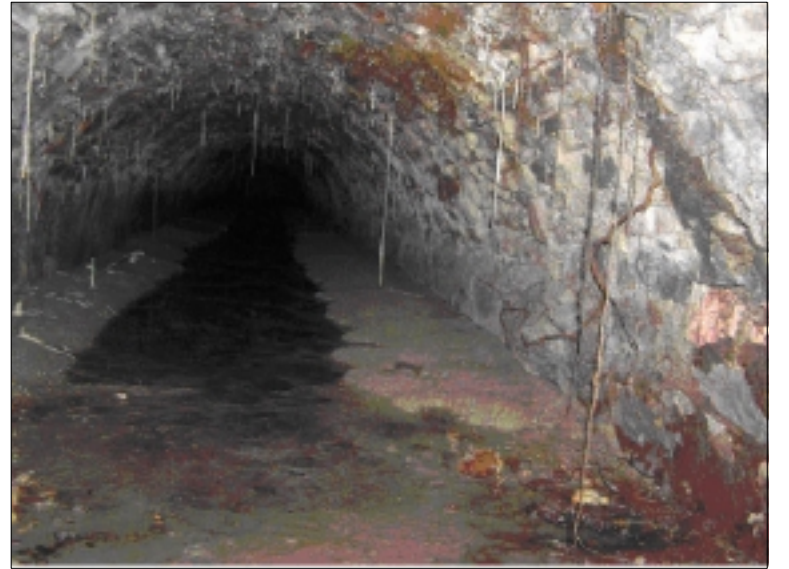
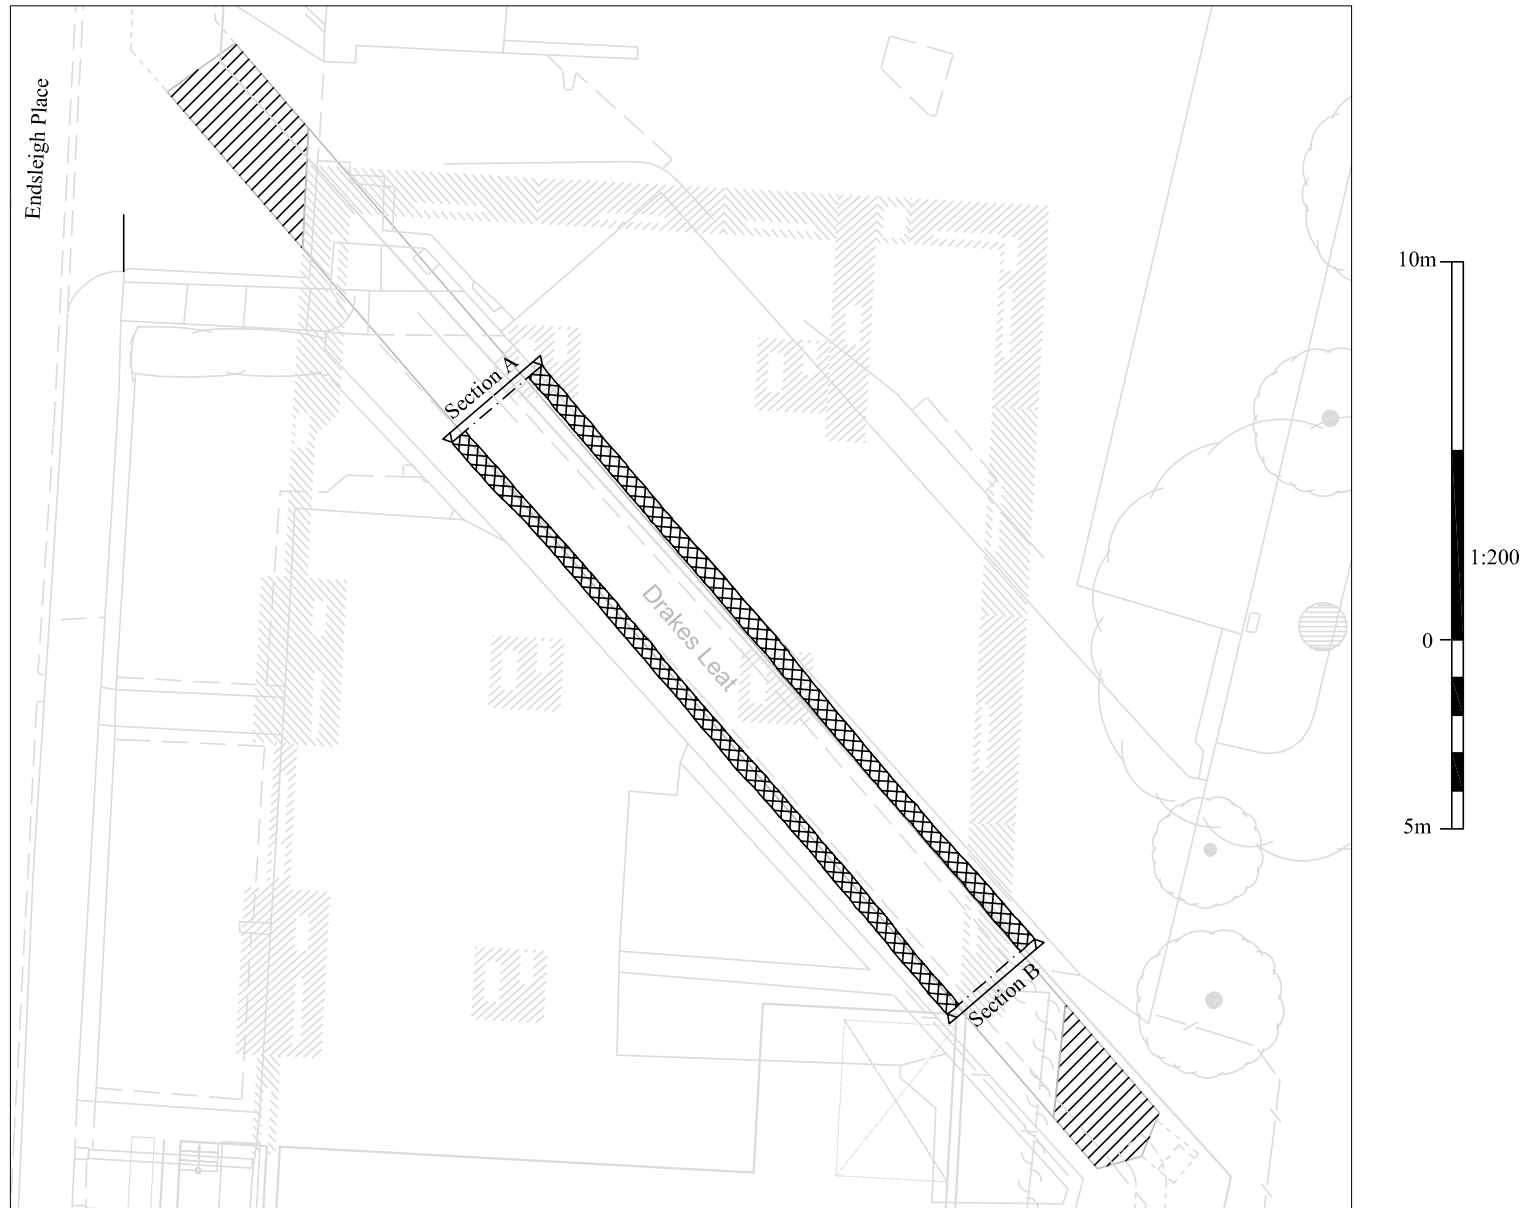
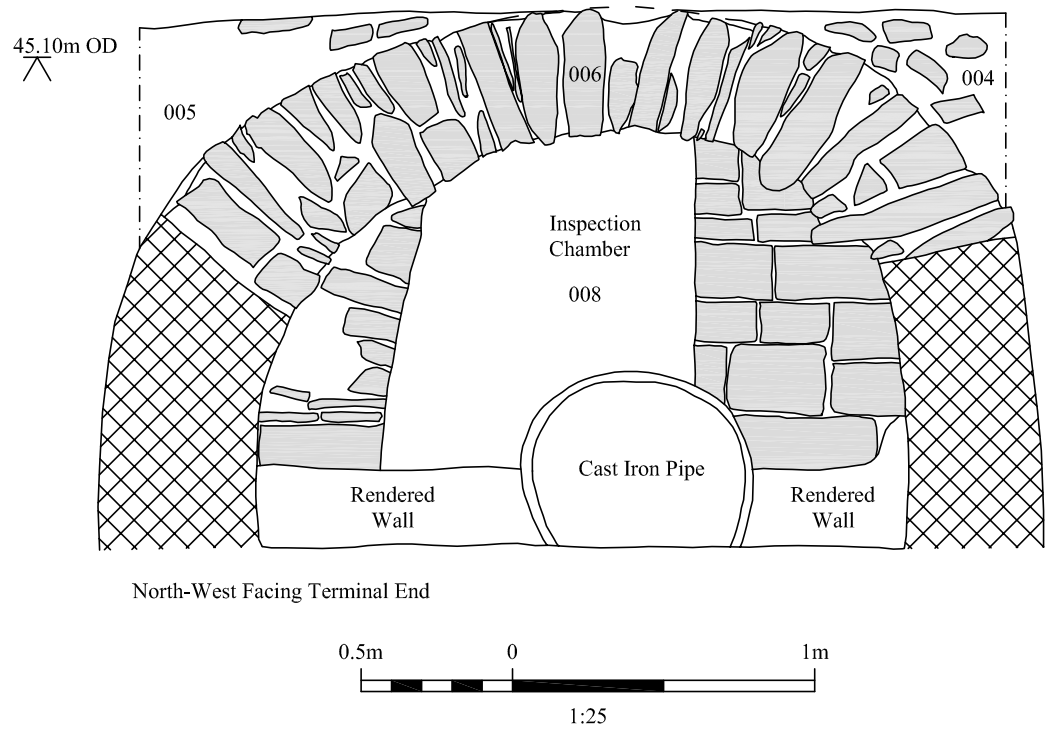
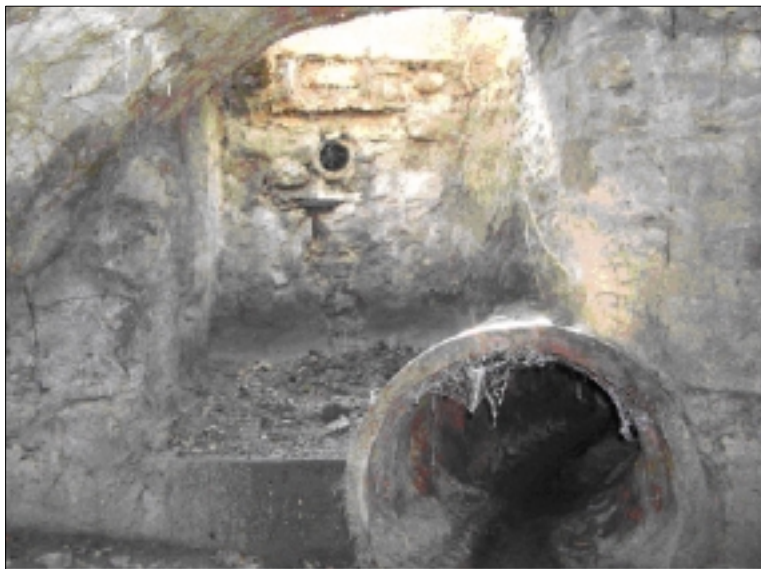
Figure 6: Located Sections Through Drake's Leat

Section A

Plan of Drake's Leat

Section B

- 6.3 Limestone structure (006) terminated at the southern end of the site. At the terminal end was the remains of a separate structure which comprised an inspection chamber and a large cast iron pipe (008) (Figure 6). The chamber measured 1.10m long by 0.90m wide and 0.90m deep and was constructed with cut limestone blocks varying in size from 0.19m long by 0.07m deep to 0.45m long by 0.17m deep. The western wall of the chamber formed a more substantial wall which curved and continued beyond the limits of excavation to the west. Both walls had rendering approximately 0.25m up the wall from the floor (Figure 6). The pipe laid within the wall and base of the inspection chamber measured approximately 0.75m in diameter and sloped significantly in a south-west direction. An inspection of the pipe suggested that it would have been used to carry water out of the leat culvert and away to the south.
