Lasswade Road, Eskbank, Midlothian: Archaeological Evaluation Data Structure Report

AOC Project 23608
18th May 2018

AOC Project No: 23608

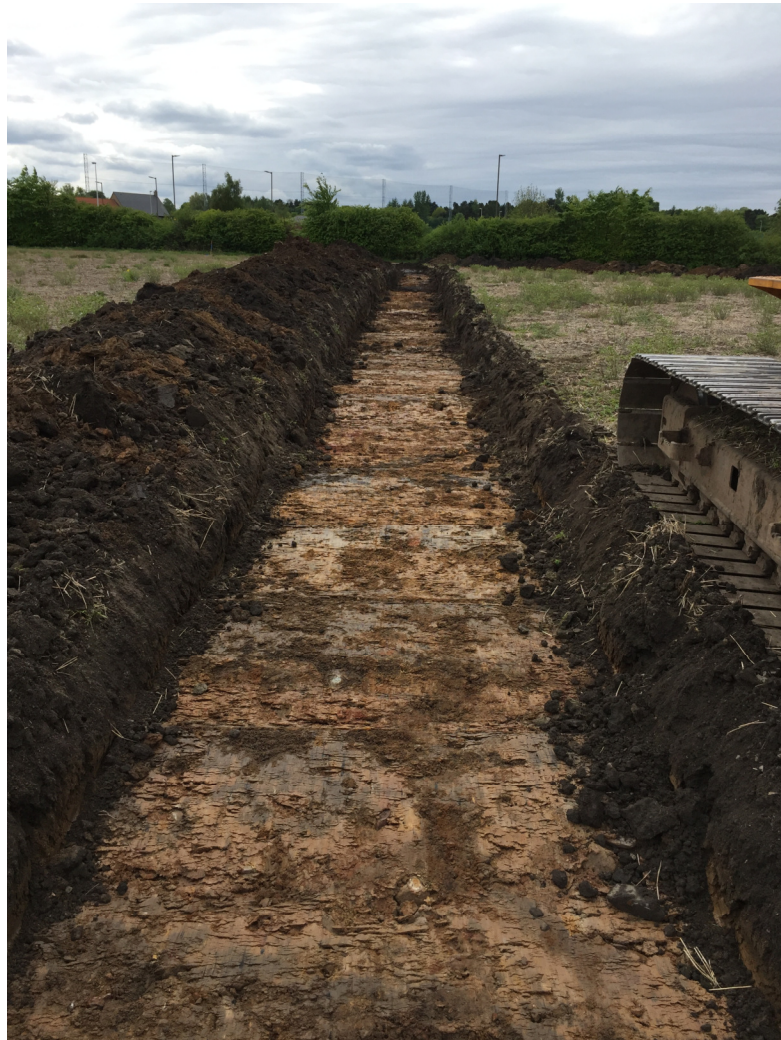
Plate 1 Trench 4 post excavation

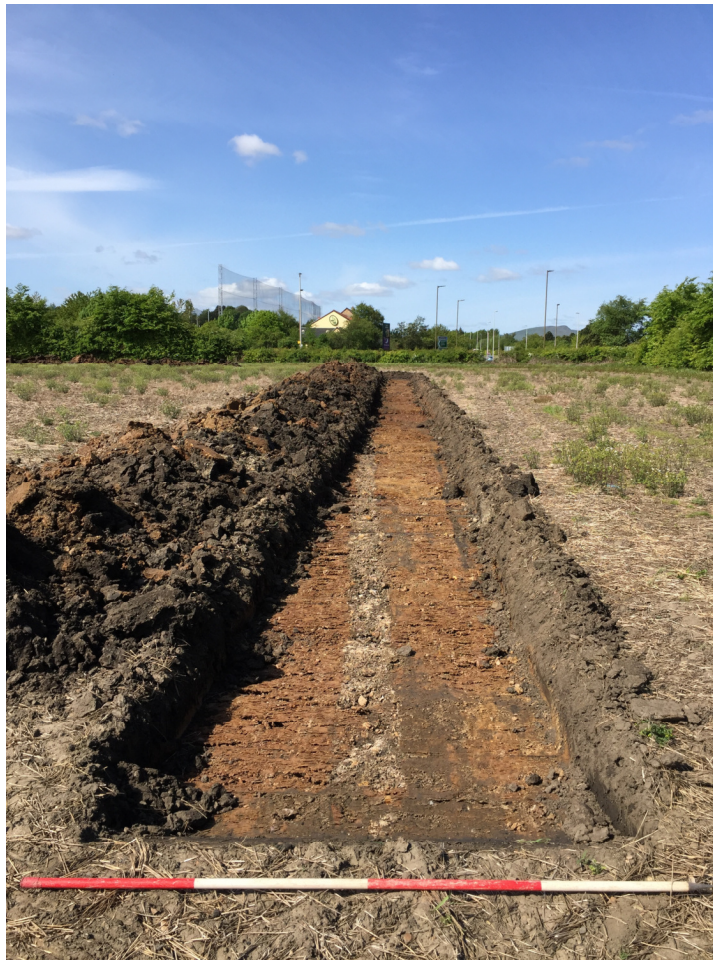
Plate 2 Trench 22 post excavation shot showing rubble drain

Context No.	Description and Interpretation
2203	Fill of [2204] – Mid orangey brown silty clay fill, occasional small stones with mix redeposited natural
2204	Cut of probable drain – Flat uneven base, steep sides, linear. 0.40m x 0.23m

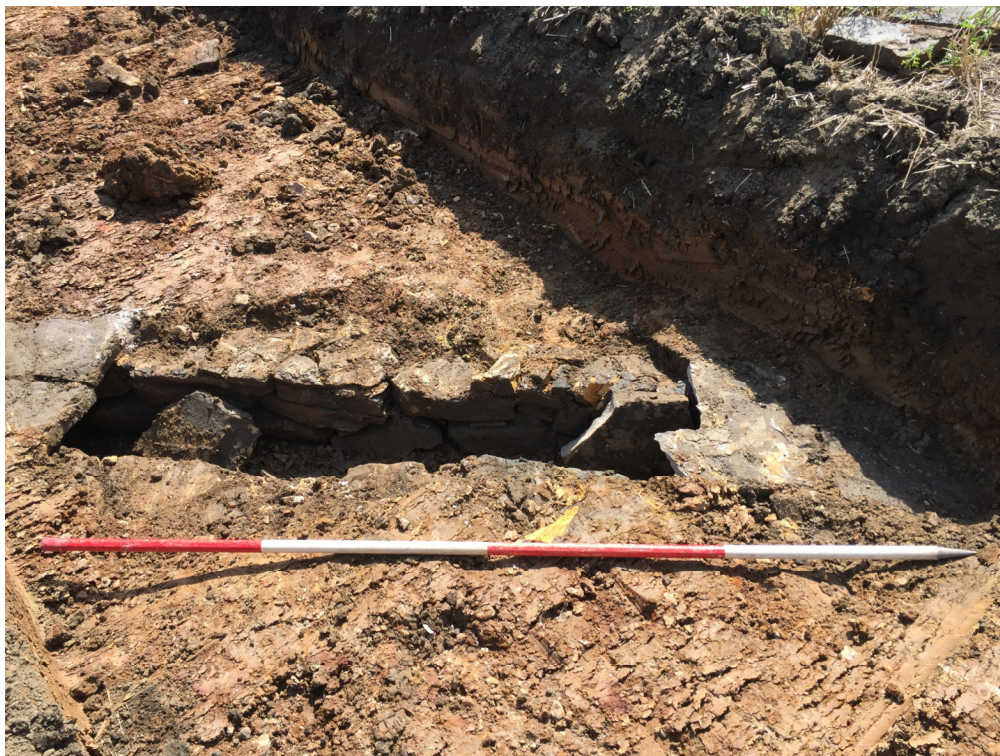
Plate 3 Trench 28 showing Culvert [2803]

- 4.6 A single E-W culvert [2803] was exposed in Trench 28. The drystone culvert measured 0.50m wide and 0.20m deep. It was composed of small flat angular sandstones, 3 stones high with a base, walls and capping stones. The walls measured 0.15m wide and were set 0.25m apart.

Context No.	Description and Interpretation
2803	Culvert - Drystone linear feature running across Trench 28. The culvert is 0.50m in width by 0.20m in depth and is composed of small flat angular sandstones. The culvert is rectangular in section and has a base, wall and cover.
2804	Deposit – Pale grey brown clay silt with occasional inclusions of small sub-rounded stones. Fill of Culvert [2803]

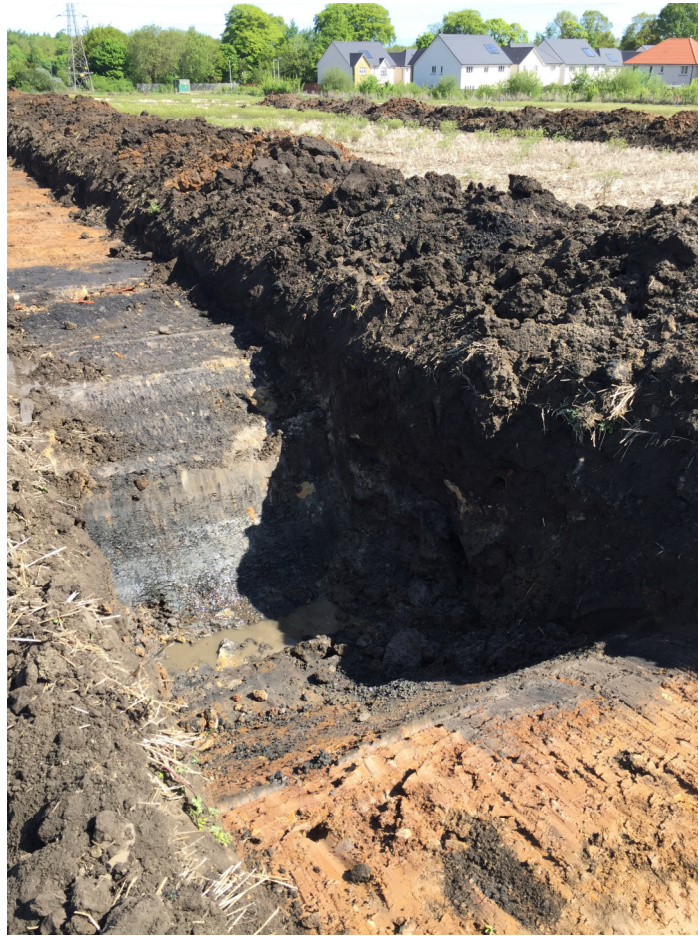
Plate 4 Coal seam [1303] within Trench 13

- 4.4 Several trenches within the south-west of Area A revealed the existence of coal seams. These were recorded within Trenches 9, 12 and 13. A linear [105] stone filled drain (NNE-SSW), was exposed in Trench 1. The drain terminated within the trench and measured 0.40m wide and 0.36m deep, with a flat based and steep sides.

Context No.	Description and Interpretation
1303	Coal seam – Trench 13 large spread of coal dust
