Loanhead Road, Loanhead, Midlothian: Archaeological Evaluation Data Structure Report

Archaeological Evaluation: Data Structure Report

AOC Project No: 24331

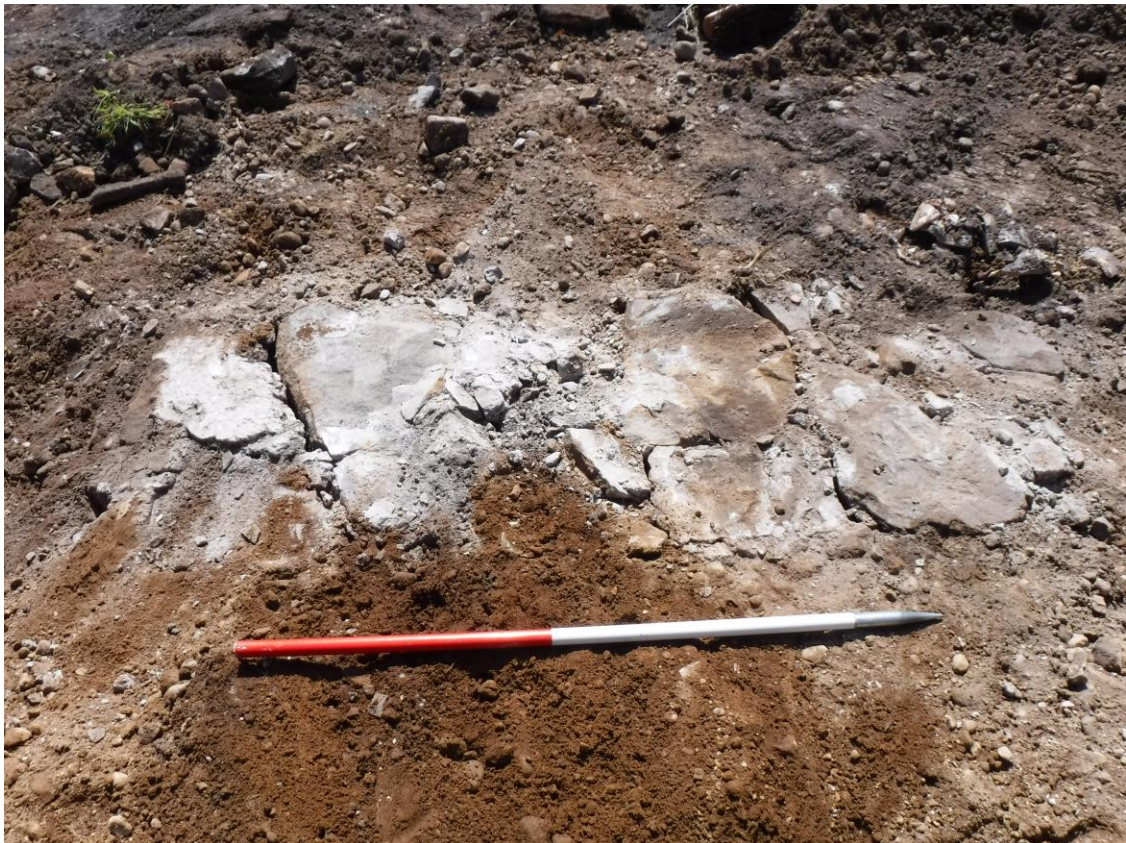
Plate 3 View of [2402]

- 4.6 Trench 24 (**Figure 2-3**) was located beside the cottages associated with Mayshade House. This trench contained the remains of a severely truncated sandstone wall [2402] (**Plate 2**). The wall survived as a single course with dimensions of 2.0m x 0.7m and appeared to be cut into the natural (2400). No cut was apparent for [2402]. Two brickwork surfaces (**Plate 3**). [2403-2404] (total dimensions as exposed 3.0m x 2.0m) were revealed next to the wall. The surface [2403] was constructed using purely red brick, while [2404] (dimensions as exposed 2.5m x 2.0m) utilised a mix of yellow and red brick. Both surfaces appeared to be constructed on top of natural (2400). All was overlain by topsoil and demolition (2401), with a depth of 0.2m.

- 5.1 The evaluation at Loanhead Road successfully recorded remains associated with Mayshade/Ashgrove House's cottages.
- 5.2 The remains in Trench 24 (**Figures 2-3**) likely relate to the external wall [2403] and possibly external flooring of the dwelling [2403, 2404]. The external wall is possibly part of the later extension when the 18th century bothy was converted, based on the map evidence (**Figure 3**). The flooring possibly relates to an external courtyard or path (**Figure 3**). These appear to have been severely truncated after the fire that destroyed Mayshade House with the demolition material left immediately overlying these features. Both features are most likely part of the 19th century redevelopment.

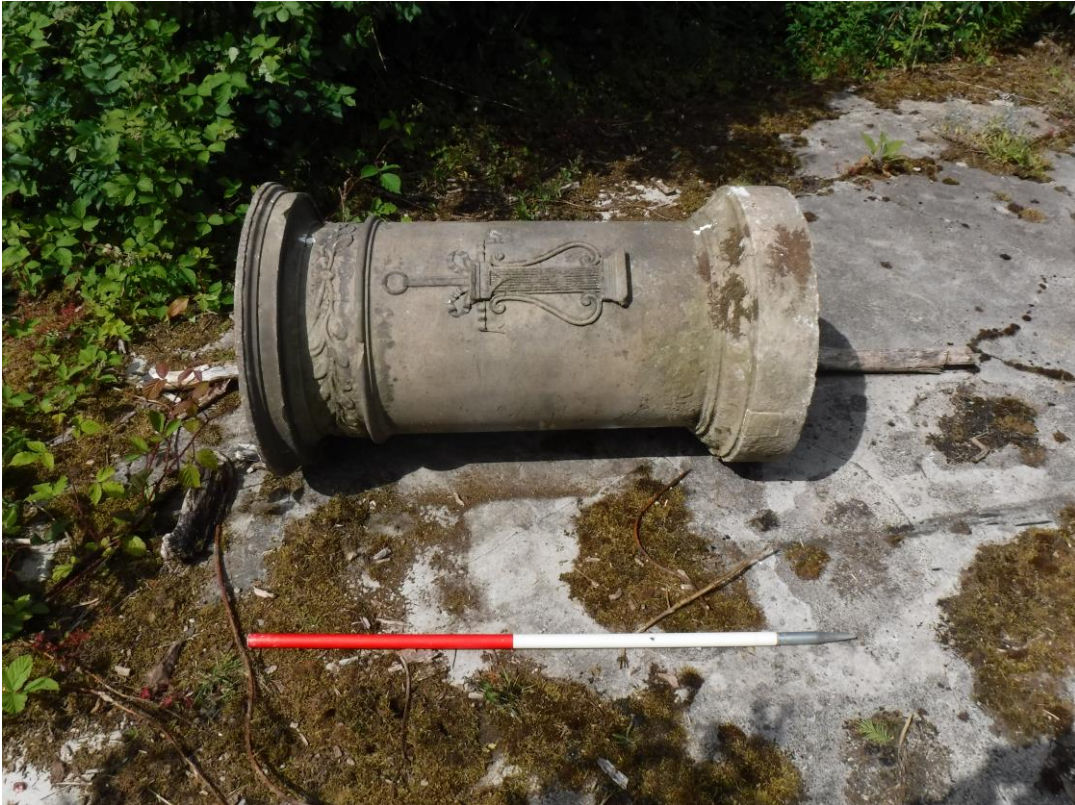
Plate 4 Base of sundial

- 4.3 None of the four sun dials said to be present on site were encountered during the evaluation. However, the decorated base of one of the dials (**Plate 4**) was observed close to the former house. This base is to be incorporated within the proposed development.

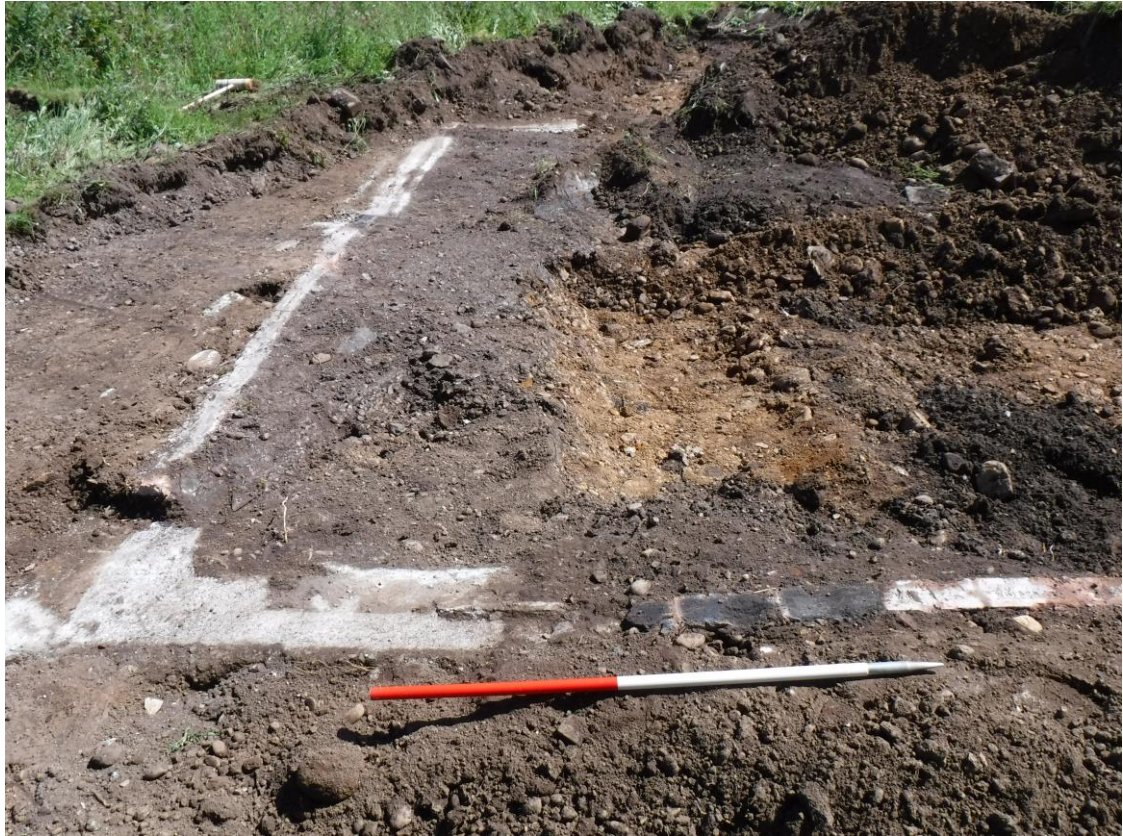
Plate 5 View of [2503]

- 4.6 Trench 25 (**Figure 2-3, Plate 5**), contained the remains of a froged red-brick and cement structure [2503]. The total dimension as exposed was 7.0m x 5.0m x 0.2-04m with the structure lying on an E-W orientation. This was overlain by topsoil (2501) with a depth of 0.3m. This feature does not appear to correlate with any building on any of the maps, suggesting a more temporary/short lived structure.

- 5.3 Walls found in Trench 25 (**Figure 2 and 3**) likely appear to a smaller structure associated with the piggery, or possibly a later garden building associated with the house. Given its construction of modern brickwork and concrete base it is a later feature that does not seem to appear on the historic or modern maps. Therefore unlikely to be a substantial or long lived structure. **Figure 3** appears to suggest this further with the building not appearing on either the 1894 or 1958 maps and so likely a later 20th century development. The extensive land improvements noted in the form of land drainage are likely associated again with the piggery.
