## SGN Gasholder Heritage Review: Park Road, Worthing

### Historic Building Recording Report

*AOC Archaeology Group was commissioned by SGN to undertake an historic building survey of the redundant gasholder at Park Road, Worthing in West Sussex in advance of its demolition.*

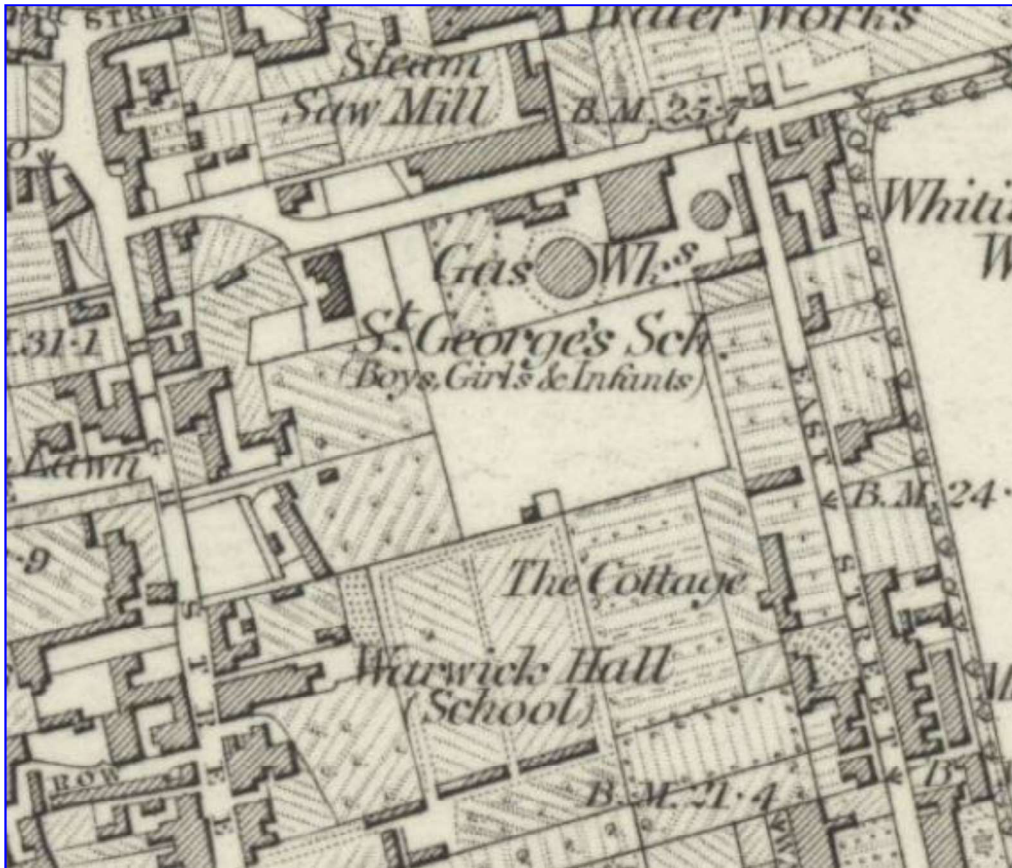
Figure 4: Extract from Ordnance Survey map, 1879

- 4.1.2 The Ordnance Survey map of 1879 shows a small discreet gasworks with a large gasholder to the west of a large gasworks building (probably the retort house) and another much smaller holder to the east (Figure 4). This holder was built in 1862, although was too small by 1898 and was therefore dismantled and covered over, the space converted into a liquor tank. By 1899, there were two holders on the site; a new holder was built to the west side of the original. Both were extended with flying lifts, as by 1900 the annual gas supply had reached 114 million ft<sup>3</sup> (3,228,121m<sup>3</sup>) (Stephenson 1931, 6; Figure 5). Further land was purchased in the early 1900s and the works expanded, with another site at Goring also adopted for another gasholder to increase capacity.

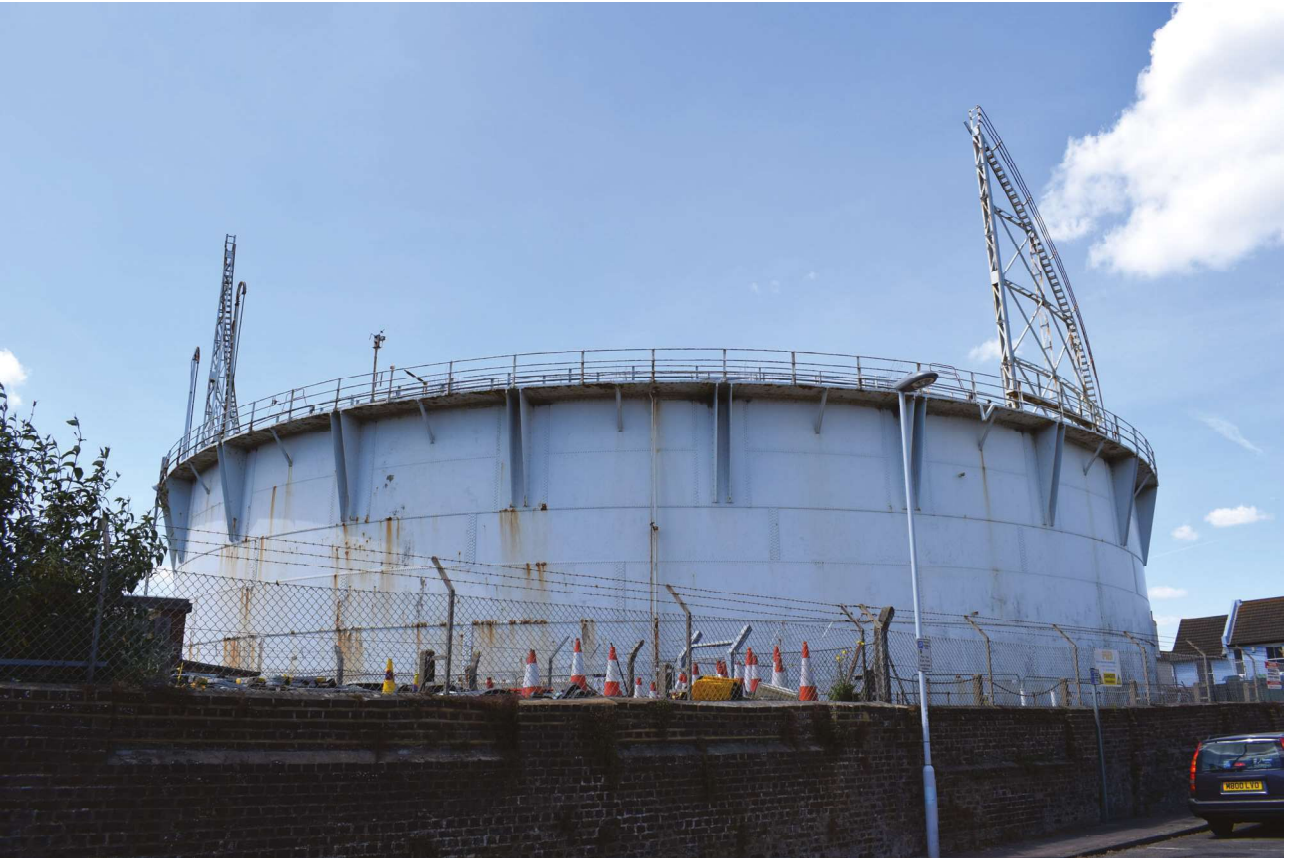
4.2.1 Gasholder No 3 was constructed in 1939 – 1940 by Clayton & Sons Ltd and is a three-lift spiral-guided gasholder (Plates 1 – 4). It comprises steel sheets riveted together with overlapping panels and a nominal capacity of 1,649,000 ft<sup>3</sup> (46,695m<sup>3</sup>) (Plates 4 – 7). The upper walkway is supported by an array of flat-edged brackets riveted to the upper two courses of plates of the holder and the main access to the walkway is located on the west side of the holder (Plates 8 – 11). It is a simple dog-leg stair with half landing platform with an additional security gate. There is then an additional inlet valve with associated pipework to the south of the holder, Structures 4 and 5 respectively (see Appendix 1, Figures A1 & A5; Plates 12 – 16), and another to the west side of the holder, Structure 7 (Figure A3; Plate 17).

Plate 1: Park Road, Worthing, general view of the gasholder from the south-east

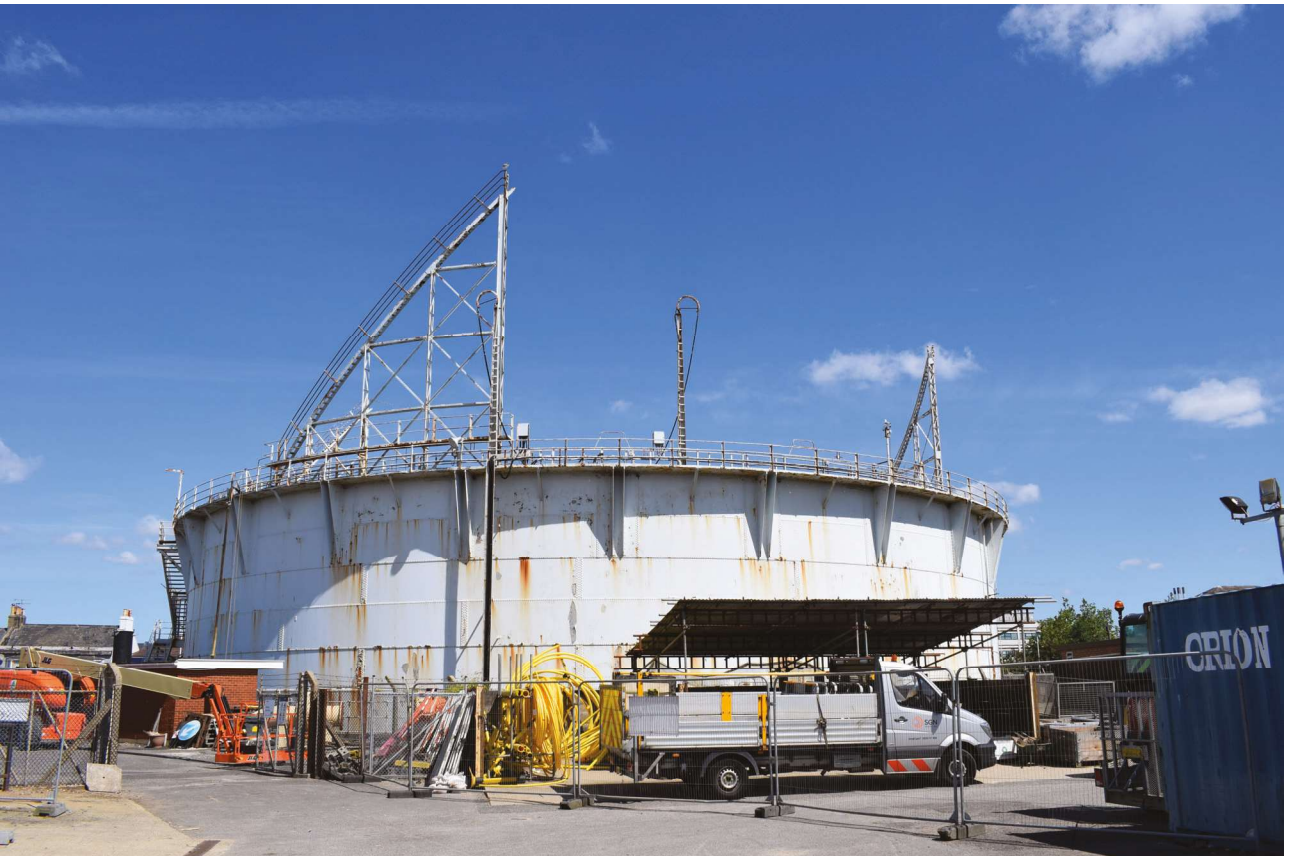
Plate 2: Park Road, Worthing, general view of the gasholder from the south

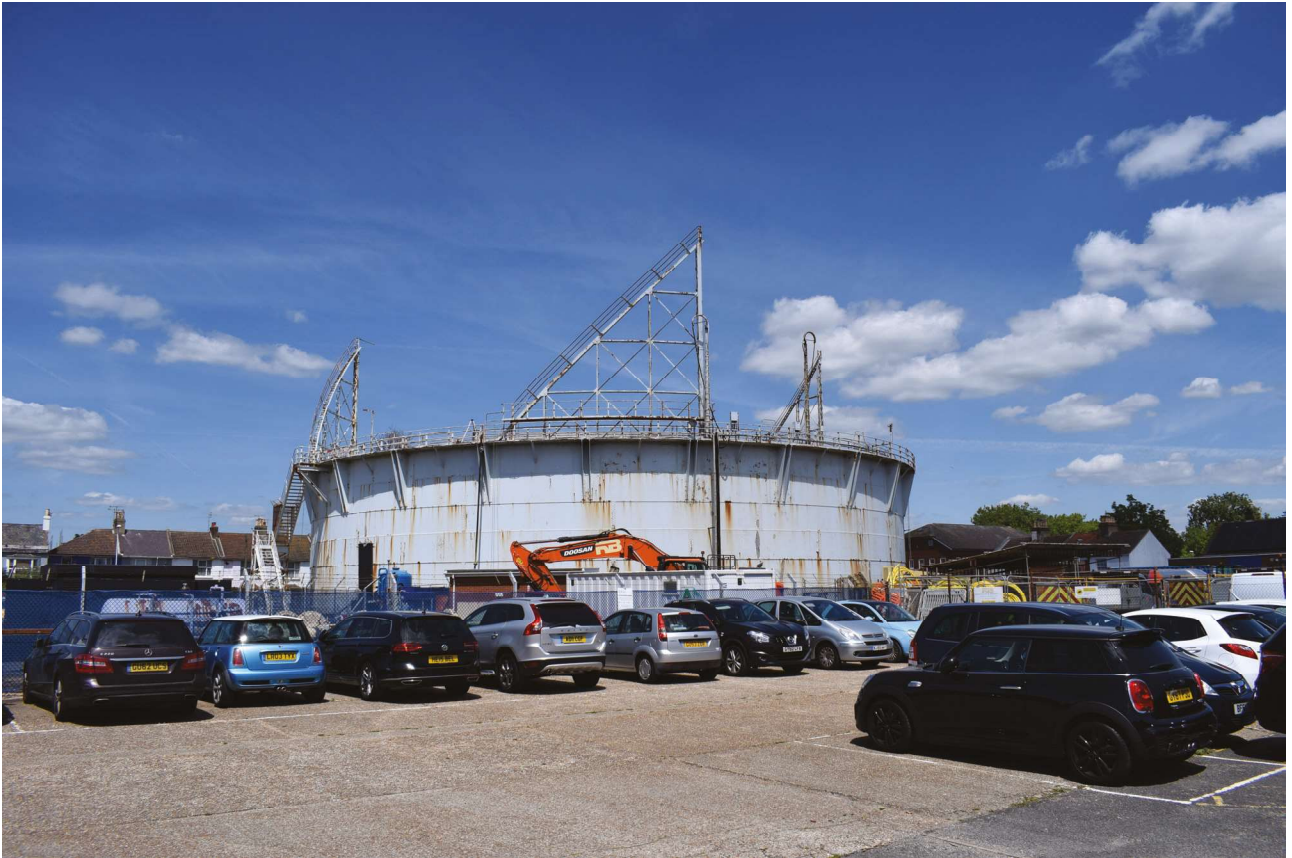
Plate 3: Park Road, Worthing, general view of the gasholder from the south-west

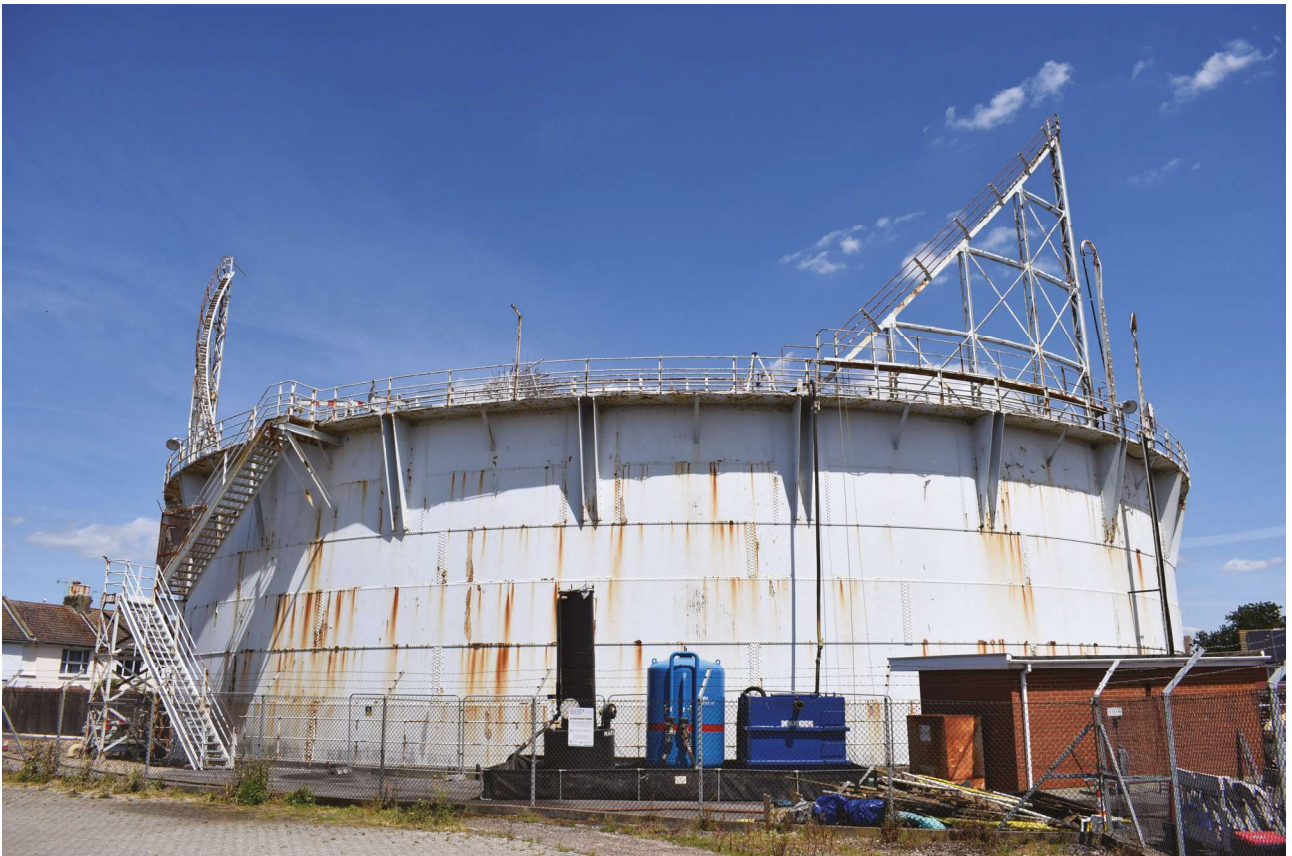
Plate 4: Park Road, Worthing, general view of the gasholder from the WSW

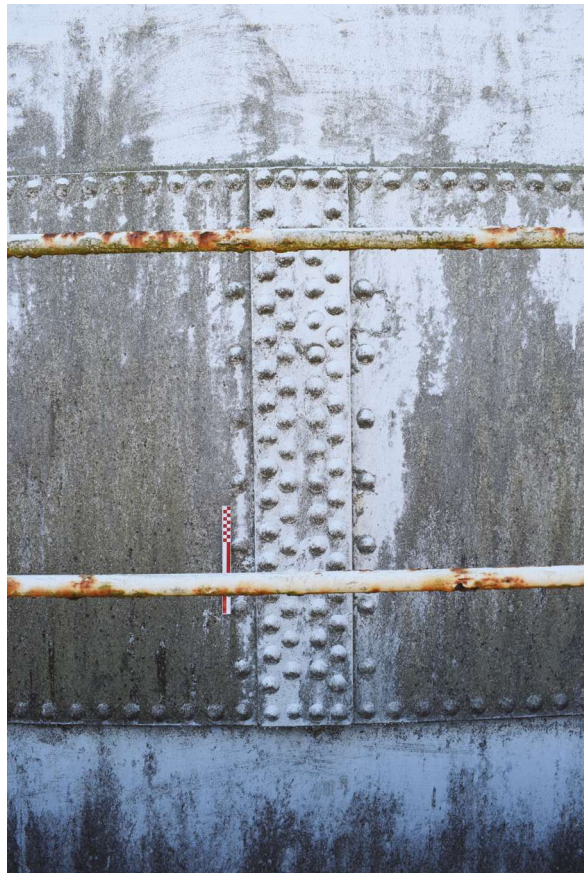
Plate 6: Park Road, Worthing, detail of riveted plate on the north-east side of the gasholder, from the north-east

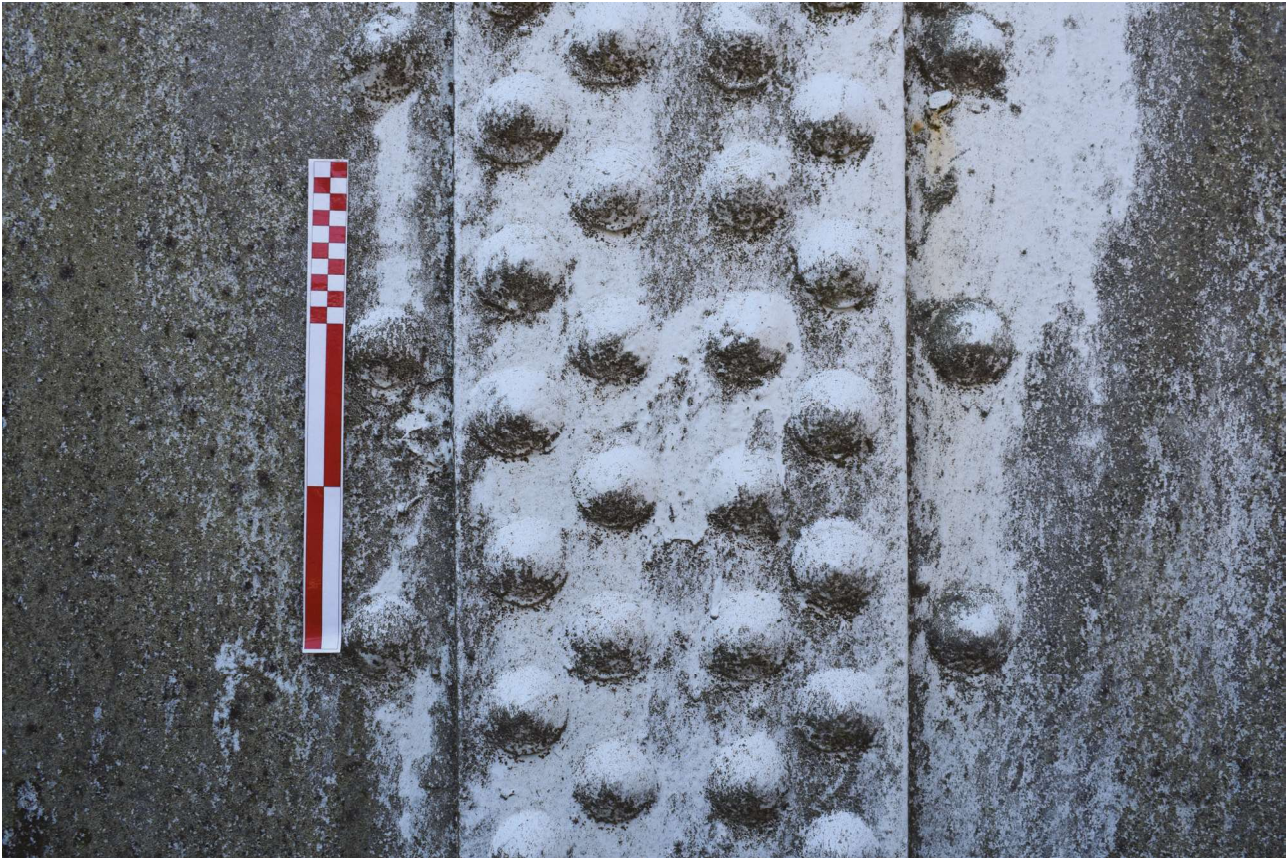
Plate 7: Park Road, Worthing, close detail of riveted plate on the north-east side of the gasholder, from the north-east

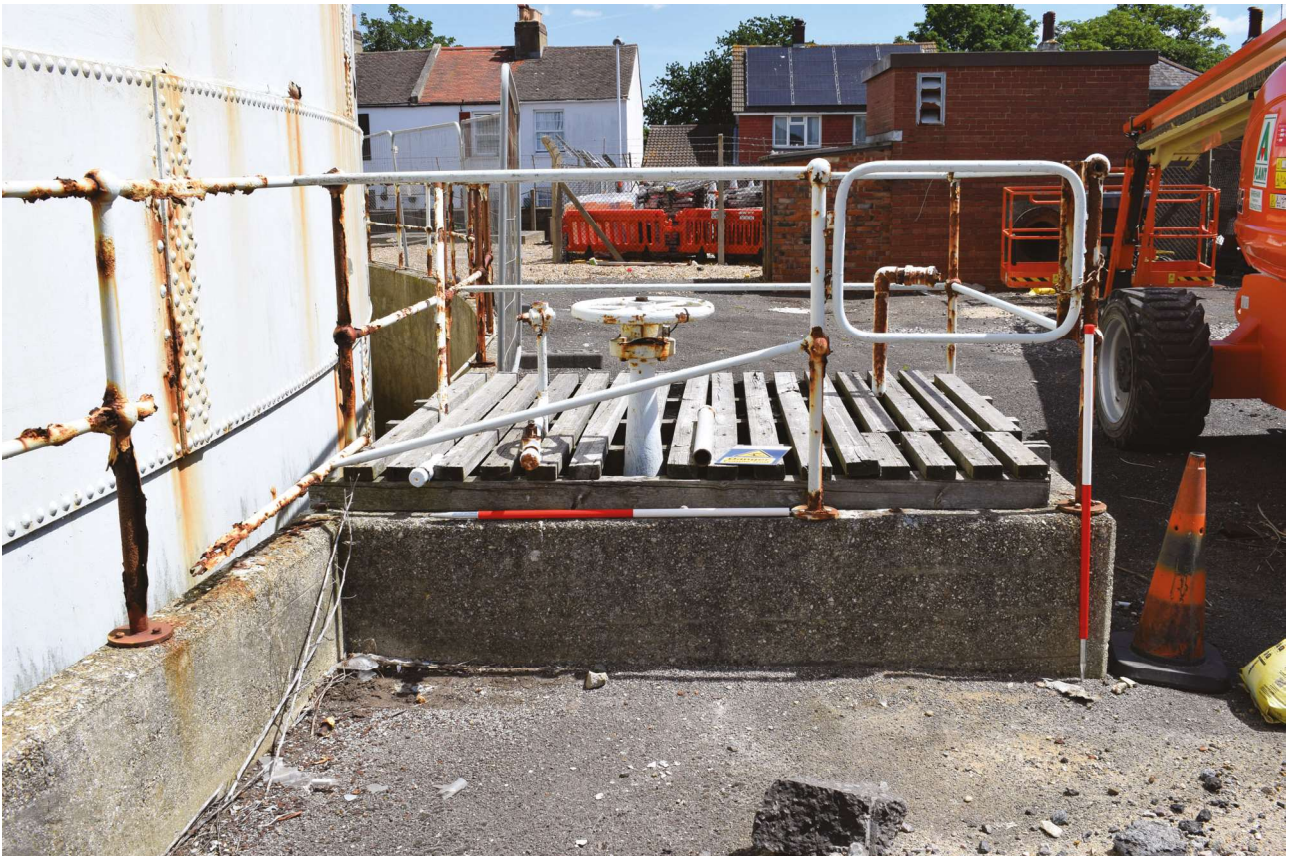
4.2.3 There are a number of additional structures associated with the former gasworks immediately prior to the decommissioning, although these are all modern structures (with the exception of Structures 4, 5 and 7, which are mentioned above and illustrated in Plates 12 – 17). These include:

Plate 12: Park Road, Worthing, Structure 4, general view from the WSW

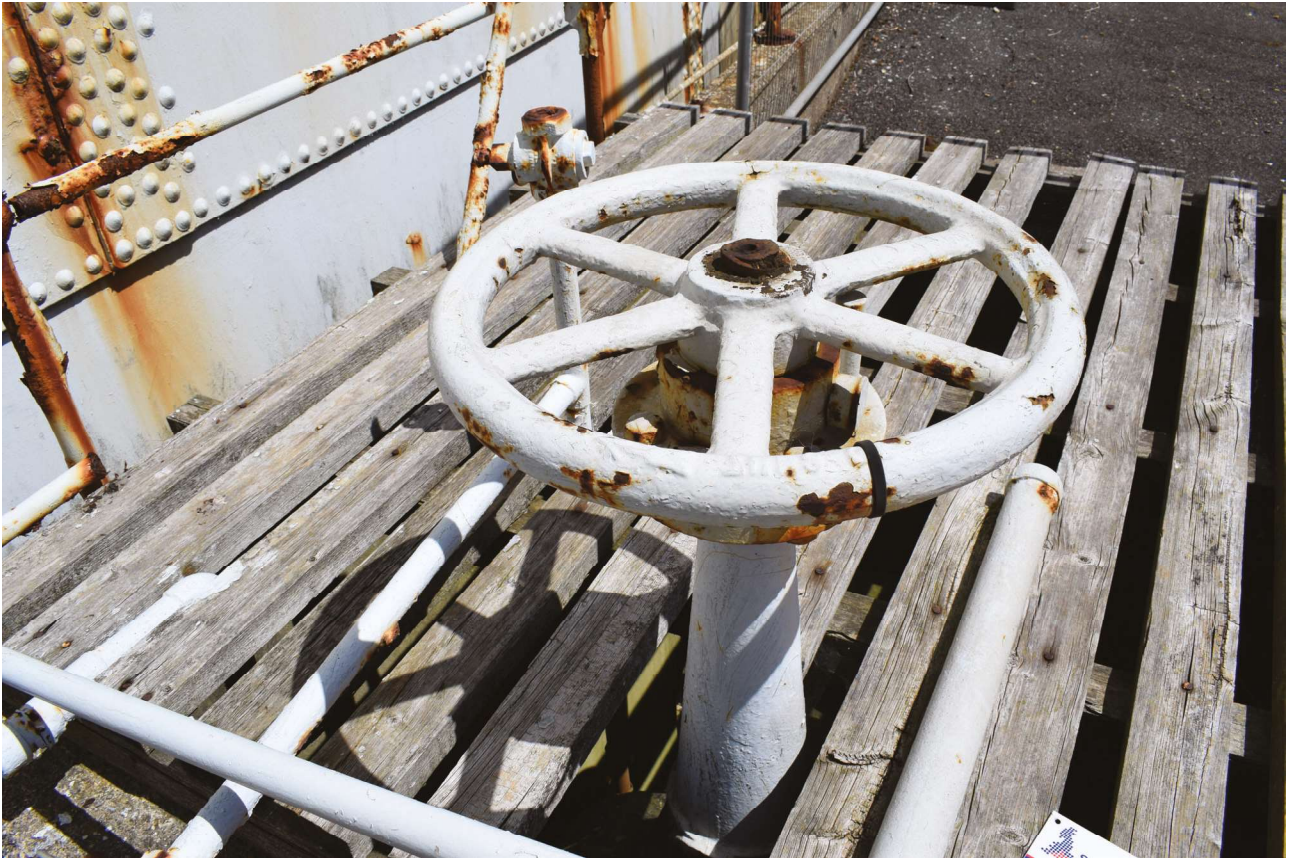
Plate 13: Park Road, Worthing, Structure 4, detail of the valve wheel, from the south-west

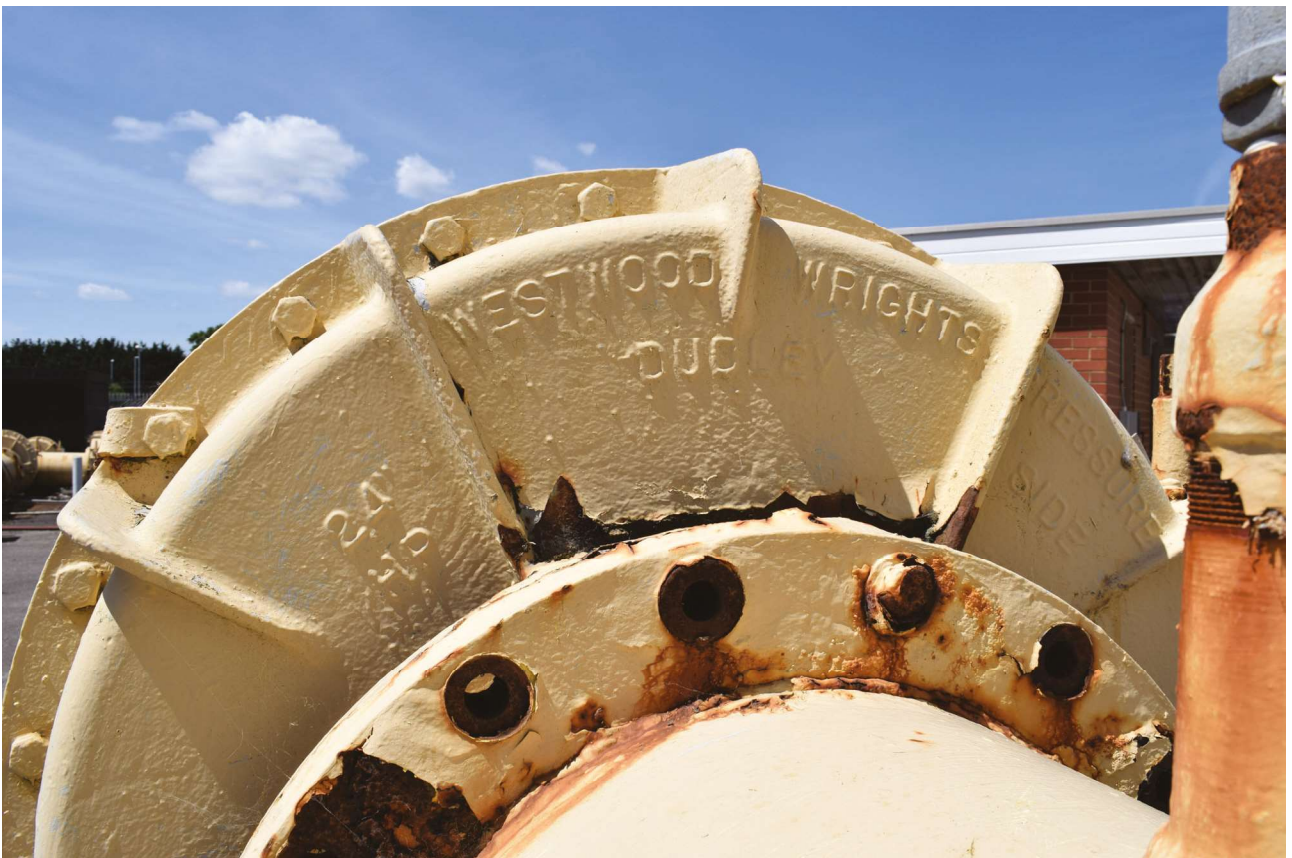
Plate 16: Park Road, Worthing, Structure 5, detail of pipework showing manufacturer's mark, from the east

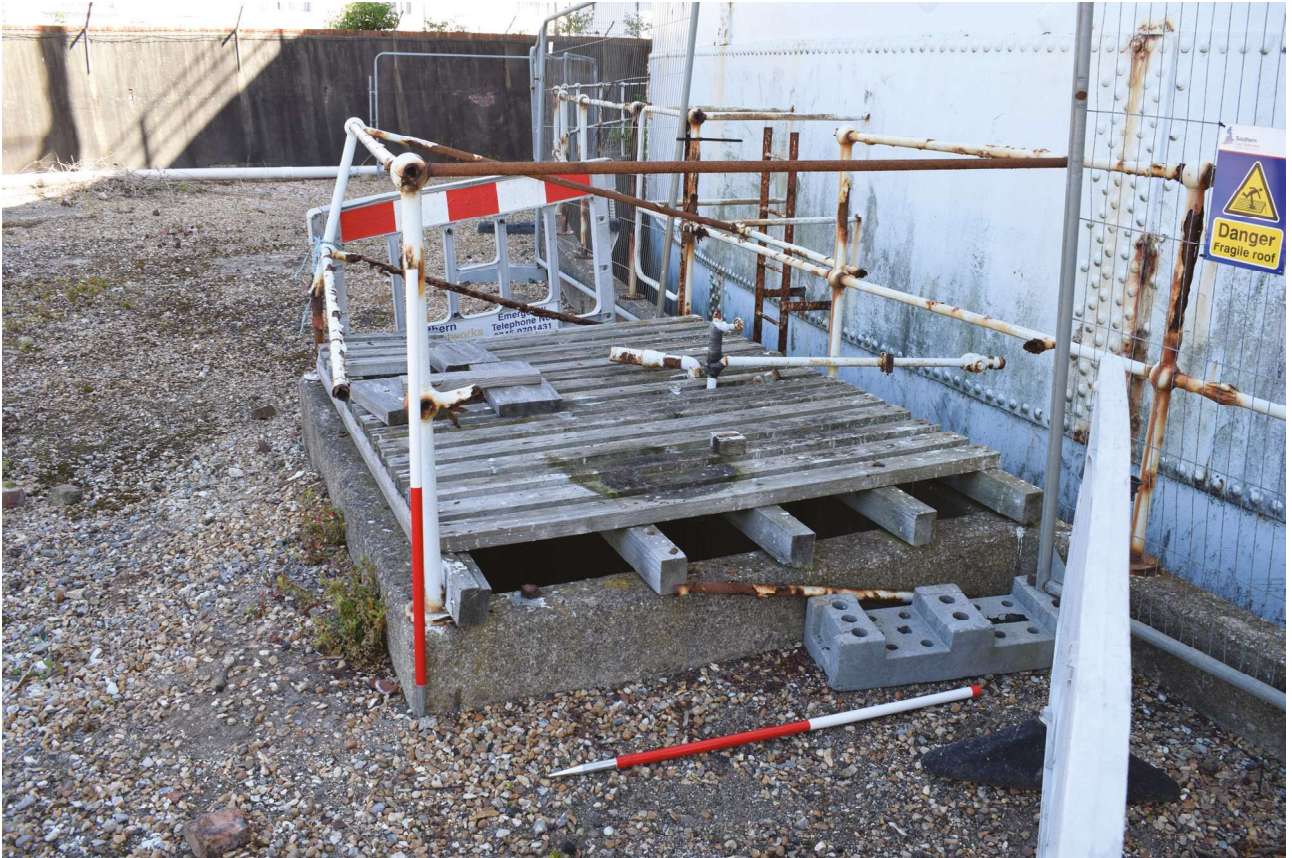
Plate 17: Park Road, Worthing, Structure 7, general view from the south-west

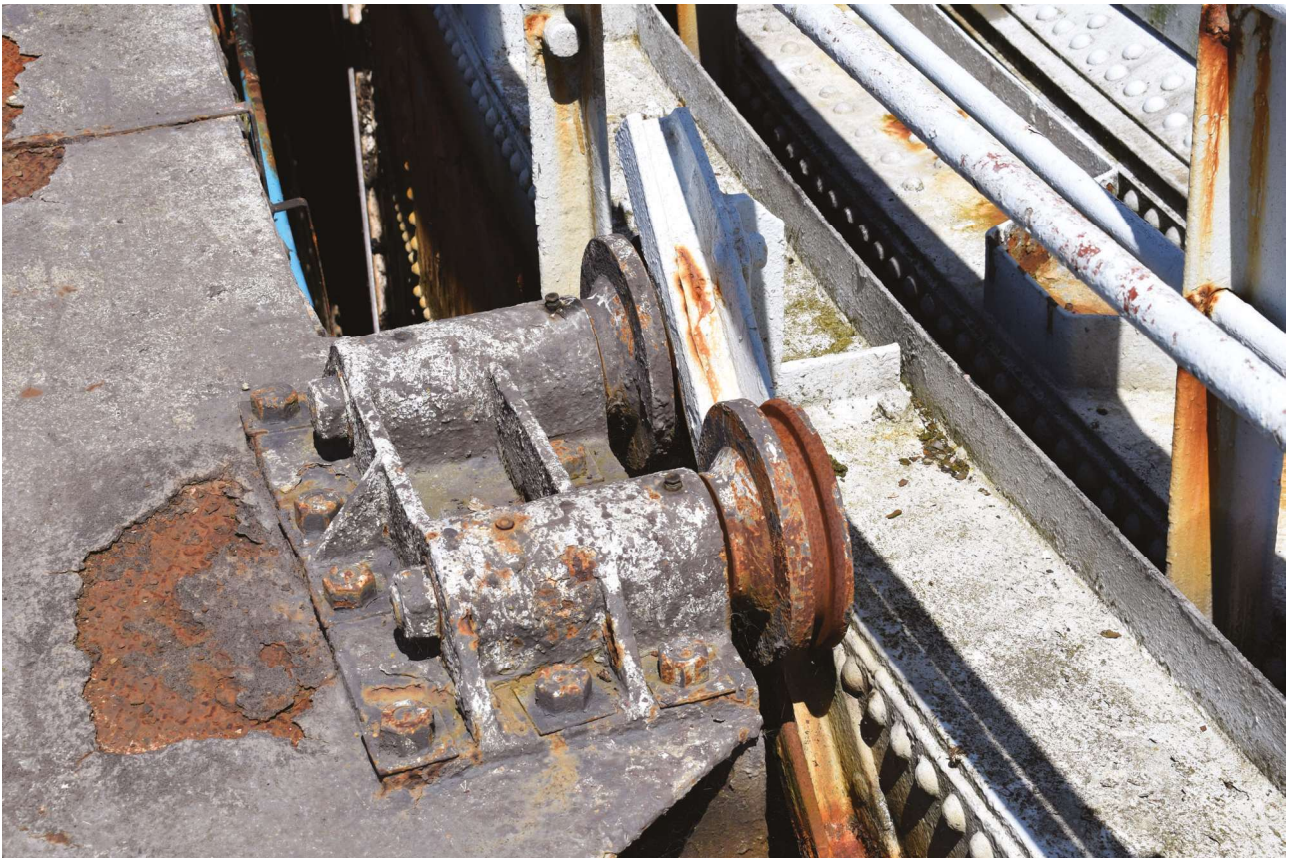
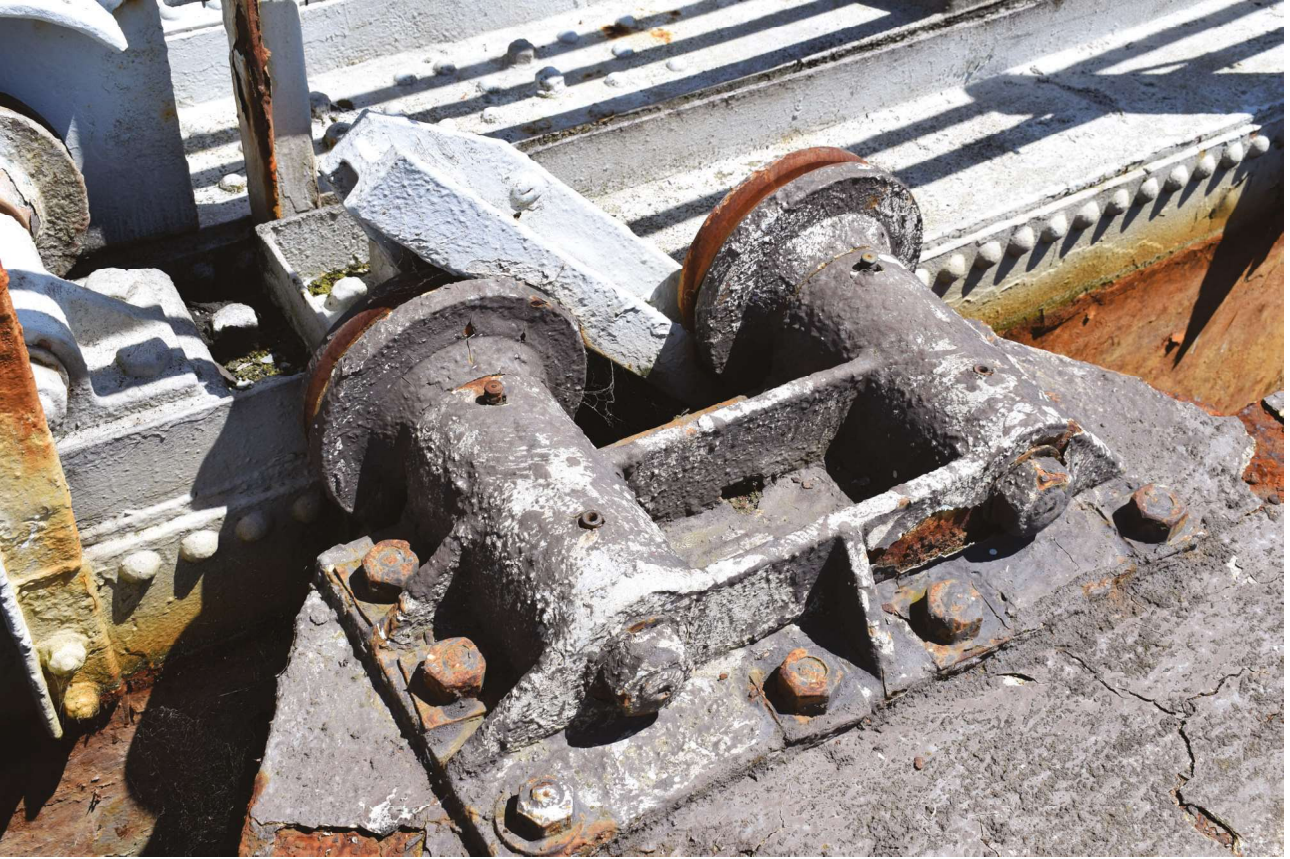
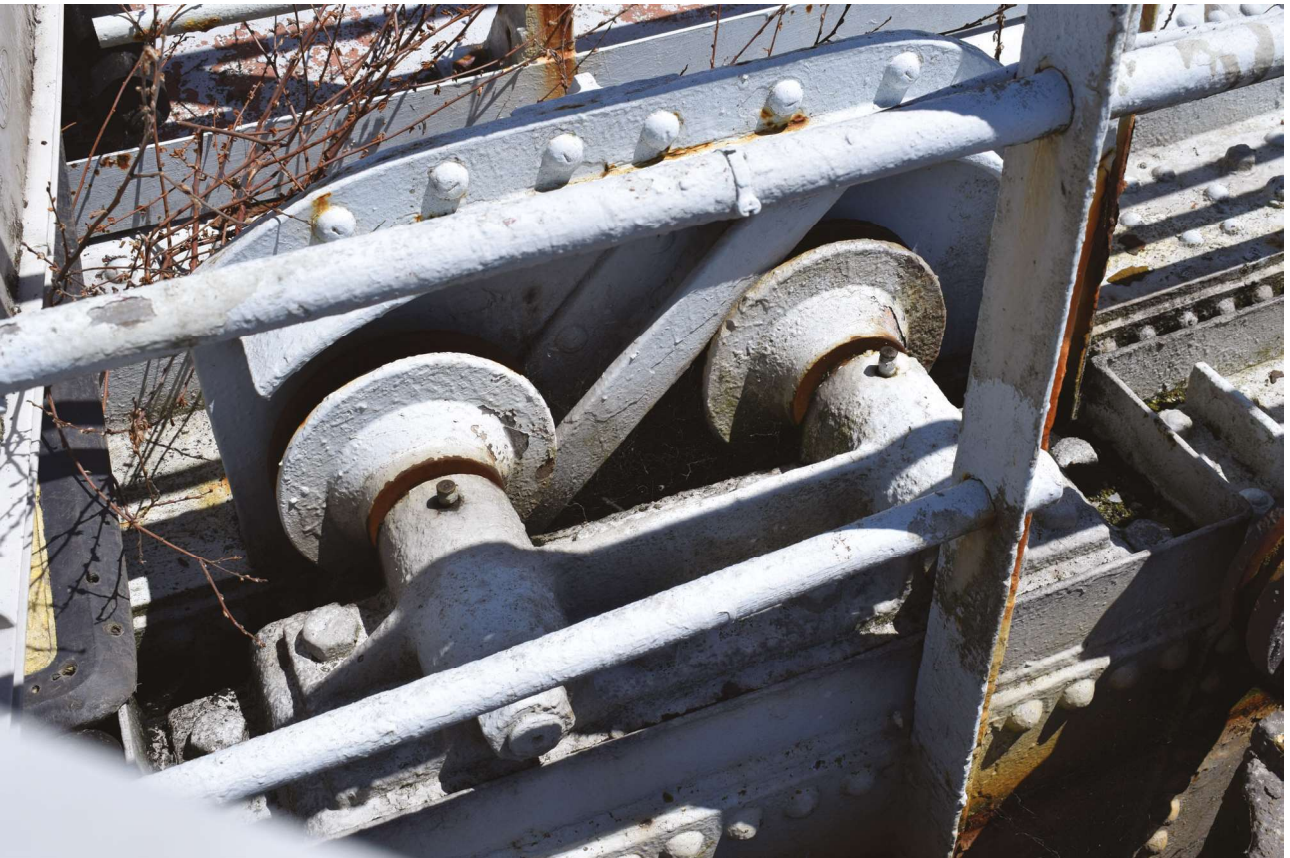
5.2 Constructed in 1939 – 1940 as a spiral-guided holder, Gasholder No 3 at Park Road, with the exception of some of the associated pipework, is the only remains of the mid-20<sup>th</sup> century gasworks at Worthing. It is an older example of its type, the first one appearing at Norwich in 1890 (Montagu Evans 2017, 2). Spiral guided gasholders were first invented in the late 1880s by W Gadd and operate via the introduction of spiral guide rails affixed to the holder site (in place of the vertical standards seen in frame guided gasholders). These rails then engage with the guided rollers on the edge of the tank so that the bell or tank of the holder can move up and down (Meade 1921, 667). The guided rollers are typically a dual guided roller system – as seen here at Worthing – and are located to the exterior side of the bell. The rollers would have been provided with constant lubrication when the holder was in operation with oil continuously supplied to the base of the roller carriage.

Plate 18: Park Road, Worthing, detail of guided rollers from the south-west

Plate 19: Park Road, Worthing, detail of guided rollers from the north-west

Plate 20: Park Road, Worthing, detail of guided rollers from the north-west

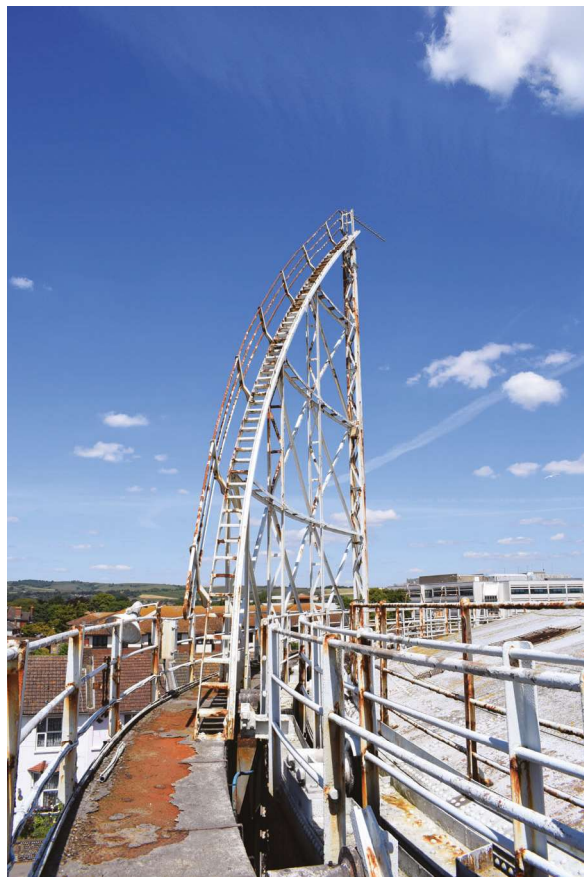
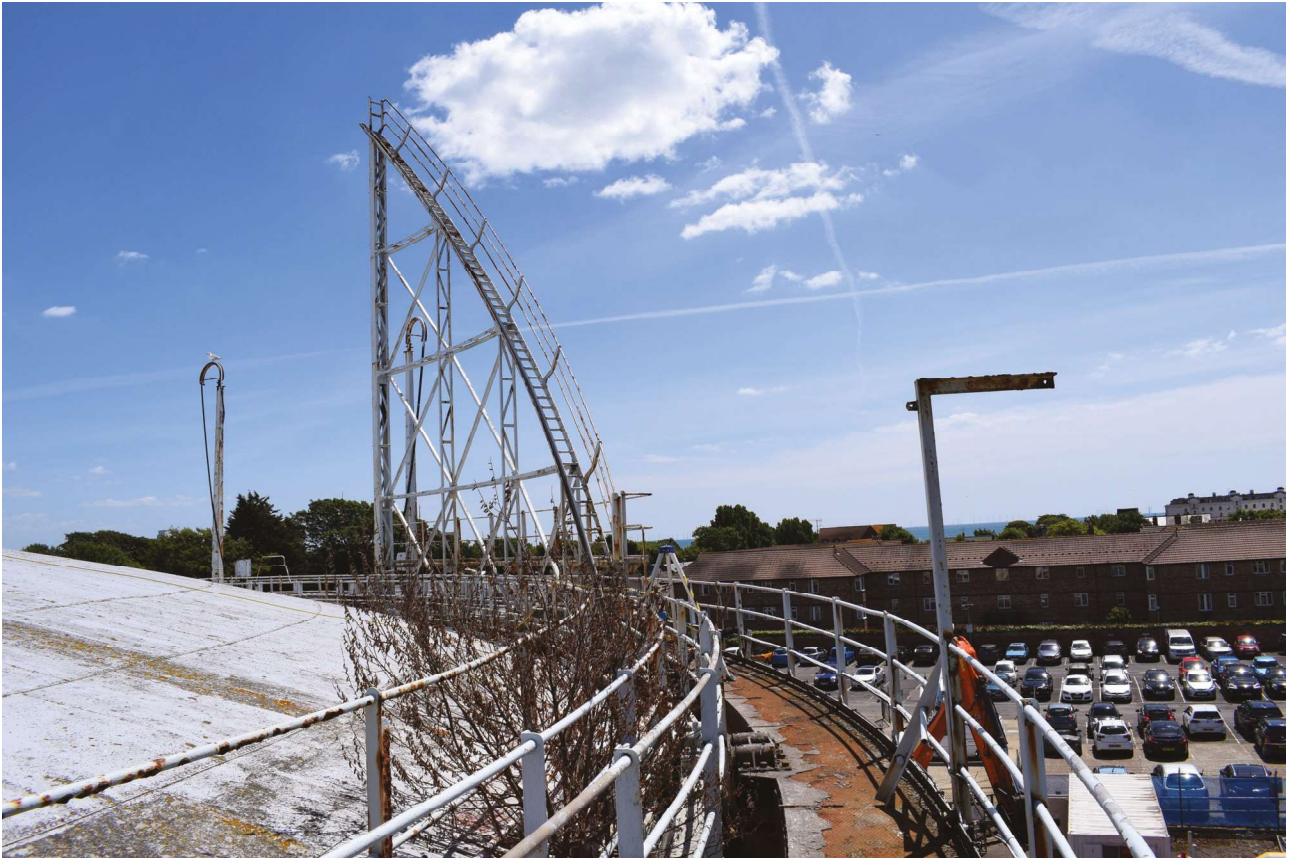
4.2.2 Access was possible to the upper walkway at the time of survey, although photographs could only be made from the top of the stair. From here, a closer view could be made of the guided rollers (Plates 18 - 20). A closer view of the crown of the holder, consisting of overlapping riveted panels can also be seen in more detail from the upper walkway (Plate 21). A better view of the rising stairwell to access the upper lifts when raised was also possible from the top of the gasholder (Plates 22 & 23).

Plate 22: Park Road, Worthing, detail of the stair from the south

Plate 23: Park Road, Worthing, detail of the flying lift from the north

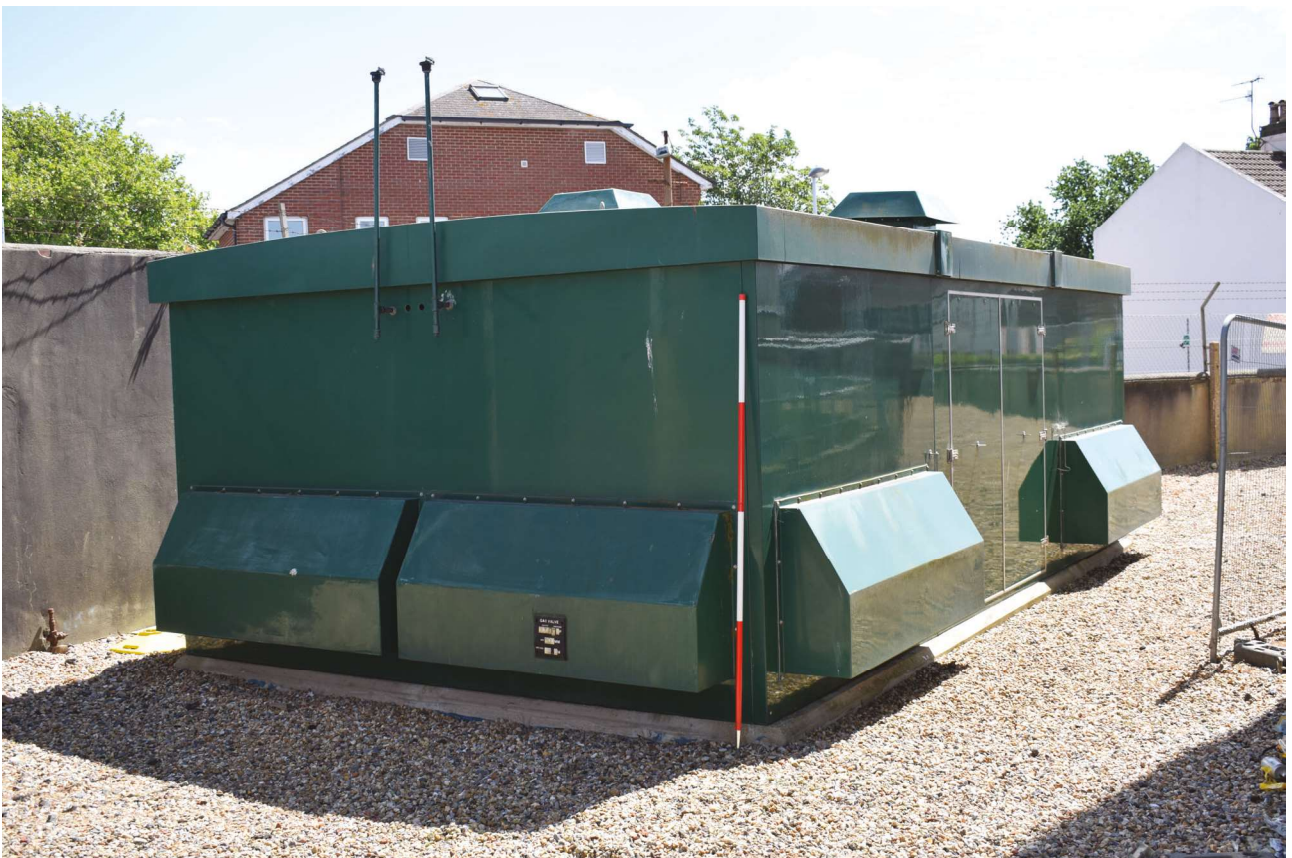
- Structure 1 (Plate 24)
  - A modern plastic tank.
- Structure 2 (Plate 25)
  - A concrete platform containing two manholes.
- Structure 3 (Plate 26)
  - A brick-built structure to house piping.
- Structure 6 (Plates 27)
  - A modern brick-built booster house.
- Structure 8 (Plates 28 & 29)
  - An area of pipework within the compound to the SW of the gasholder.
- Structure 9 (Plate 30)
  - A small modern shed containing pipework.
- Structure 10 (Plate 31)
  - A tank set in a concrete compound.
- Structures 11 and 12 (Plates 32 & 33)
  - Large areas of pipework within the compound to the south-west of the gasholder, Structure 11 forming a heat enclosure supplied by Paul and Loughran Ltd from Consett in Co Durham.

Plate 24: Park Road, Worthing, Structure 1, general view from the WNW

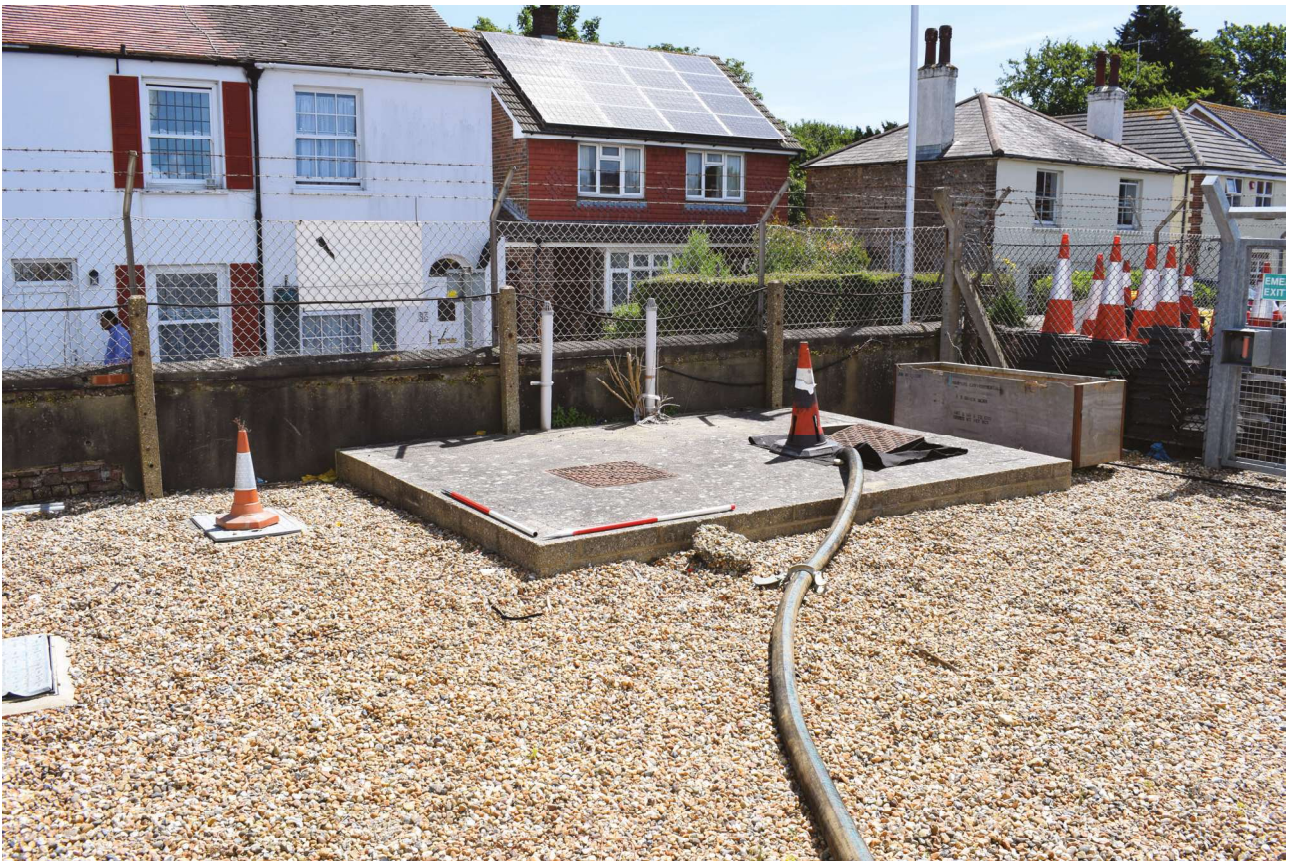
Plate 25: Park Road, Worthing, Structure 2, general view from the south-west

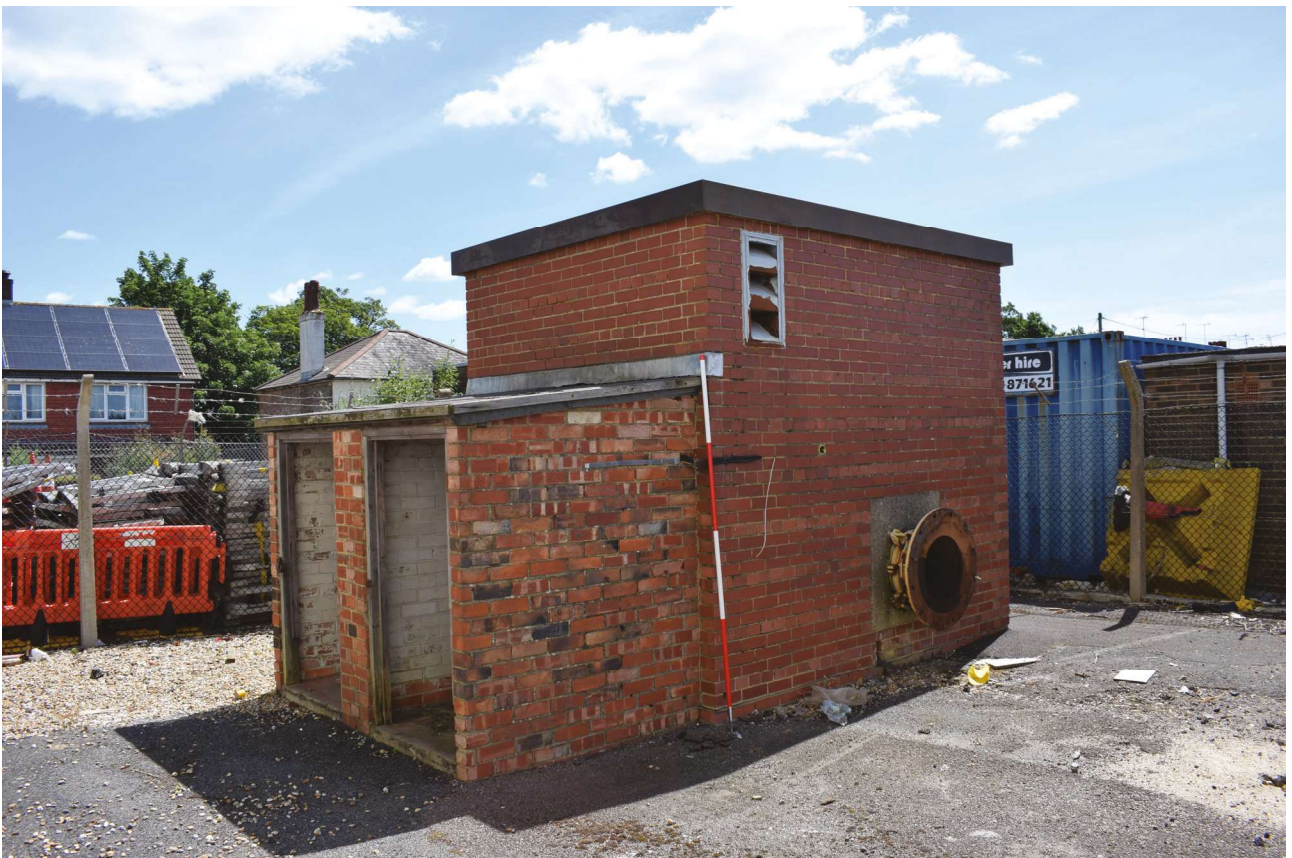
Plate 26: Park Road, Worthing, Structure 3, general view from the south-west

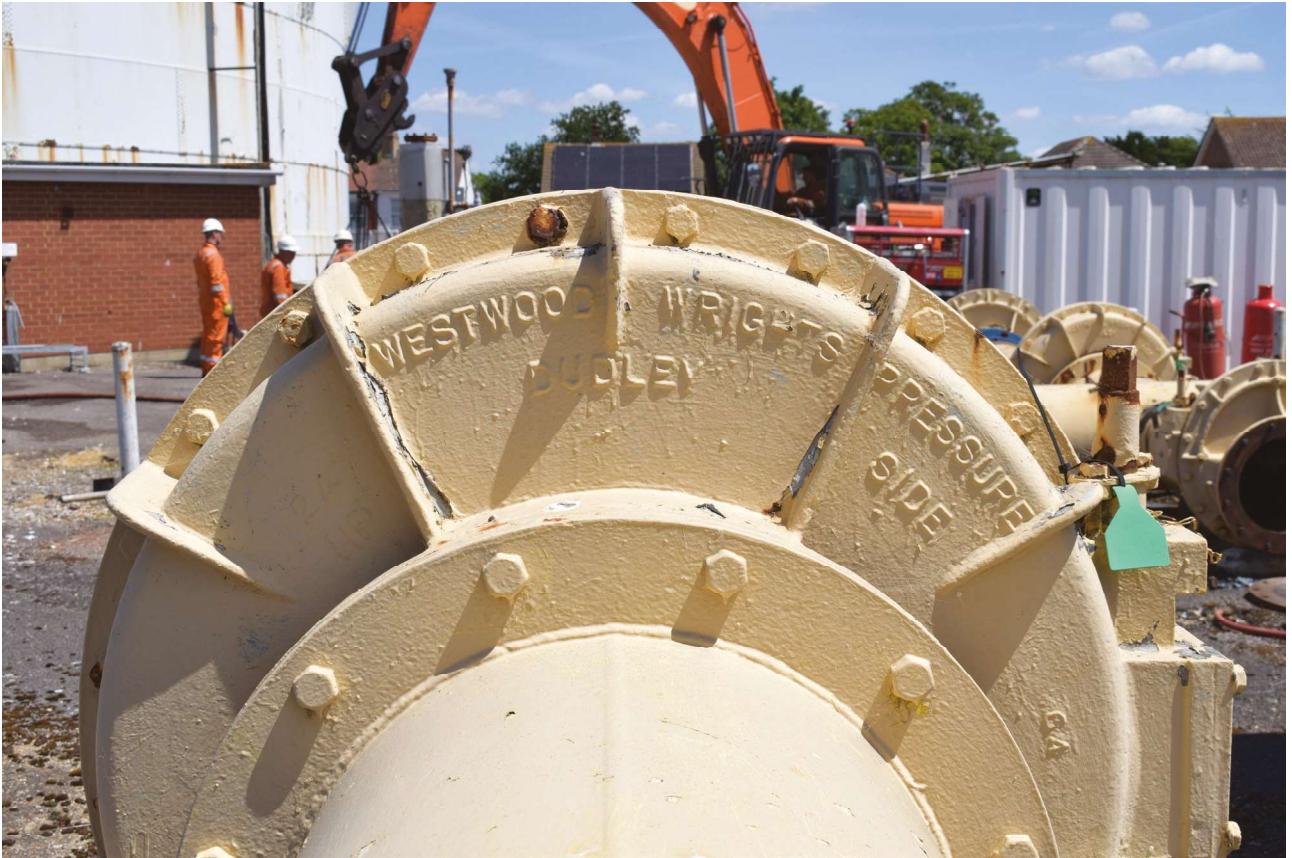
Plate 29: Park Road, Worthing, Structure 8, detail of the pipework showing the manufacturer's mark, from the ENE
