A9 Dualling, Bankfoot Temporary Compound: Monitored Topsoil Strip & Excavation Data Structure Report

Oasis No: aocarcha1-336742

AOC Project 24642

AOC Project No: **AOC 24642**

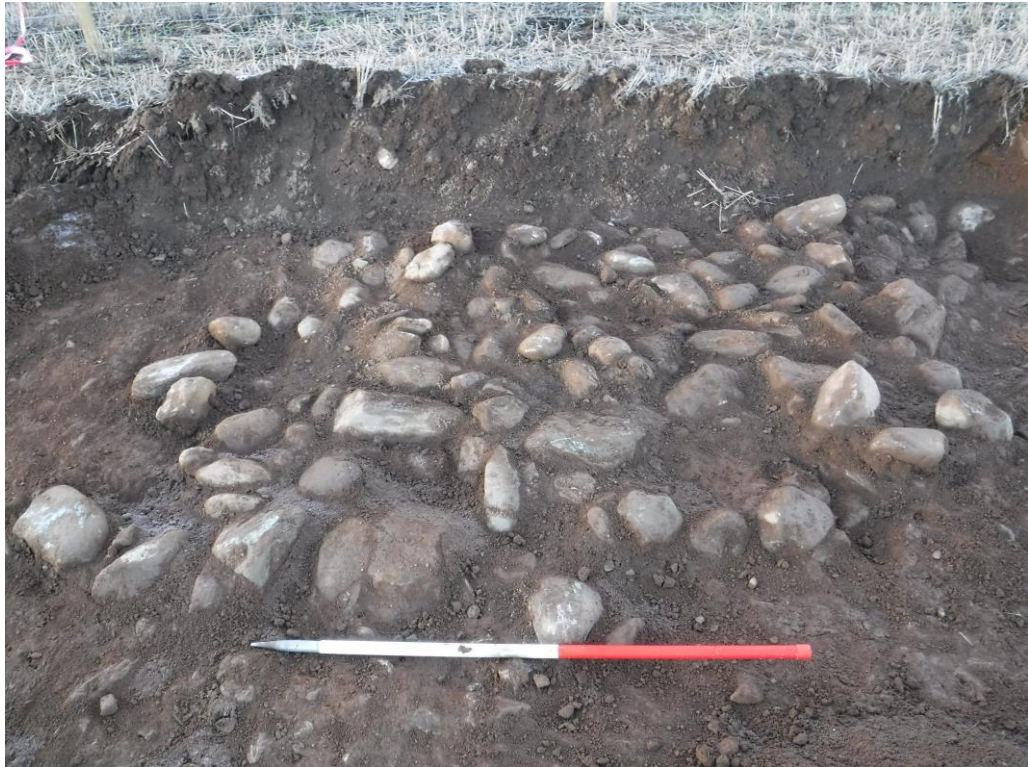
4.2.2 The possible clearance cairn [003] consisted of a large area of medium to large sub rounded stones and was contained within a mid red-brown silty sand matrix. This feature extended outside the limit of excavation with approximately 2m x 1.4m having been exposed by the works.

Plate 1 Post clean photo of cairn [103]

- 4.2.3 As it was at the site boundary and did not impact on important elements of the temporary compound it was preserved in-situ. Geotextile fabric was placed over the extent of the feature and the topsoil was reinstated. A suitable buffer was also reinstated, and a stock proof fence erected around its extent (see Plate 2 and Figure 2). It has now been excluded from the works and no further impact to this feature is expected.

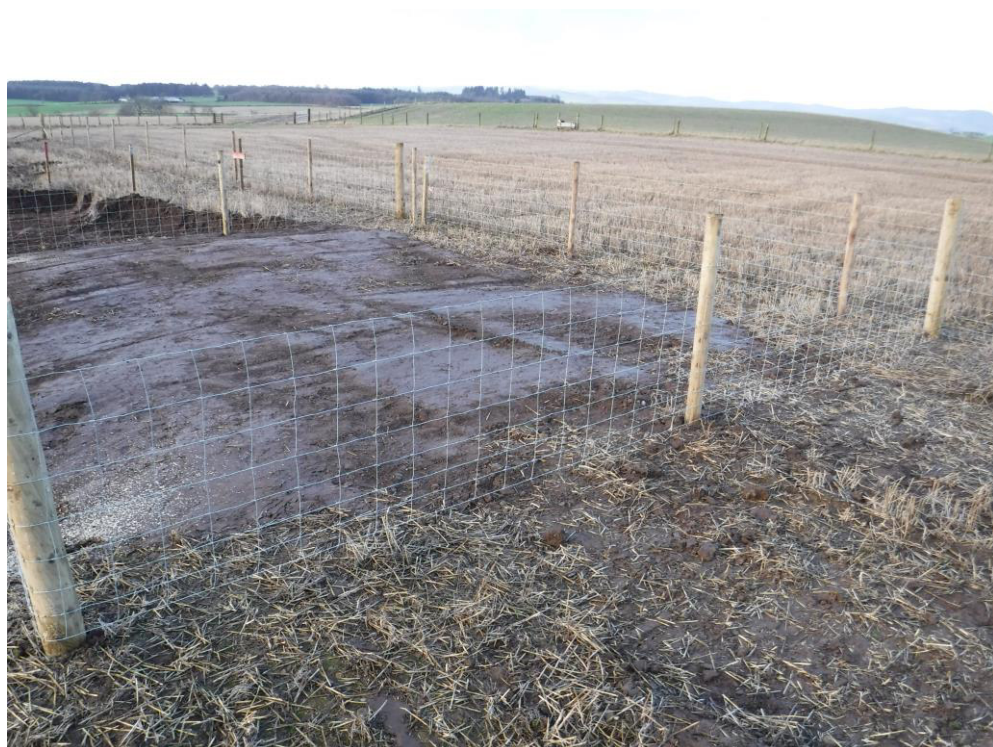
Plate 2 Reinstated area and fence for preservation of cairn [003]

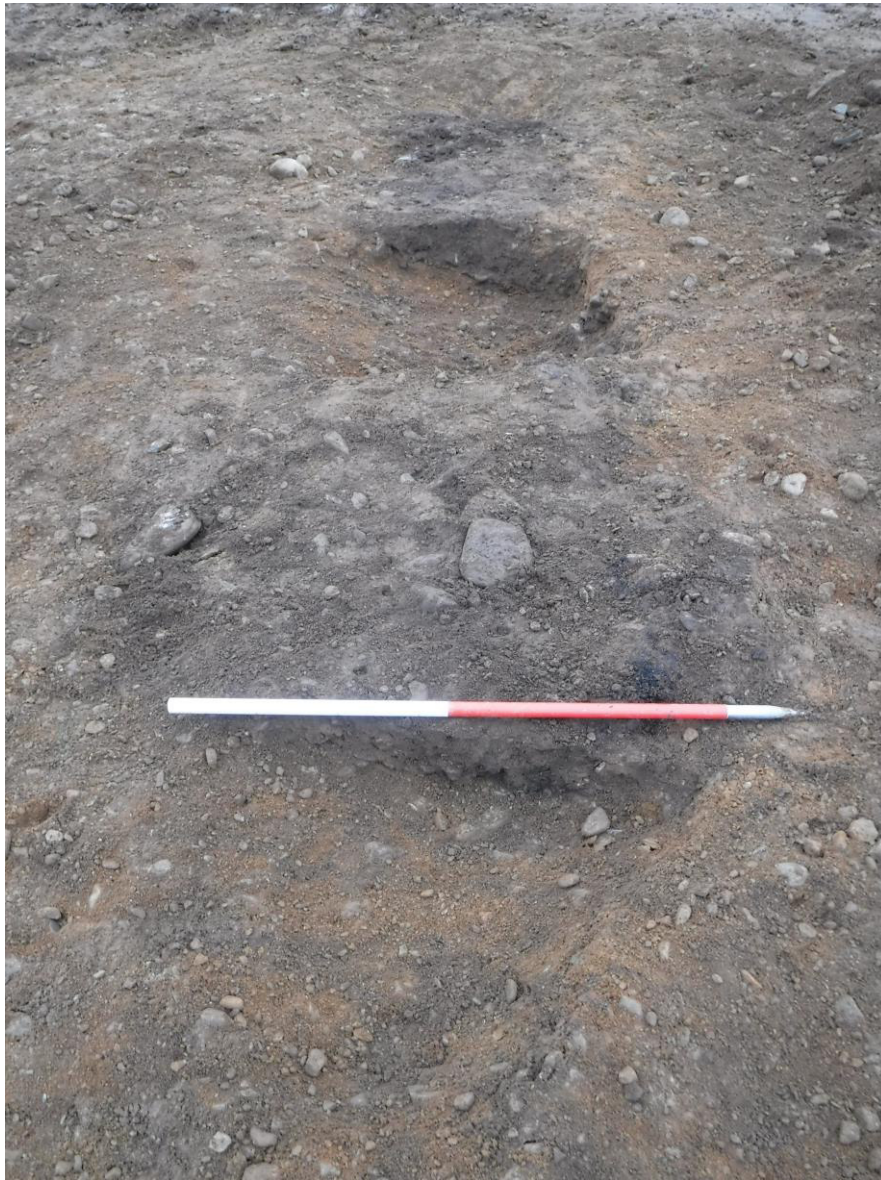
- 4.2.5 A linear feature [004] of unknown date and function was present towards the centre of the site (Figure 2). It measured 4.6m x 1.4m x 0.3m deep and was linear in plan. The base had an irregular and inconsistent shape, but predominantly sloped towards the south (see Plate 3). The fill consisted of mottled grey brown sandy silt with large patches of charcoal and discreet patches of possible in situ burning. No finds were present within the fill and therefore no date for the feature could be ascertained. It is likely, due to the nature of other features present, such as a clearance cairn and the afore mentioned agricultural evidence for use of these fields that this feature may also represent the remnants of agricultural activity. Samples were taken from the charcoal rich fill of this feature for further investigation if deemed necessary by PKHT.

Plate 3 Post excavation of linear feature [004] from the NE
