# Marshall Meadows, Northumberland

## Groundwork Investigation

### Archaeological Watching Brief

### Data Structure Report

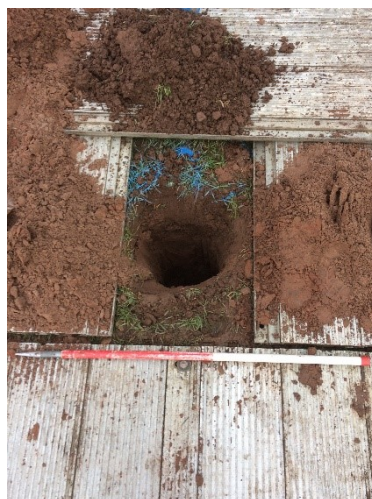
- 4.2 Nineteen test pits were dug in the southern field (including 02A). The stratigraphy in each was relatively similar. Generally, the topsoil was a dark brown, loamy clay to a depth of 0.2m. The subsoil was usually a mid-brown clay to a depth of about 0.8m and is thus often 0.6m deep. At 0.8m a natural red clay was encountered. This was at sometimes silty clay, though often it was sandy, particularly in the southern end of the southern field. In only one test pit (test pit 02) was archaeology encountered. This is to be expected as heavy ploughing of the field probably erased all other archaeological deposits.

Plate 1: Test pit 21 showing the different types of soil encountered in the southern field [photo 42].

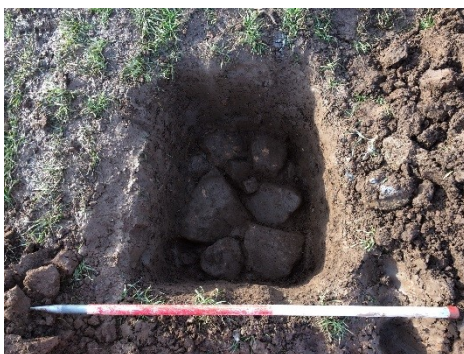
- 4.3 The one test pit in the southern field which contained any archaeological deposits was test pit 02. Here at a depth of 0.4m a layer of large, rounded overlying stones was encountered. These were given context number (004). They were cleaned and recorded in situ. The small size of the test pit precluded the possibility of determining whether these stones were structural or simply field clearance. However, there was no sign that they had been bonded so the latter possibility appears to be more likely. Nonetheless the stones were preserved in situ and the test pit backfilled. A replacement test pit (02A) was dug 5m to the south of test pit 02. No archaeology was observed in 02A.

Plate 2: Test pit 02 showing layer of large overlying stones (004) [photo 14].

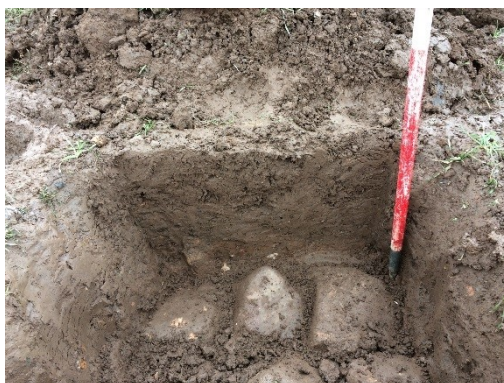
Plate 3: Rough working shot of south-facing section of test pit 02 showing layer of stones (004) [photo 16].

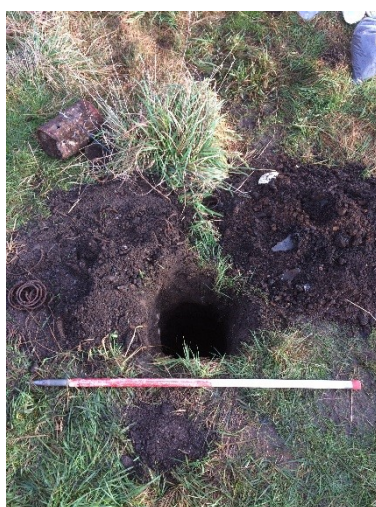
- 4.4 Twelve test pits were dug in the northern field (including 14A, 14B and 15A). Here the stratigraphy was very different to that encountered in the southern field (except for that encountered in test pit 11). The test pits in this field were generally dug into made ground. Much of the test pits were filled with black soil full of dumped modern material. The depths of this dumped material was such that all of the hand-dug test pits on this side of the road, apart from No.11, did not reach natural deposits.

Plate 4: Test pit 18. The spoil contains examples of the dumped modern material which was found in most of the test pits in the northern field [photo 20].

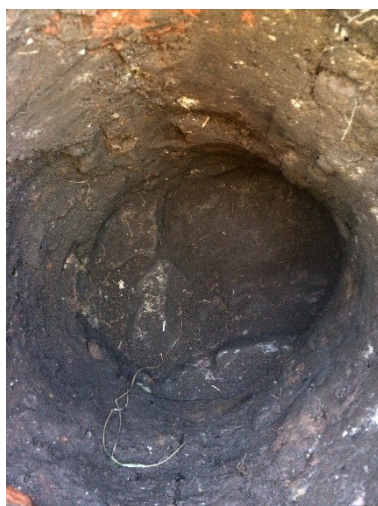
- 4.5 In both Test Pits 14 and 15 a layer of closely packed, rounded, medium sized stones were encountered at a depth of 0.7m. As with the stones in test pit 02 it was very difficult to determine whether these were structural or simply field clearance due to the dimensions and depth of the test pits. However, these stones were much more regularly sized and closely packed than those in test pit 02. Unlike the stones in test pit 02 there was possibility that these were bonded, again it is difficult to be certain. All this suggests that these stones are more likely to be structural than those in test pit 02. Windowless samples undertaken in other parts of the field (detailed below) found modern material at much greater depths than 0.7m. This indicates that even if these stones were structural then the structure is probably of no great antiquity. The stones were recorded in situ and the test pits backfilled. Replacement test pits 14A and 15A were dug in the immediate vicinity. In 14A a similar layer of stones was encountered at a depth of 0.8m requiring yet another replacement test pit, 14B, to be dug. The similarity of the layer stones in test pits 14, 15 and 14A, their close proximity and the fact that they were all encountered at roughly the same depth strongly suggests that they represent the same deposit.

Plate 5: Shot showing the stones (005) at the base of test pit 14 [photo 36].

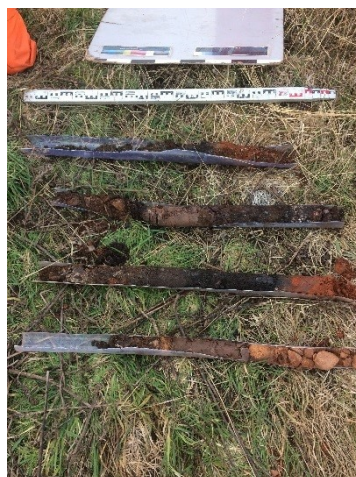
- 4.6 A number of windowless samples were drilled into the base of the hand-dug test pits. Those in the southern field were not observed as natural deposits had been reached in the hand-dug test pits. Those in the northern field were monitored as the test pits had not reached natural except for test pit 11. Windowless samples were drilled into test pits 11, 13, 16 and 19. As previously mentioned 11 had already hit natural but the windowless samples in 13, 16 and 19 revealed that the dumped modern material continued to a considerable depth, between 3.35m and 4.7m. These modern deposits directly overlaid the natural with no paleoenvironmental deposits observed. A cable percussive borehole was drilled in test pit 12 in the north field.

Plate 6: The windowless samples collected from test pit 13. Note the sandy pale reddish-brown natural in the right-hand corner [photo 46].
