Saughton Hall, Edinburgh: Watching Brief Data Structure Report

AOC Project 22747

Saughton Hall, Edinburgh: Watching Brief

Data Structure Report

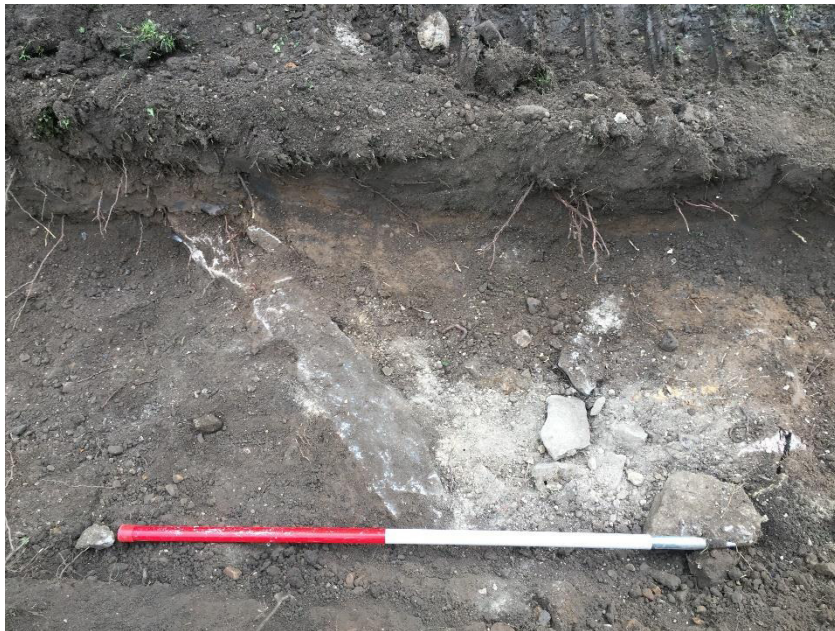
4.1.1 The excavation pipe trench started at the northeast near the glasshouse and was found to contain the remains of six truncated sandstone walls towards the southwest extent of the pipe trench. Five of these were found to be orientated northwest to southeast and one was found to be orientated northeast to southwest. Walls [101] and [102] measuring 0.55m by 0.66m wide respectively, were found to be 5m apart and walls [102] and [103], measuring 0.4m wide, were spaced 3m apart. Walls [105] and [106] also orientated northwest to southeast were spaced 1.4m apart and measured 0.25m and 0.32m respectively. Wall [104] was orientated northeast to southwest and was present in the trench for 6m. All walls appeared to be constructed using angular and sub angular sandstone blocks with a lime mortar bonding (Plate 1)..

Plate 1: Robbed out wall [101] in service trench

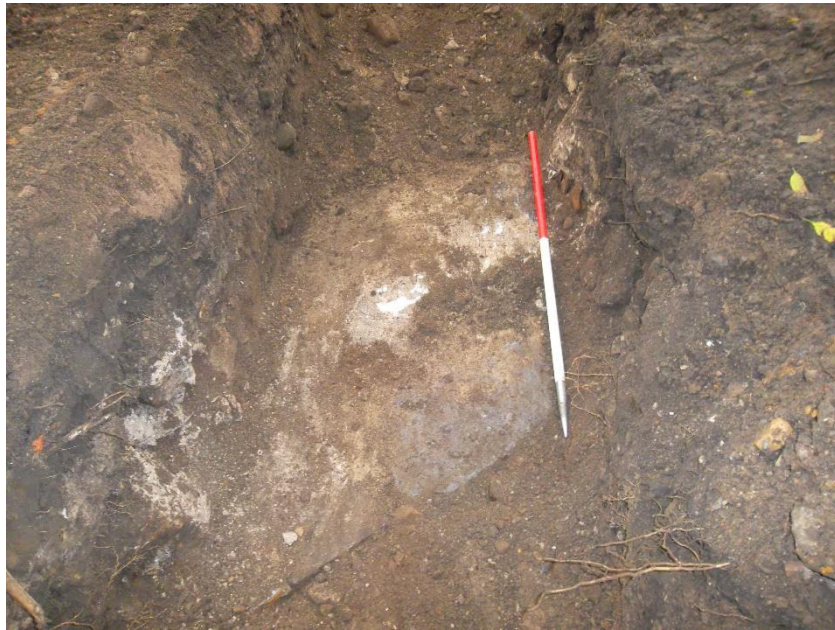
4.1.2 Once the trench approached the site of the former gardeners compound it turned to the northwest. This service trench measured 0.8m wide by 0.4m deep. A single sandstone wall orientated northeast to southwest measuring 0.85m wide was discovered comprising of large rectangular sandstone blocks and lime mortar bonding similar to the walls discovered in the previous service trench (Plate 2).

Plate 2: Sandstone wall [107] in second service trench

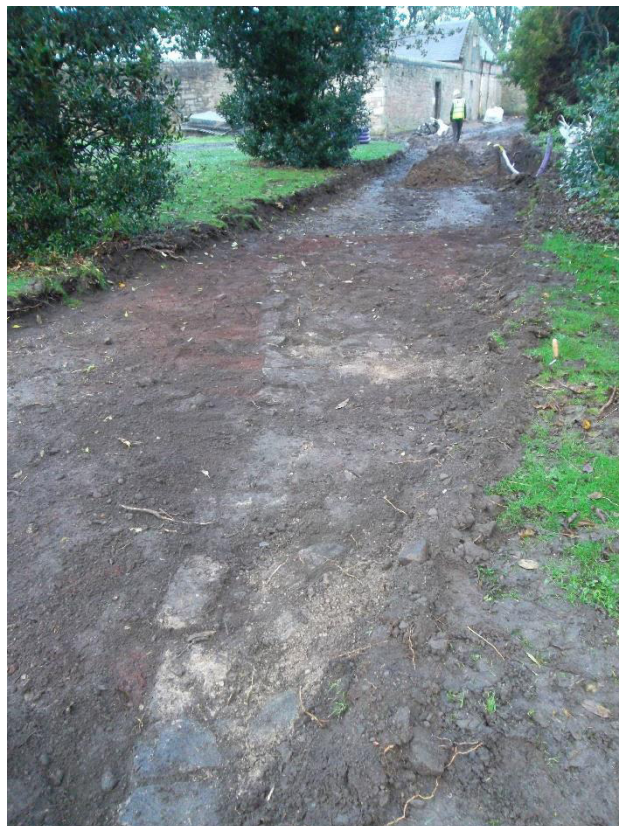
4.1.3 Adjacent to this service trench a topsoil strip was conducted to check for potential services this measured c.2.7m wide by 0.1m deep. The strip revealed a surface comprised of angular and sub angular sandstone blocks forming a kerb with a mortar deposit forming a possible surface. This feature likely formed part of a path or road associated with the house (Plate 3). This structure was to be left in situ, so was not excavated but recorded to the fullest extent possible.

Plate 3: Surface [108] exposed NW of main excavation

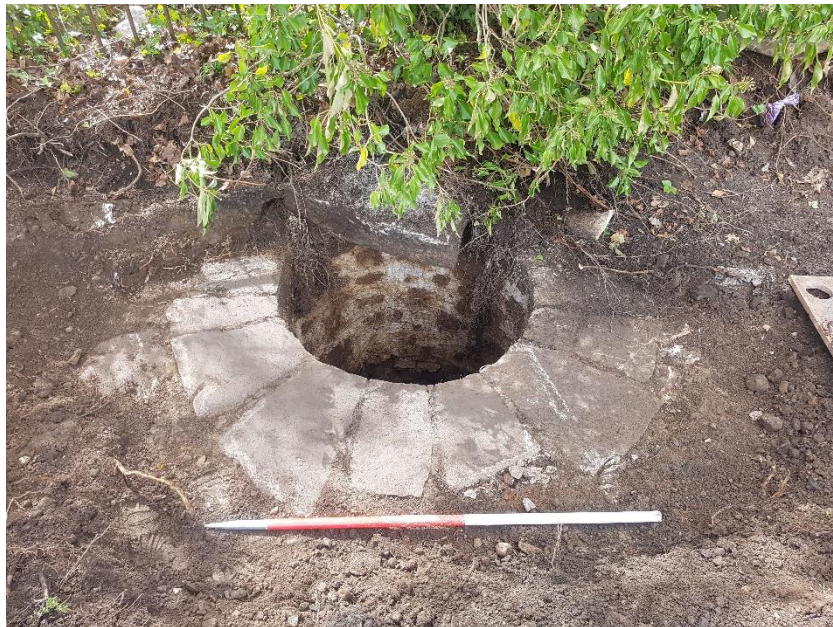
- 4.2.1 AOC was requested on site after the discovery of a well by the principal contractor on site within the car park south-west of development area. This feature was found to measure 1.6m in diameter with an internal measurement of 0.92m. It was constructed using sub angular sandstone blocks with lime mortar bonding till 1.1m in depth then changes to drystone cobbles. The depth measured approximately 5m. This structure was to be left in situ and capped, so no further excavations took place however the structure was recorded to the fullest extent possible.
- 4.2.2 A number of moulded stone figures were discovered on site and reported by a member of the public however upon visiting site these were found to be highly fragmented. These are not considered to be part of the house more likely garden ornaments.

Plate 3: Sandstone lined well in car park
