Meadowbank Phase 2, Edinburgh: Archaeological Evaluation Data Structure Report

AOC 24273

April 2018

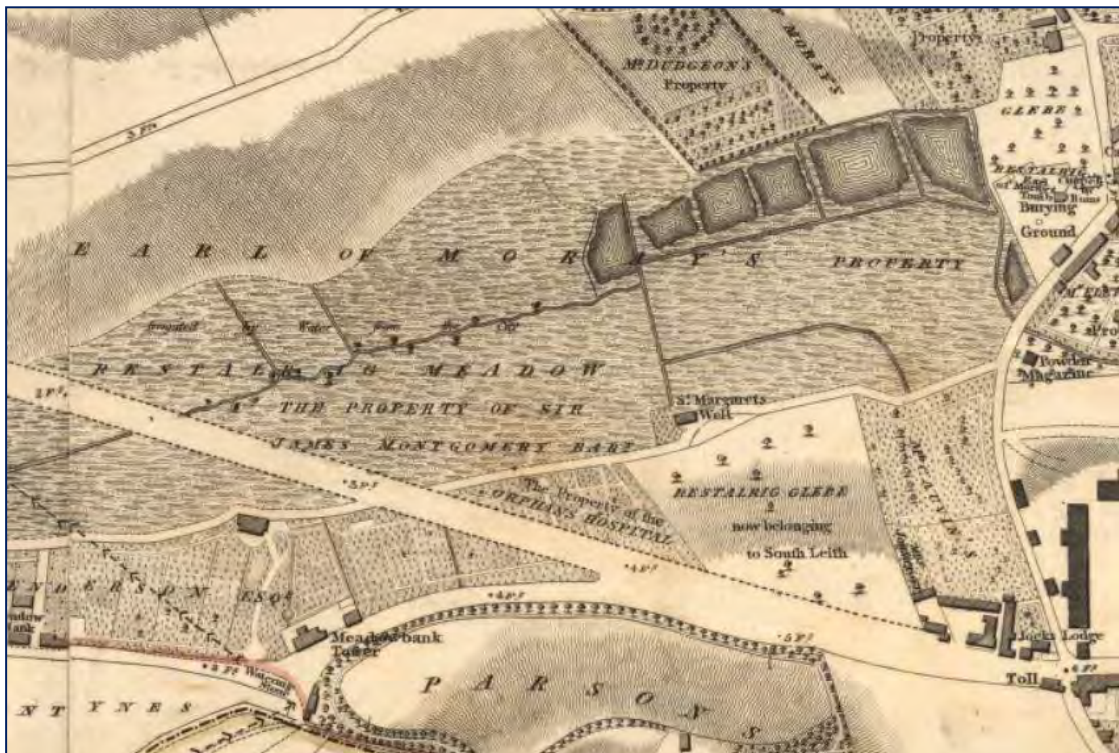
Figure 3: Extract from Kirkwood's map, 1817

- 1.3.2 The earliest mapping covering the site shows it to be predominantly farmland up until the start of the 19th century where it becomes known as ‘Restalrig Meadow’, much of which belongs to the Earl of Morton. Kirkwood’s map of 1817 is the first to show the presence of St. Margaret’s Well with a north-east/south-west road providing access (Figure 3). St Margaret’s Well (HES No. NT27SE 5976) was a 15th century spring with a surrounding vault which was demolished and removed in 1860 with the remains rebuilt in Holyrood park. In 1969, as part of the works on site ahead of the Commonwealth Games, the site of the well was uncovered and backfilled. Kirkwood’s map also shows the site to be crossed by a burn orientated north-east/south-west.

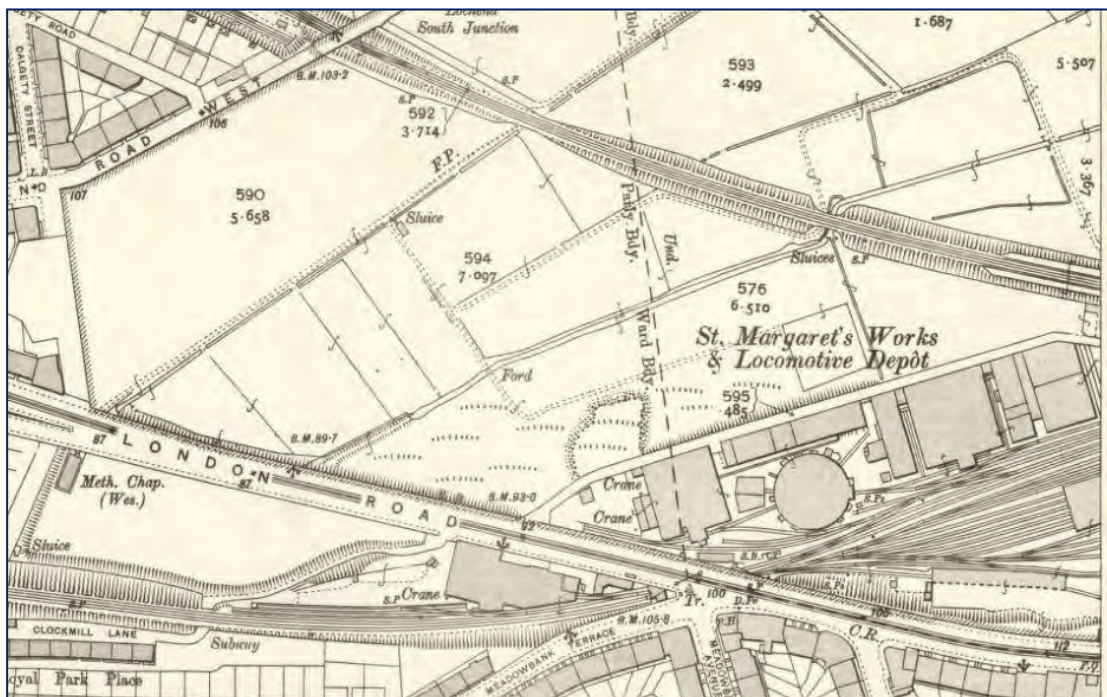
Figure 5: Extract from Ordnance Survey map, 1908

- 1.3.3 By the middle of the 19th century, the North British Railway had been constructed and a large railway depot called the 'St Margaret's Station North British Railway Works and Locomotive Department' was constructed to the east side of the development area (Figure 4). It is noted that during the construction of the depot the remains of St. Margaret's Well were removed and backfilled. The depot included a turntable for locomotive engines and comprised a large number of buildings. The works continued into the early 20th century, as can be seen on the subsequent 1908 and 1914 Ordnance Survey maps (Figures 5 & 6). However, by the 1931 Ordnance Survey map, a collection of neatly arranged pre-fabricated houses were built on the site to the immediate west of the Railway Works (Figure 7). In the years following WW2 the 'turning platform' was remodelled and the roofed engine shed removed (Figure 9). A large football ground has also been laid out to the north.

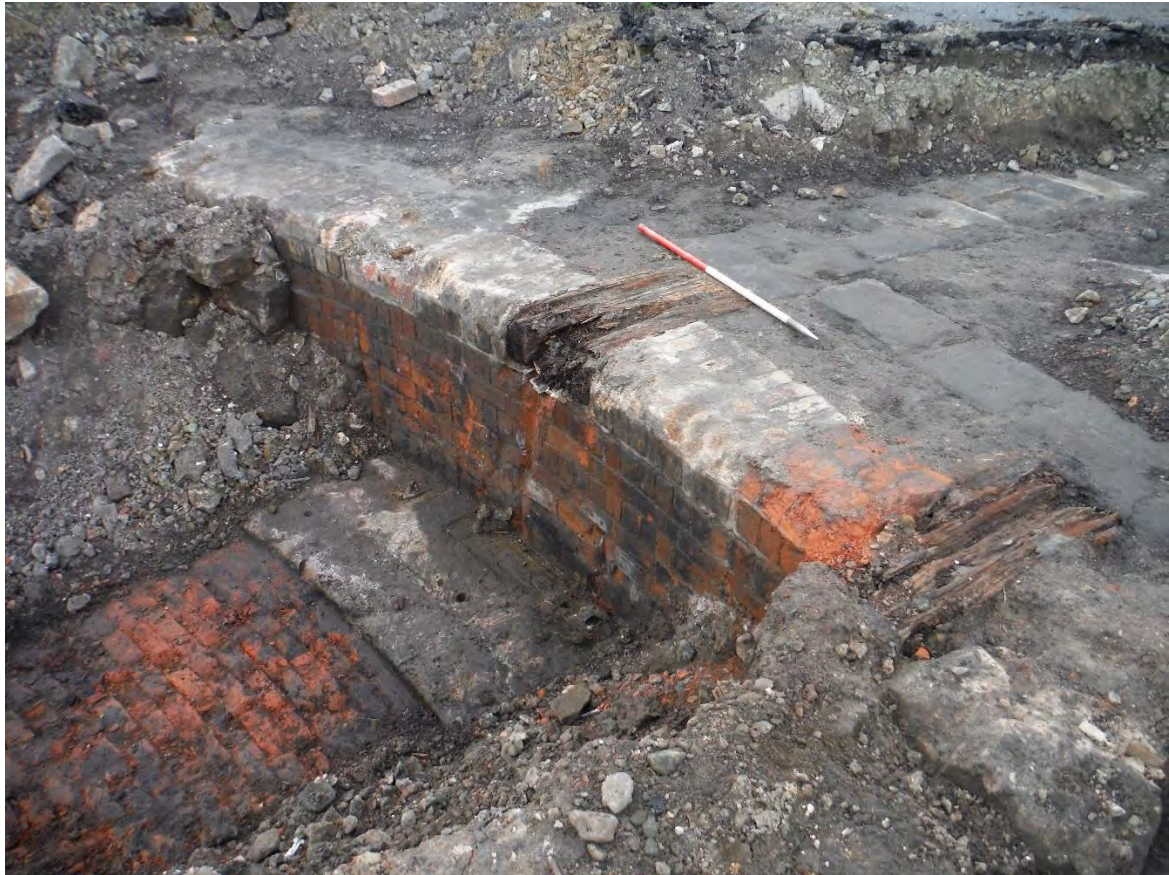
Plate 1 'Turning Platform' [108] with stone kerb [109] and brick floor [110]

- 4.3.2 Much of Trench 1 was difficult to interpret with large amounts of heavily compacted demolition material present beneath the tarmac and was crossed by a series of deep set large late 20th century drainage features. However, in the middle of the trench there was a concrete surface with wooden railway sleepers [106] surviving and at the eastern end of the trench was found more substantial railway remains relating to the mid-20th century version of the 'turning platform' as shown on Figure 9. This smaller 'turning platform' was constructed after the original roofed engine shed was demolished. The outer wall of the 'turning platform' [108] was constructed of brick and approximately a 5.0 m section somewhat damaged was revealed. Built from yellow brick in the upper two courses with red brick used for the lower seven courses it extended to a depth of 1.0 m where it rested on a 0.7 m wide stone kerb [109]. Inside the stone kerb there was a red brick brick floor [110].

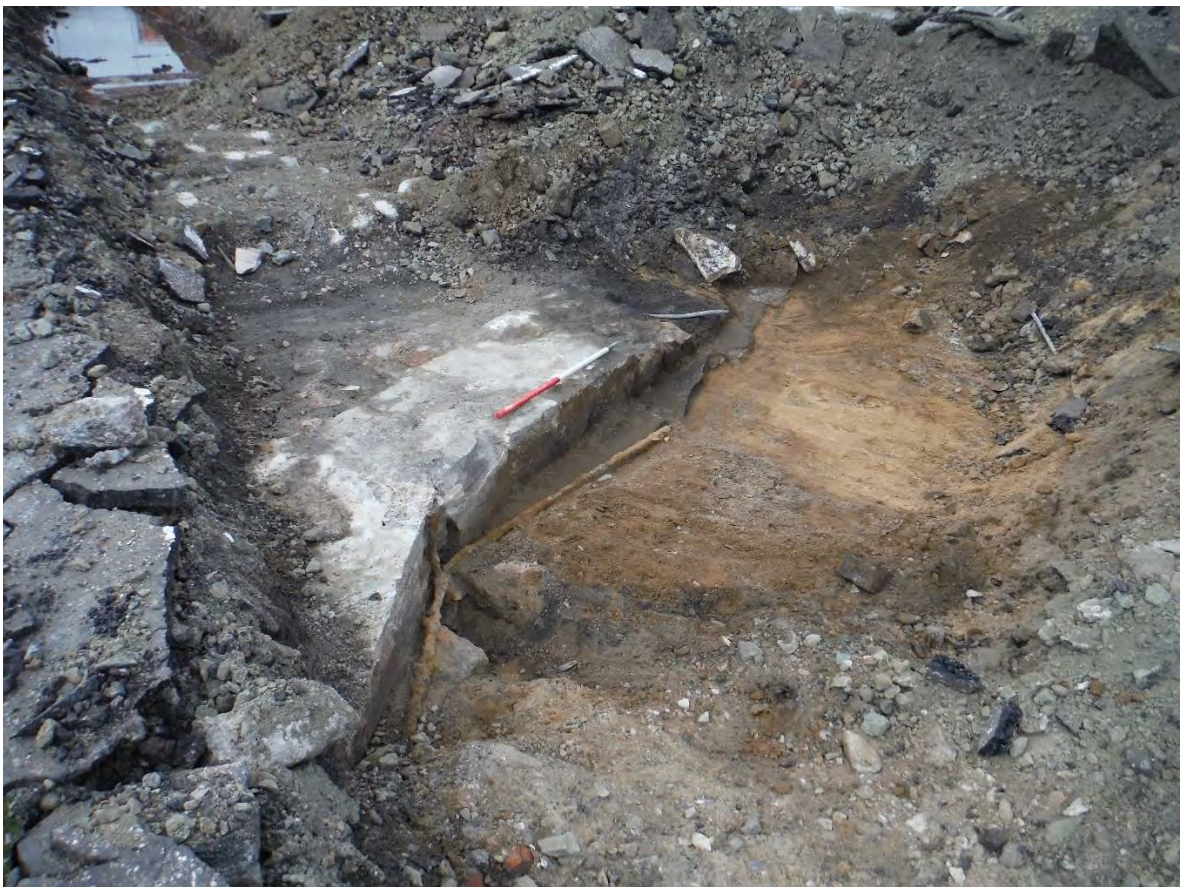
- 4.4.1 Trench 2 was aligned parallel to Trench 1 and also uncovered features relating to the 'turning platform' with two lines of stone slabs with railway fittings, [211] and [212] most likely representing two separate tracks connected to the later 'turning platform' [108] in Trench 1. Lying close to these were the remains of the original 'Engine Shed' from the 1850's visible as a section of large mortared sandstone wall [208]. The plans such that in Figures 4 to 7 show this as a large roofed circular engine shed which contained a 'turning platform'. The detailed plans, (Figure 17, Plate 3) show the perimeter wall of the shed was built in short straight sections rather than a continuous curving wall and feature [208] shows one of the angled joins between two short straight sections. The wall as exposed was 0.6 m deep with a stepped foundation and 0.8 m wide but unfortunately the northern end showed substantial disturbance.

Plate 2 Sandstone 1850's Engine Shed perimeter wall [208]

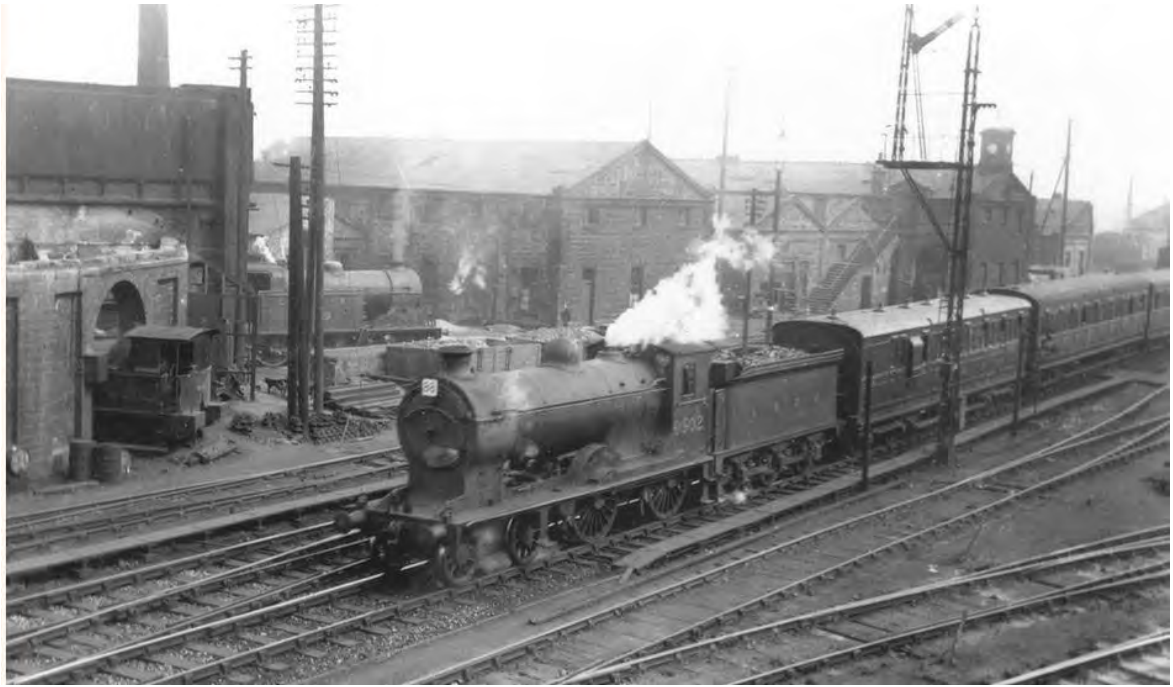
Plate 3 Showing 'Engine Shed' with roof removed early 20th century to left with 'Turner' Workshop' centre and 'Carriage Building and Tinsmith's Workshop' to the right

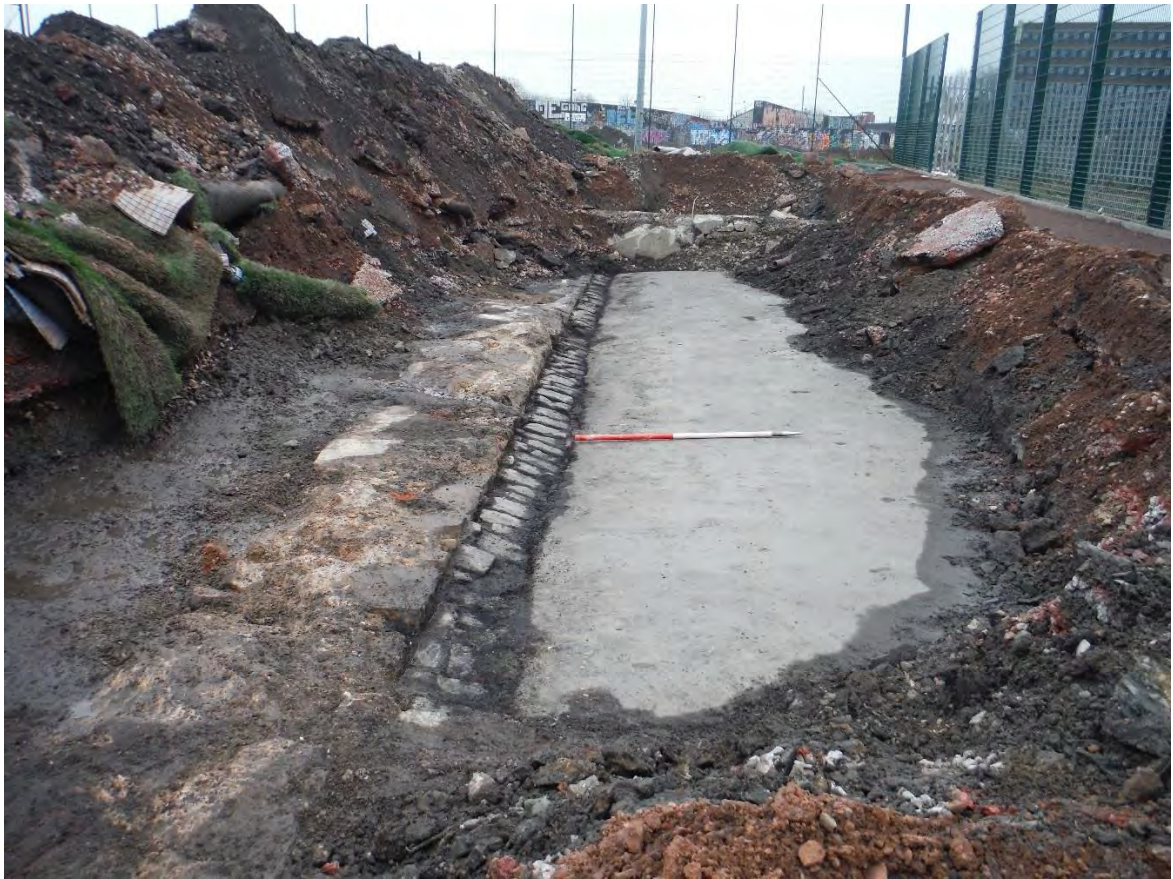
4.5.1 Trench 3 was also on an East to West alignment and was positioned over the front of the large east to West aligned building that formed the northern edge of the railway depot. On Figure 17 you can see this building labelled as 'Store', 'Offices' and 'Smith's Workshop' with the trench exposing elements of the 'Store' and 'Offices'. The majority of the trench revealed concrete flooring, [303], [305], [307] and [309] with c.North to South Brick walls forming internal divisions to the building. Wall [308] could feasibly mark the separation between 'Store' and 'Offices'. The front wall of this large two to three storey building is present as a sandstone built wall [312], with more than 13 m in length exposed revealing it to be 0.75 m wide with dressed stone and brown mortar. The foundations were not exposed as to the inside lay a concrete floor and to the outside, on the South there was a stone sett drain [313] lying parallel to the wall [312]. The cobble drain was partially covered by a tarmac surface [314] which it is believed may lie directly over the original 1850 cobble surface of the depot yard (Plate 4).

Plate 4 View of 1850 building wall [312] with associated cobble drain [313] and tarmac [314]

4.5.2 The Eastern extent of the building defined by [312] was truncated by a modern North to South aligned concrete base. This truncation can be seen in top of Plate 4.

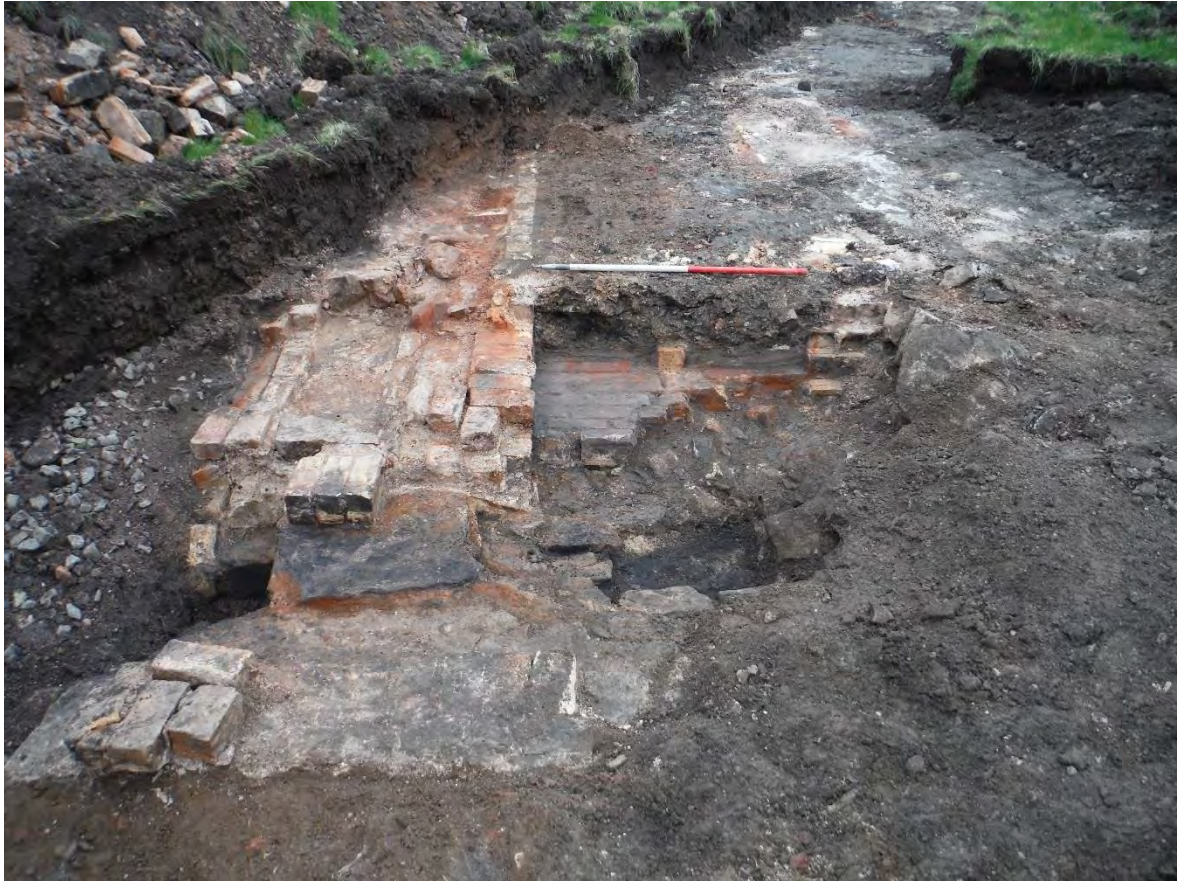
4.6.1 The main elements with Trench 4 which was aligned Northeast to Southwest comprise a flue system and the exterior wall of the 'Turner's Workshop' (Figure 17, Plate 3). The flue system [412] covered an area within the trench some 6.5 m by 4.5 m North to South (Plate 5). It was primarily brick built with two parallel brick built walls, [413] and [414] with a brick floor [415]. At the South end it there was brick wall sealing the end [418] made of firebricks over concrete. Walls [413] and [414] were made of an outer and inner brick wall with stone rubble infill and each measured about 1.2 wide in total. Between these two walls there was red brick floor, 1.1 m wide with a central divider of set firebricks. The flue had been backfilled with sand and the upper part of demolished flue. There was evidence of heating to surround subsoil.

Plate 5 View flue system in Trench 4

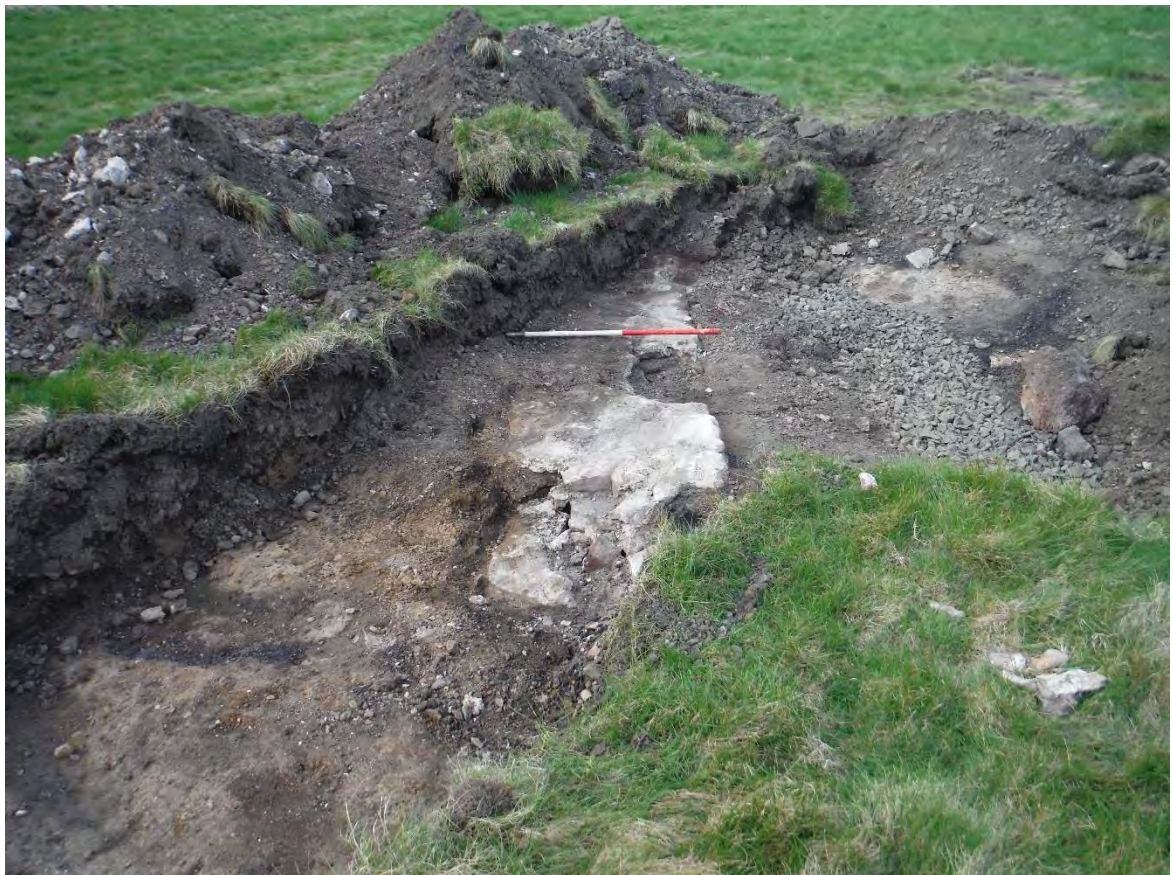
4.6.2 At the northern end of Trench 4 there was revealed a large sandstone wall [420] constructed of mortared, dressed sandstone blocks which match with the 'Turner's Workshop' as shown on Figure 17 and Plate 3. The wall was 0.9 m wide and over 5 m was exposed (Plate 6).

Plate 6 Sandstone wall [420]

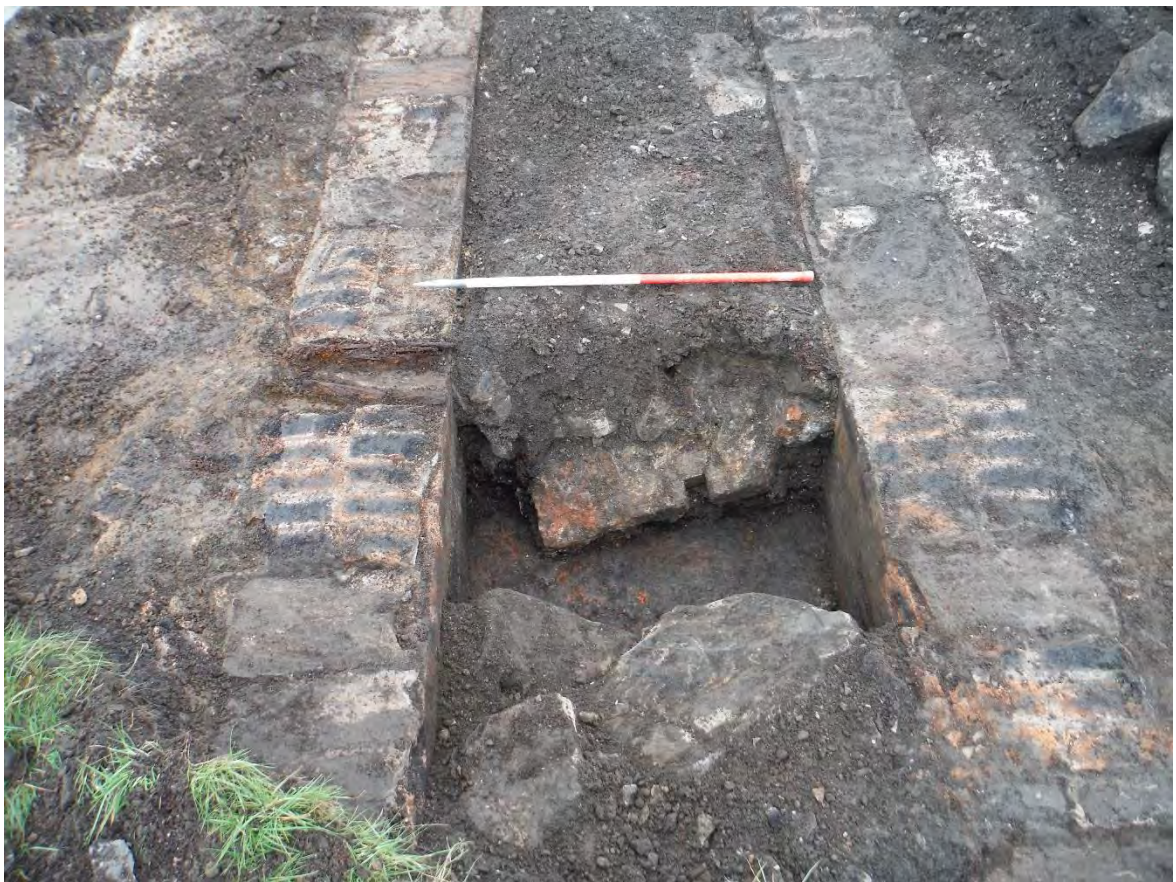
Plate 7 Brick inspection channel [514] & [515]

- 4.7.2 Within the interior of the building defined by sandstone wall [506] and [520] there were a series of at least four brick built parallel channels, inspection pits. These were designed to take rails presumably for the carriages during construction. These brick channels comprised double thick brick walls, [507] & [508], [510] & [511], [512] and [513] and [514] & [515]. Plate 7 shows a slot through one of the channels which were backfilled with demo material and cinder. The channels were about 1.0 m wide and the locations of wooden crossmembers could be seen which presumably held railway tracks. A brick square structure [516] can be seen as contemporary and associated with these features.

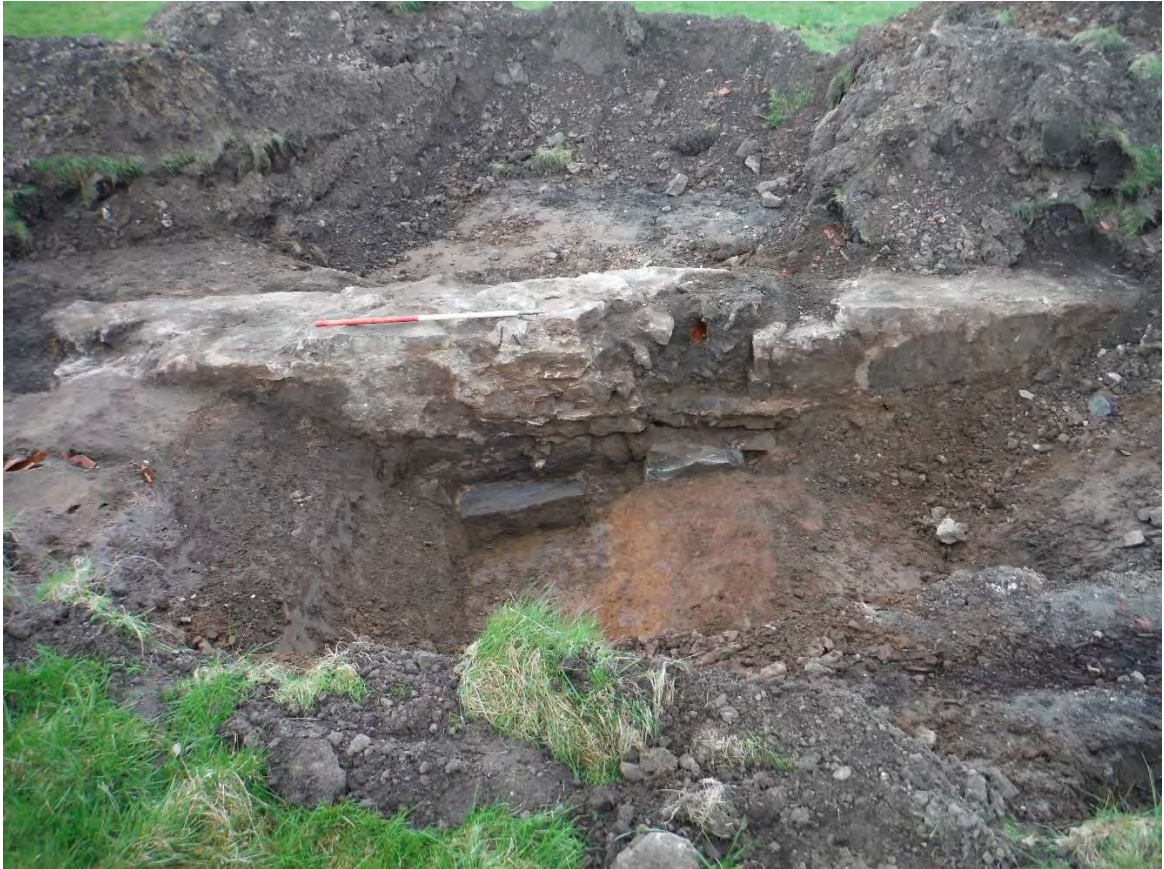
Plate 8 Sandstone wall [506] showing foundation step and modern service cut

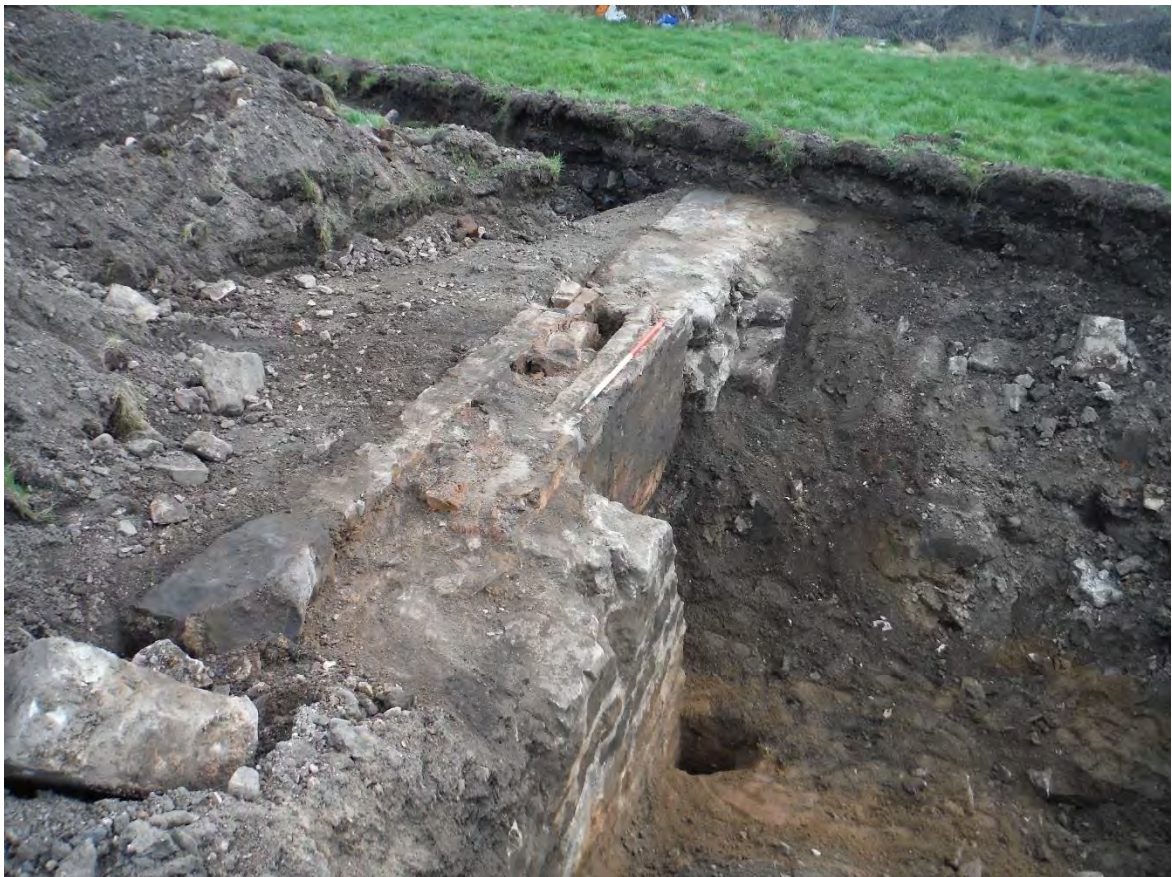
- 4.7.1 Both Trench 5 and Trench 7 were as placed over the 'Carriage Building and Tinsmith's Workshop' shown on Figure 17 and in Plate 3. In Plate 3 the building is seen as slightly smaller than the 'Turner's Workshop' though the walls found in trench 5 and 7 are substantial. In Trench 5 at the Southwest end of the trench is found the c N-S external wall [506] and at the other end of the trench the East to West external wall [518]. Both walls are built of mortared, dressed sandstone blocks. Wall [506] was exposed along a length of 8 m but was partially truncated to the north and south and cut by a later service (Plate 8). It measured 0.9 m wide with a depth of 1.0 m and had a stepped foundation. In contrast wall [518] was much deeper and larger in construction with more than one phase of building apparent with brick augmentations visible [520] (Plate 9). It was over 2.3 m deep, up to 1.2 wide and extended for 7 m. The bricks [520] had been used to block a hole in the wall.

Plate 9 Sandstone wall [520] showing later brick augmentation

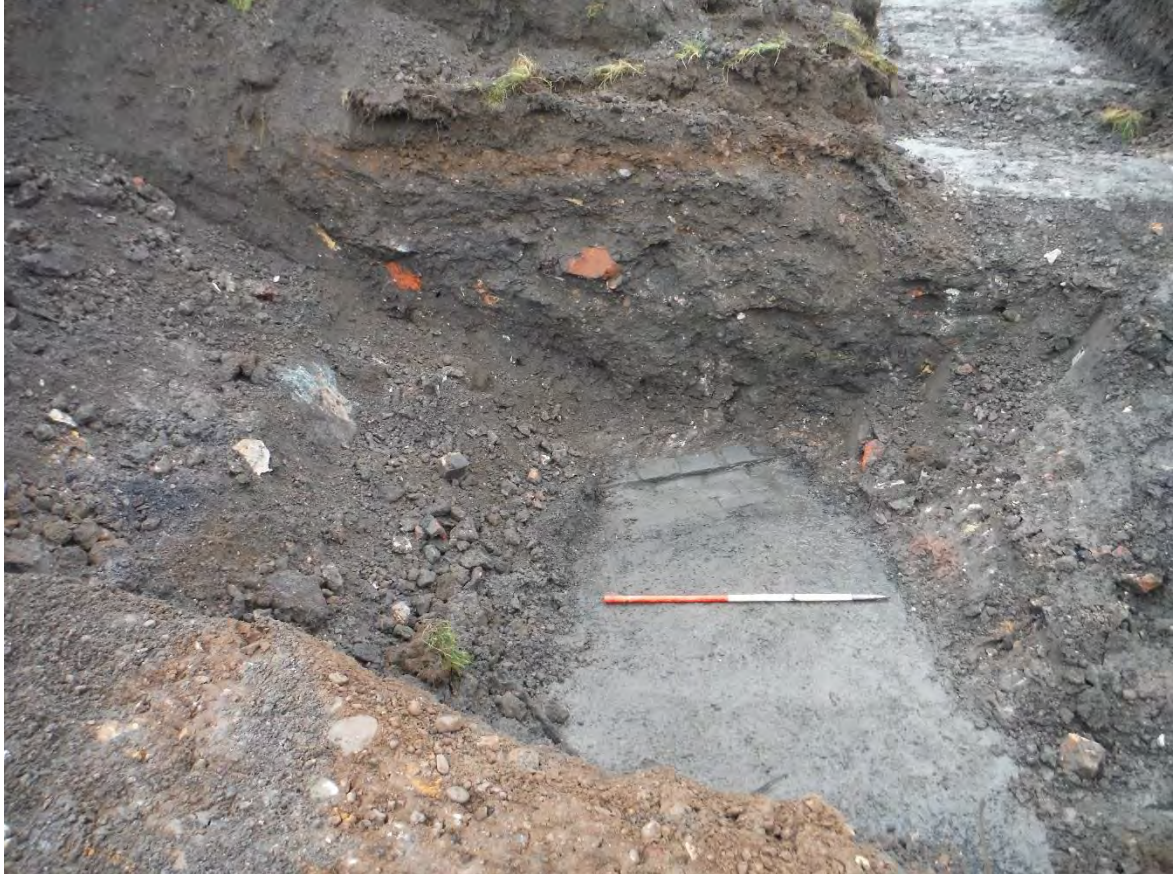
- 4.7.3 The last feature in Trench 5 was the remains of 'Clockmill Lane' the c East to West aligned road which defined the northern extent of the mid-19th century railway buildings. This road was found 1.5 m below the ground level and comprised cobble sett drain [523] with what would appear to be a later tarmac covering [522]. It is likely the original setts from the 1850's survives under the later tarmac (Plate 10).

Plate 10 Showing 'Clockmill Lane' tarmac [522] and setts drain [523] under 1.5 m of made ground

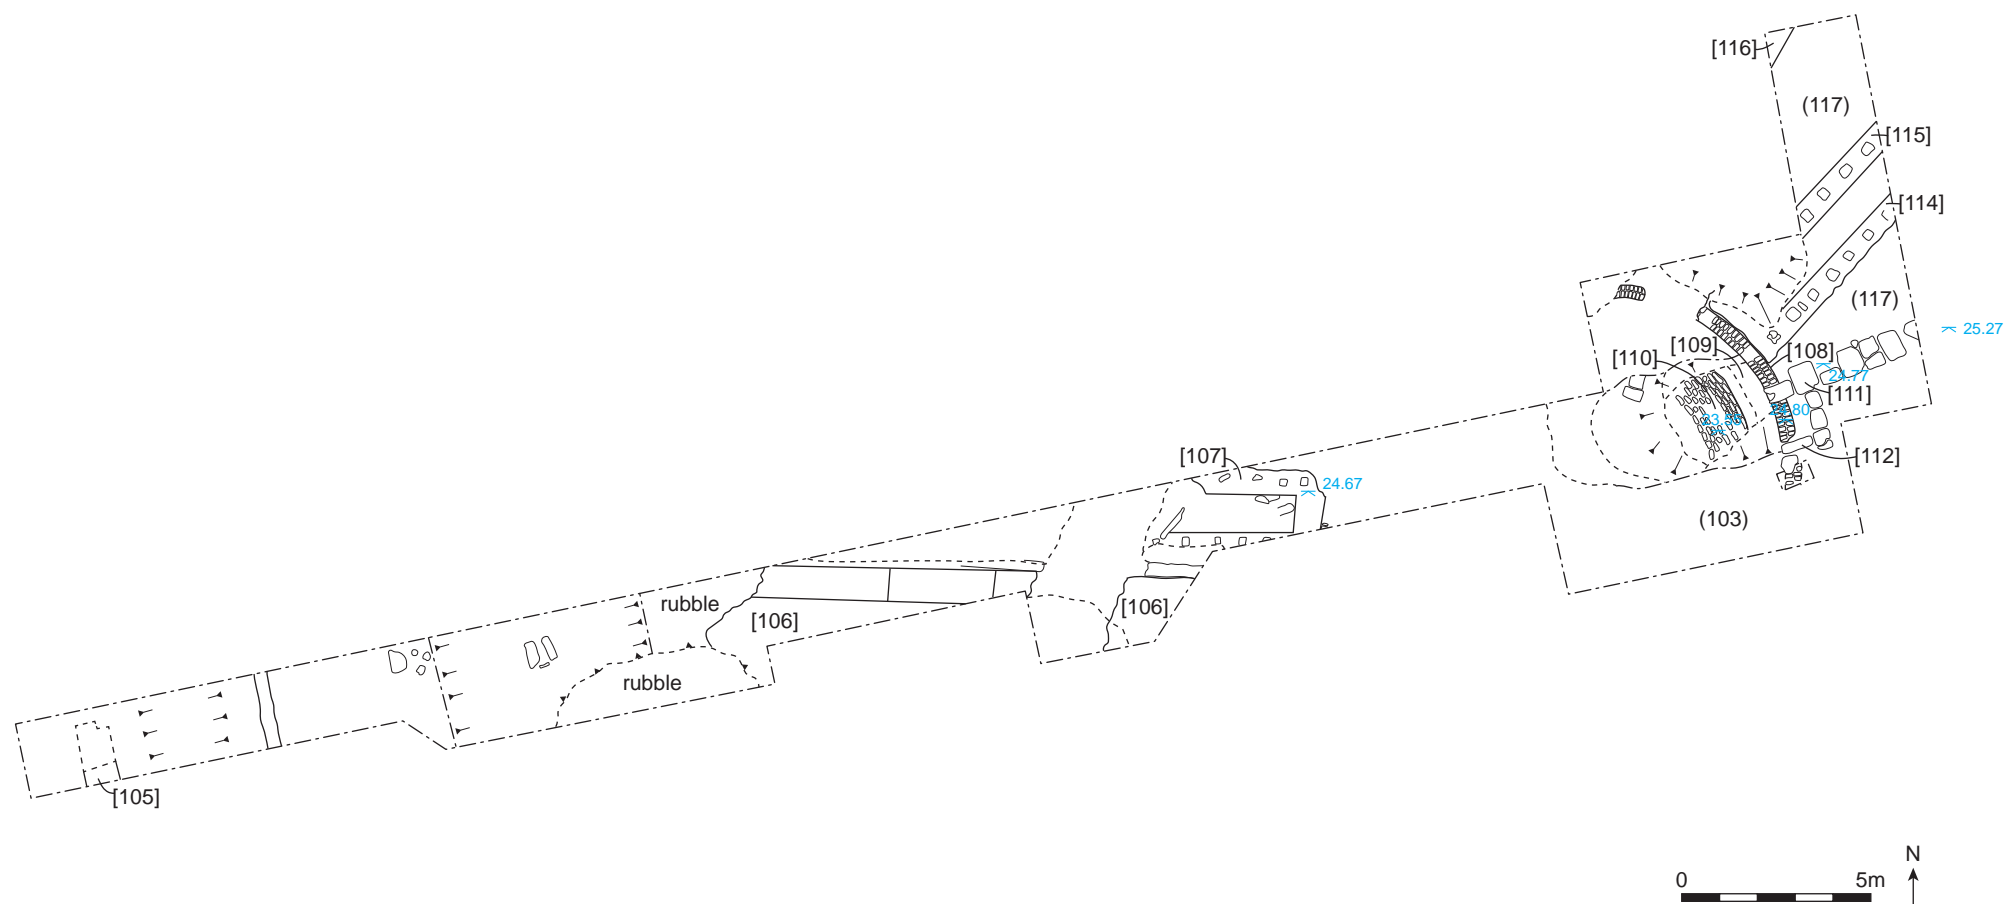
Figure 10: Plan of trench 1

- 4.3.3 Lying directly outside brick rim of the 'turning platform' there was a stone slabs [111] some of which had cut holes presumably for fittings or railings. Also set into the brick rim [108] were occasional wooden railway sleepers [112] for rail tracks. As can be seen in Figure 9 radiating from the turning platform were sixteen sets of railway tracks and [114] and [115] are one of these tracks. They comprised concrete strip with cast iron fixings for rails.

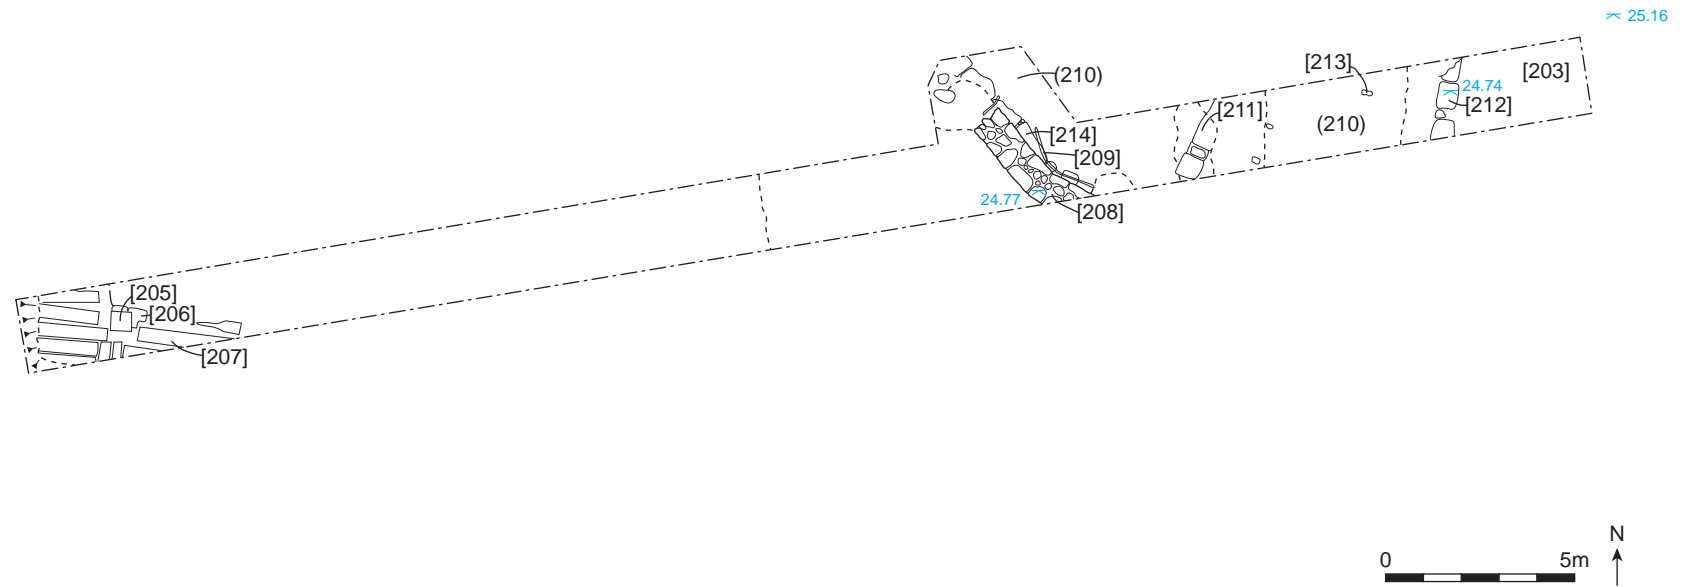
Figure 11: Plan of trench 2

- 4.4.2 At the western end of Trench 2 there was a series of reused wooden sleepers [207] laid together to form a surface set around large squared stone block [205] and [206] with associated metal fittings.

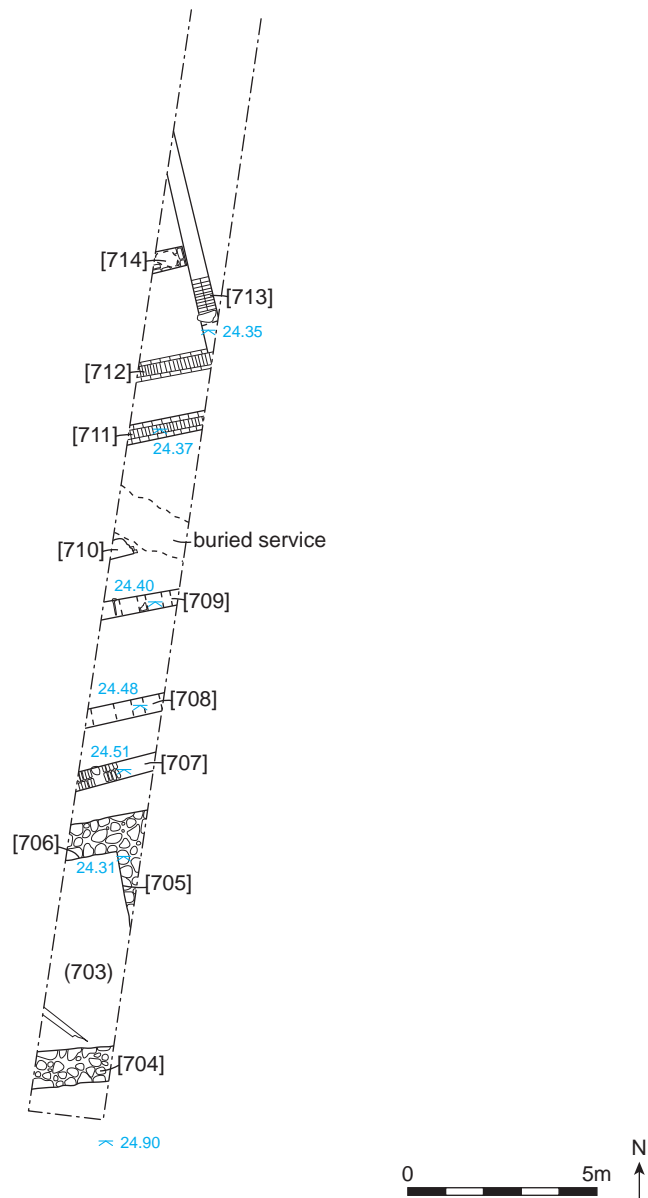
Figure 16: Plan of trench 7

- 4.9.1 This trench mirrored the findings in Trench 5 with many features representing brick channels encountered [707] & [708], [709] & [710] and [711] & [712] and East to West tarmac road [715]. However, there was another brick wall running perpendicular to the channels [713] which appeared to signify the eastern extent of these channel features. Also, to the south there were three large sandstone walls [704], [705] and [706]. The walls were similar in size with widths of 0.90 m and construction, mortared dressed sandstone blocks. Wall [704] corresponds to the external southern wall of the 'Carriage Building and Tinsmith's Workshop' shown on Figure 17 and in Plate 3 with walls [705] and [706] appearing to lie within the building. These two sandstone walls are the only two such internal walls identified and may suggest a different phase of buildings.

- 4.9.2 At the Northern end of Trench 7 another section of tarmac road [715] was encountered matching that found in Trench 5 and on the expected alignment of 'Clockmill Lane'
