# A9 Dualling Tay Crossing to Ballinluig, Supplementary Ground Investigation Archaeological Watching Brief Data Structure Report

# A9 Dualling Tay Crossing to Ballinluig, Supplementary Ground Investigation

## Archaeological Watching Brief Data Structure Report

On Behalf of:	Transport Scotland (undertaken on behalf of Soil Engineering Geoservices Limited)
National Grid Reference (NGR):	OS NGR 295659E 756396N to 273172E 770324N
AOC Project No:	70386
Prepared by:	L. Teufel
Illustrations by:	S. Williamson
Date of Fieldwork:	7 <sup>th</sup> March to 26 <sup>th</sup> April 2019
Date of Report:	24 <sup>th</sup> June 2019
OASIS No.:	aocarcha1-348641

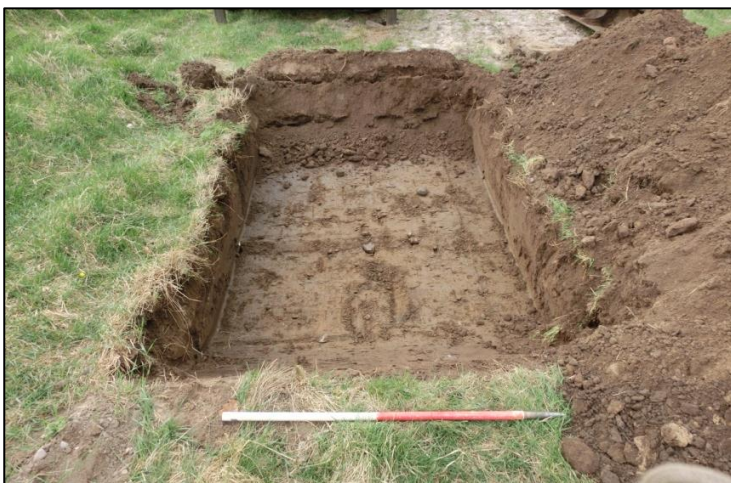
**Plate 1: A typical trial pit (TBT4049)**

- 5.3 The trial pits were between 1.3-4.1m long and between 0.6-2m wide (**Plates 1-3**). The size of some trial pits was limited by thick vegetation and tree cover. The trial pits were extended to a depth of 4.5m or 6m after completion of archaeological excavation unless groundwater, collapse or other unavoidable factors prevented further excavation.

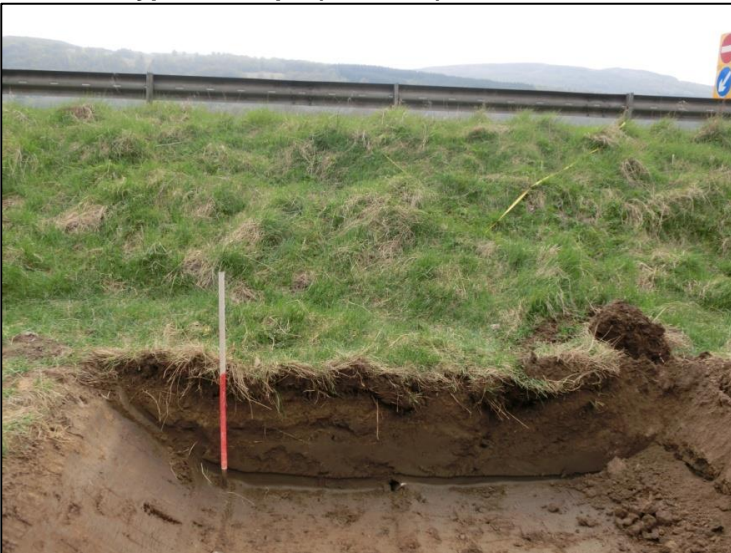
**Plate 4: A typical soil profile (TBT4049)**

- 5.4 In general topsoil was dark brown sandy loam between 0.03-0.6m deep. The natural subsoil was mostly light or mid orange-brown sandy silt with occasional small sized sub-rounded and rounded stones (**Plates 4-6**). Made ground was also frequently encountered. Some variations in colour and composition of the subsoil were observed across the site.
