# Leith Links, Edinburgh Archaeological Watching Brief & Metal Detecting Survey: Data Structure Report

## Leith Links, Edinburgh: Archaeological Watching Brief & Metal Detecting Survey Data Structure Report

On Behalf of: Edinburgh & Lothians Greenspace Trust

AOC Project No: 24845

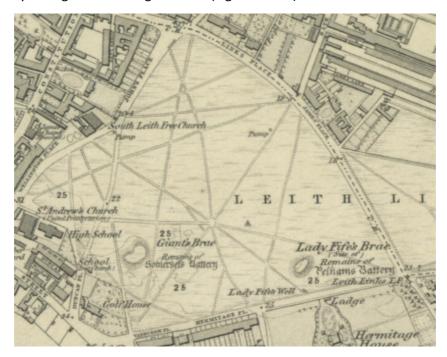
Figure 2: Extract from the 1st Edition OS 6 inch map.

3.1 The site lies to the east of the medieval port of Leith (Figure 1). Cartographic evidence suggests that area has not been heavily developed from the end of the medieval period until the present day (Figures 2 & 3). However, two mounds within the park, locally known as Giant's Brae and Lady of

Fife's Brae, have been identified as the sites of possible gun emplacements built by the besieging English army during the 1560 siege of Leith (Figures 2 & 3).

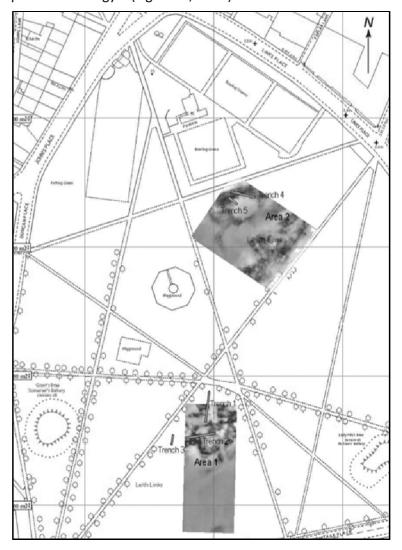
3.2 A geophysical survey was undertaken on parts of Leith Links in 2006 in order to assess the survival of earthworks associated with the 1560 siege. This showed a number of anomalies. In 2007, five trial trenches were dug across some of these anomalies (Figure 4). Nothing of archaeological interest was recorded in trenches 1-3. In trenches 4 and 5 a linear bank and a shallow ditch were recorded. It has been suggested that this might be the linear siegework depicted in a near contemporary map of the siege of Leith (Figure 5). However, no dateable artefacts were recovered from this feature and it was concluded that a larger excavation would be required to definitively determine its date and nature (Pollard 2008). Trenches 4 and 5 and the possible military earthwork

was of particular significance to this project as it appears that the linear feature will run through the site of the proposed outdoor gym (Figures 1, 4 & 5).

Figure 4: Plan of the geophysical surveys and excavations carried out in 2006-2007. Note the linear feature running WSW to ENE through both trenches 4 and 5 and the area of the proposed outdoor gym (taken from Pollard 2008).

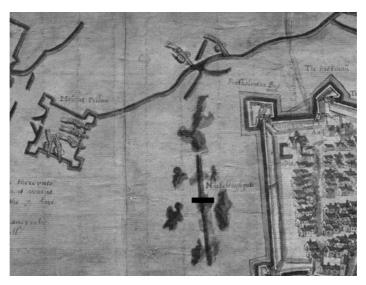
Figure 5: Extract from the Petworth Map showing the approximate location of trench 4 in Leith Links as a thick black line. Note that it transects the linear earthwork apparently related to the siege (taken from Pollard 2008).

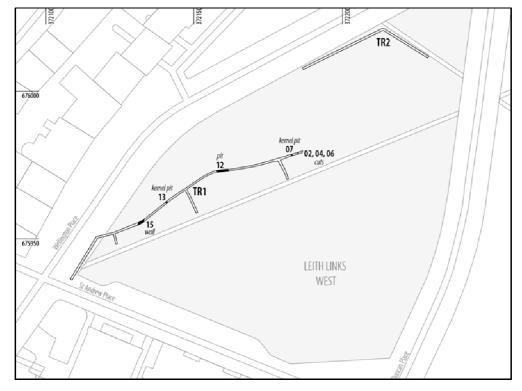
Figure 6: Plan showing results of 2015 watching brief (taken from Dalland 2015).

3.2 In 2015 an archaeological watching brief was undertaken by Headland Archaeology on the excavation of cable trenches in the west of Leith Links (Dalland 2015). The excavations uncovered a number of disarticulated human bones in charnel pits (Figure 6). A stone wall (Figure 6) was also uncovered. It is known that plague victims were buried in Leith Links and it is believed that the human remains found during the watching brief died during a medieval or early modern plague epidemic (Turner Simpson et al 1981). There is no record of the wall on any ordinance survey map and it is therefore most probably pre-nineteenth century in date.

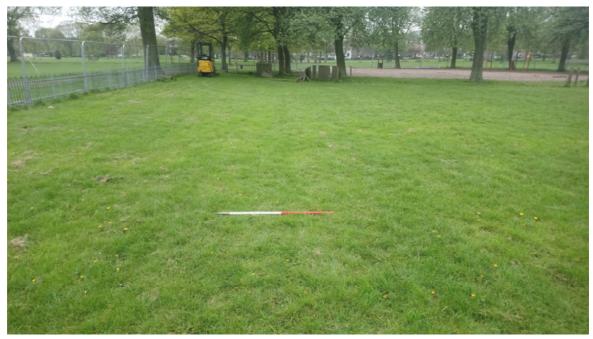
Plate 1: General shot of area, pre-excavation

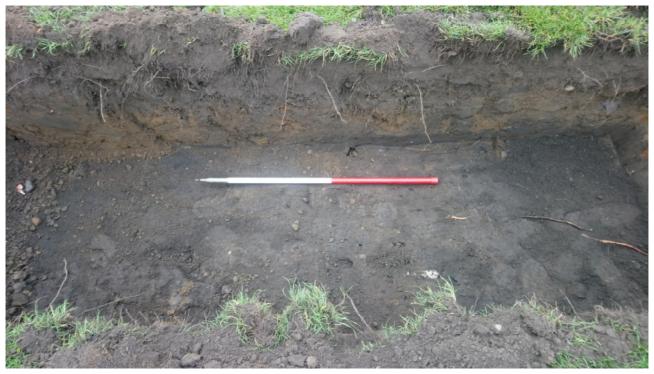
Plate 2: Test-pit 1

- 5.2.2 Excavation revealed a loamy clay topsoil ranging between 0.27 m and 0.35 m across the area. A dark grey/dark brown silty sand with small stone inclusions appeared immediately beneath the topsoil running to a depth of 0.50 m to 0.60m. A natural subsoil of light brown/yellow sand was reached between 0.55 m and 0.70 m throughout. The area strip undertaken between Test-pits 4 and 5 reached a formation level of 0.25 m.

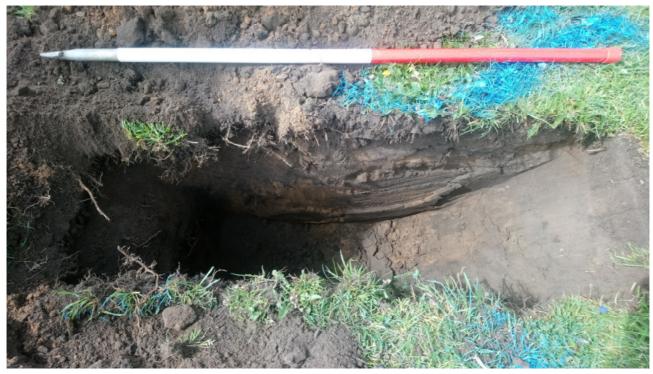
Plate 8: Test-pit 7

- 5.2.1 The watching brief consisted of the excavation of 7 test-pits and 1 topsoil area strip. All work was undertaken to the north of the existing playpark area, with the exception of Test-pit 7 which was located to the north-east.

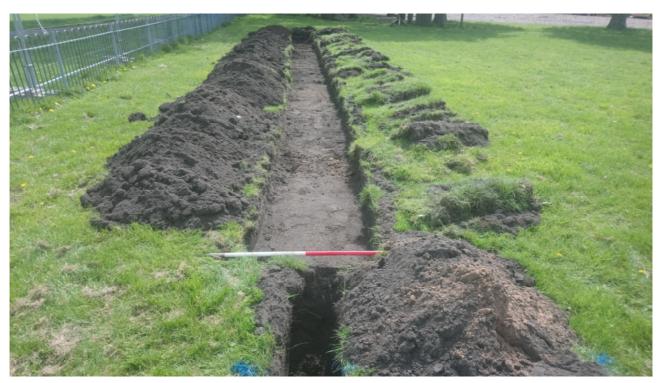
Plate 9: Area strip between Test-pits 4 and 5

6.1 The negative linear feature [004] (Plates 9-10) was possibly a ditch later backfilled to level the ground for the park. The material of its fill suggests that it is possibly of 19<sup>th</sup>-early 20<sup>th</sup> century date.

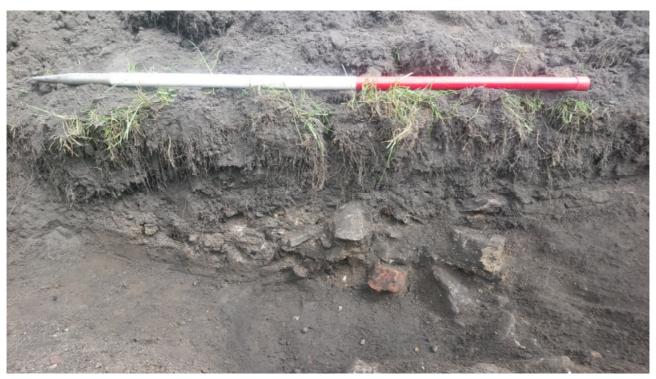
- 5.2.3 A linear cut feature [004], was observed running NE-SW 1.7 m from the NW end of the area strip to the east of the development area. The feature was 1.07 m wide and appeared immediately beneath the topsoil. The cut was steeply sloping (45 degrees) with an uneven flat base and a depth of 0.28 m. The feature extended beyond the limits of the excavation and was filled by broken brick and crushed stone mixed with sand. No artefacts were found.

Plate 10: Rubble filled linear [004], South-West facing section

7.1 No further archaeological works are considered necessary within the development area. This will need to be confirmed in writing by CECAS on behalf of the CEC.

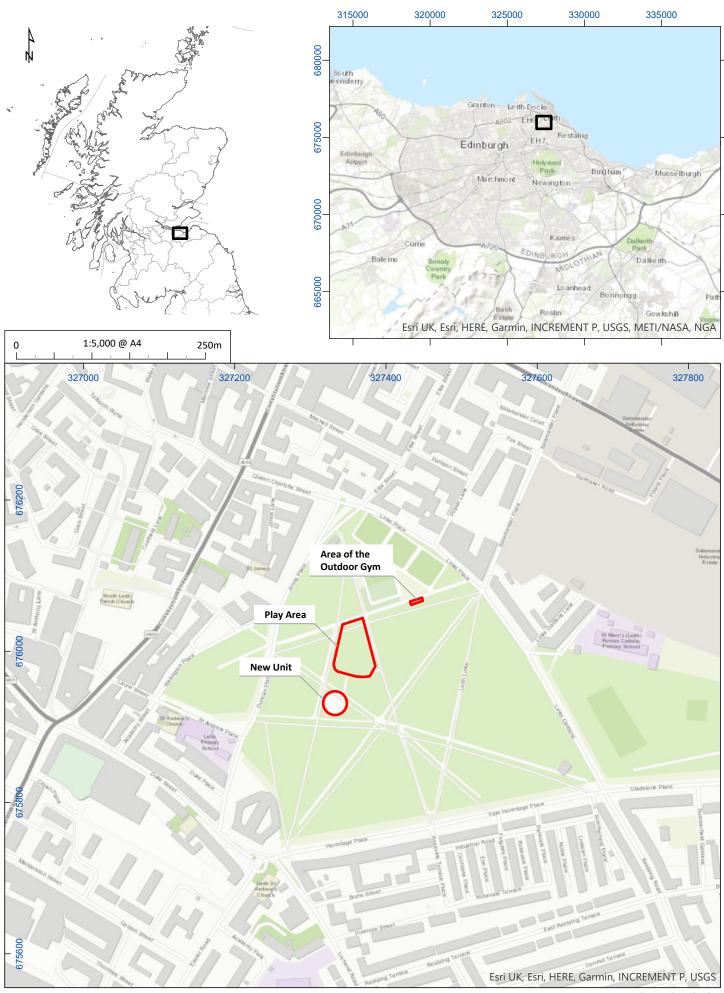
Figure 1: Site location plan

1.2.1 The development area lies in the centre of Leith Links (Figure 1) (NT 27369 75968). Most of the work took place on the site of the existing play area. An outdoor gym will be built to the north-east of the play area and a net unit will be erected to the south.
